Large Landslide Repair in an Area of Limited Data I-64, MP 45.65 Slope Repair – Horizontal Drains

August 17, 2017

Jonathan Brown, PE

Staunton District Materials

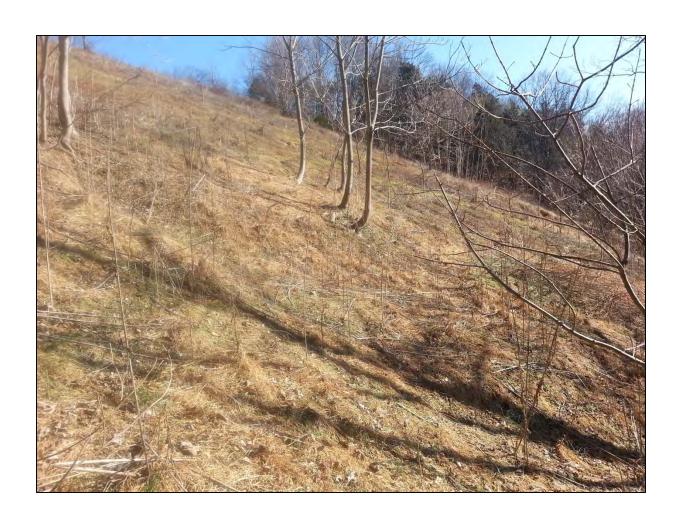
J'ed Trees on the Slope

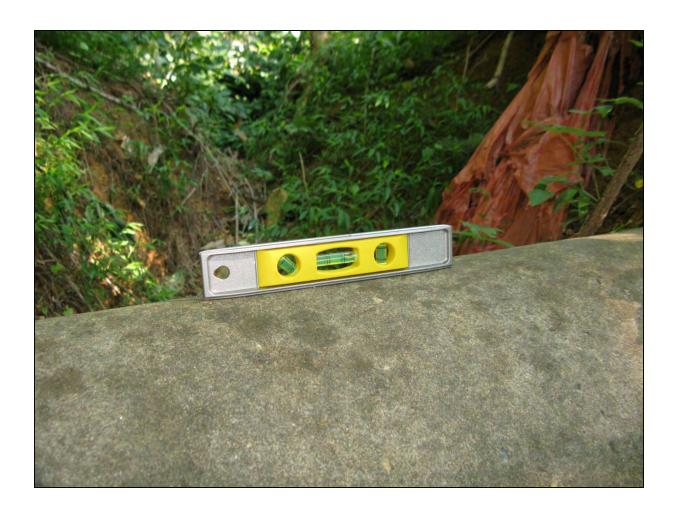
Drainage out of Slope

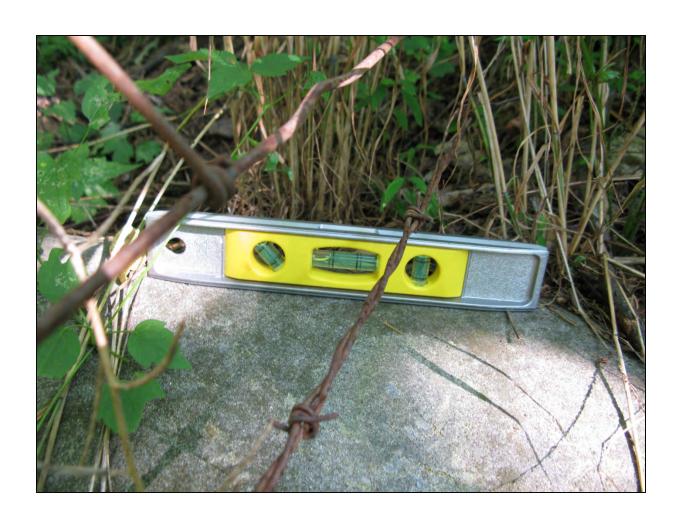
Drainage into Cistern

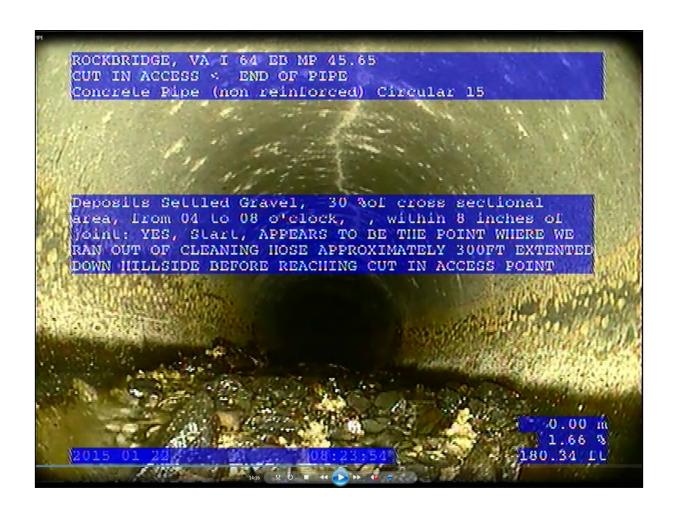
Sag in Drainage Pipe
