"Drilled Shafts for Bridge Foundation Stability Improvement Ohio 833 Bridge over the Ohio River" An Update

Meigs County, Ohio Mason County, West Virginia

By Stan Harris, P.E. and Eric Kistner, P.E. FMSM Engineers

Geohazards in Transportation Appalachian Region Technical Forum August 1-2, 2007

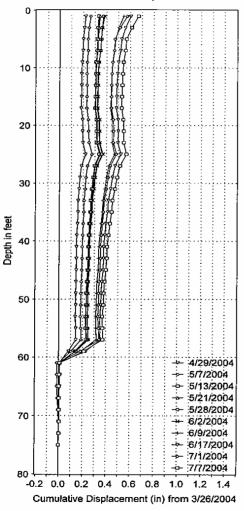
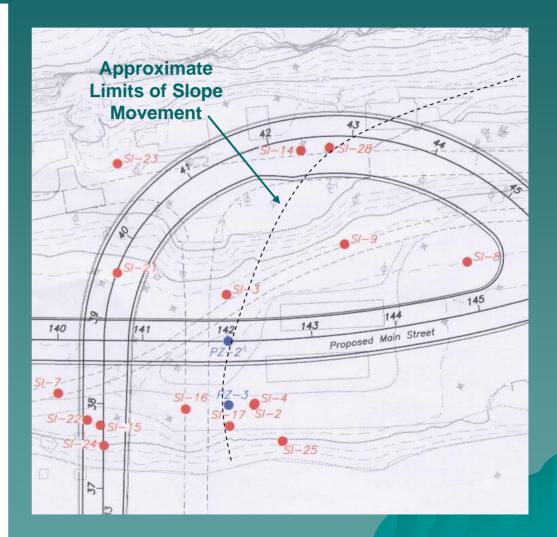
Original Extents of Slope Movement

Weak slickensided clay shale (mudstone)
 Possible ancient movement
 Construction activity/embankment
 Rapid drawdown cycles of Ohio River

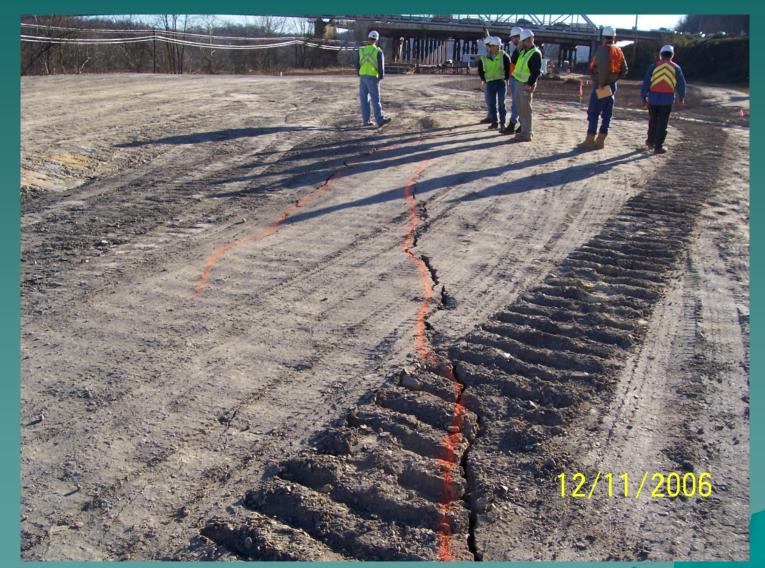
Tension Cracks – 12/11/06

- Instrumentation Activity (late October)
 Tension Cracks (early December)
 Water Main Break (early December)
 Causes
 - Construction Activity
 River Fluctuation

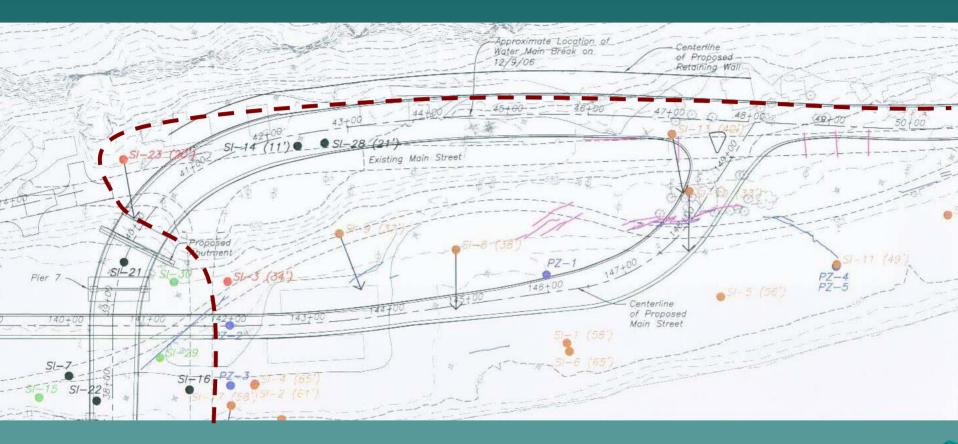
Current Extents of Slope Movement

Limits of Movement

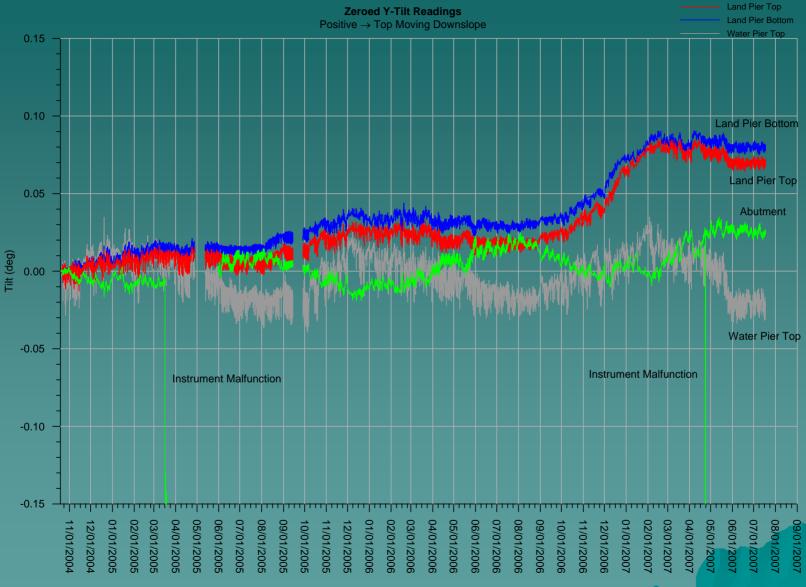
Existing Bridge Tiltmeter Results

- 4 Years of Data
- Numerous Inclinometers Sheared Due to Slope Movement
- Existing Bridge
 - 3 Years of Data
 - Abutment Tilt Due to Recent Movement
- New Bridge Touch Down Pier
 - 3 Years of Data
 - Top Deflection Due to Lateral Loading
- Stabilization Shafts
 - -2 Years of Data
 - Northernmost Shaft Being Loaded

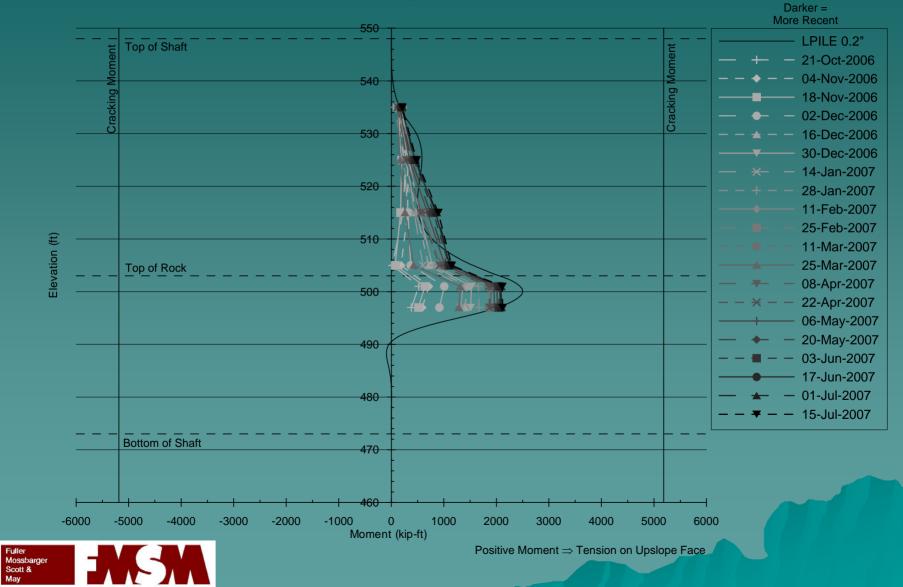
Stabilization Shaft Strain Gage Results

SS9: Moment Diagram
