West Virginia Route 2 Rock Fall Hazards at "The Narrows" Using a Rock Fence Catchment System for Remediation

Aaron L. Wentz WV DOT

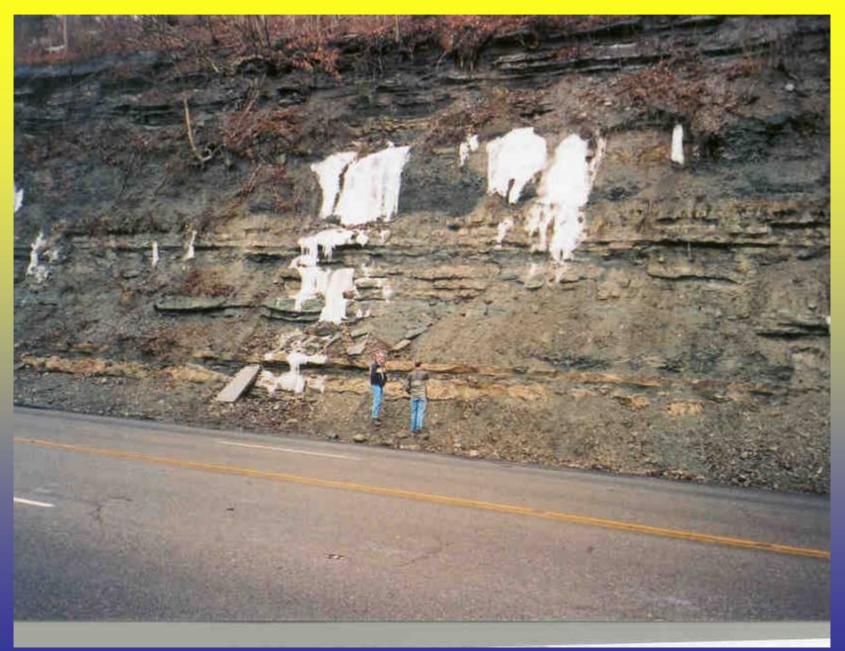
Northbound Lane Rock Cut Prior to Construction

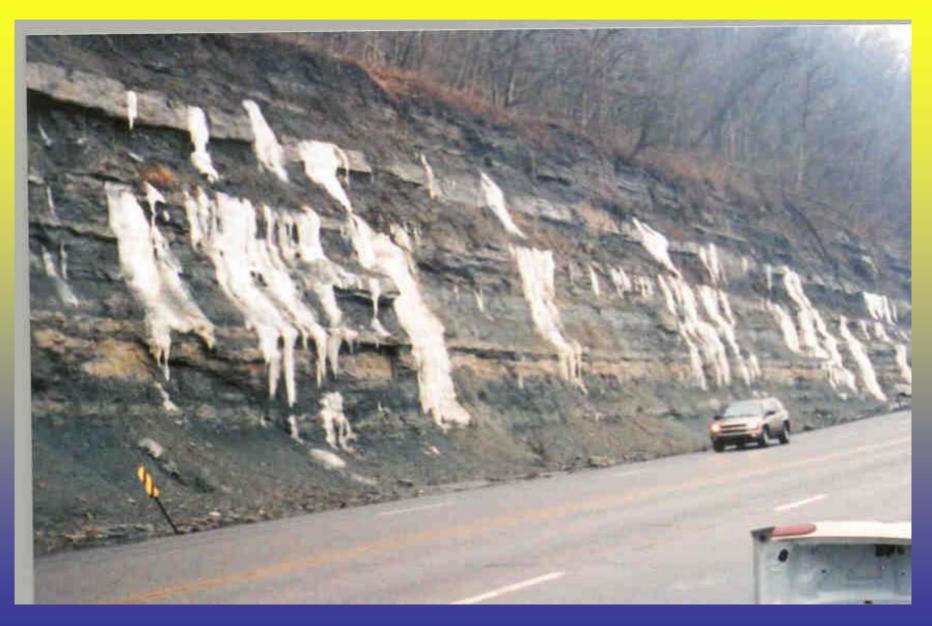
Northbound Lane Rock Cut Prior to Construction

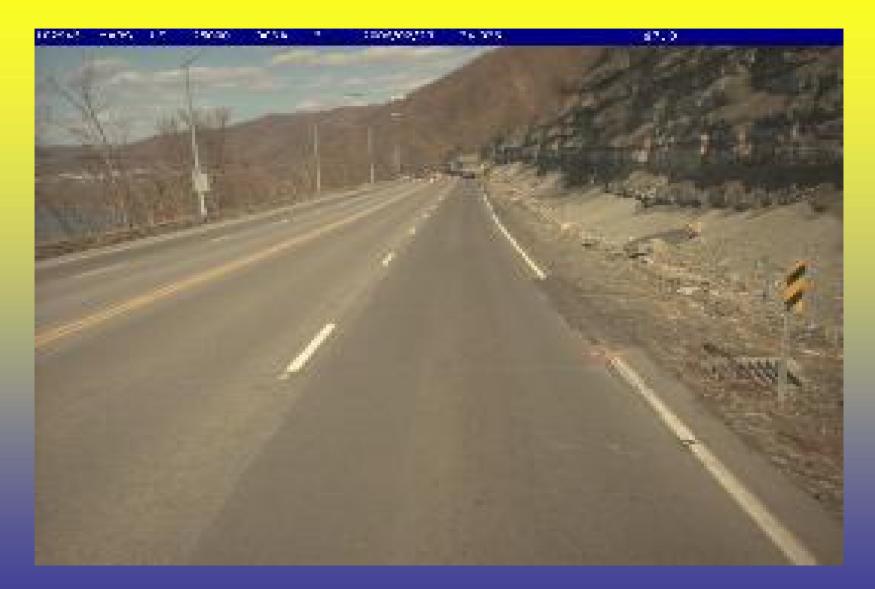
Northbound Lane Rock Cut Prior to Construction

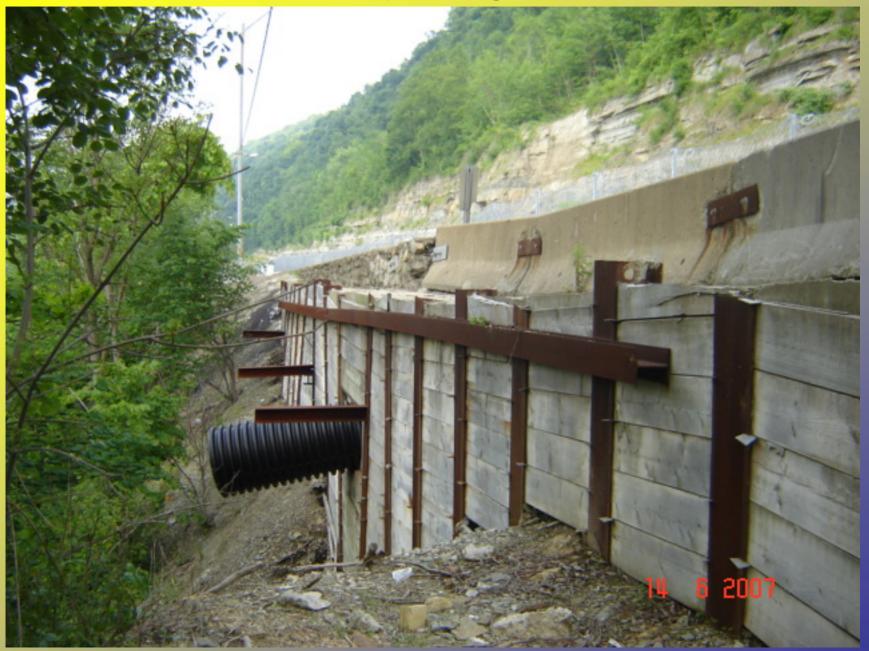
Soldier Pile Wall Repair Along Southbound Lane

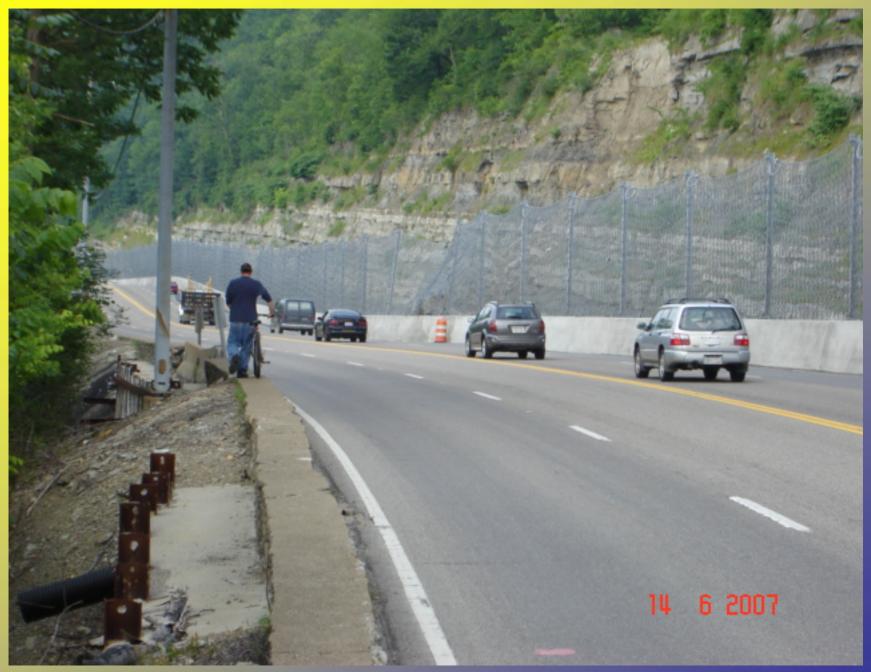
Narrow Shoulder With "Modified" Bike Path!

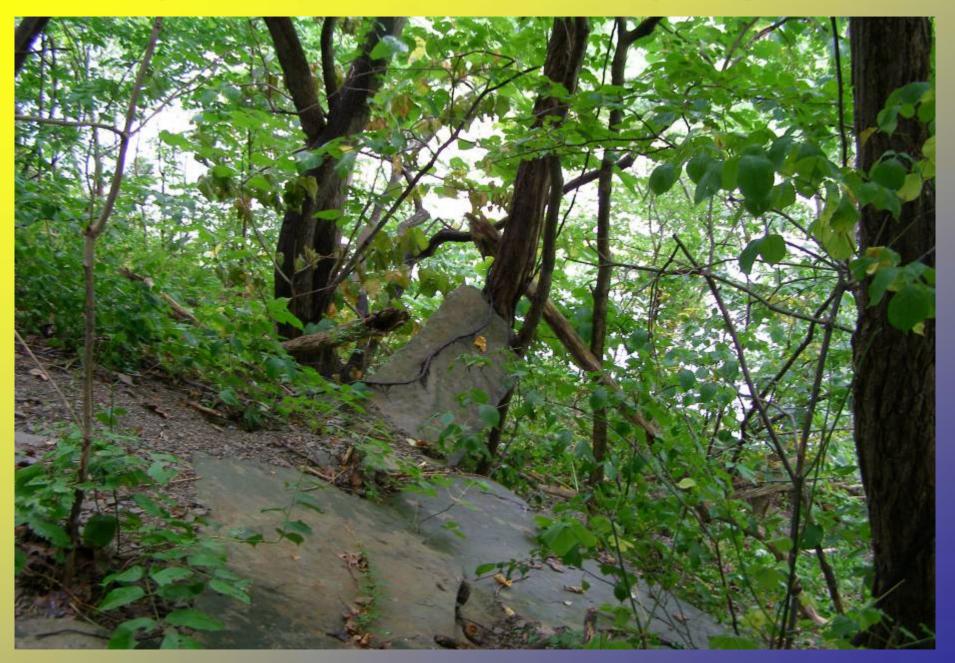
Vegetated Slope Above Rock Cut Catching Falling Debris

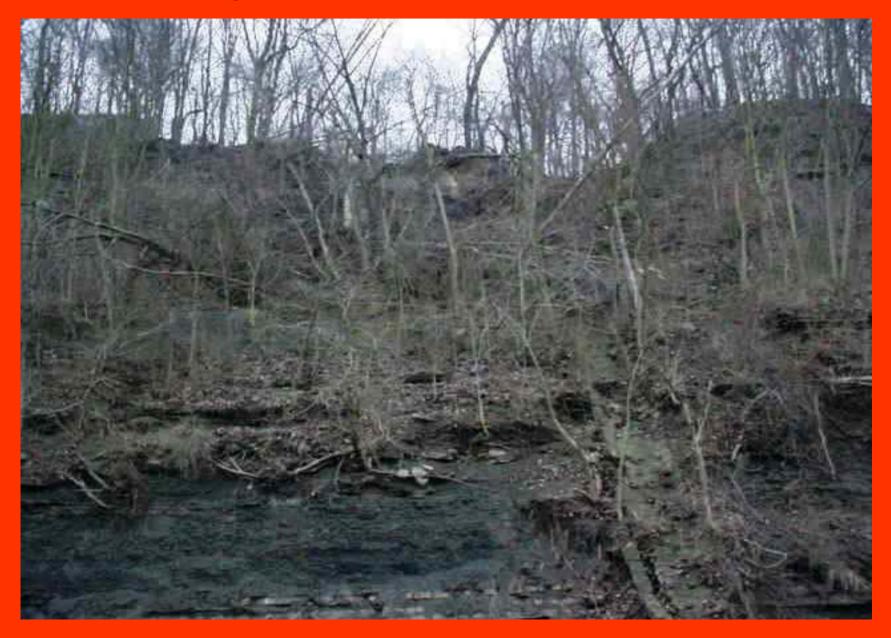
Origin of March 25, 2005 Rock Fall/Debris Flow

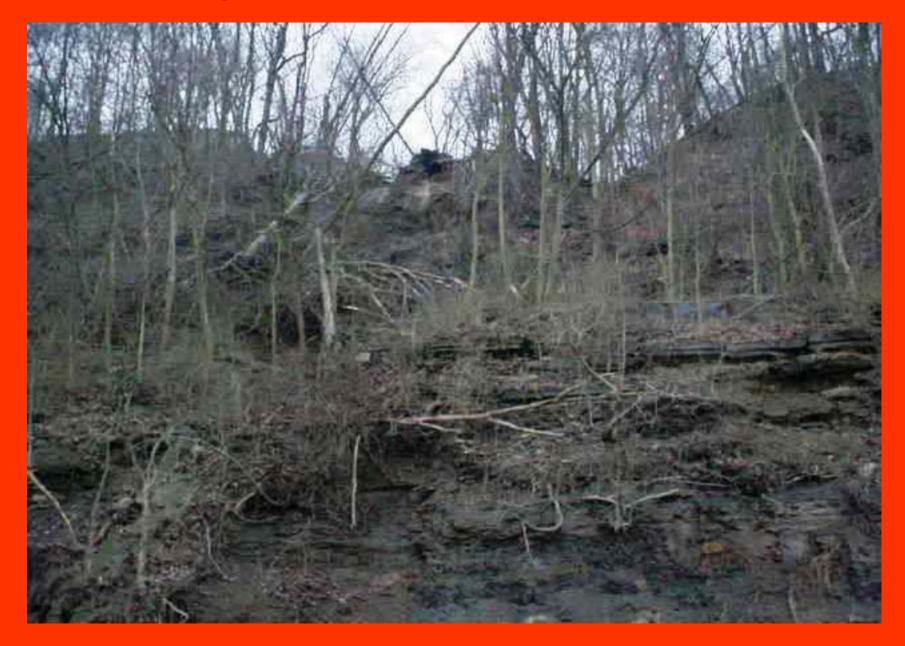
Origin of March 25, 2005 Rock Fall/Debris Flow

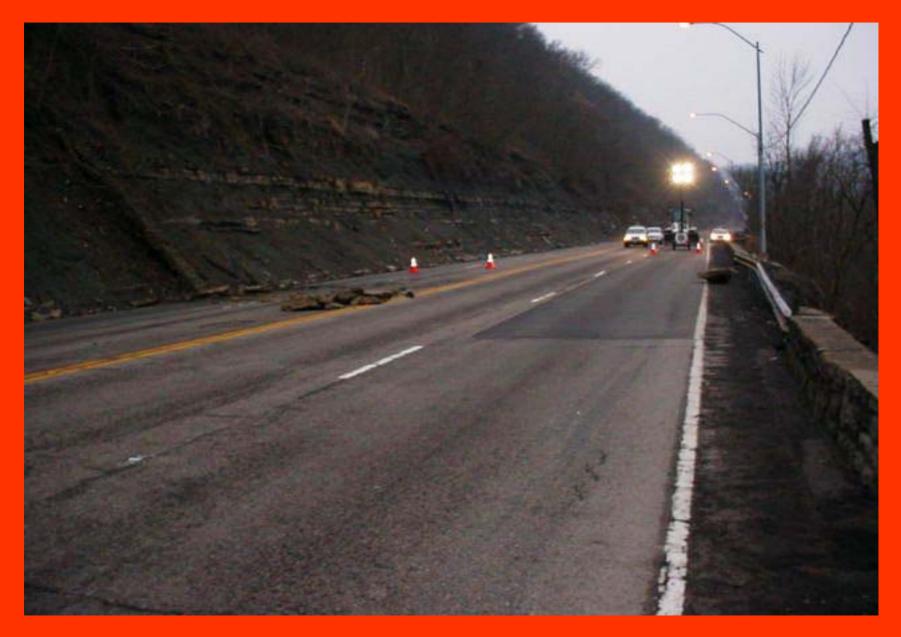
March 25, 2005 Rock Fall Debris

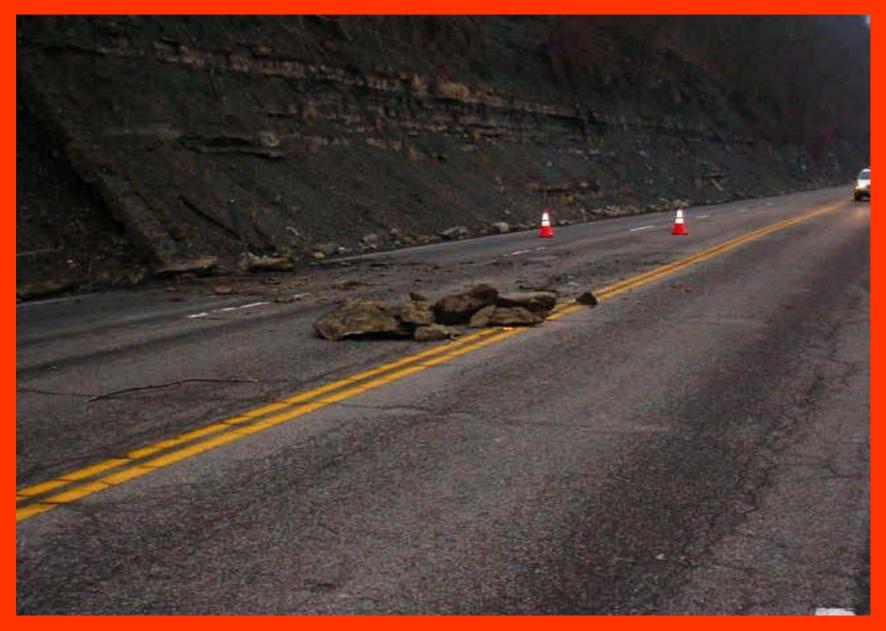
March 25, 2005 Rock Fall Debris

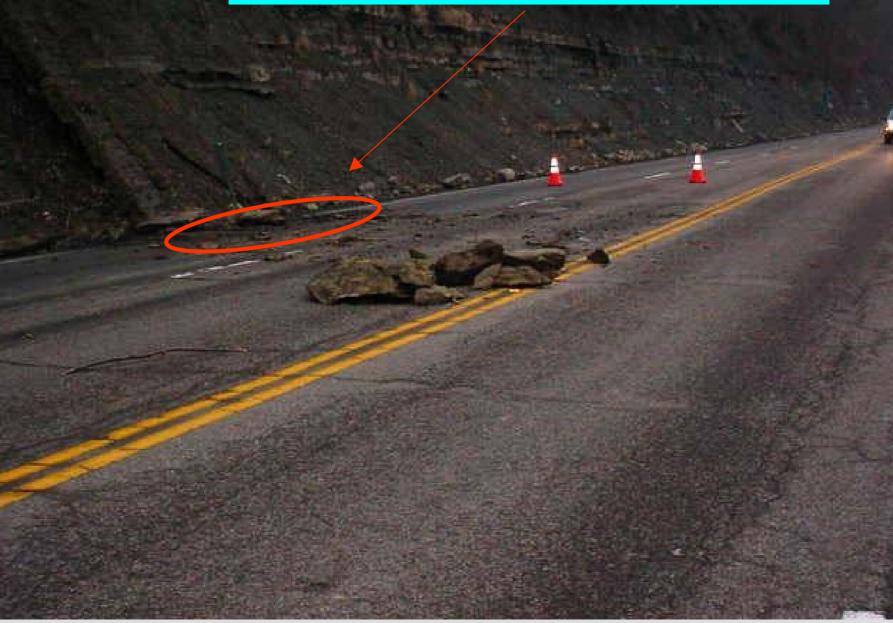
Impact Location of March 2005 Rock Fall

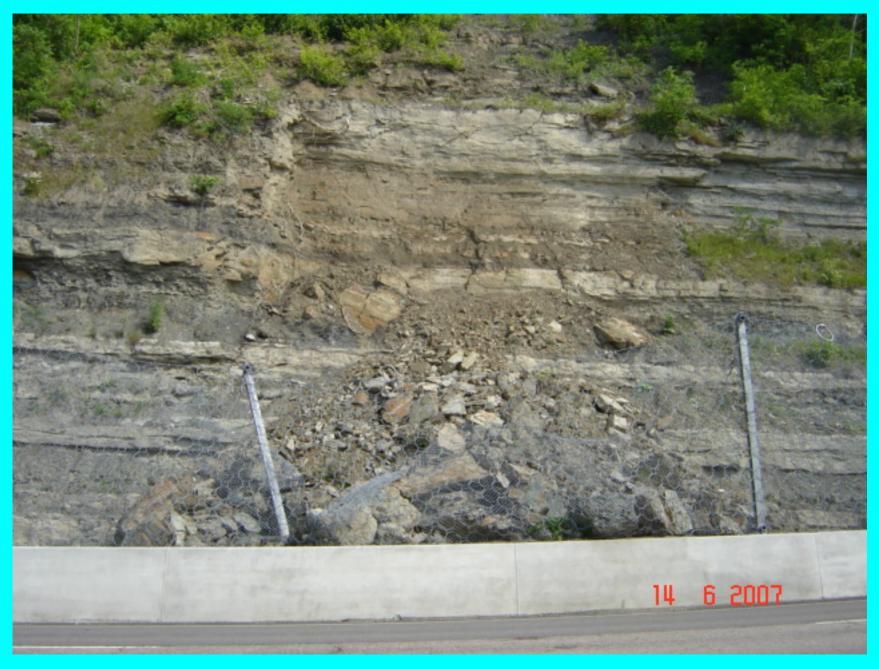
First Post-Construction Rock Fall

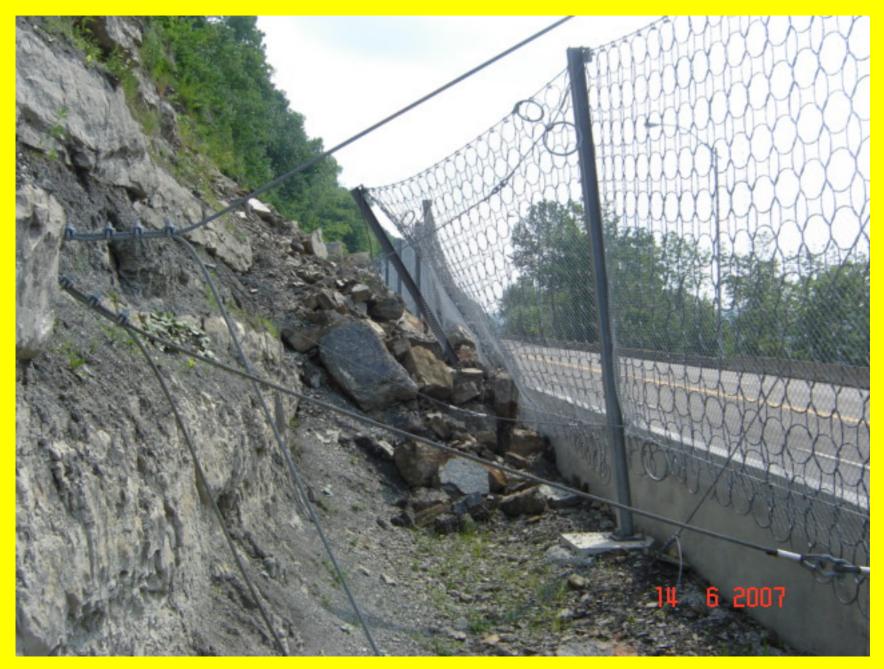
Rock Fall Debris Behind Fence
