“Getting Out of the Pits”

Investigating Ohio’s Coal Mine Hazards

Ohio Department of Natural Resources

Case Study #1
Tunnel Hill Road

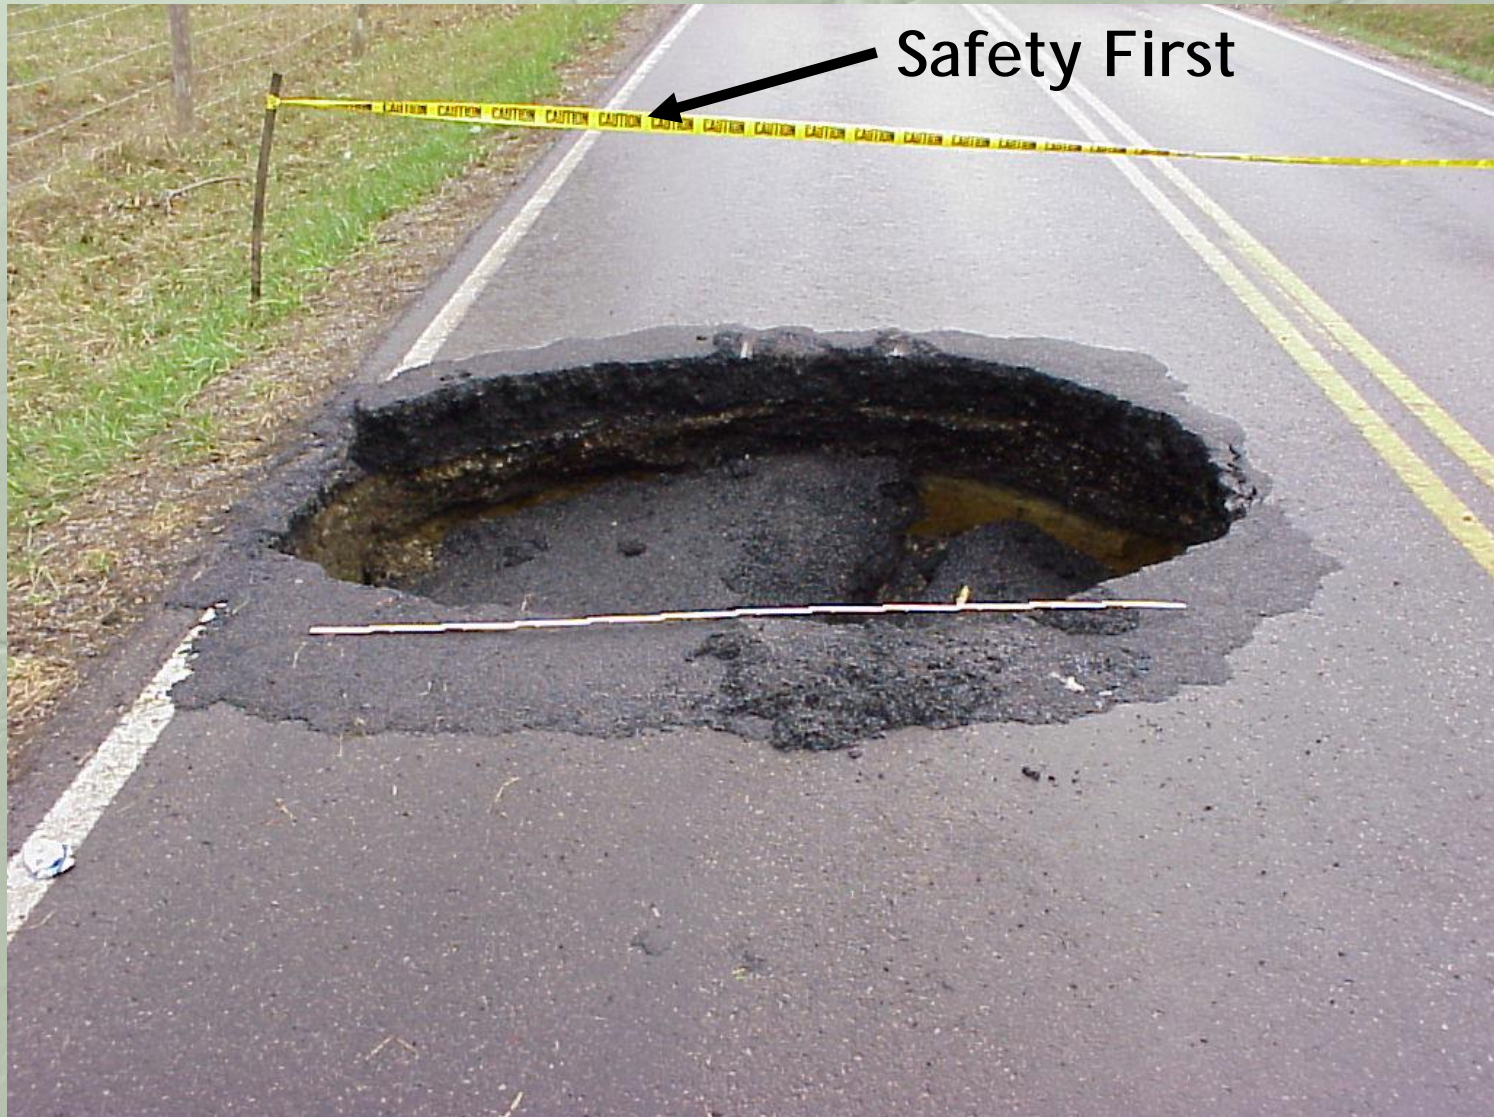
- Tunnel Hill Road
- Connects New Lexington & Crooksville
- Road patched at 3:00 p.m.
- Road collapsed at 5:00 p.m.

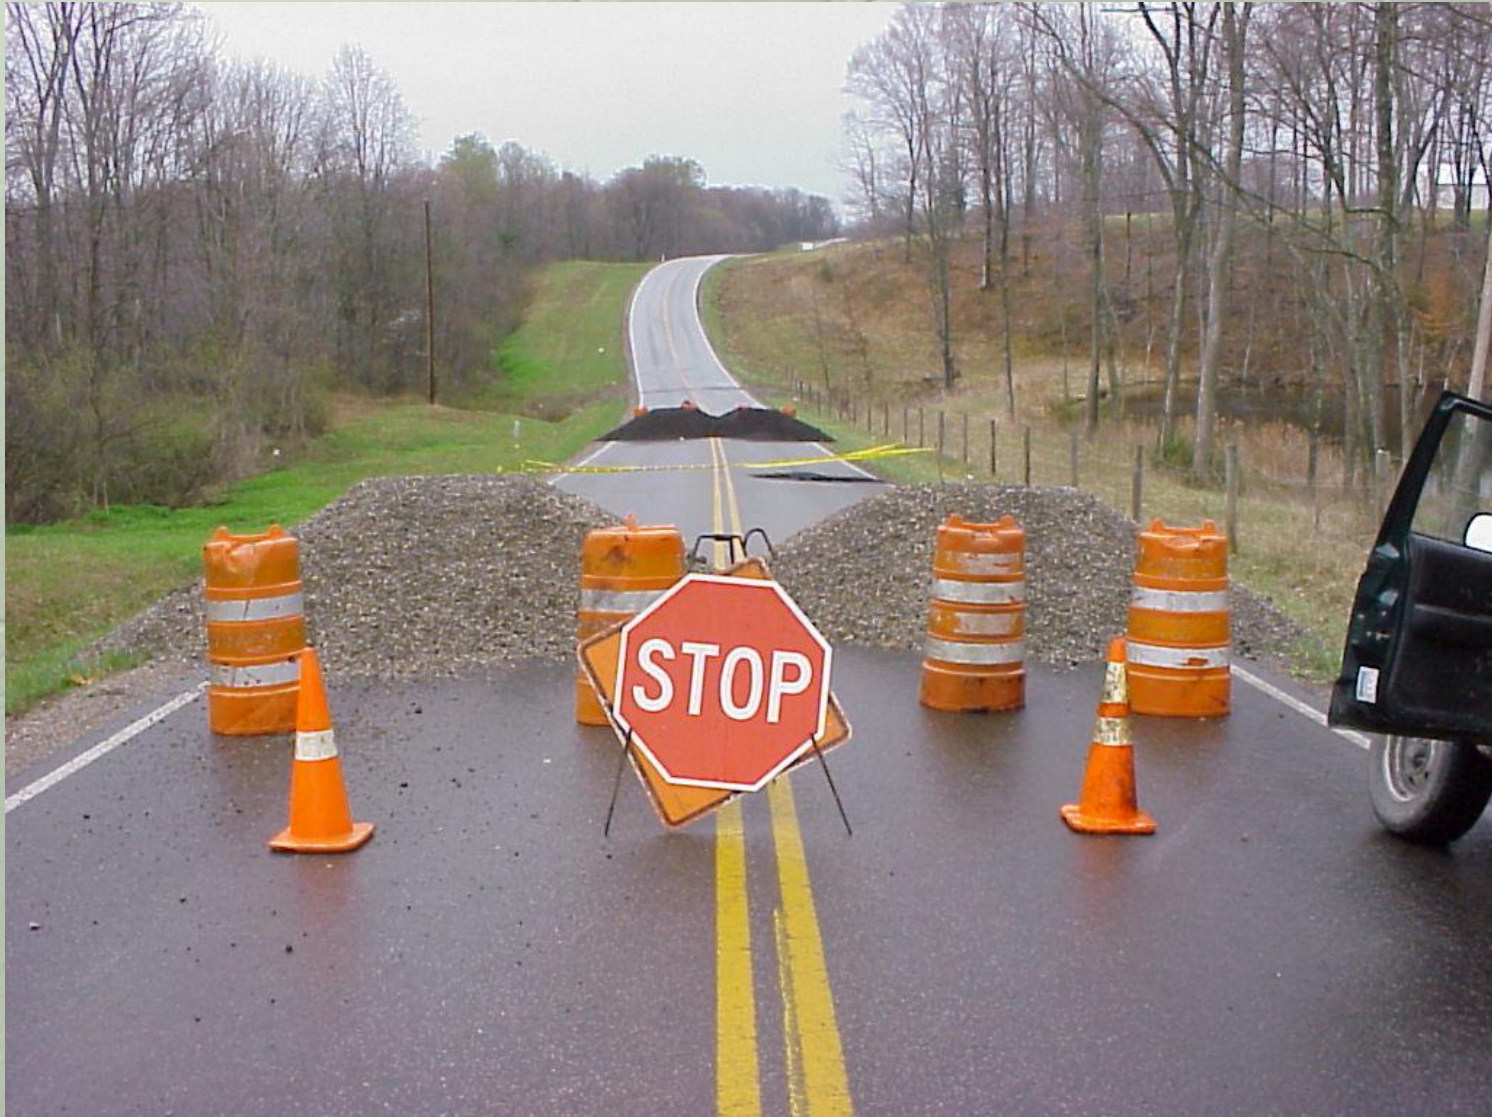
- Tunnel Hill Road
- Connects New Lexington & Crooksville
- Road patched at 3:00
- Road collapsed at 5:00
- **Road temporarily closed**

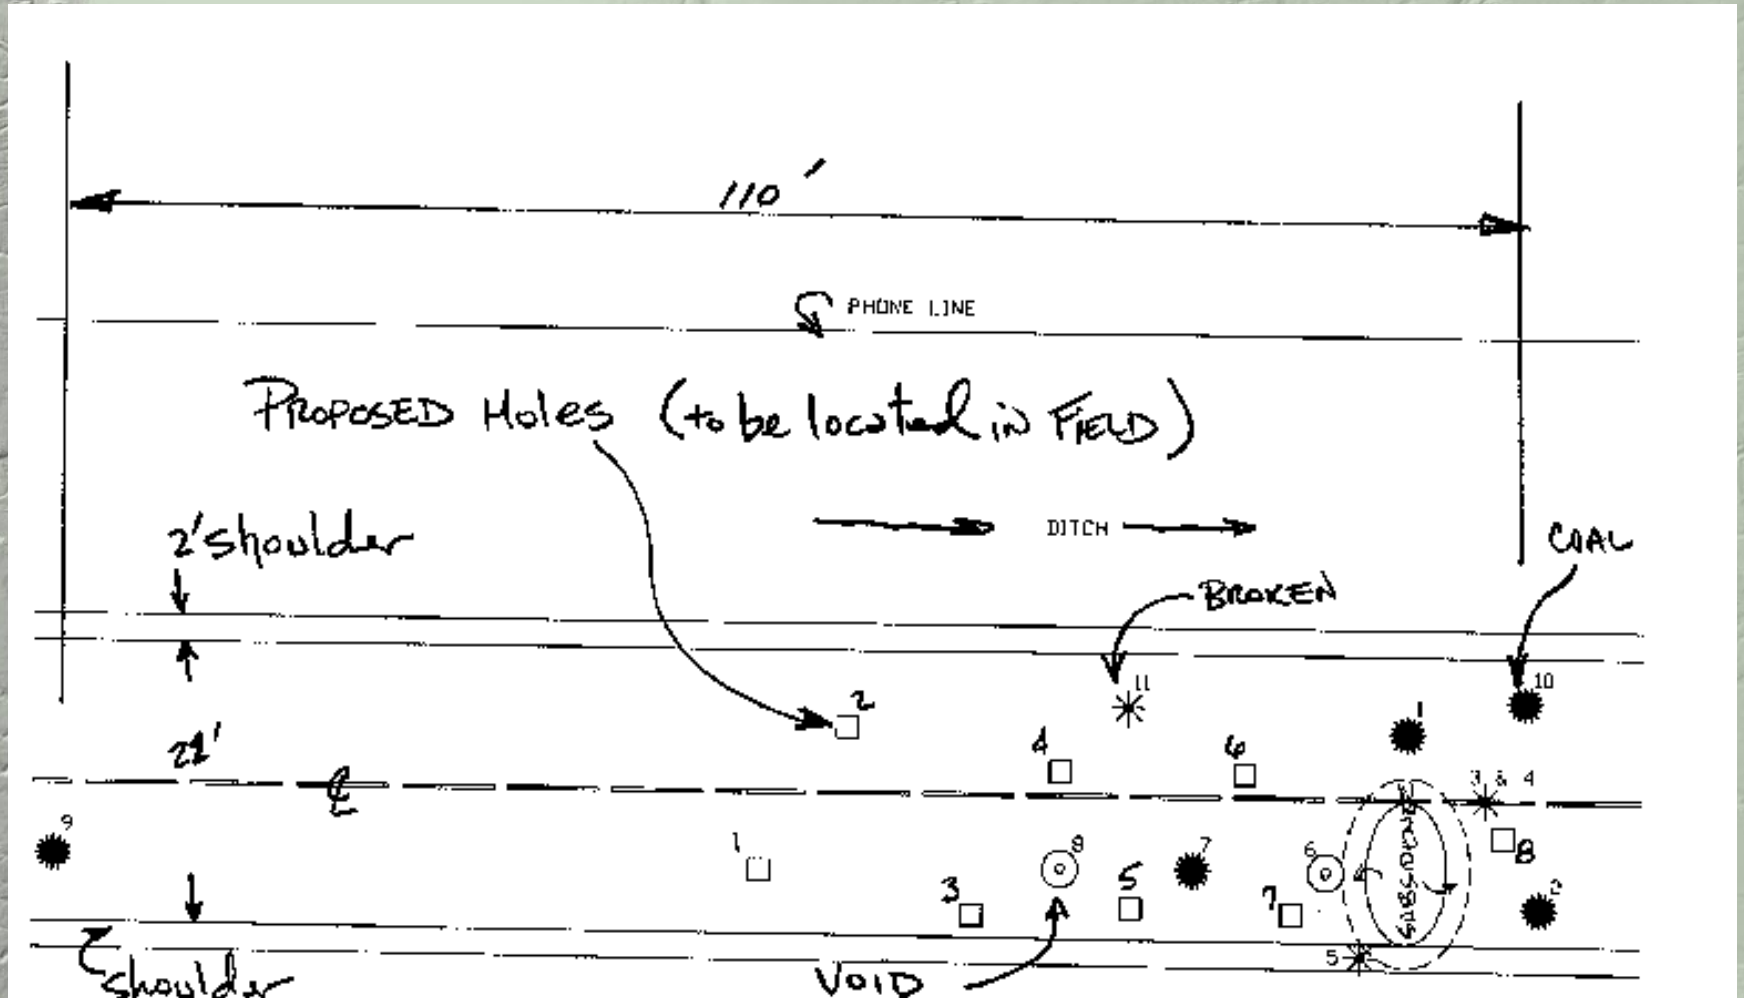
- Some borings collapsing before casing
- No large open mine voids
- Mine void filled with water & gob
- Grout takes not as high as estimated
- Project cost \$14,067.75

- Stabilizing about a length of 60 feet
- 10 borings drilling to a depth of 31 feet
- Placed in the field (~ 15 feet alternating)
- Casing to keep holes from collapsing
- Inject grout 200 CYD (500 psi 10 inch slump)
- Engineers estimate \$26, 220.00

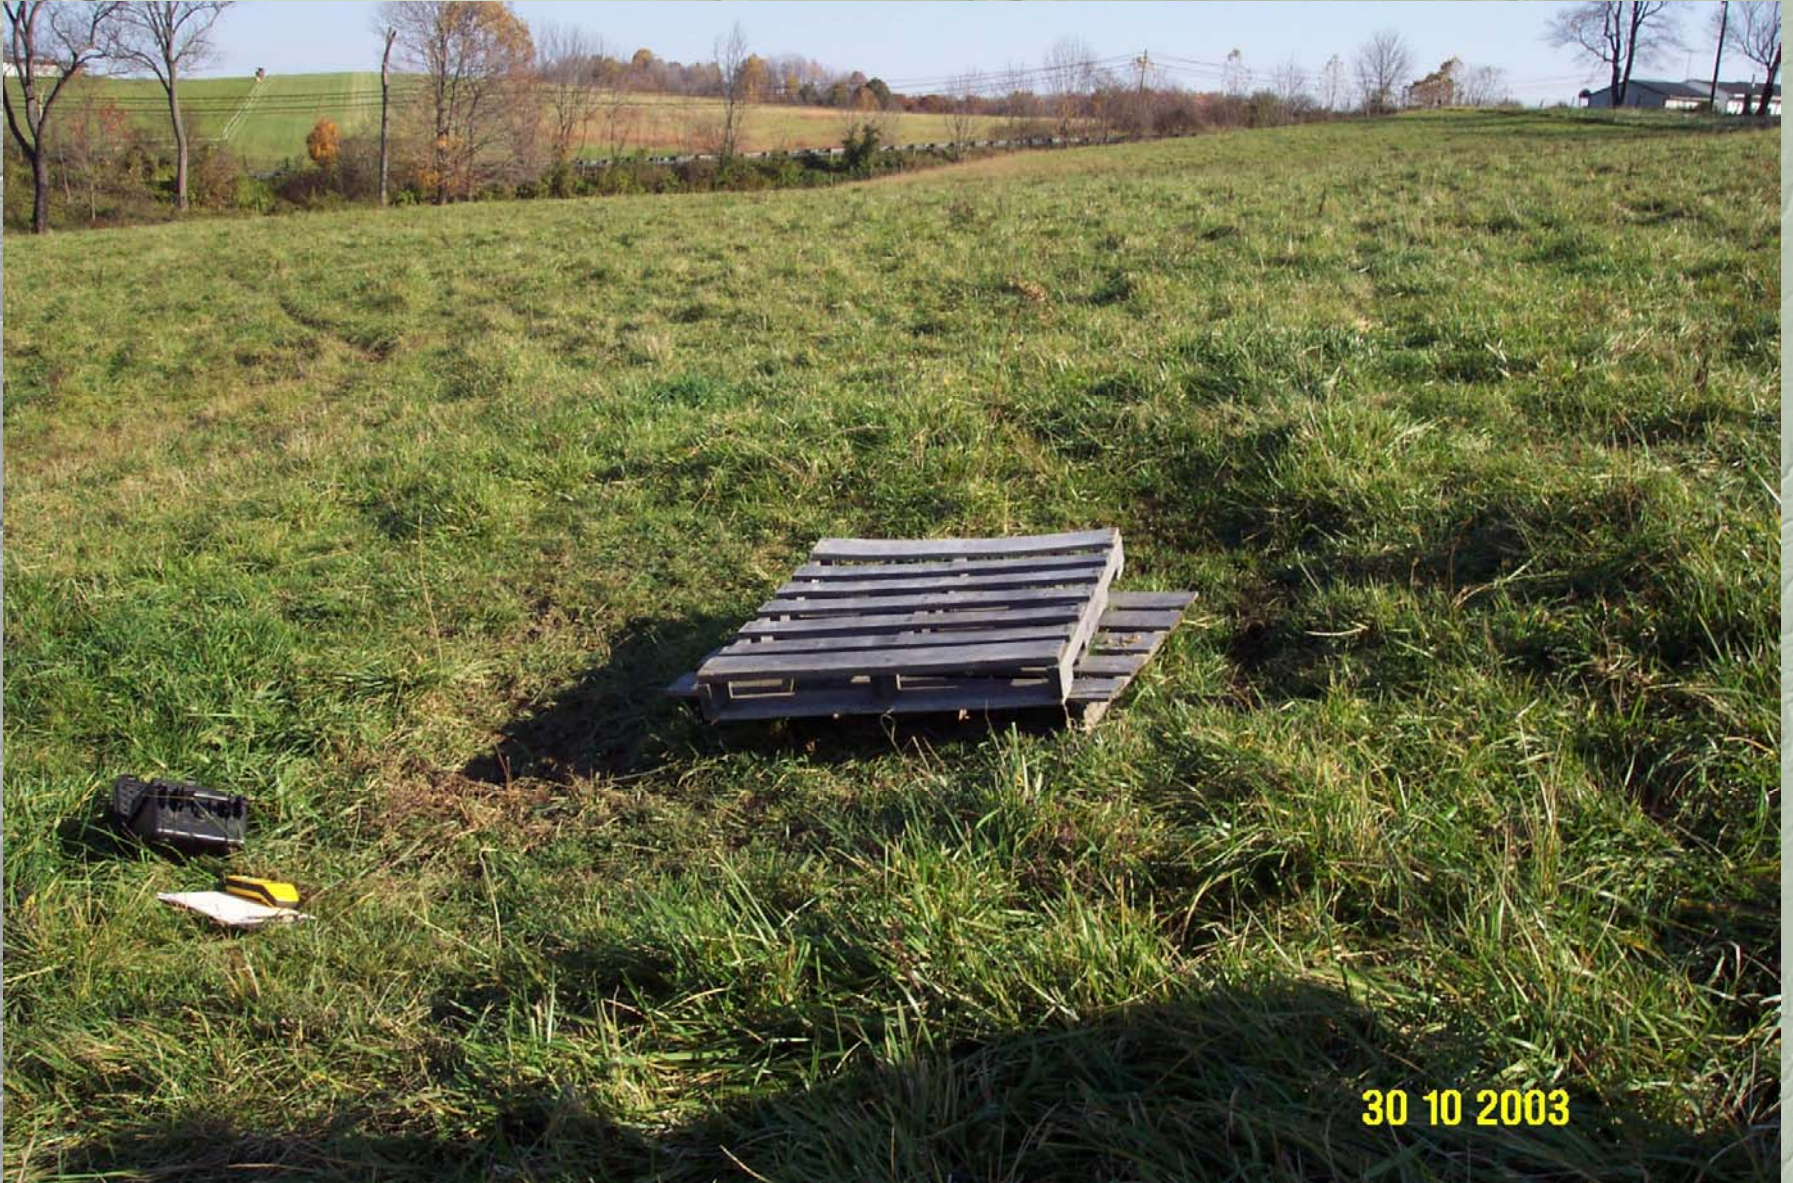
30 10 2003

- Not on road but in close proximity
- Small diameter - It doesn't look like much
- Must know the area & history
