Engineering Geophysical Application to Mine Subsidence Risk Assessment

GEOHAZARDS IMPACTING TRANSPORTATION IN THE APPALACHIAN REGION

August 2-4, 2011, Chattanooga, TN

Conduct multi-phase investigation to determine mine subsidence risk along pipeline/utility corridors **leading to nearby power plant**

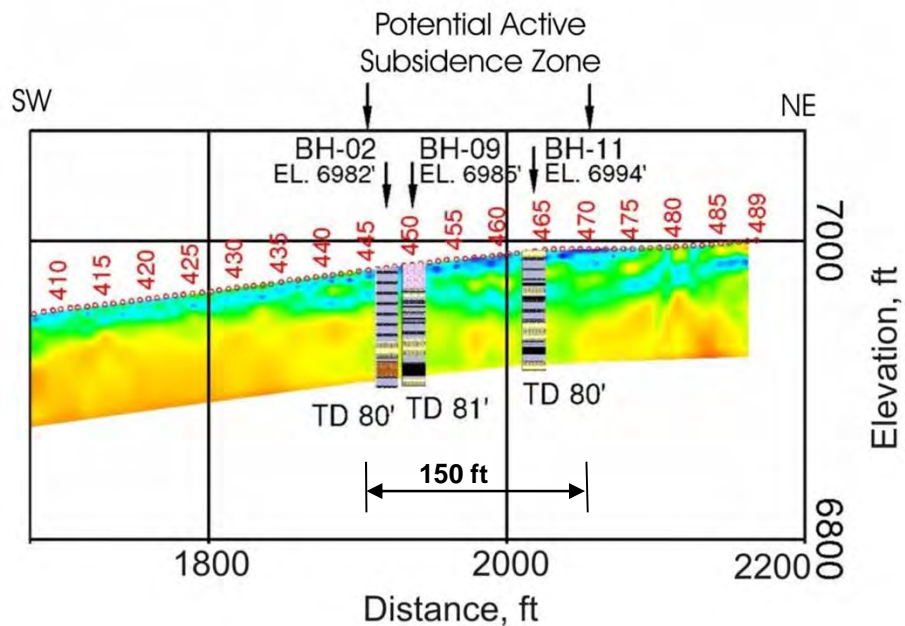
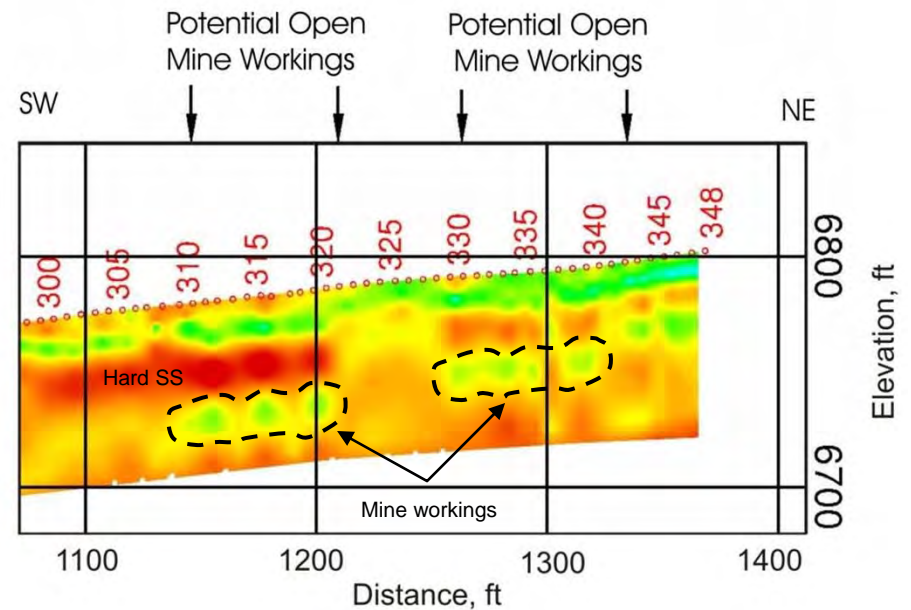
Portion of MASW Profiles for Lines 1 & 3

Low velocity anomaly between ST's 445 – 470 (150')
 BH-01 & BH-11 show disturbed / rubblized mine roof, reducing rock shear strength & decreasing its Vs (**weak rock**).

Anomalies characterized by **velocity reversal**
 Results of thin but hard sandstone layers above the mine workings.

Low Vs / weaker rock (strata)

High Vs / harder rock (strata)

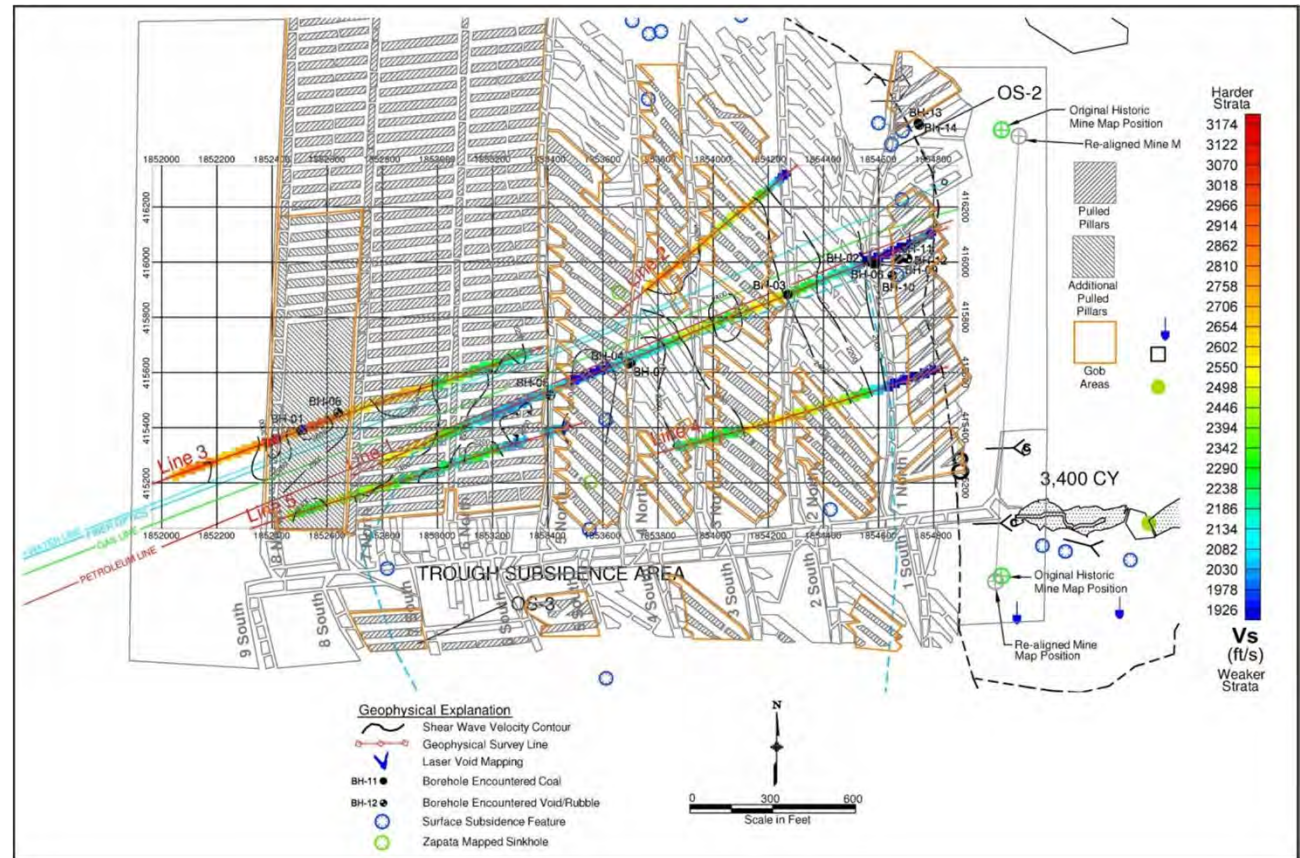
Average Shear Wave Velocity (V_s) Isopach Map

(Interval from 45 to 65 ft bgs approximates the immediate mine roof over the eastern two-third of the site)

- **Slower V_s** can be the result of:
 - Fractured rock where subsidence has already occurred
 - Naturally occurring changes in the strata that affect the overburden competence (i.e. less hard sandstone vs. more soft shale)
 - Sinkhole-type subsidence propagating to the surface
- **Faster V_s** is indicative of harder strata with higher beam strength

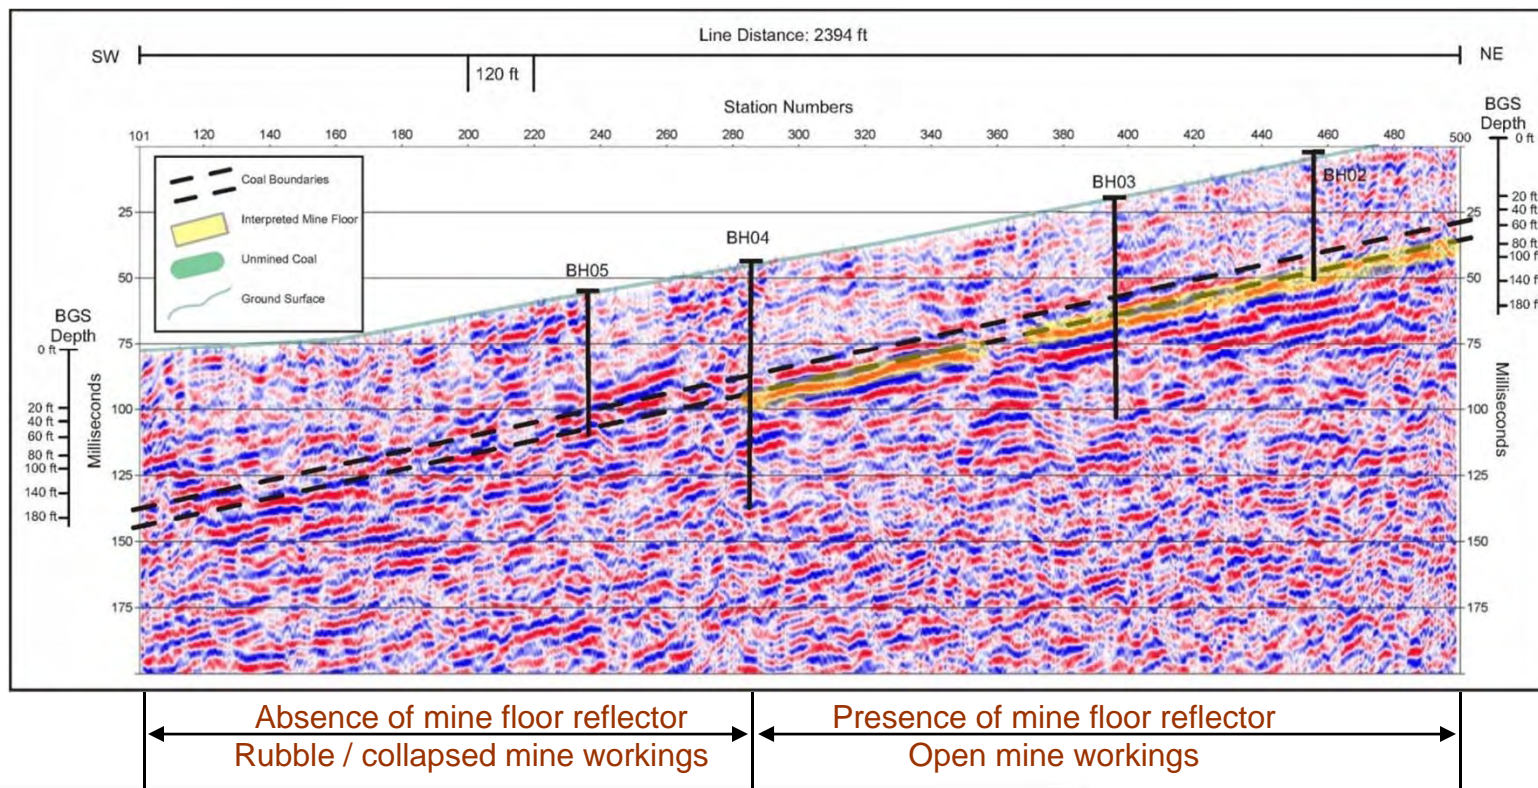
Reflection Profile – Line 1

(Interpretation focuses on the presence or absence of mine floor reflectors)

- Compressional acoustic energy (P-wave) transmits more effectively through intact pillars & empty air spaces
- Presence of mine floor reflector (yellow) is indicative of intact pillar and open mine workings
- Absence of a mine floor reflector is indicative of rubble (acoustic energy is scattered in all directions, and does not return to the surface as a coherent echo)

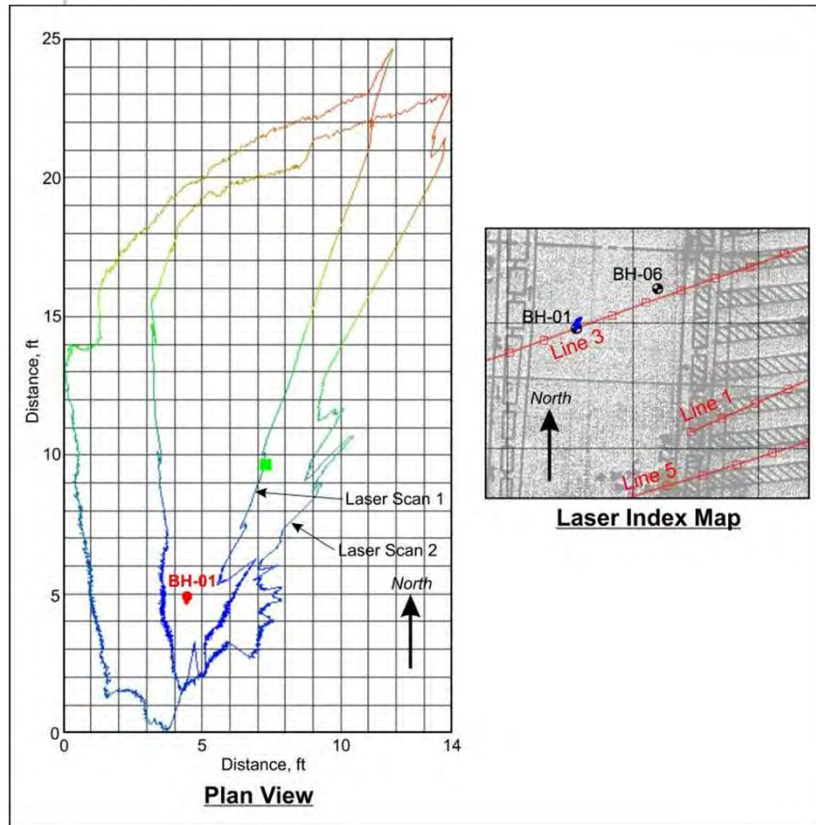
BH-01 (SW of Line 3) @ depth 90 ft

Mine workings (18 in high):

- Void extensions: 25' N-S direction
14' E-W direction

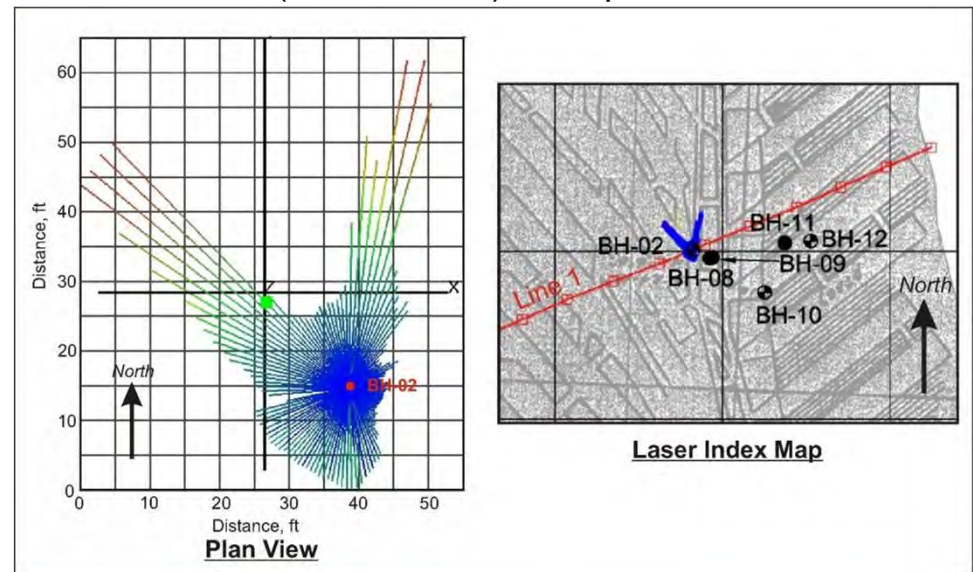
BH-02 (NE of Line 1) @ depth 61 – 73 ft

Open mine workings (12 ft high):

- Two lateral void extensions: NW & NNE ~ 10' W x 45' L
- South void extension: ~ 15' L x 18' W
- Mine map re-alignment (room & haulageway)

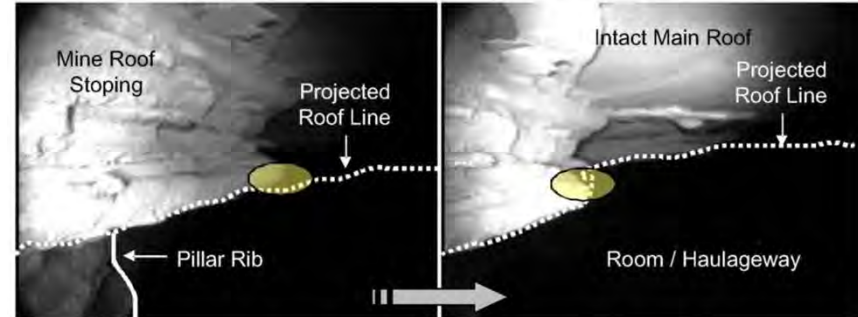
Open mine workings (12 – 15 ft high):

- Large void @ 64', indicative of a room and/or haulageway
- Mine roof failure to ~ 7' forming a new roof line
- Large rock pile on mine floor
- Coal rib, indicative of remaining stable coal pillar
- Overall void height, including coal pillar and roof fall, is ~ 15'

Room / Haulageway
Showing Pillar Rib, and Roof Stopping
@ 64 ft bgs
(Camera Oriented Horizontally)

Extent of the Room / Haulageway
@ 64 ft bgs
(Camera Oriented Horizontally)

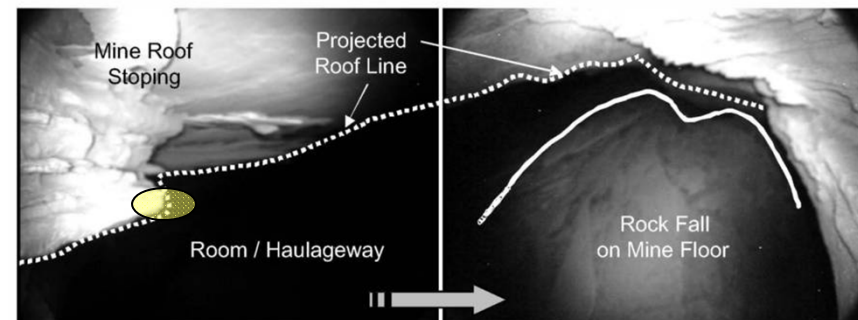
Room / Haulageway
Showing Roof Stopping, and
Projected Roof Line into Adjacent Picture
@ 64 ft bgs
(Camera Oriented Horizontally)

Extent of the Room / Haulageway
with Rock Fall on Mine Floor
@ 63 ft bgs
(Camera Oriented Horizontally)

NOTE: Opening height (including pillar and roof fall) is estimated at approximately 15 ft.

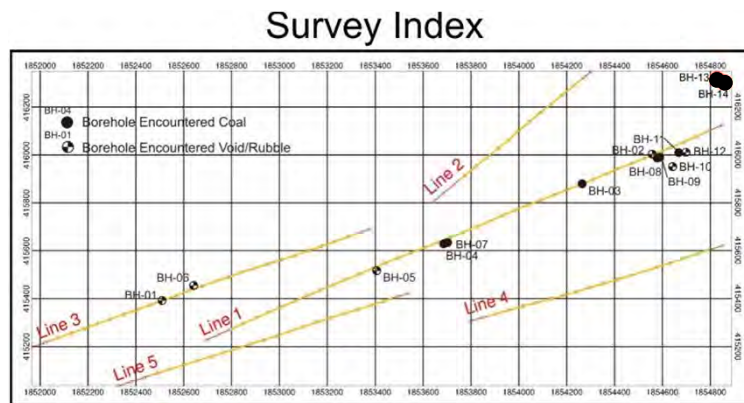
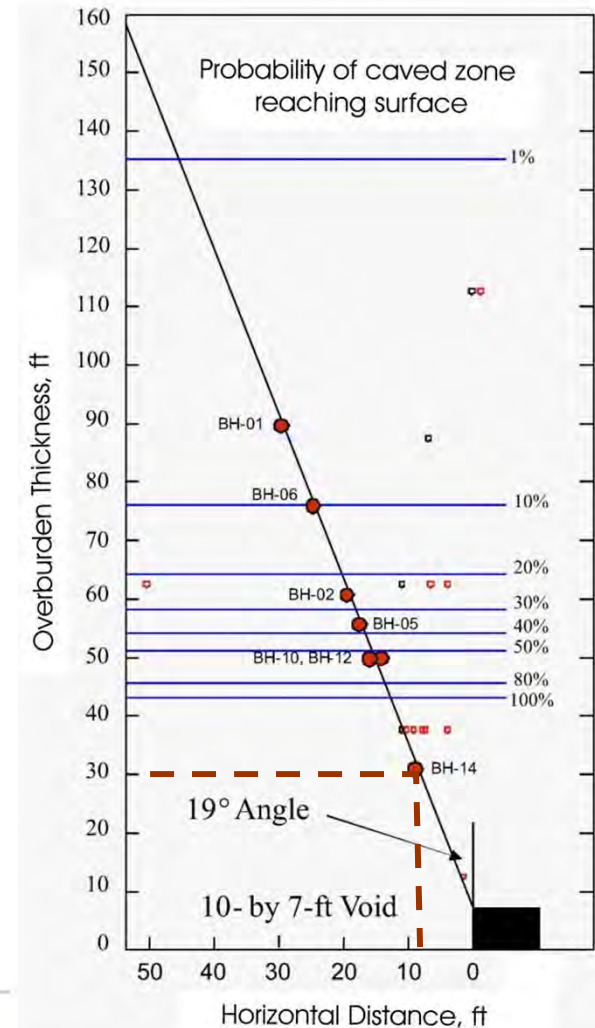
Probability of Sinkhole (Caved Zone) Development Reaching Surface As a Function of Overburden Thickness

- Angle of draw: 19° (margin of safety in sinkhole size estimation, American West ranges from 12° to 16° (Peng, 1978))
- Void size: 7 ft H x 10 ft W

- Area within BH-14: >100% probability forming a sinkhole at the surface
- Surface settlement will have propagated 8 ft from the edge of the void space
- Area within BH-01 & BH-06: <10% probability forming a sinkhole

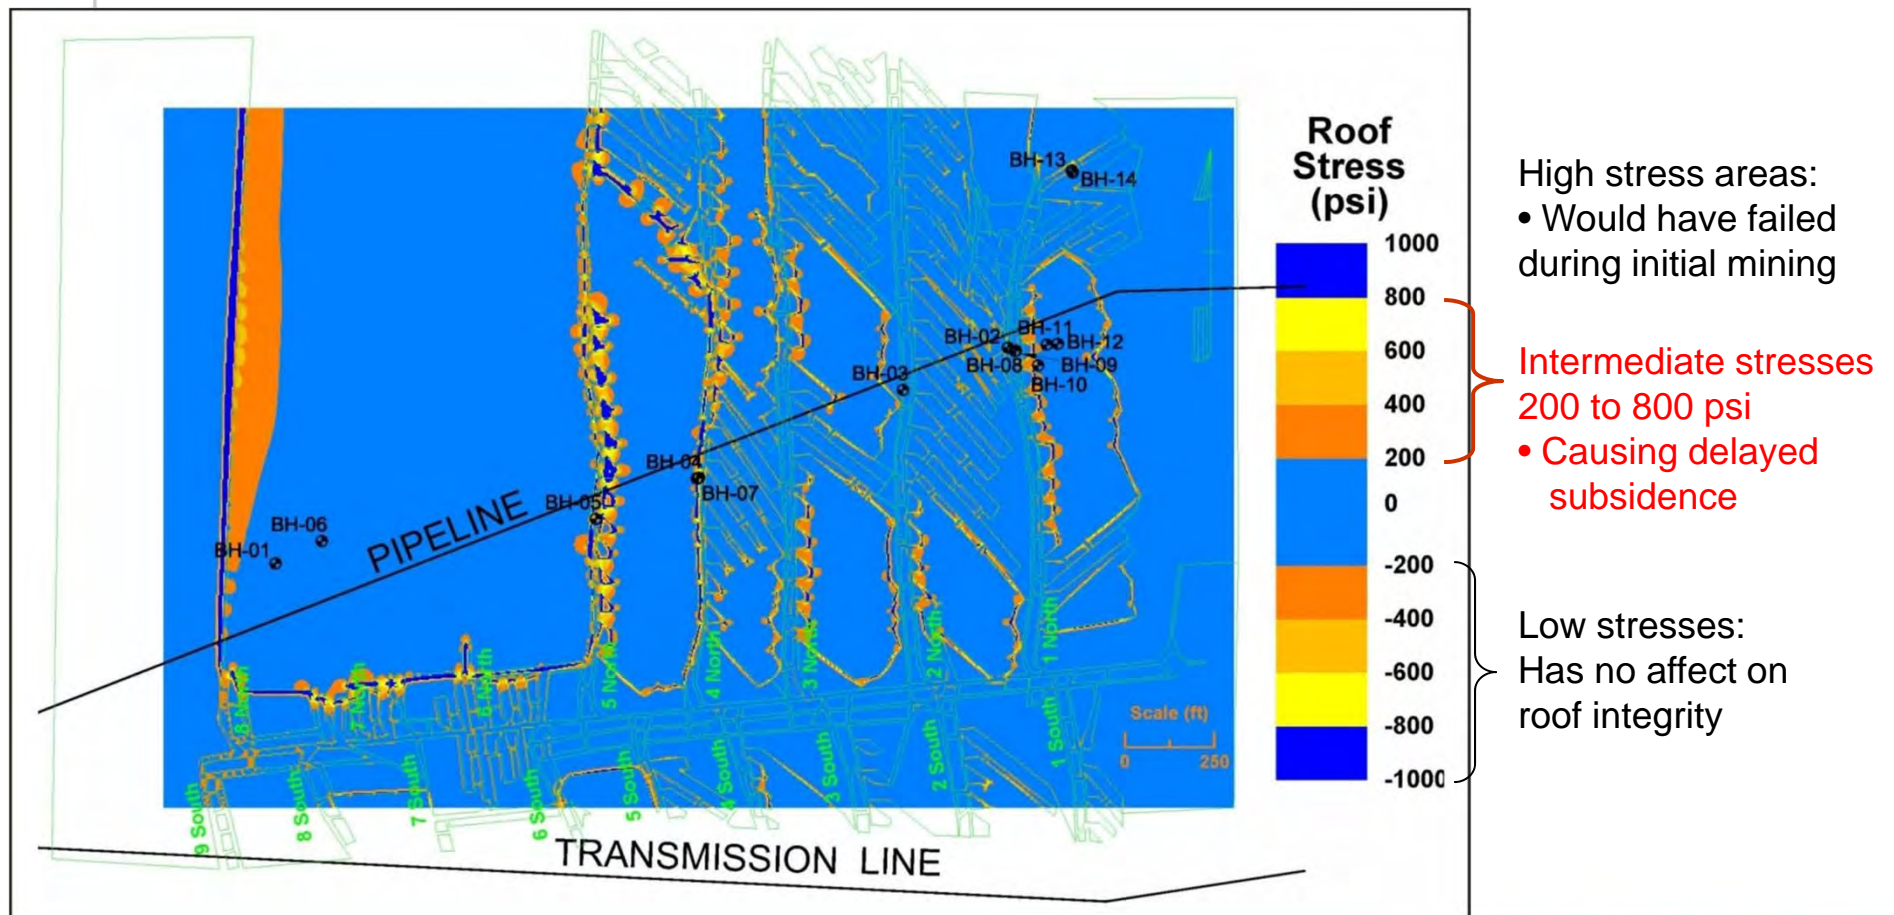
Intermediate Roof Stresses for 650 psi Coal

- Potential delayed subsidence areas are located at the edge of the major gobs
 - Prone to continued failure and sinkhole development
- Seven of the ten sinkholes observed over the modeled area are located at the edge of a gob

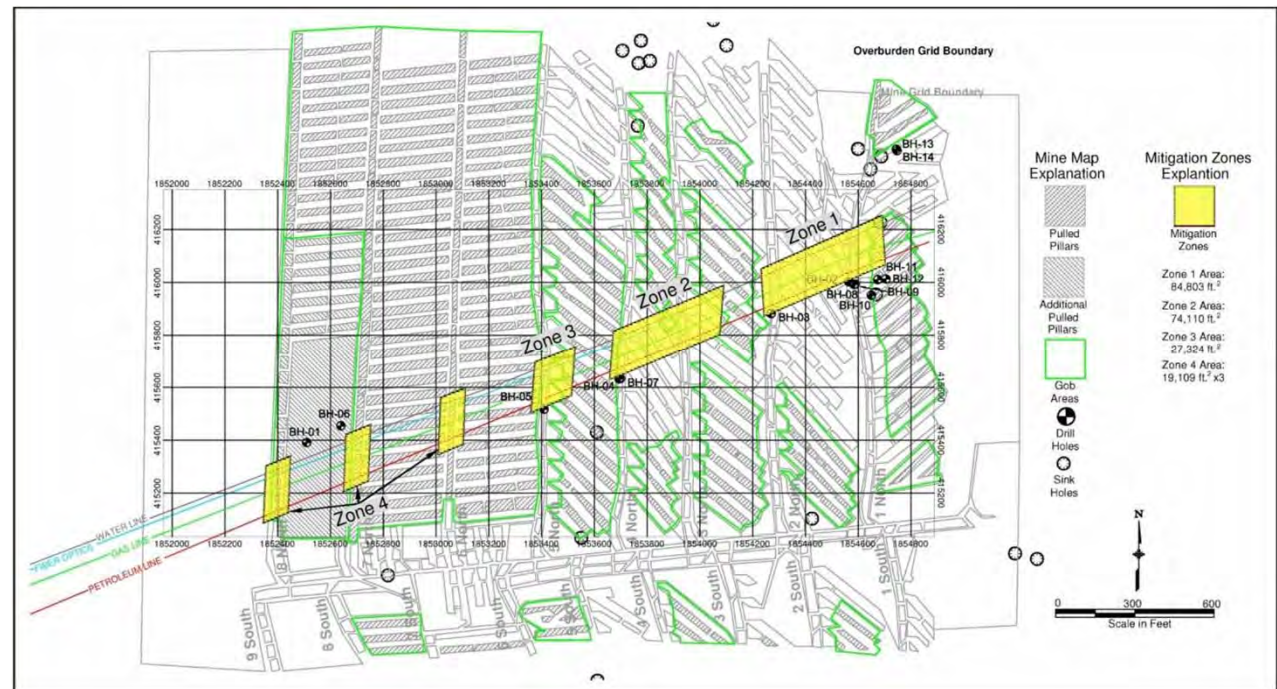
Potential Trough and/or Sinkhole Subsidence Risk Zones under the Pipeline/Utility Corridors

“Identified four zones with risk levels ranging from relatively *negligible* to *very low* at the west site (overburden ~ 90' thick), to *high* at the east side (overburden ~ 50' thick)

- Zone 1: Potential sinkhole development – requiring mitigation
- Zone 2: Potential subsidence development-requiring mitigation
- Zone 3: Low subsidence risk – requiring test borings
- Zone 4: Negligible subsidence risk – requiring test borings

- Foamed-sand slurry backfilling technique for ground stabilization of Zones 1 & 2 beneath the corridors
