The Keowee Creeper

By Daryl Wurster, PE and
Doug Chappell, PE

Wurster Engineering & Construction, Inc.

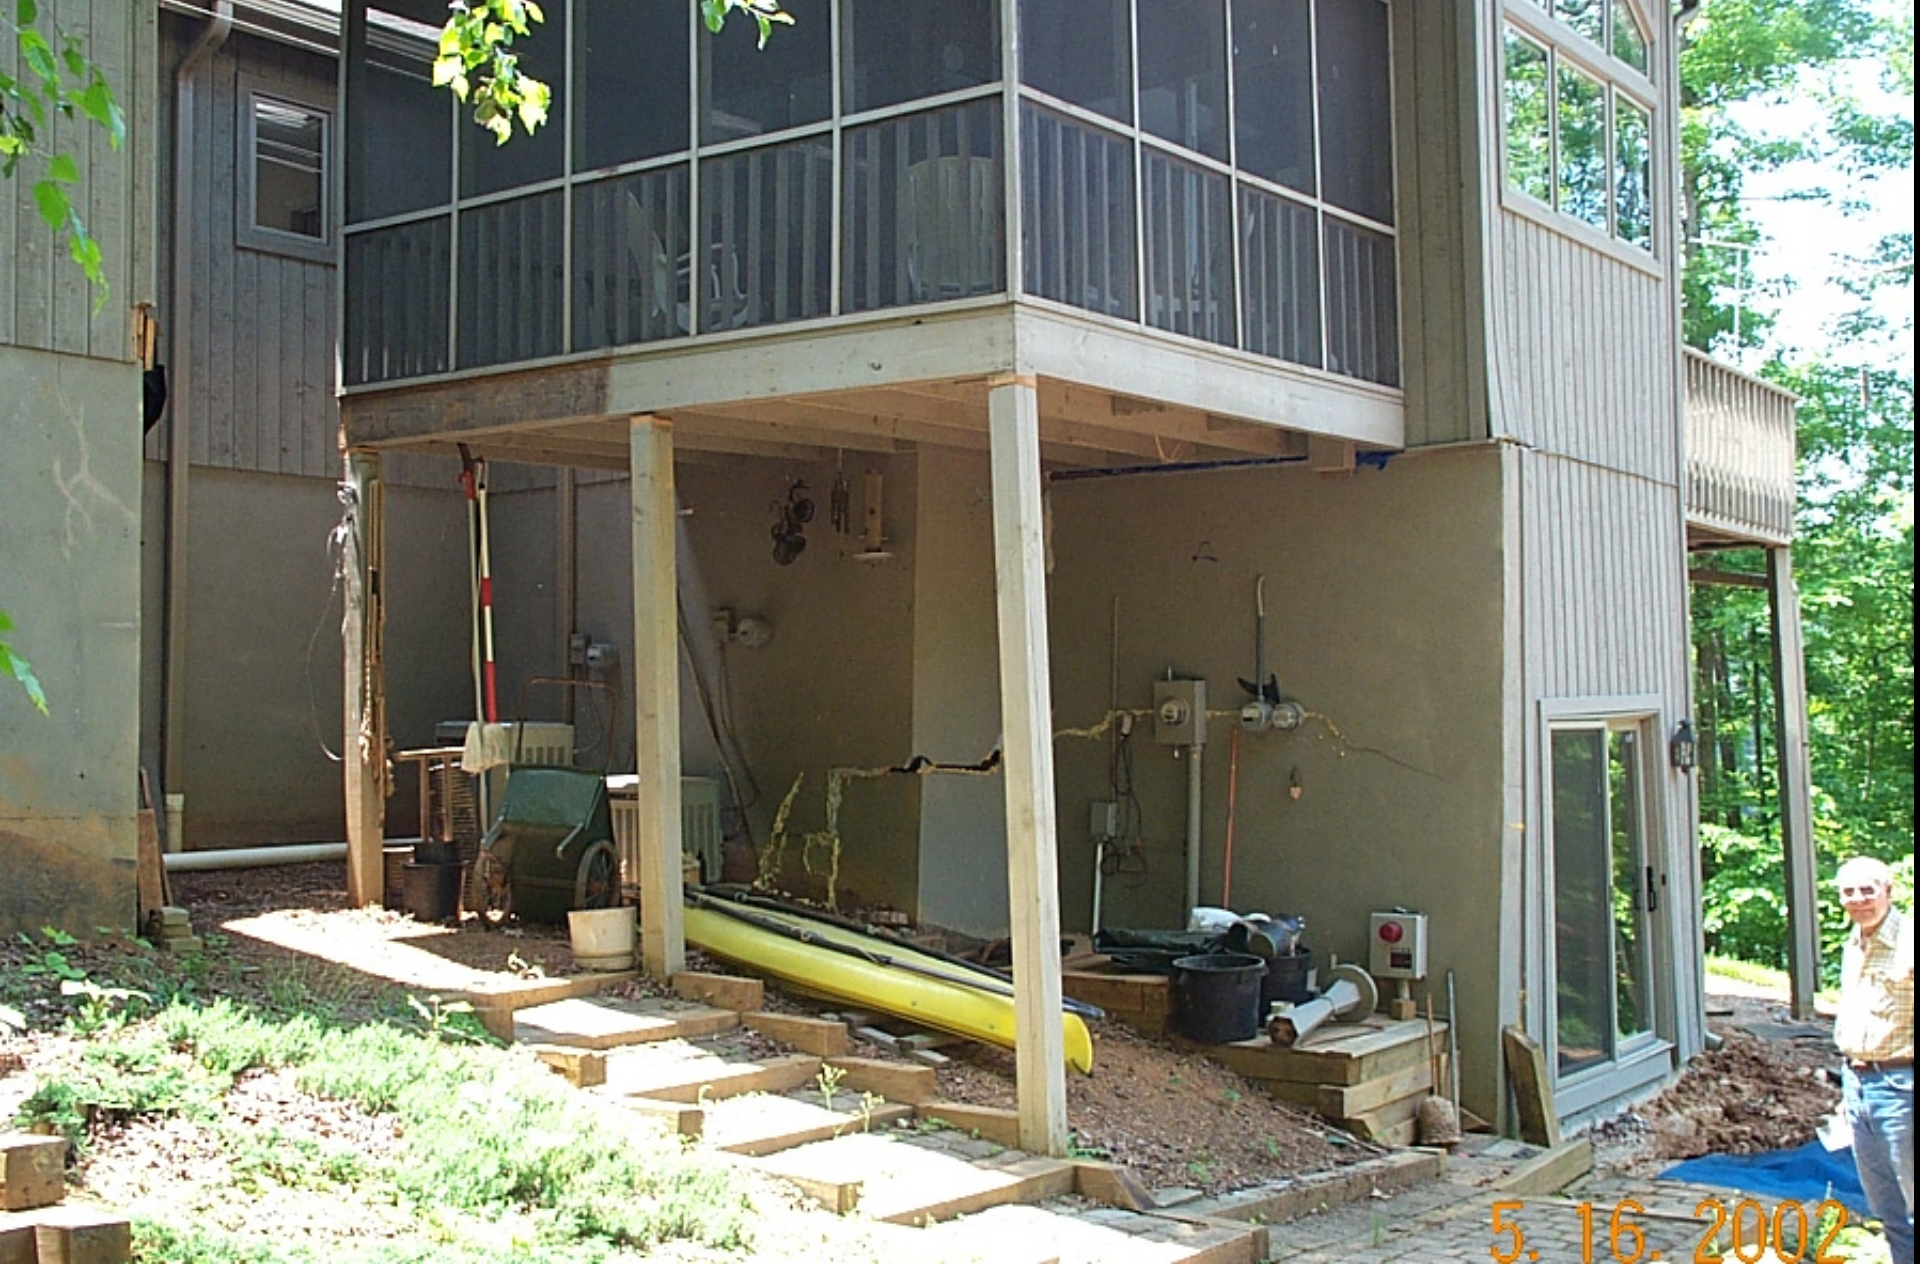
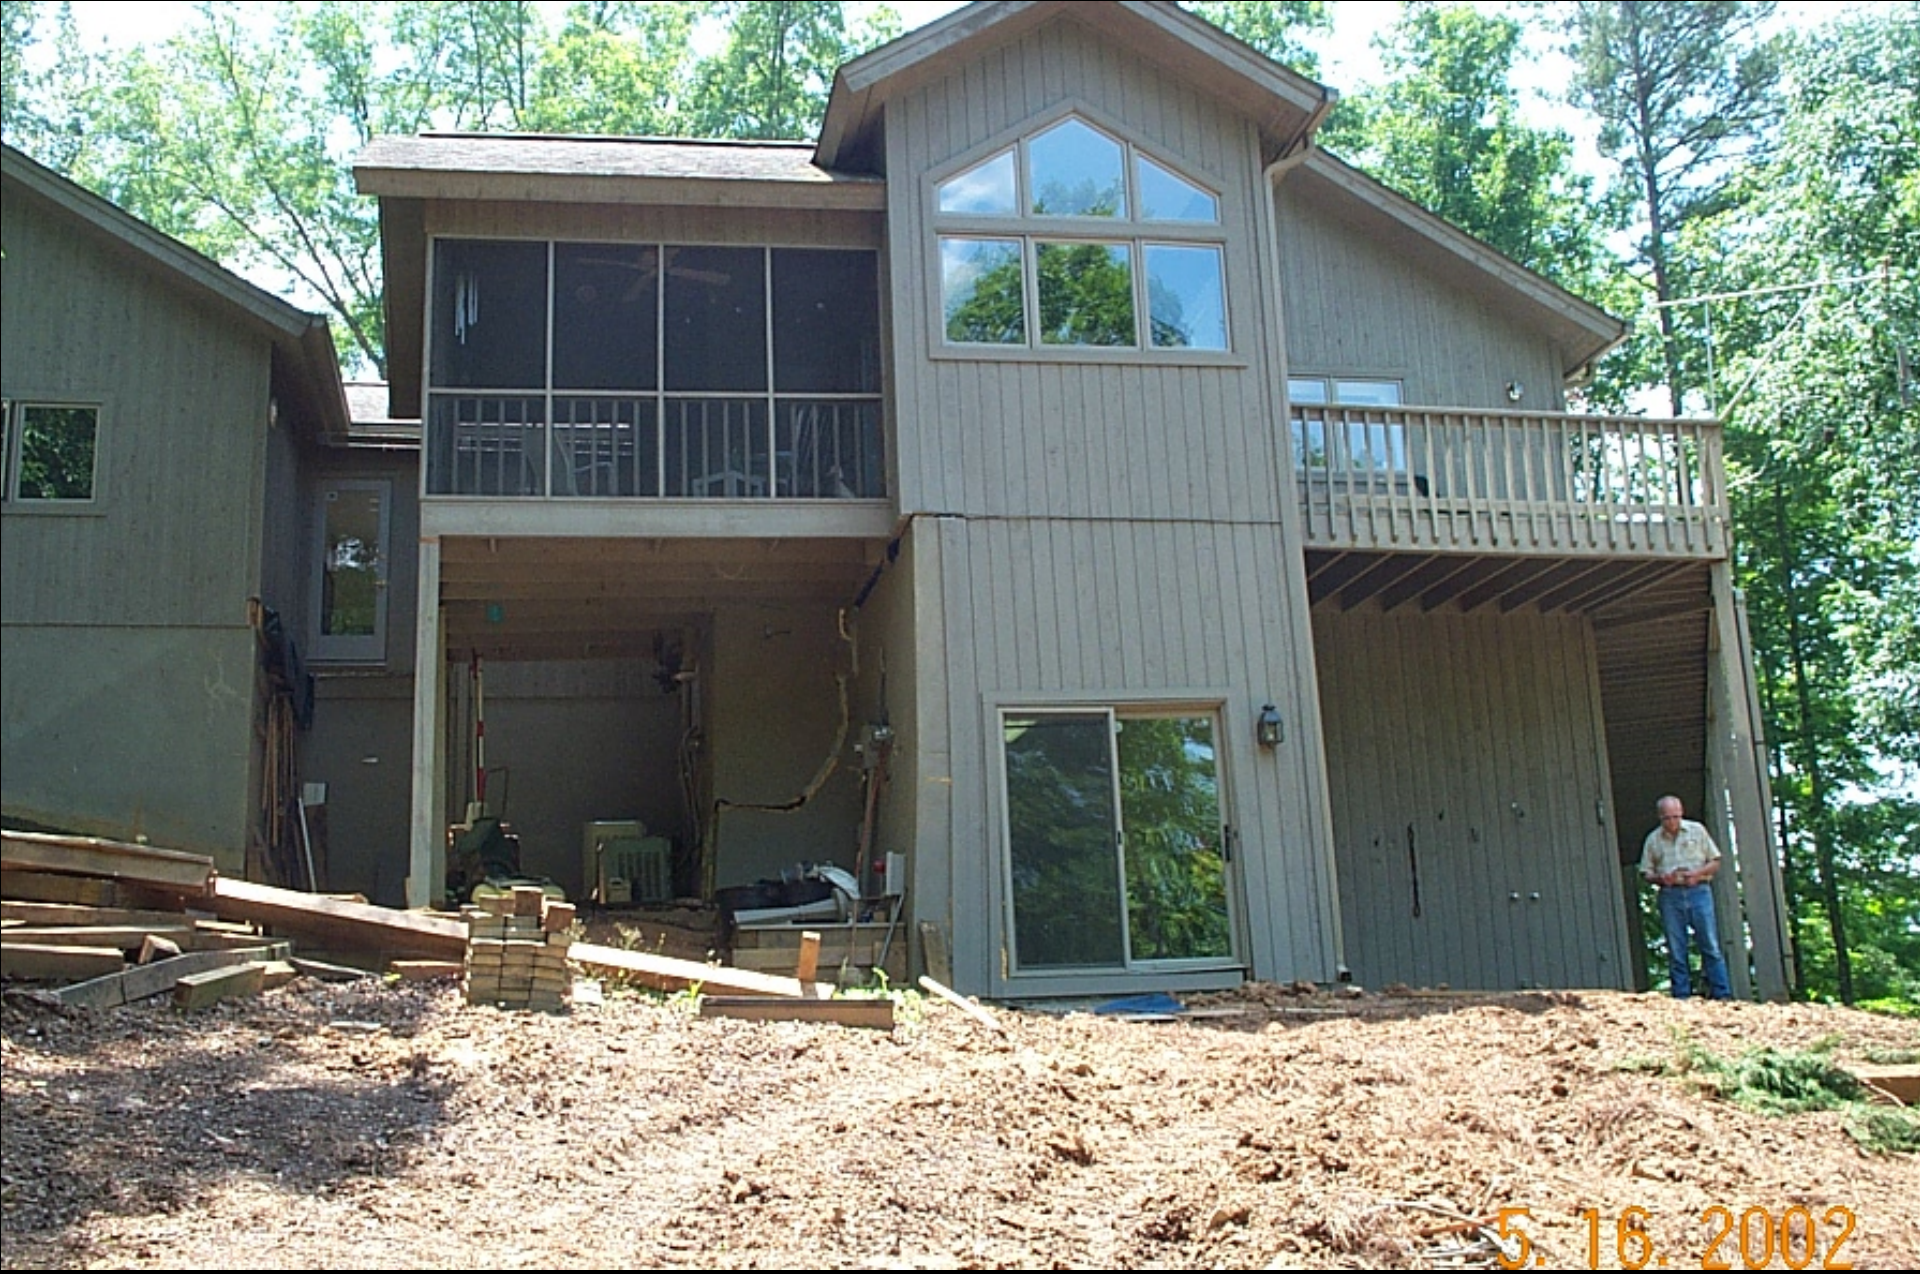
- Site 1 slide was repaired by others using patterned ground anchors.
- Slide was deep seated and extended into lake.
- Ground movement showed up as separation cracks in house.
- Ground was gently sloping.

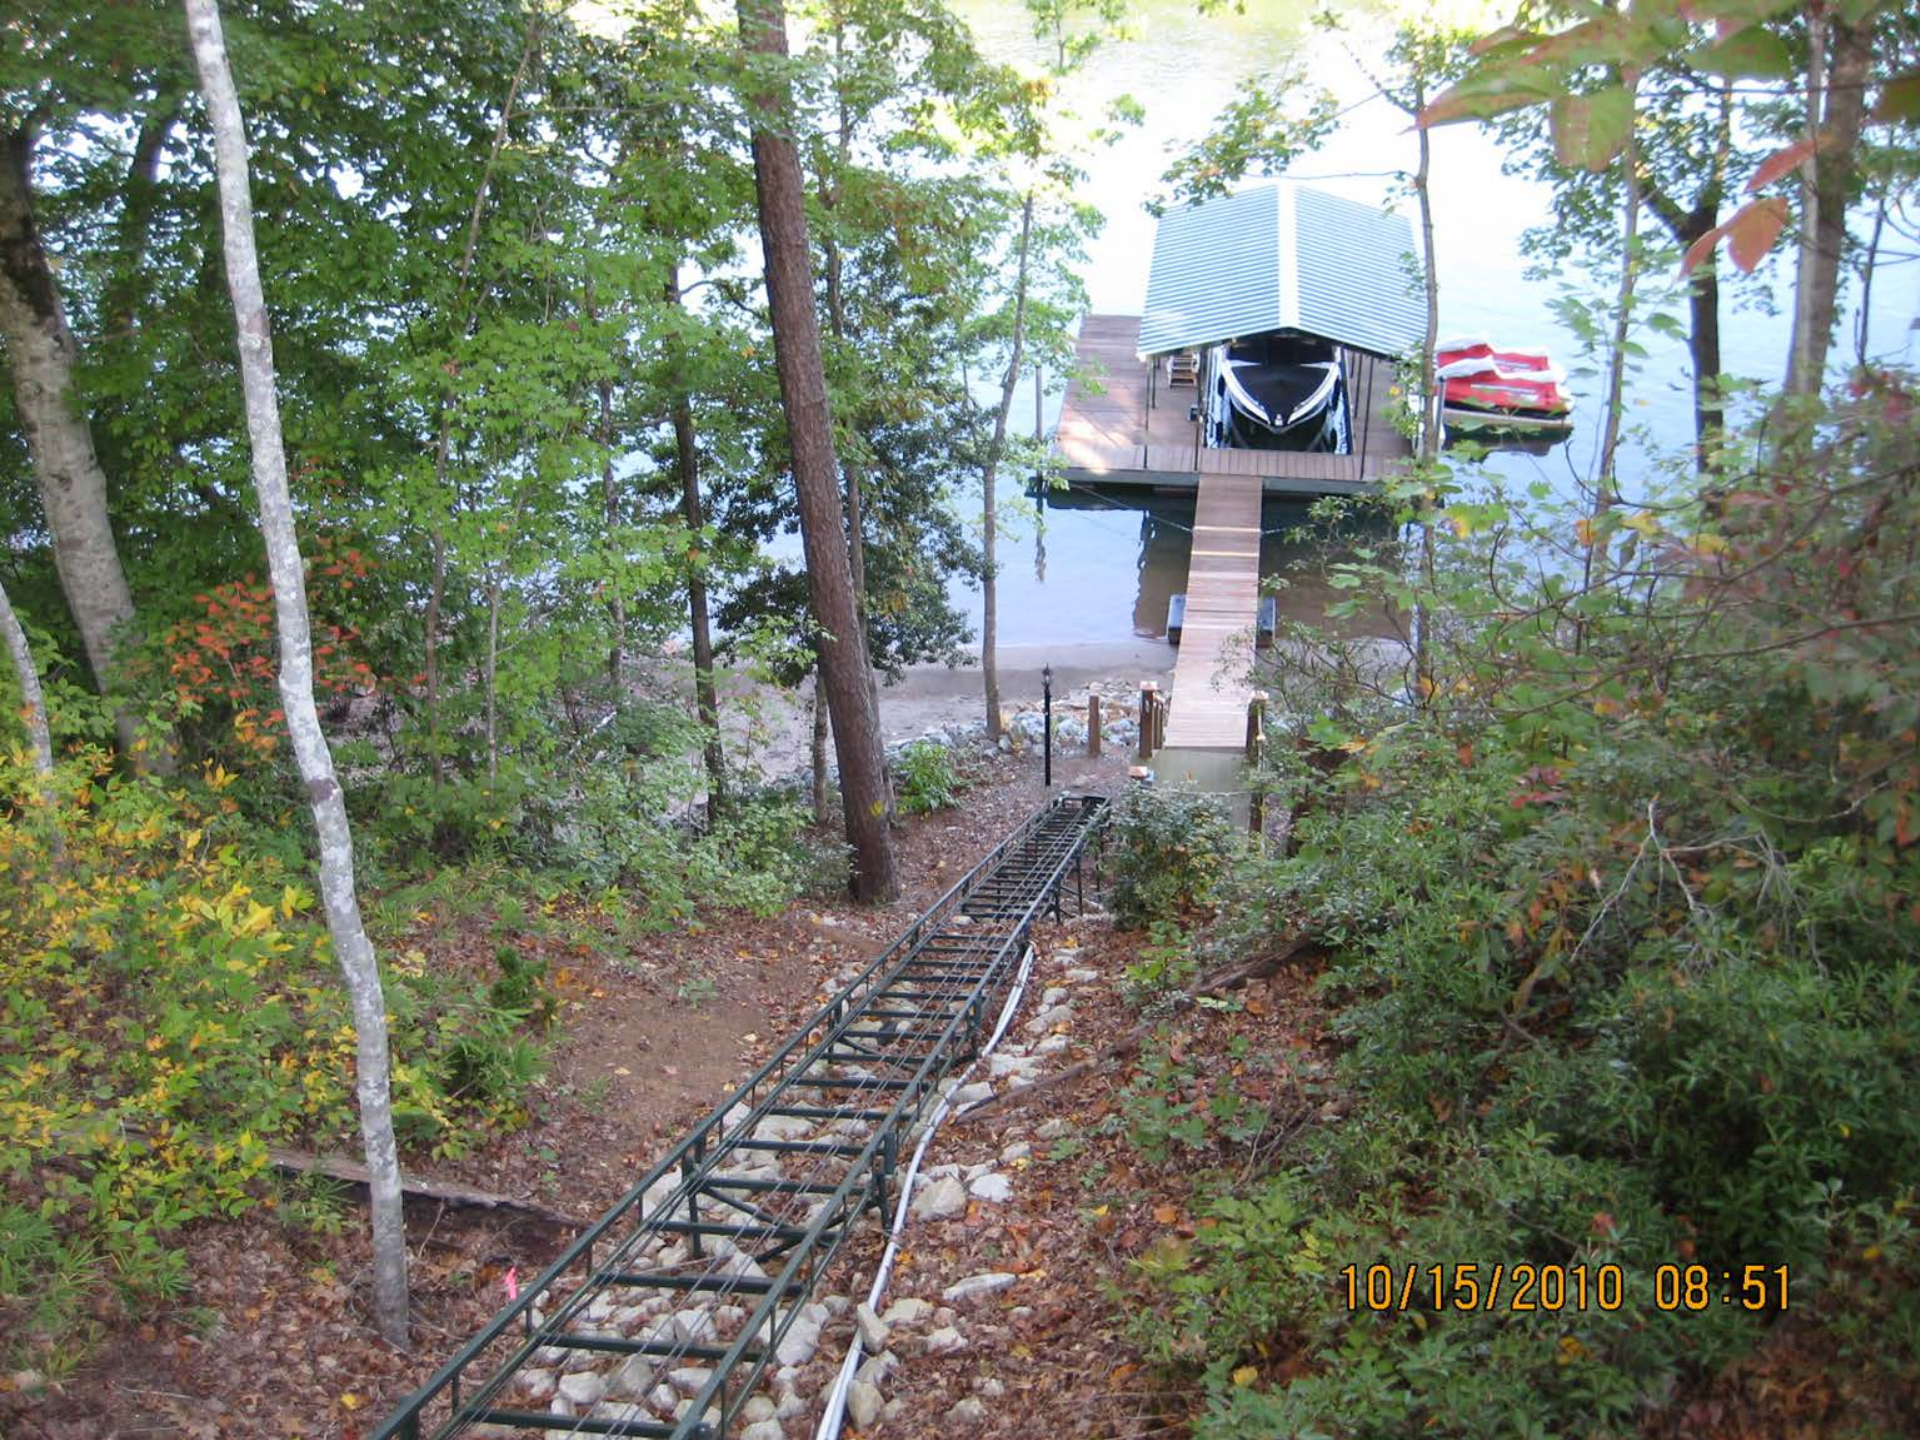
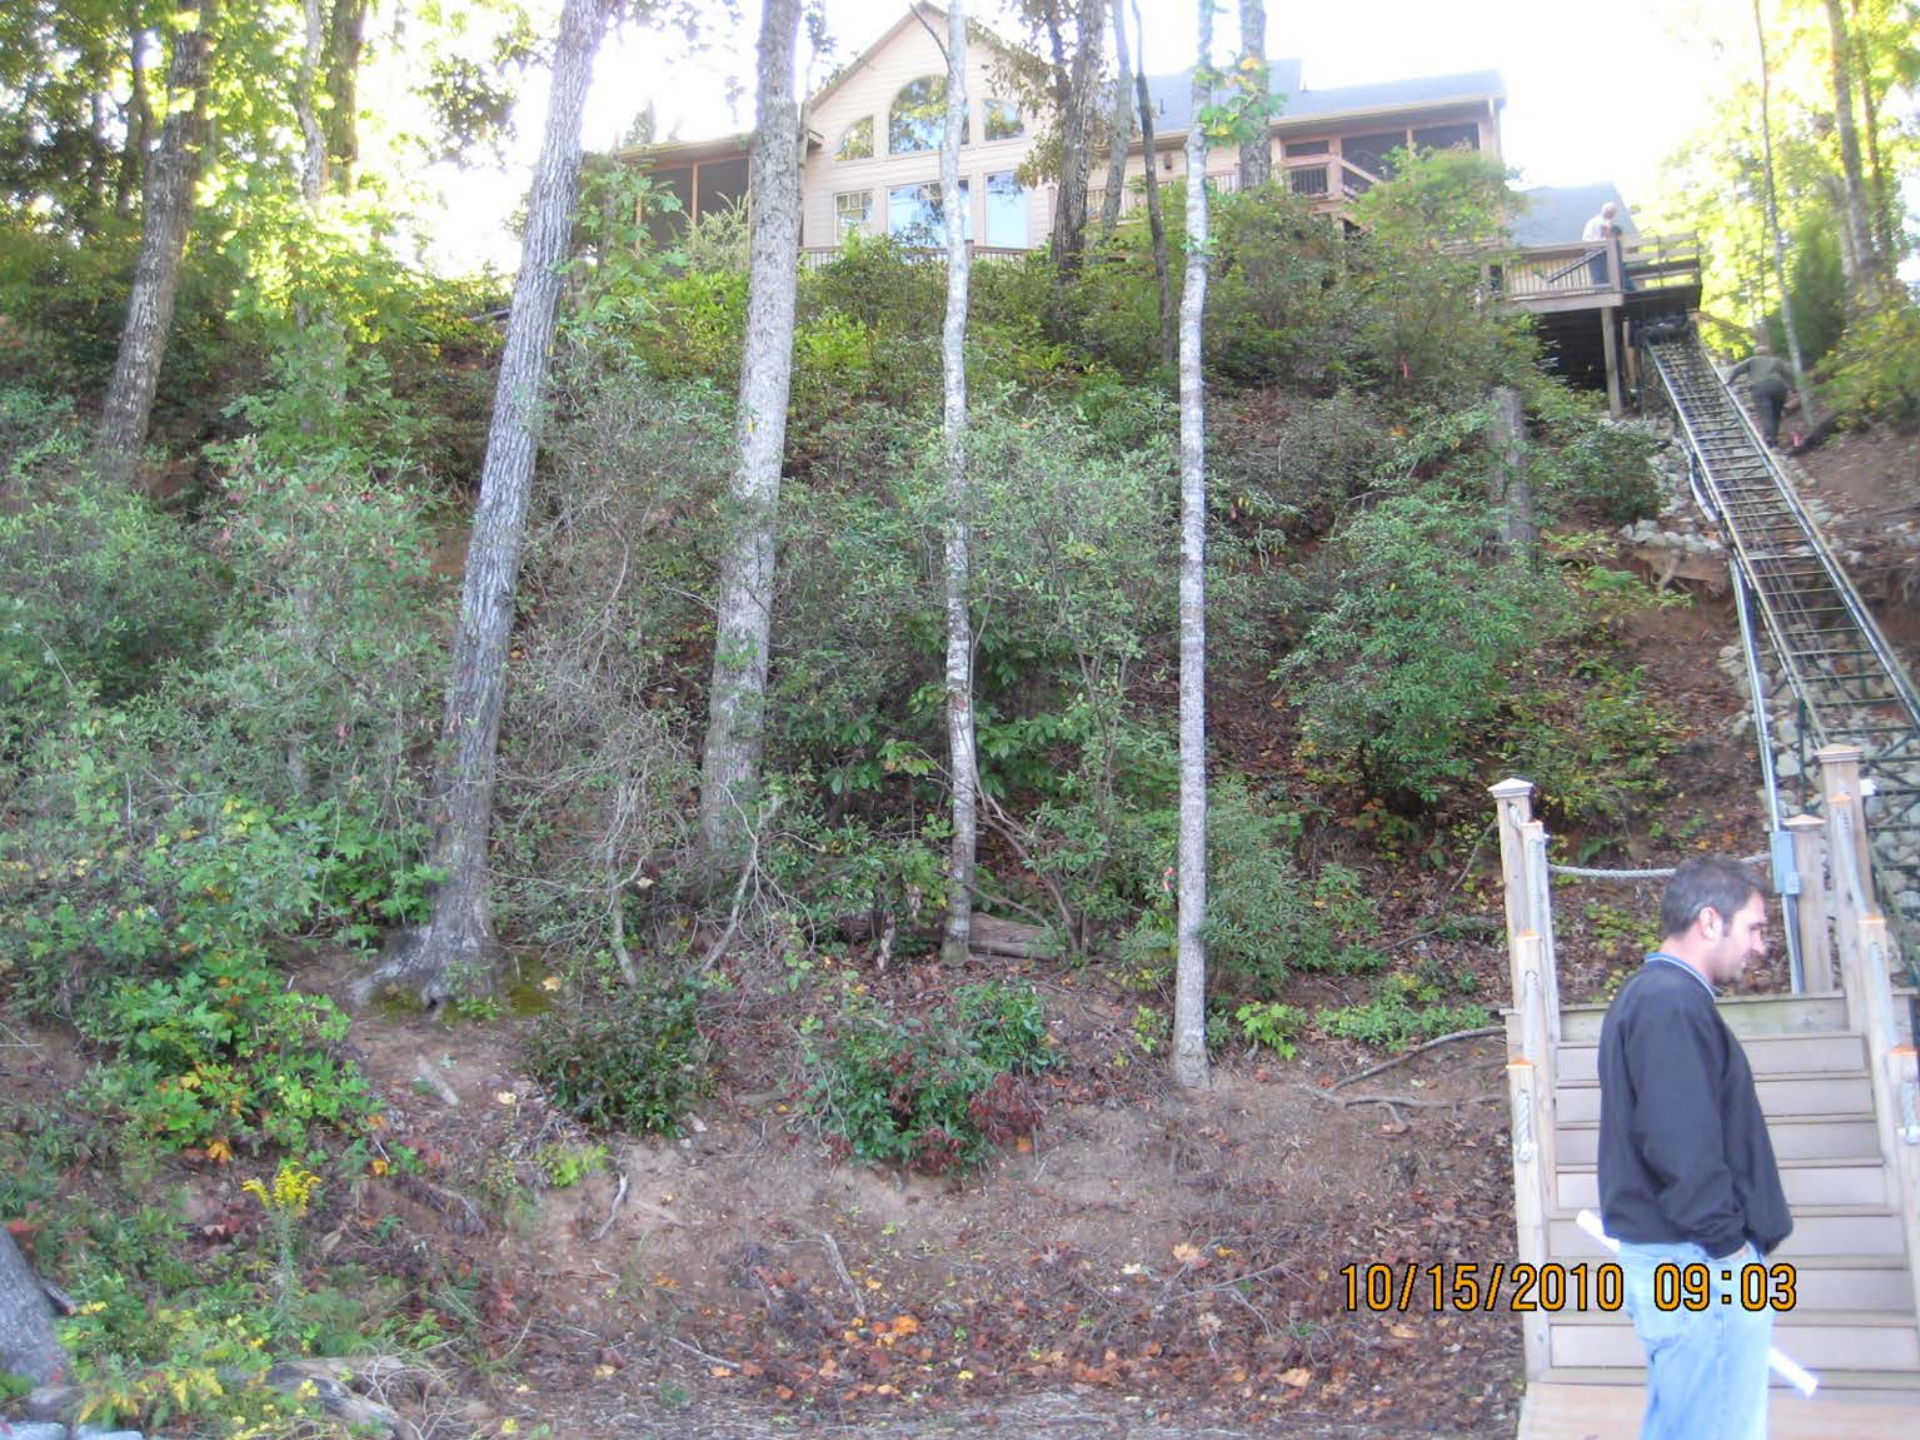
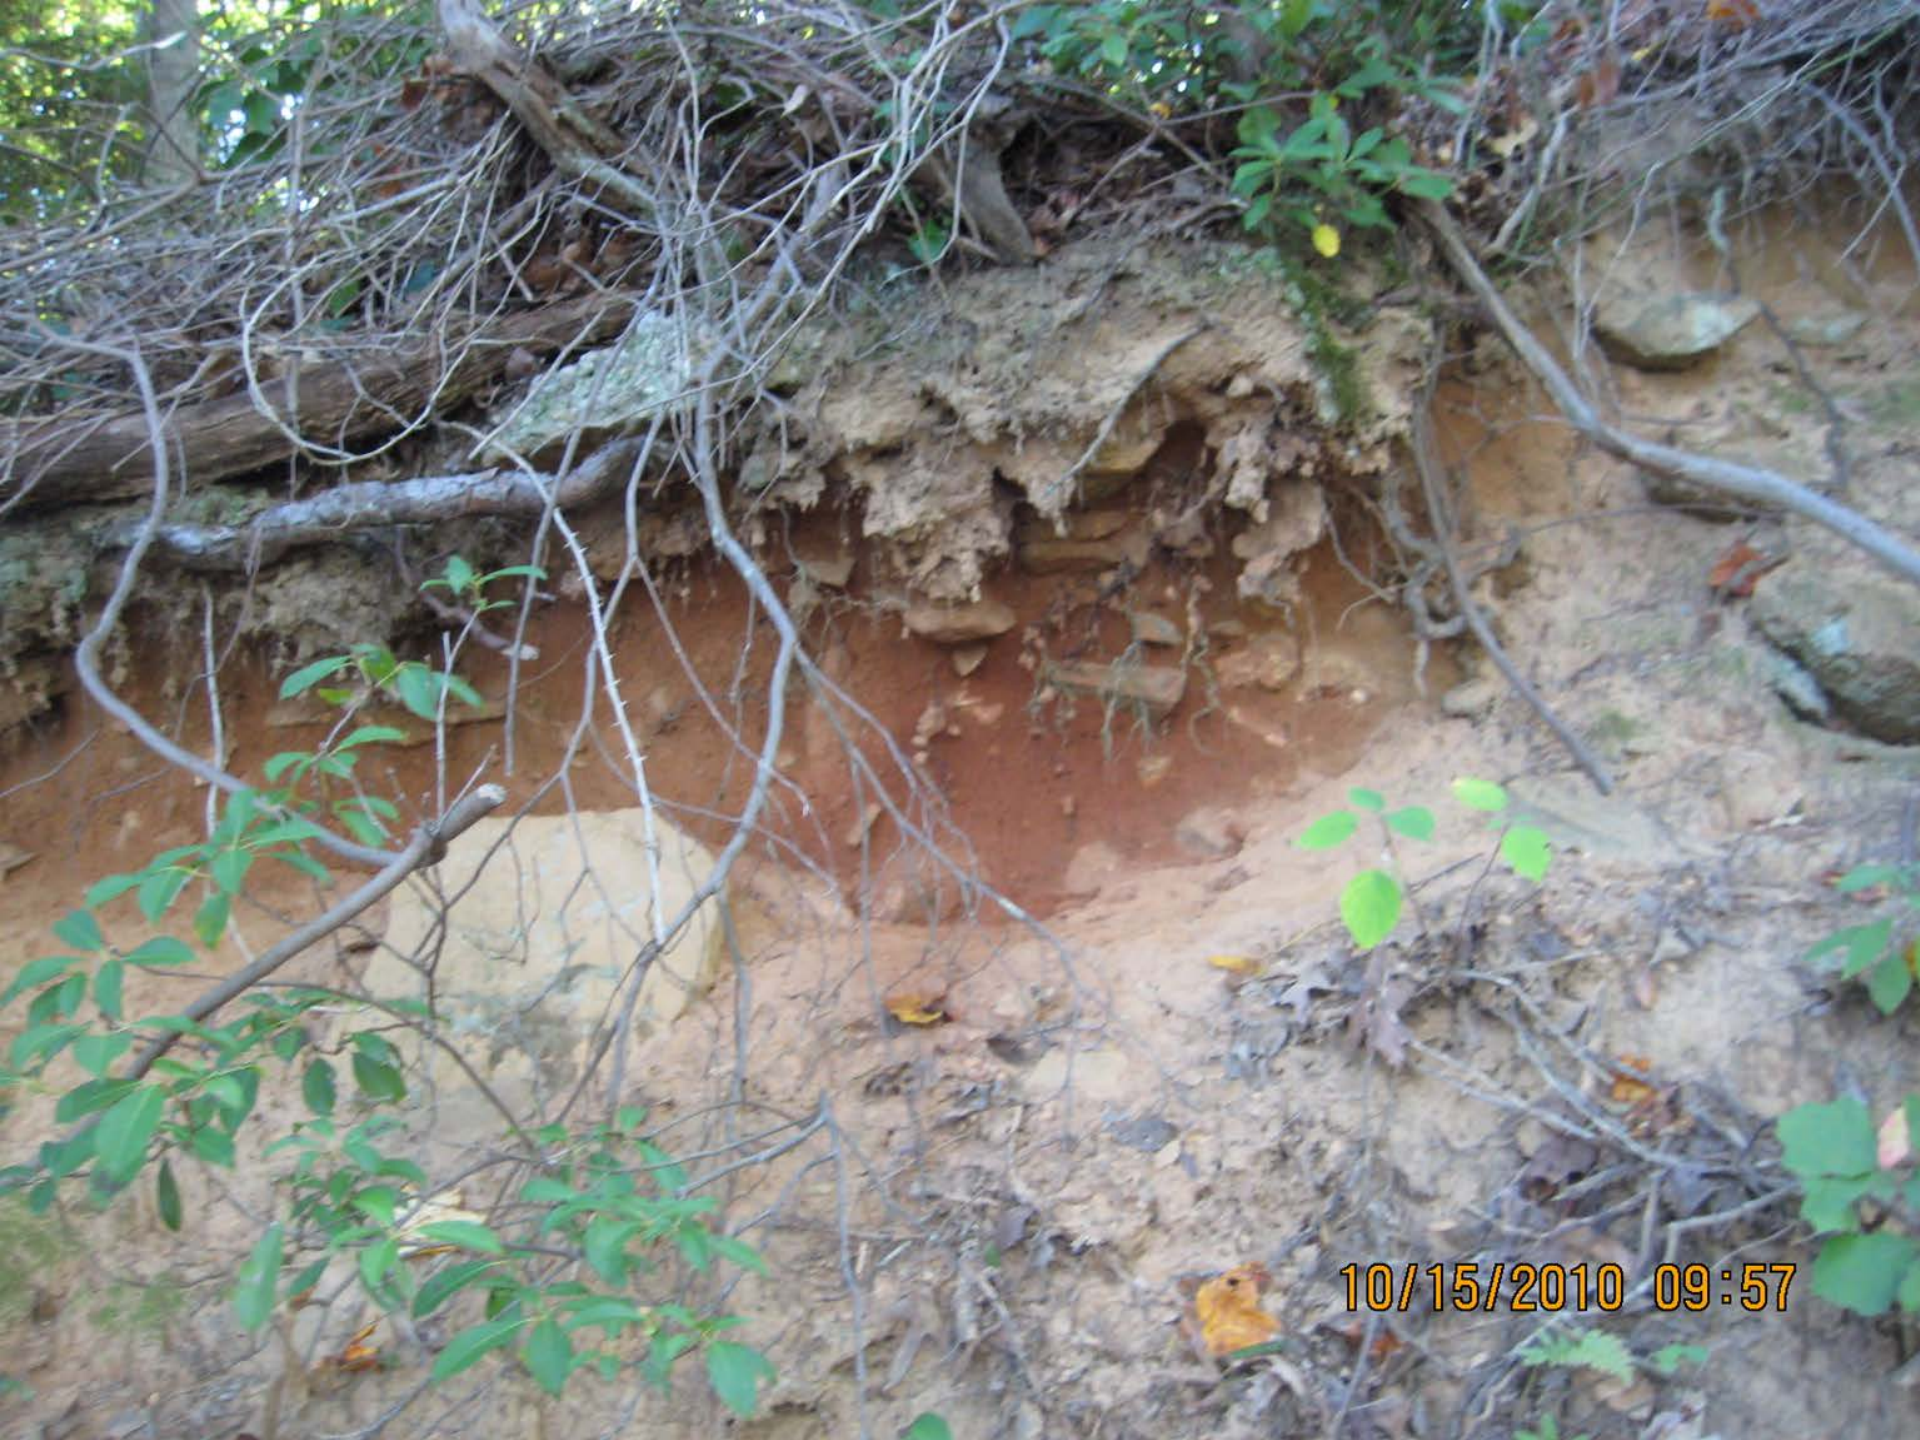
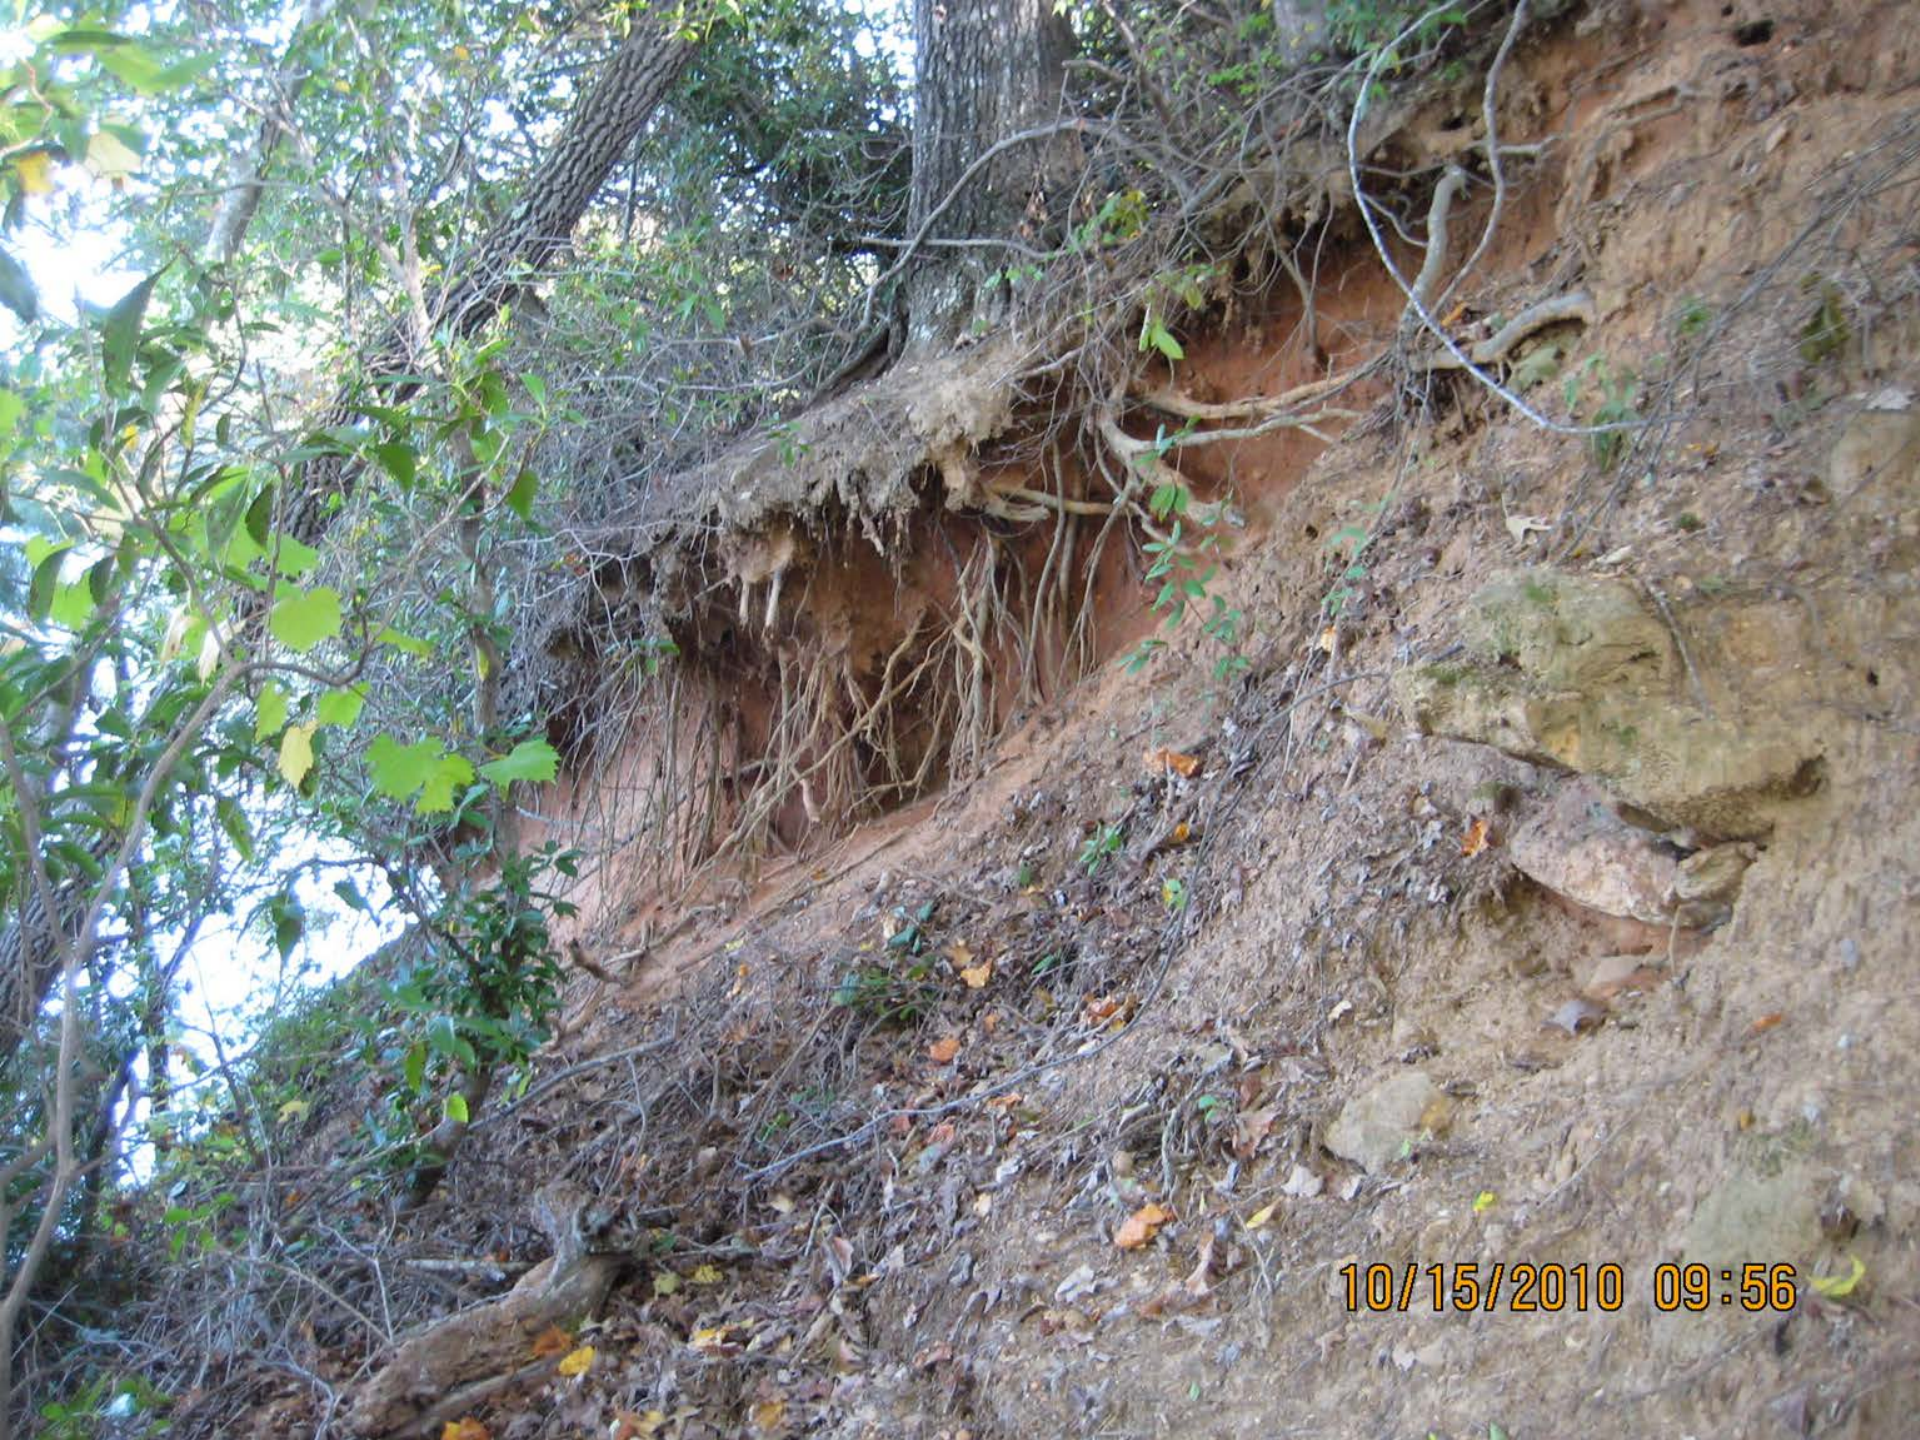
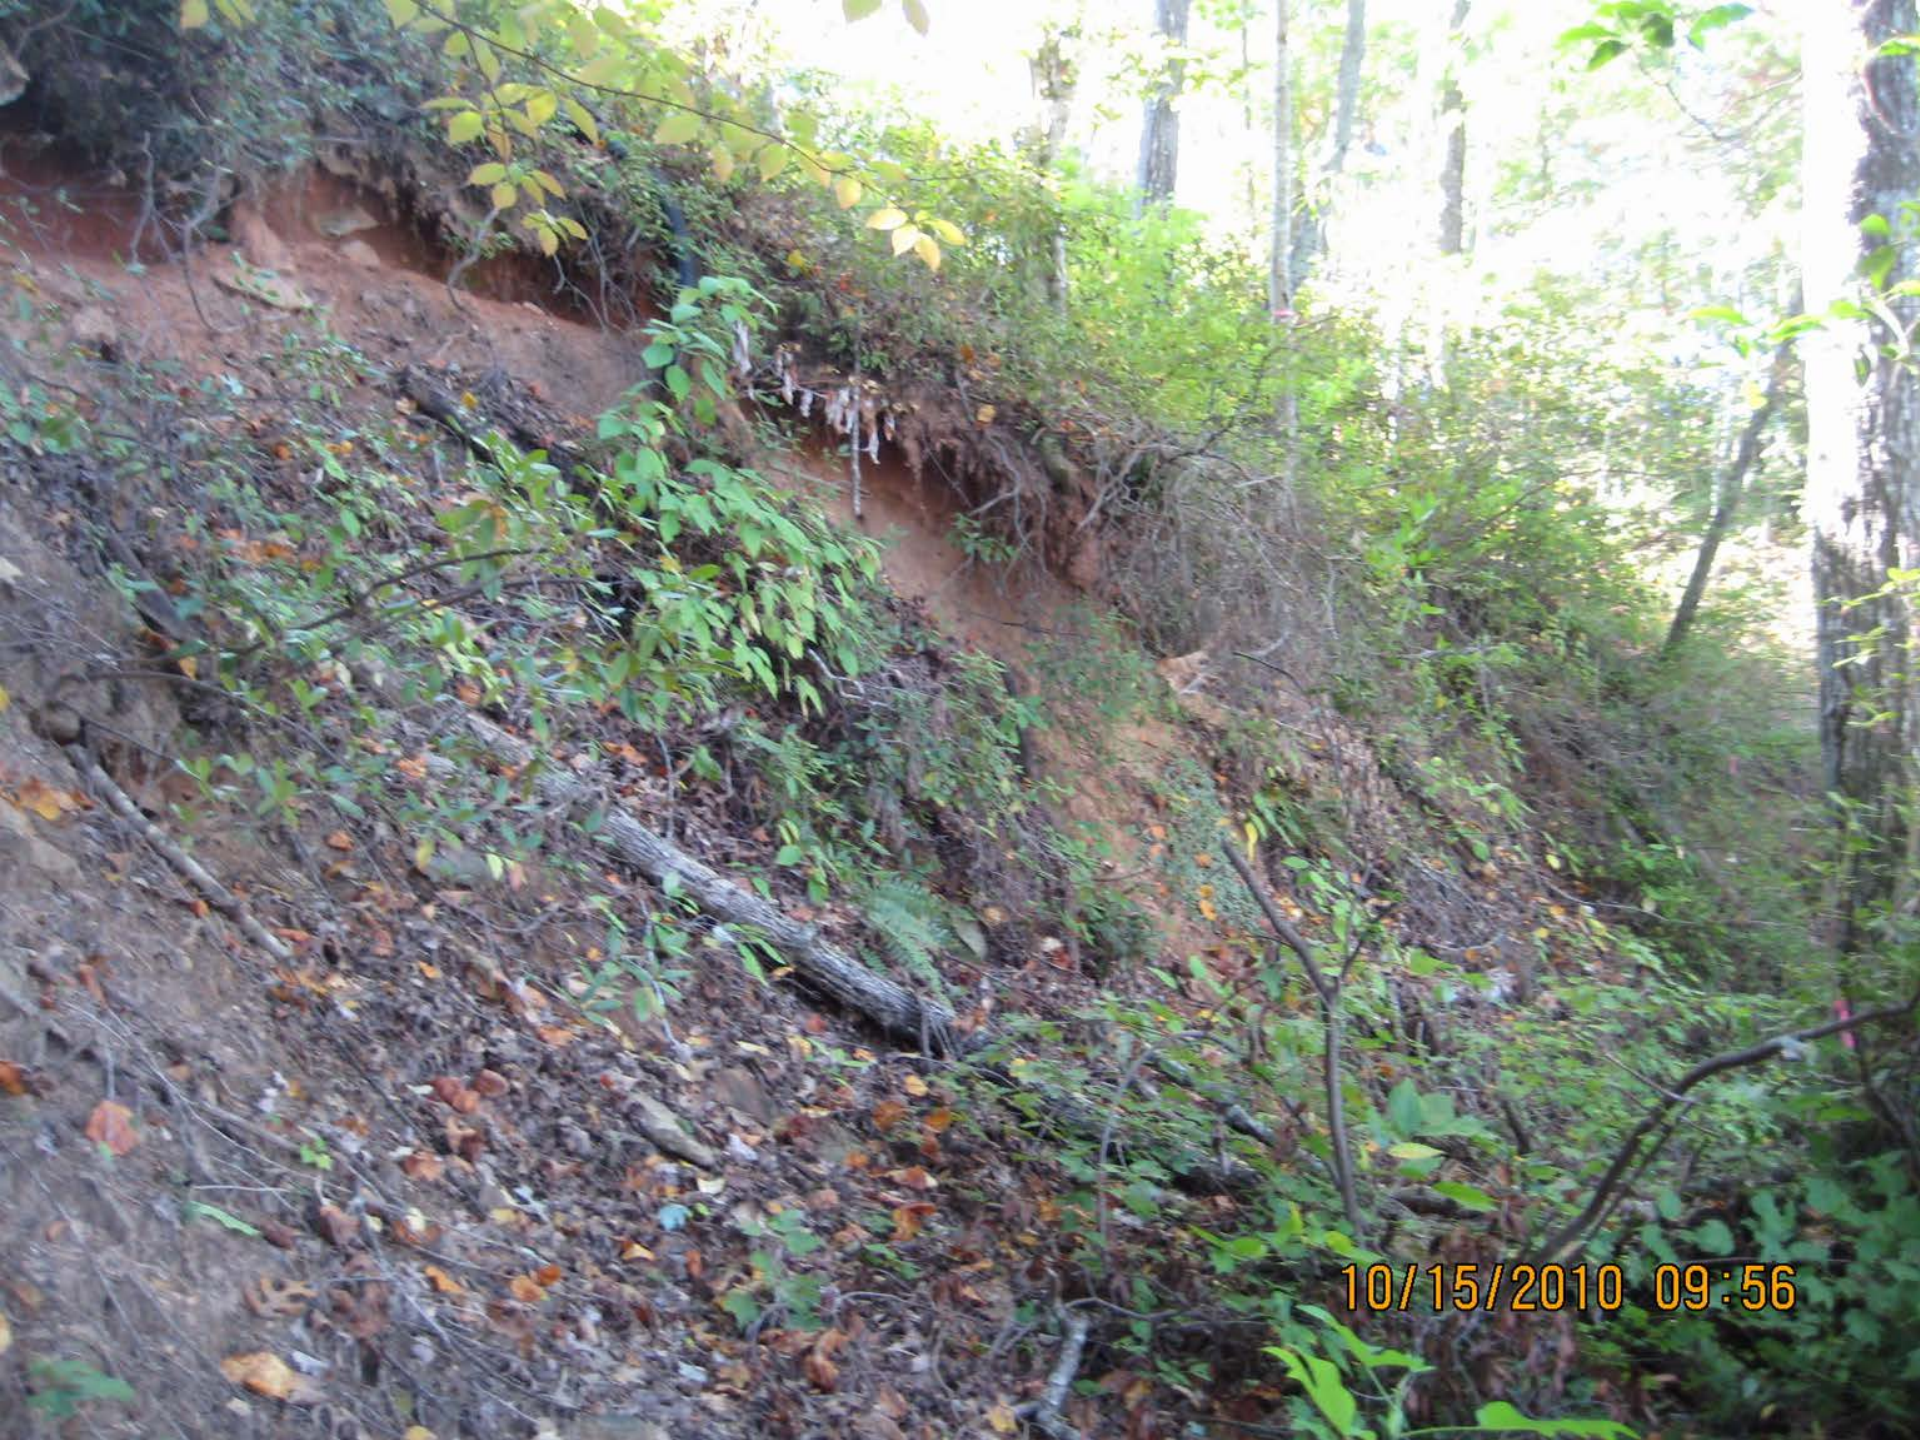
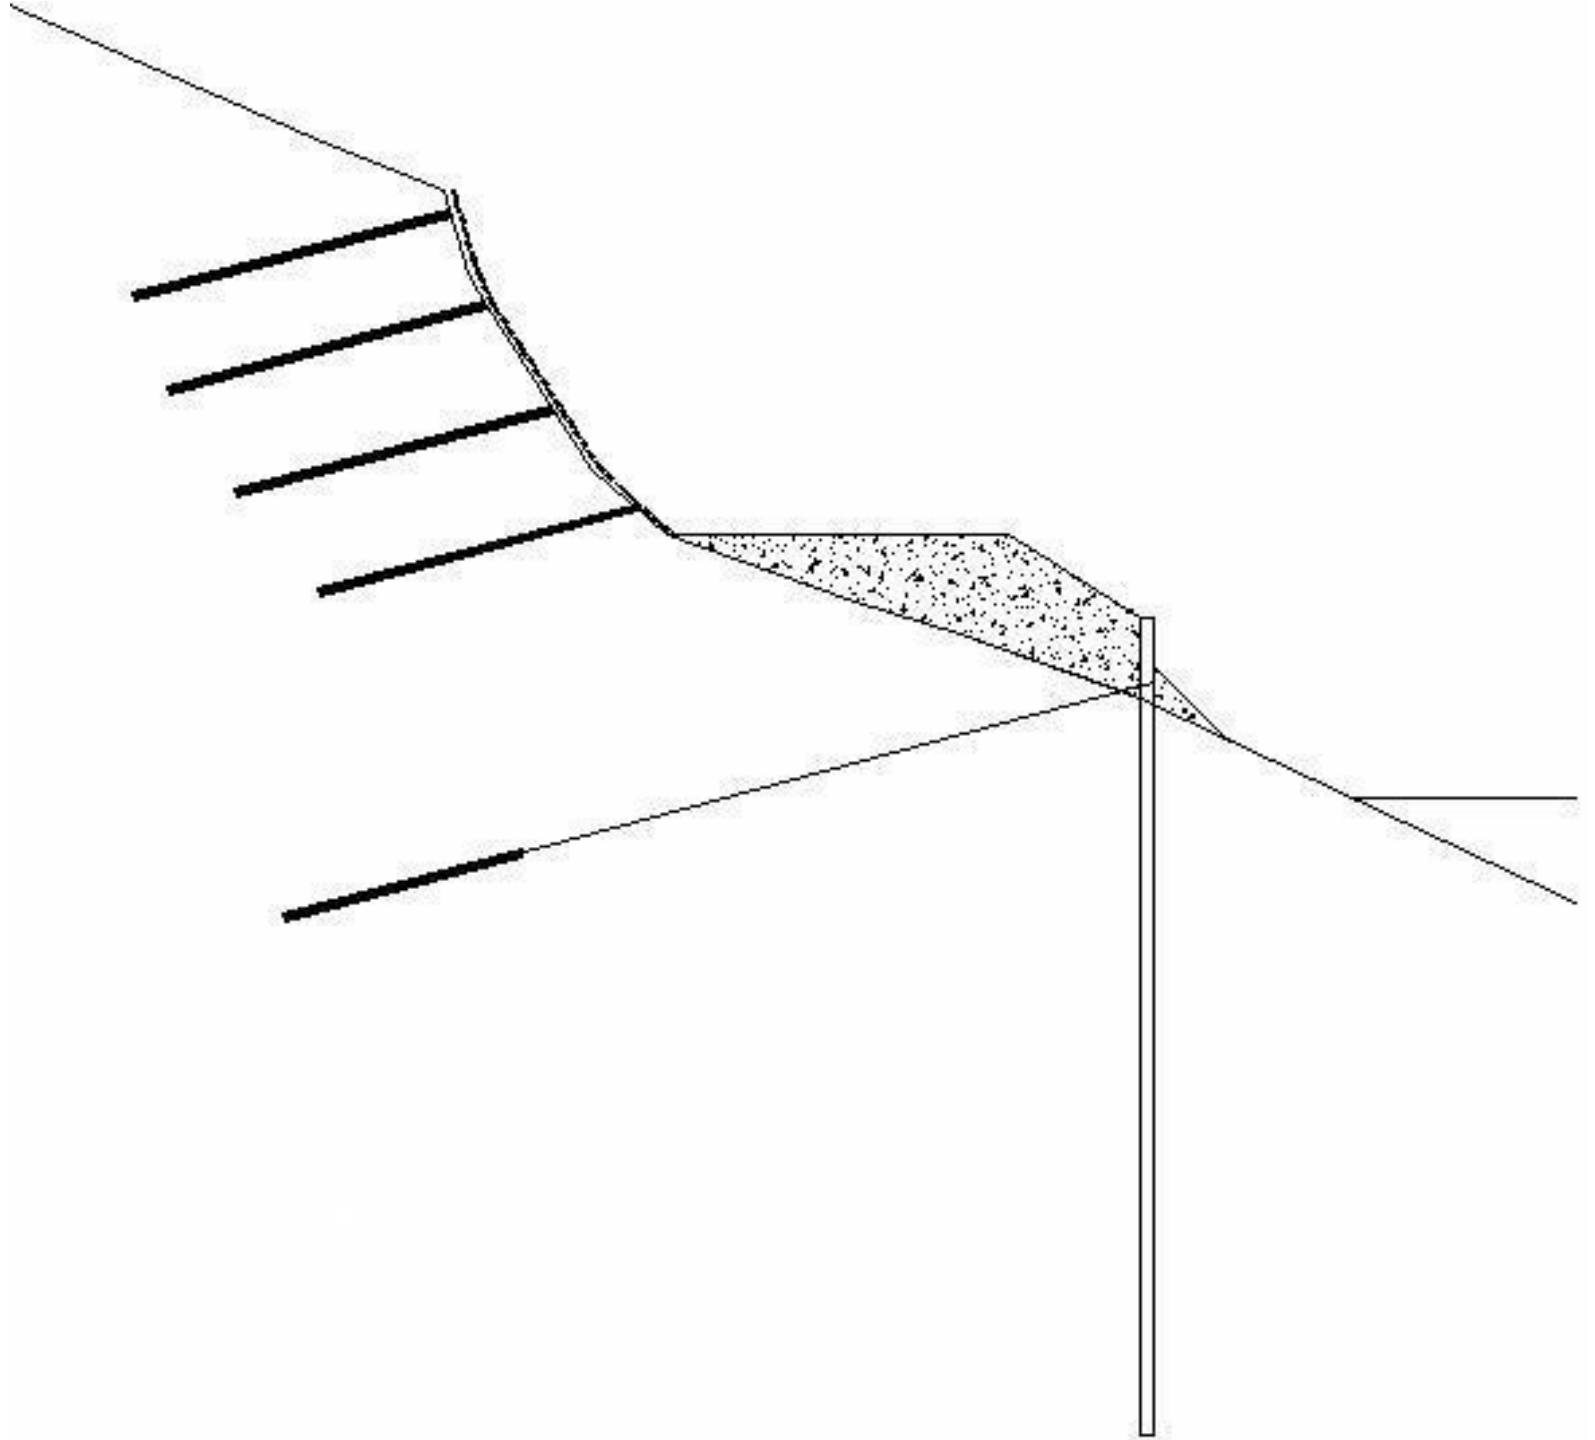
- Site 2 slide was repaired by others by regrading slope.
- Effectiveness of repair unknown.
- Slide was deep seated and extended into lake.
- Ground movement did not extend as far as house.
- Ground was moderately sloping.
- Slide is the edge of a larger slide that encompasses most of the adjacent lot and a third lot.
- Adjacent lot was abandoned.
- The third lot has a house on it and repairs were reportedly made by regrading the lot.
