The Keowee Creeper

By Daryl Wurster, PE and
Doug Chappell, PE

Wurster Engineering & Construction, Inc.

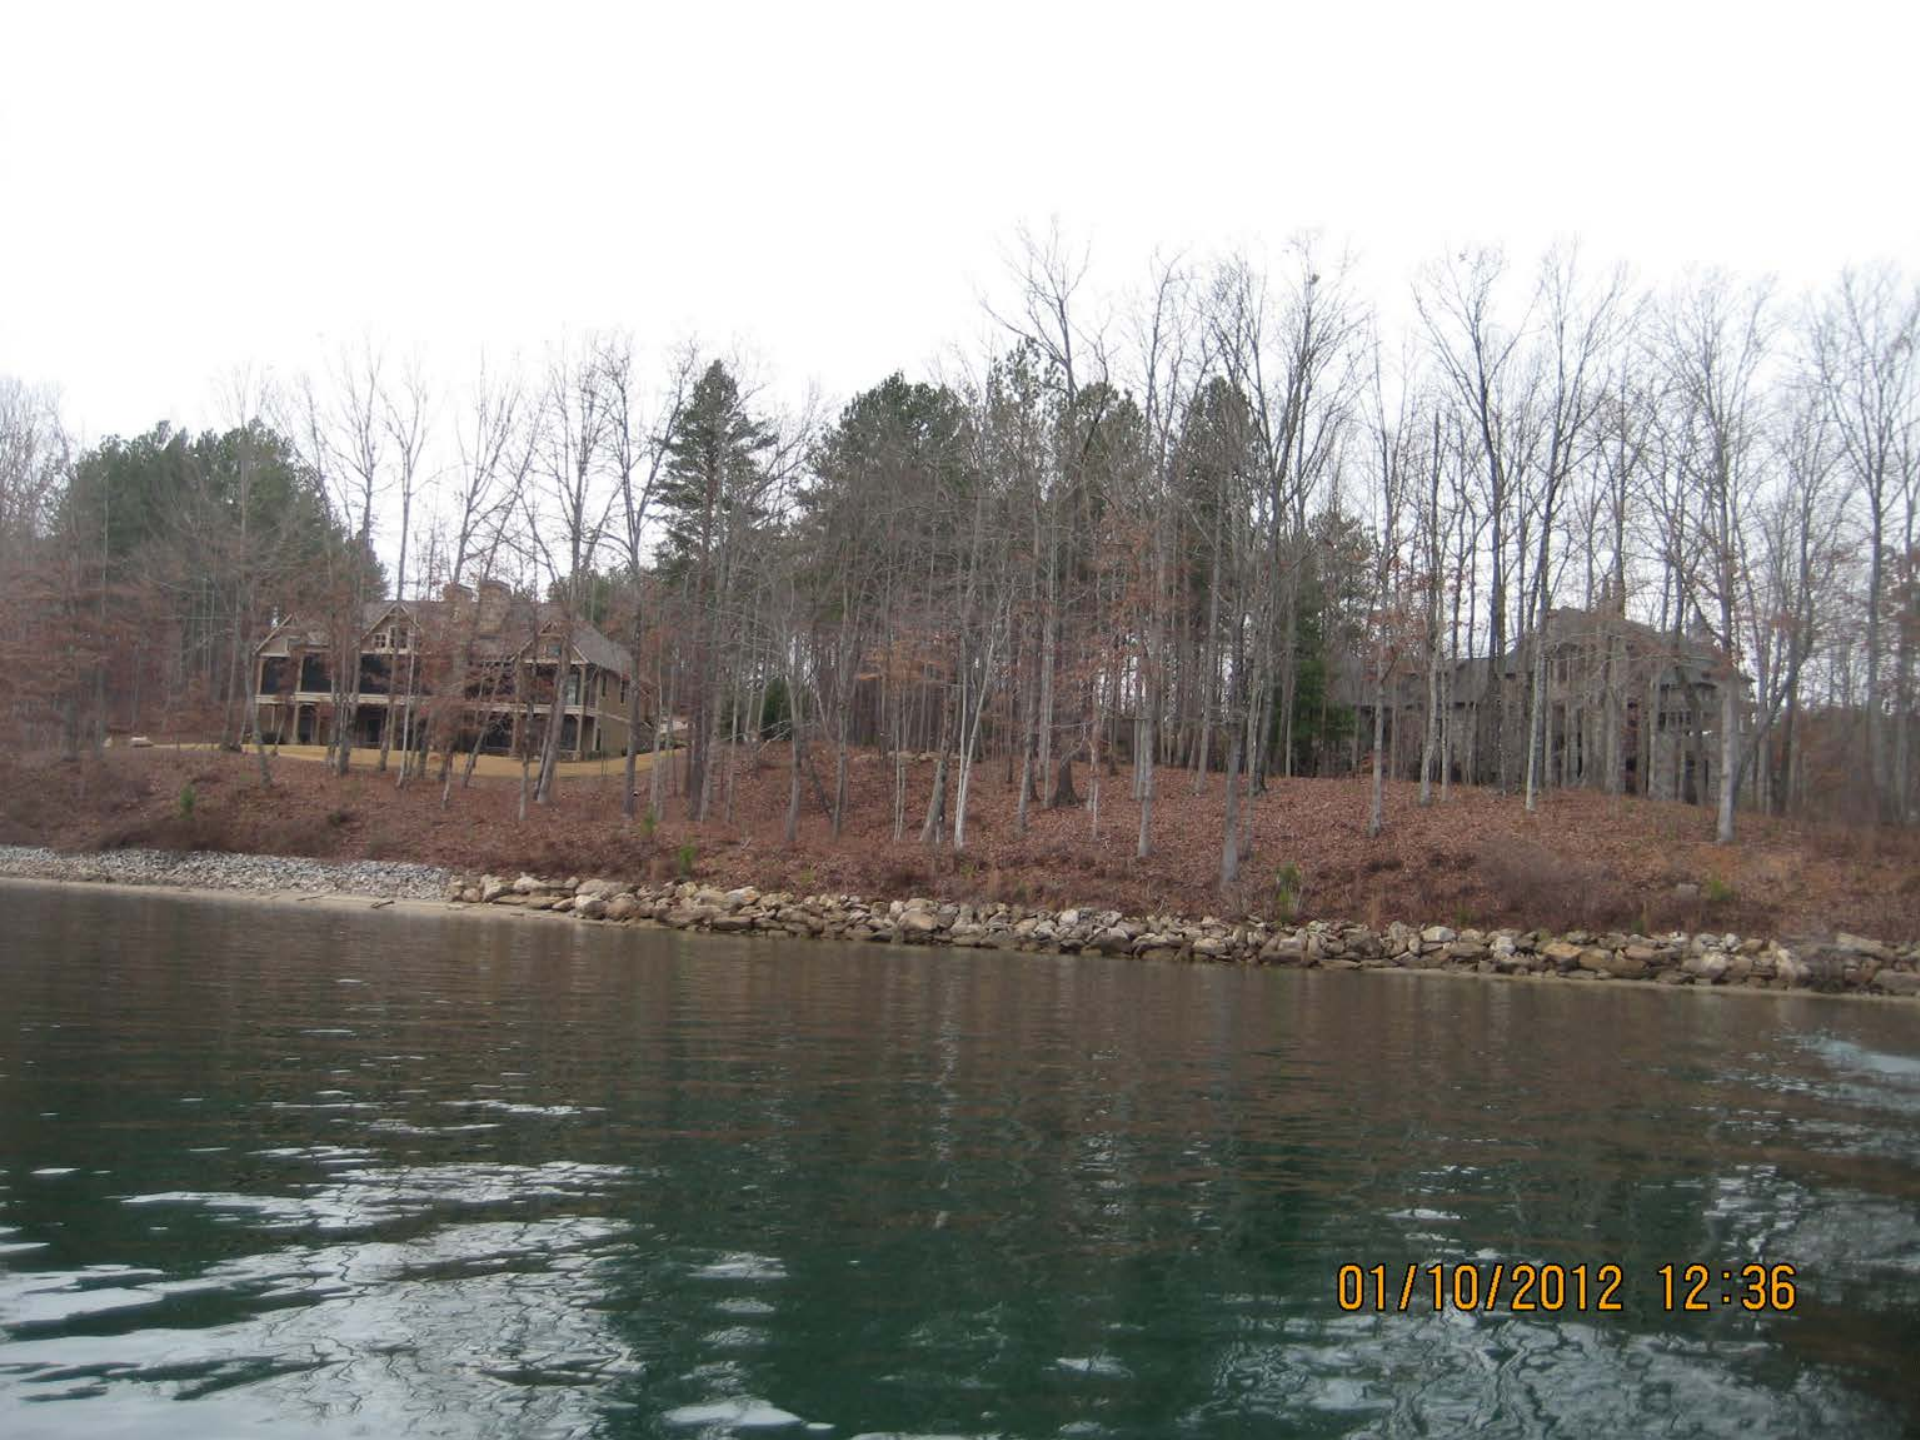
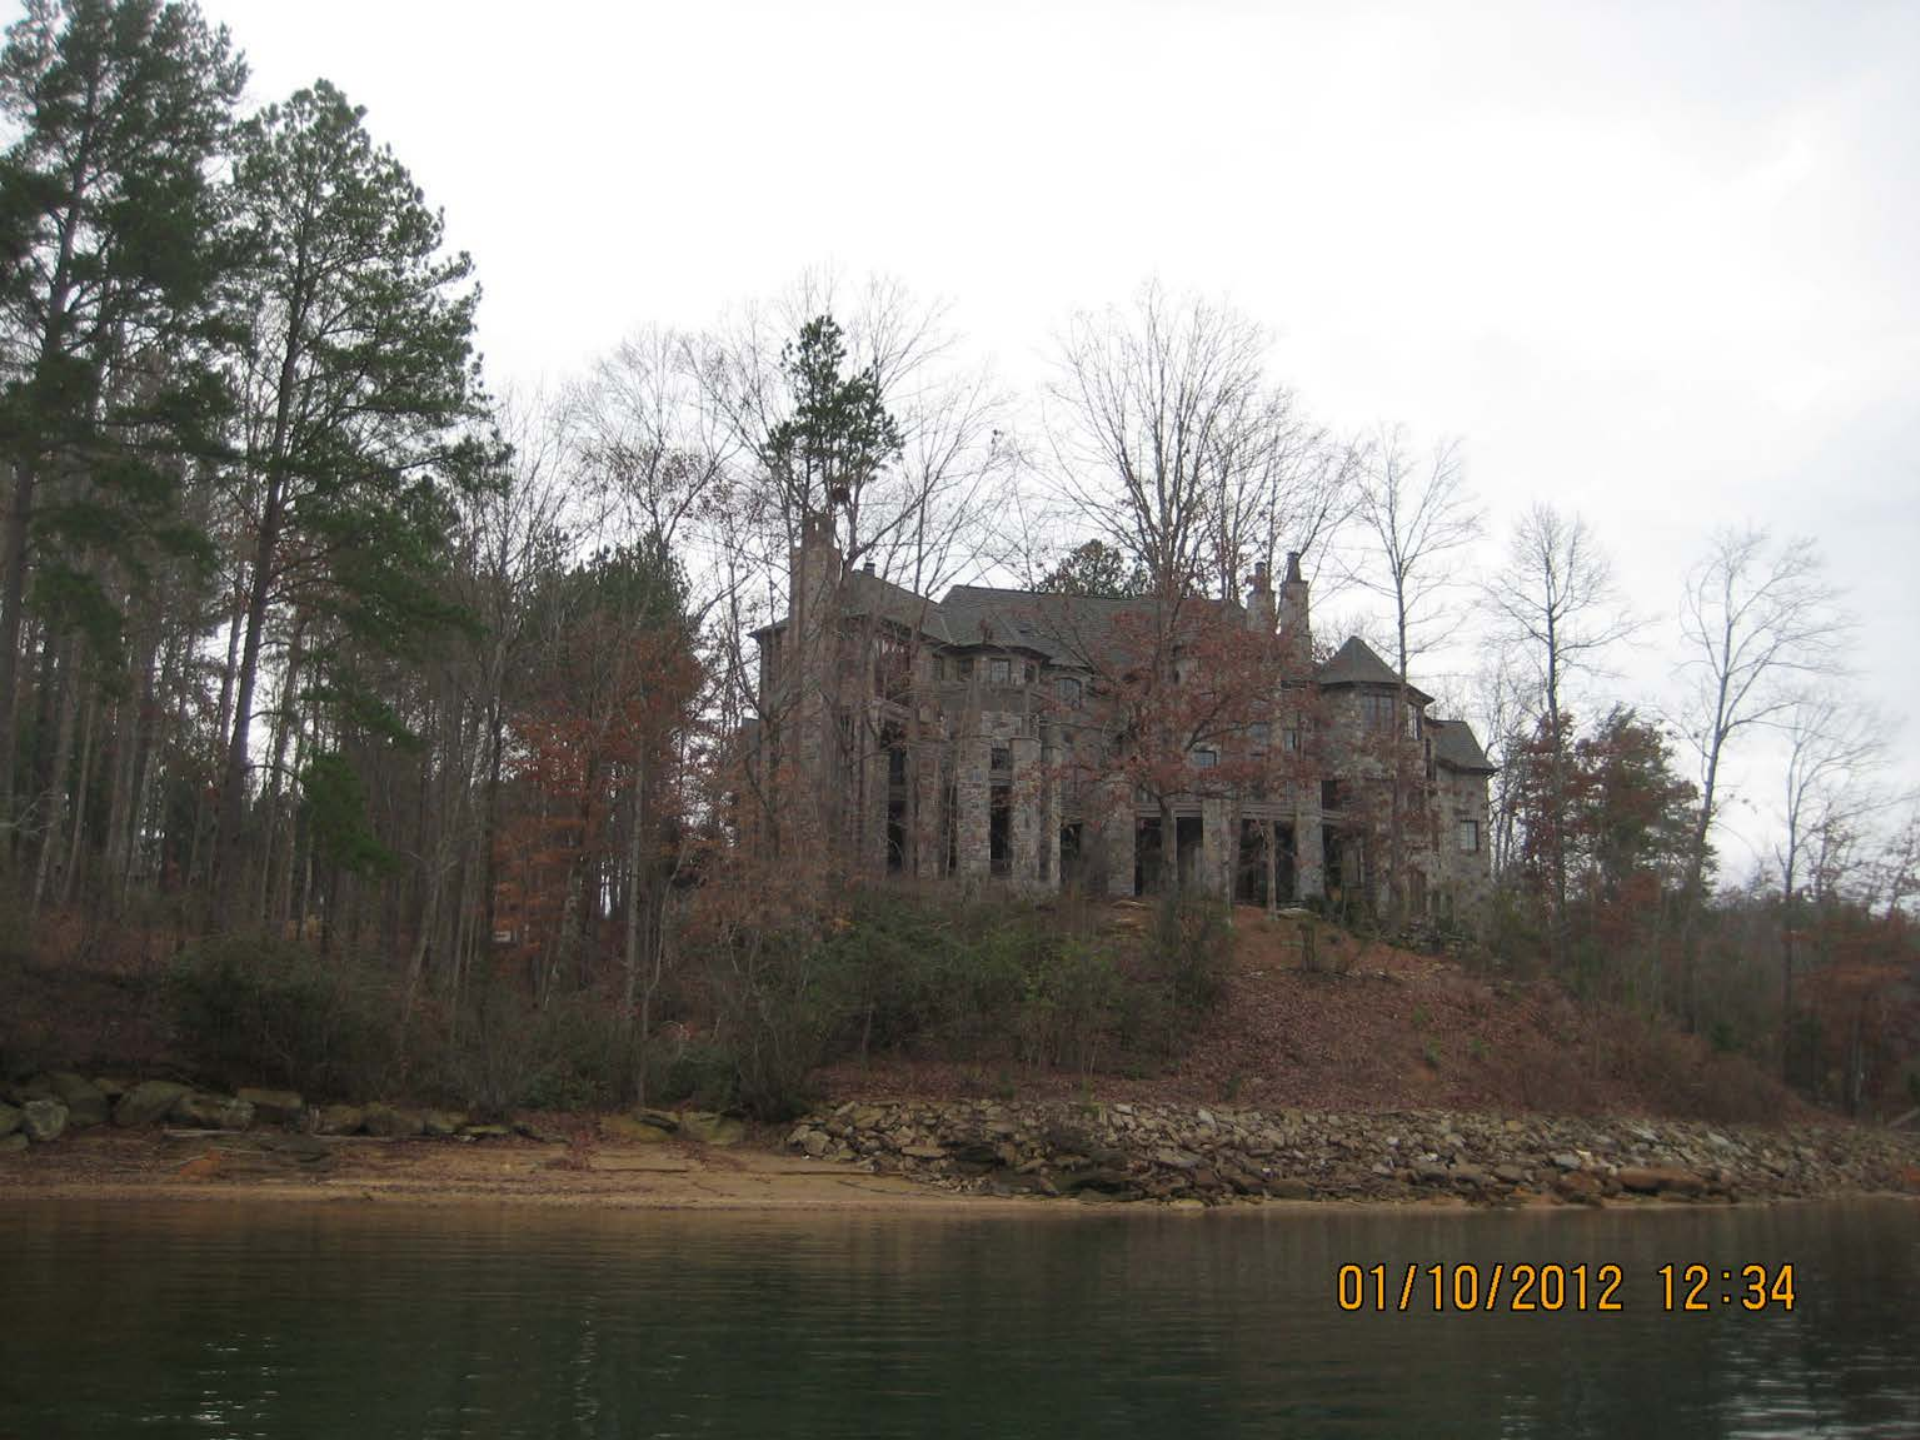
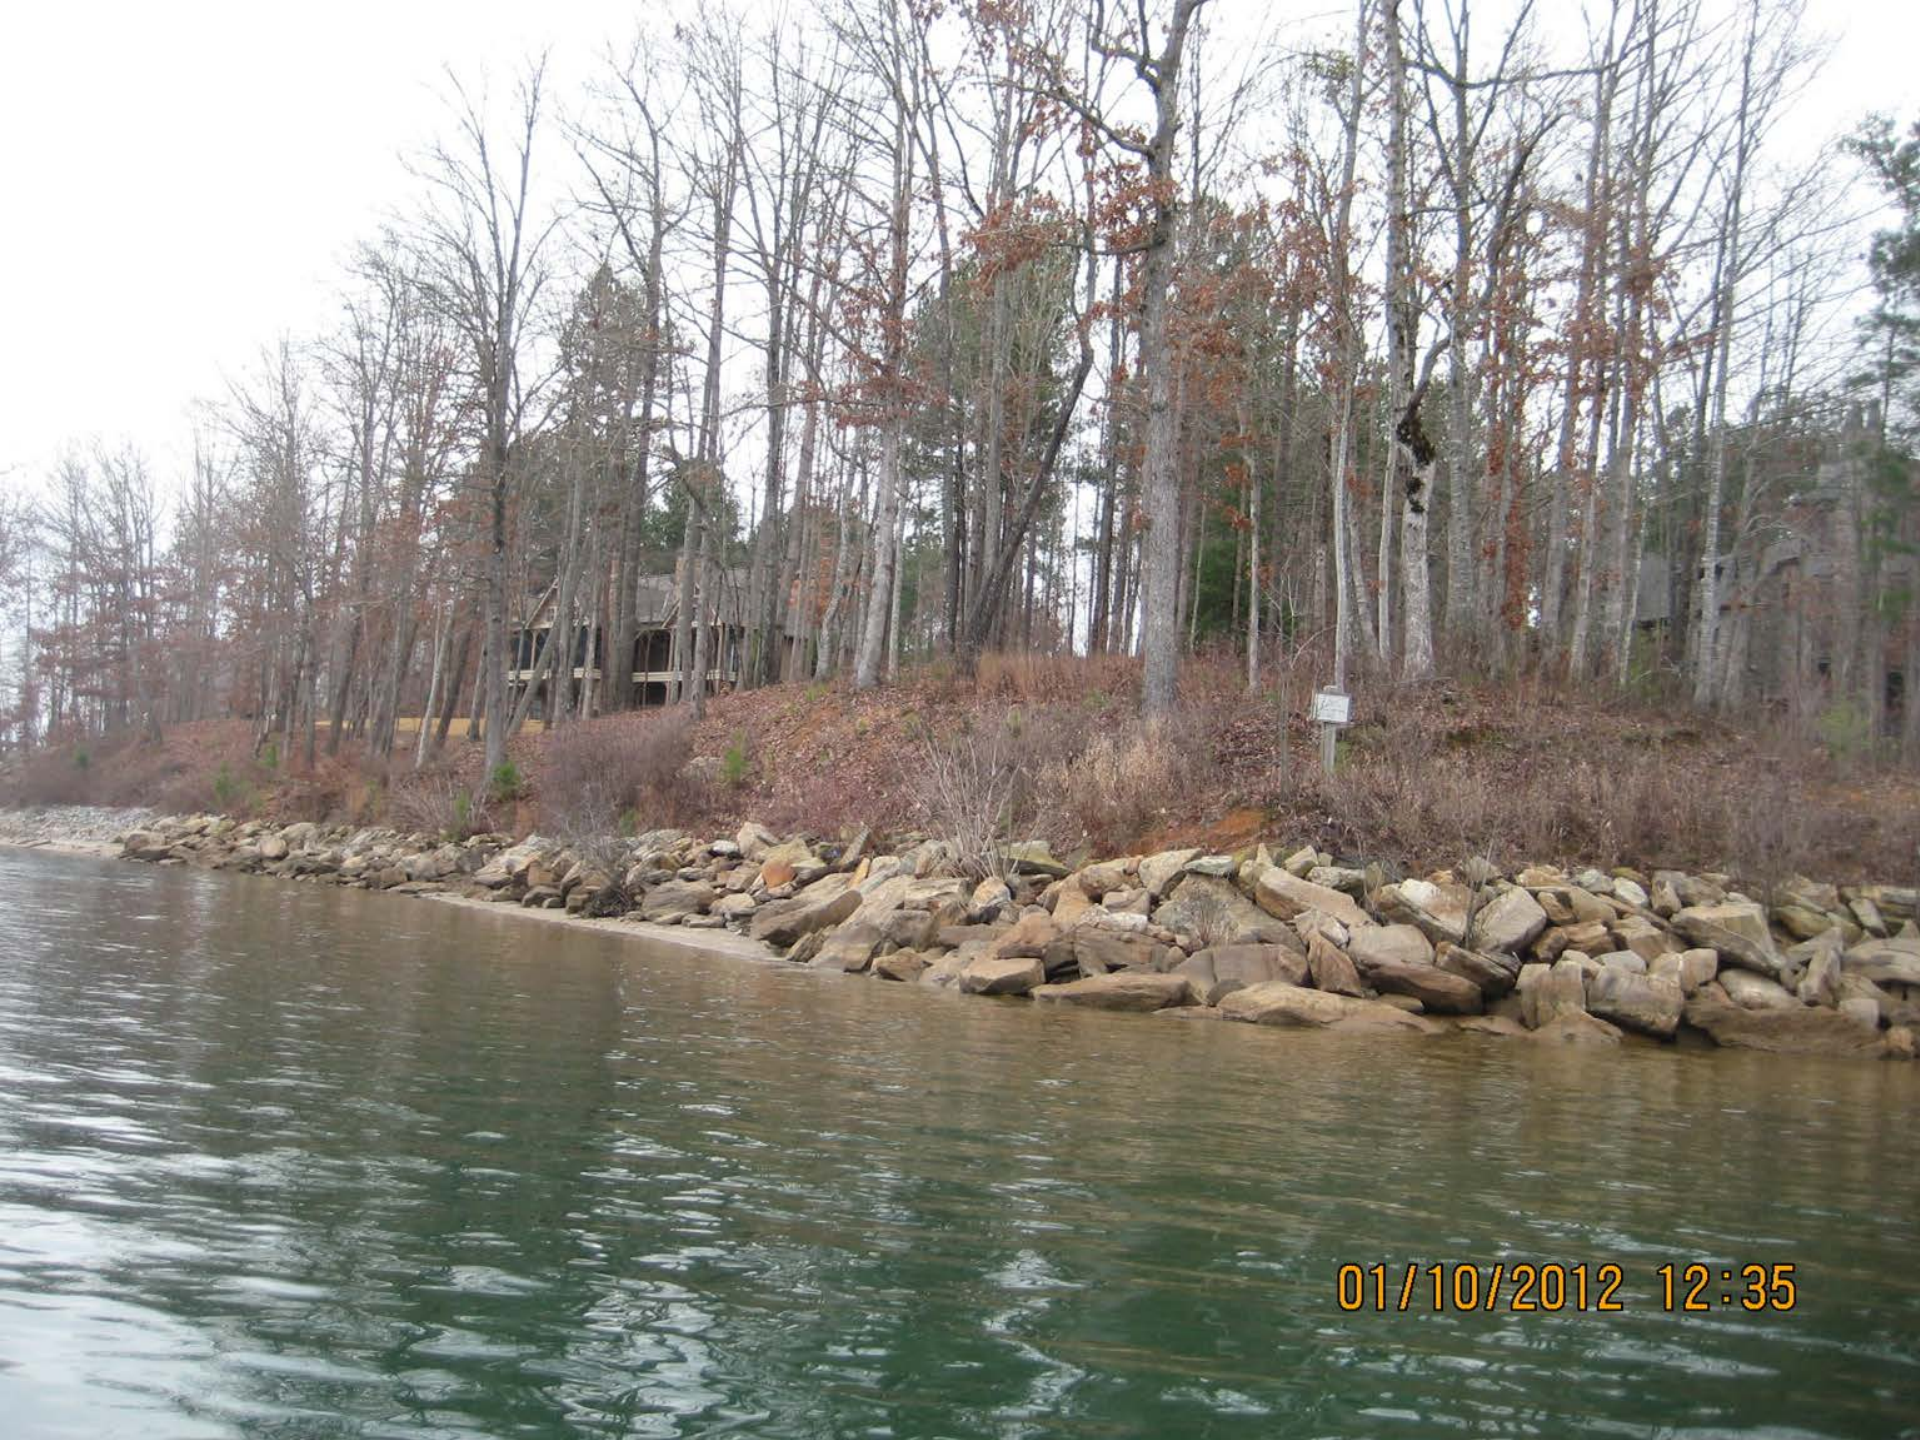
- Site 3 slide has not been repaired at this time.
- Slide is deep seated and extends into lake.
- Ground movement showed up as small to large tension cracks.
- Large tension cracks at first appear to be ditches and old roads.
- Ground was gently sloping (ie 6H:1V), however, ground offshore is as steep as 1H:1V.
- Initial repairs were made by others to a new house located in the middle of the slide area included helical piers. Piers could be tightened up, then would loose. WEC was then asked to look at site.

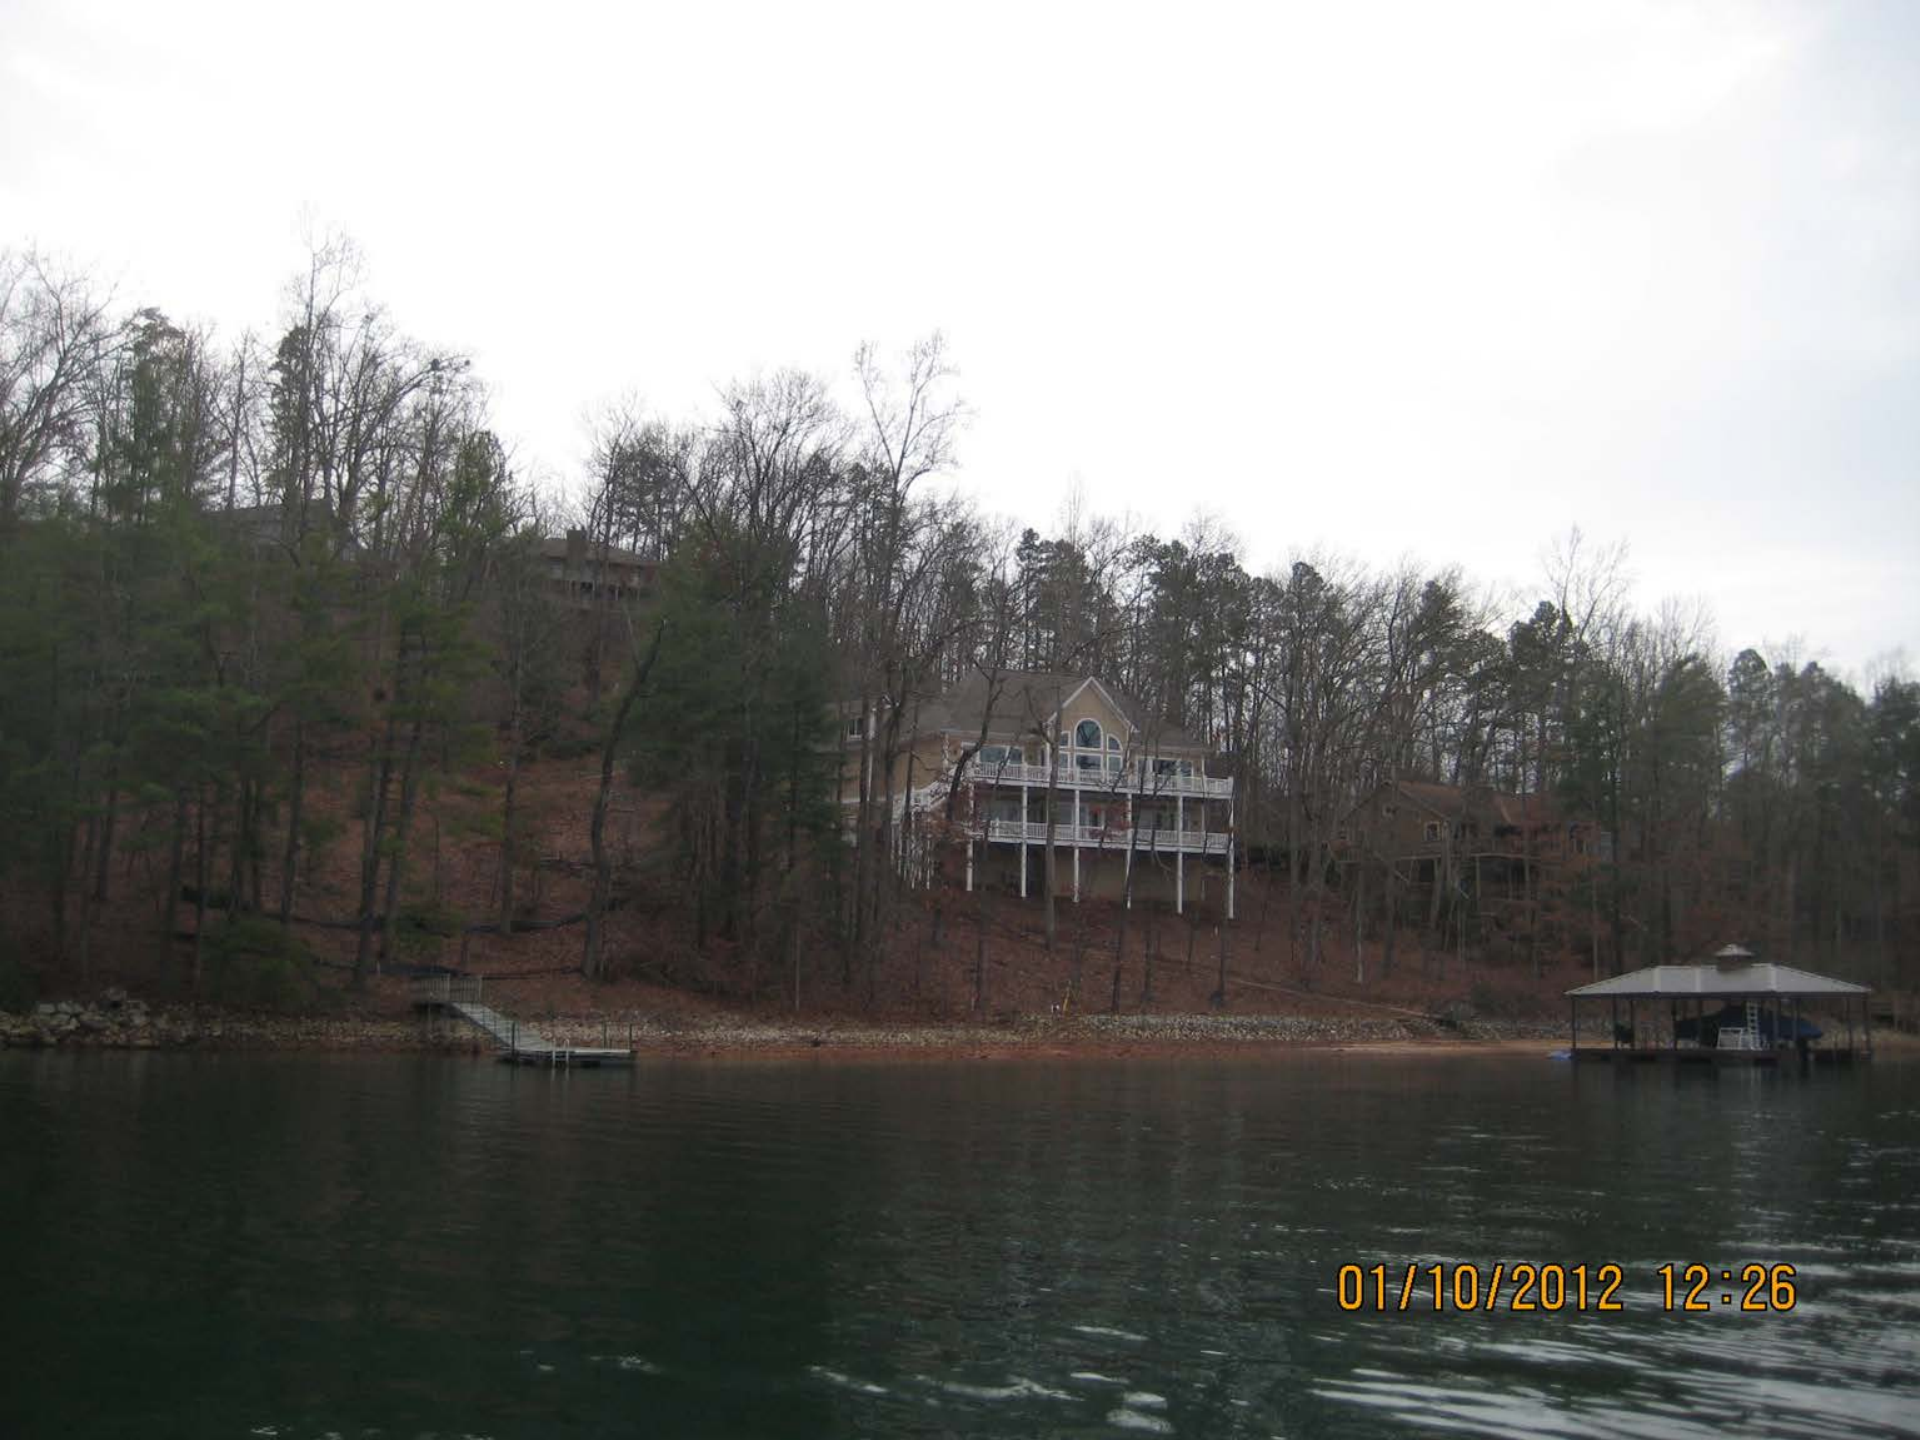
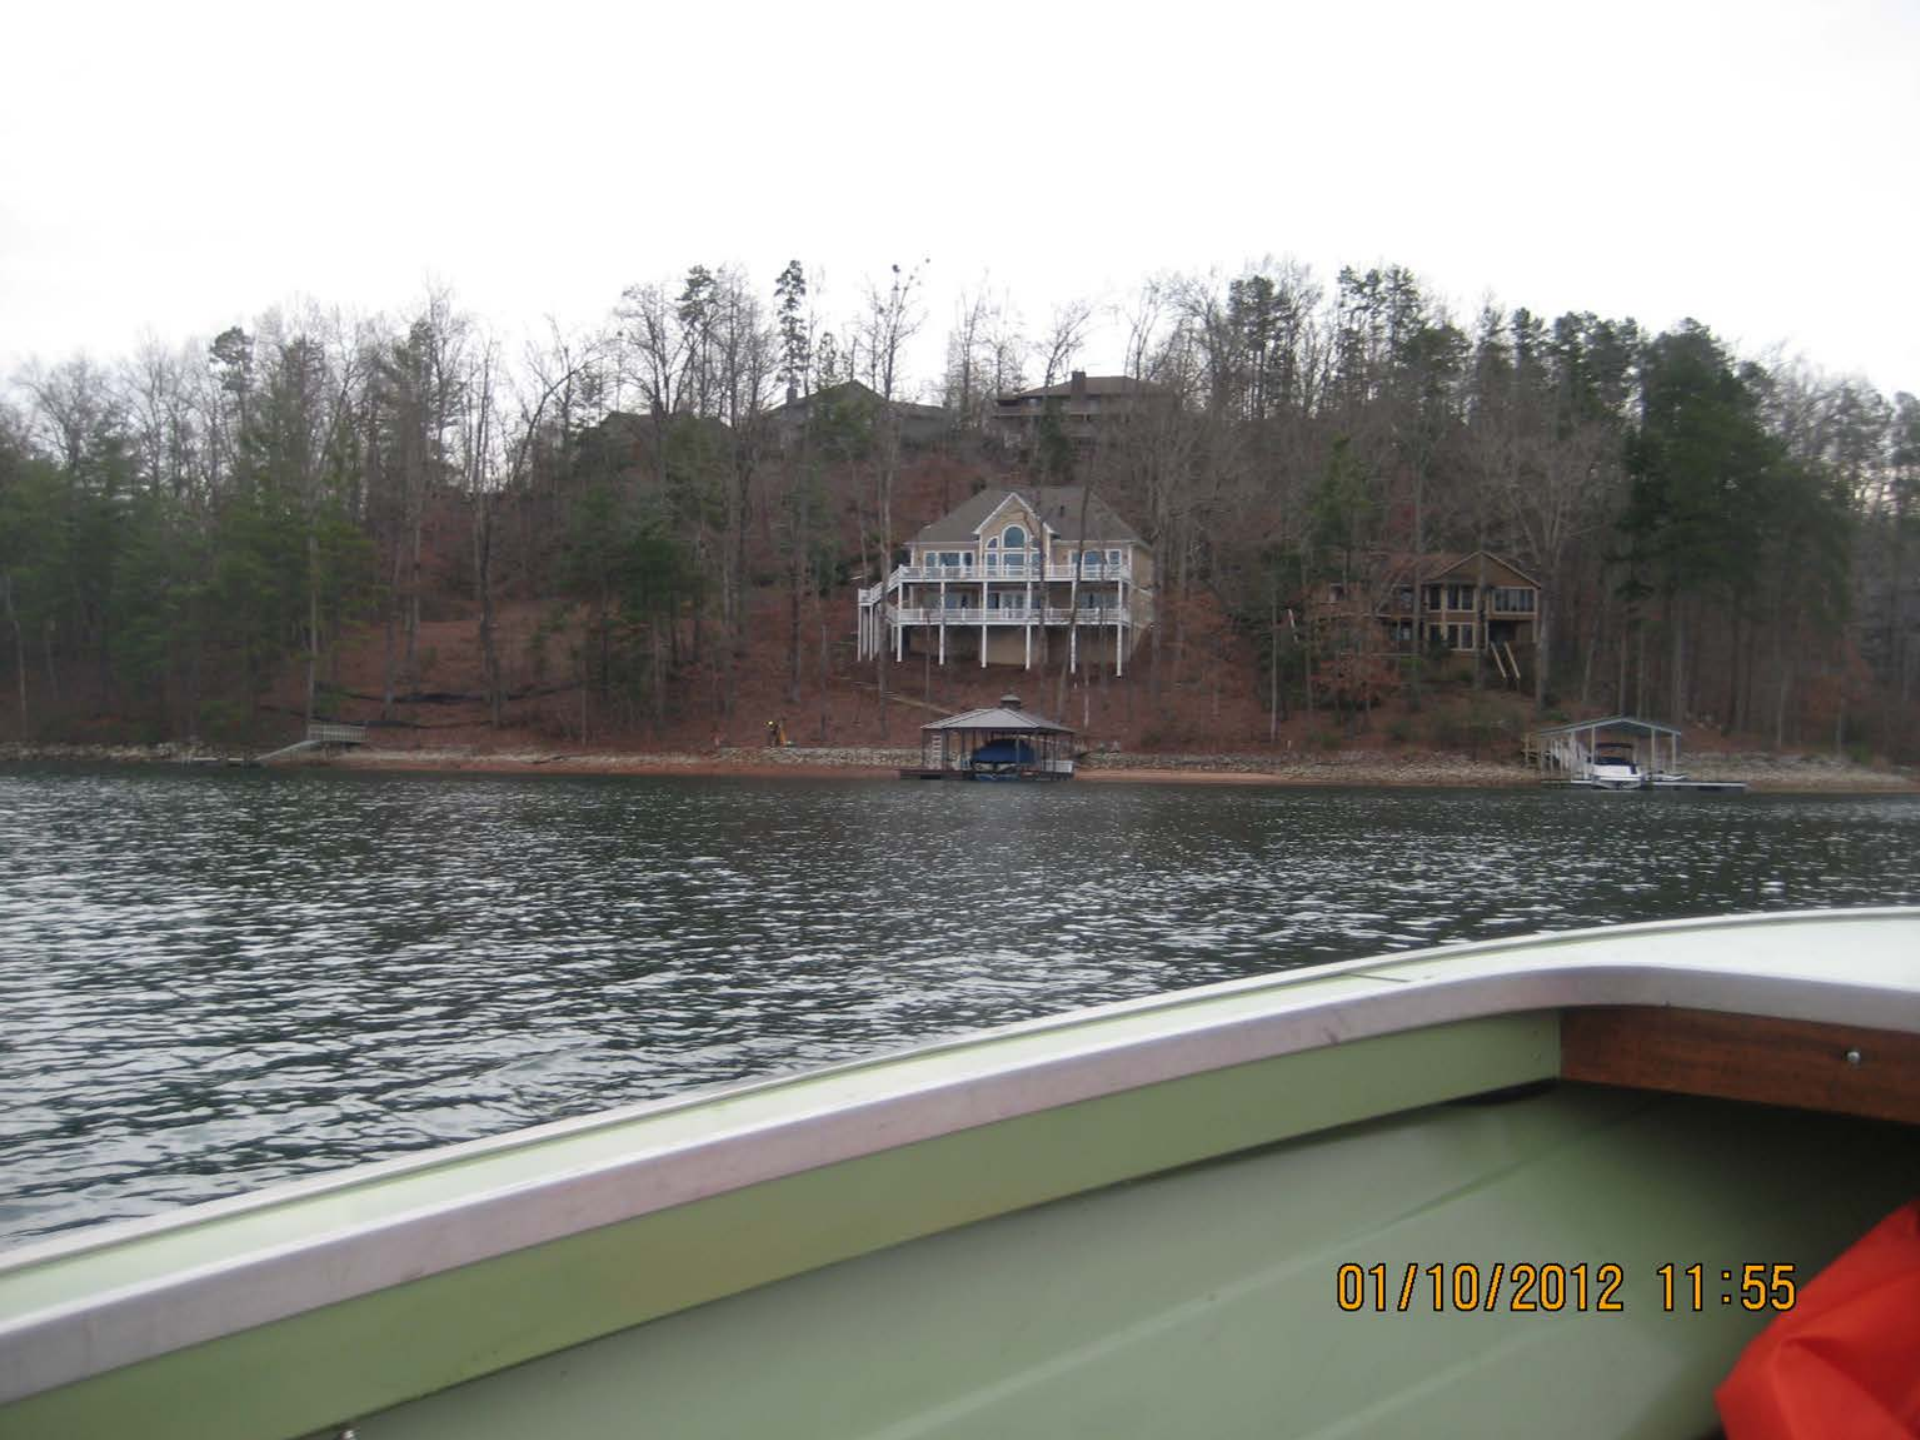
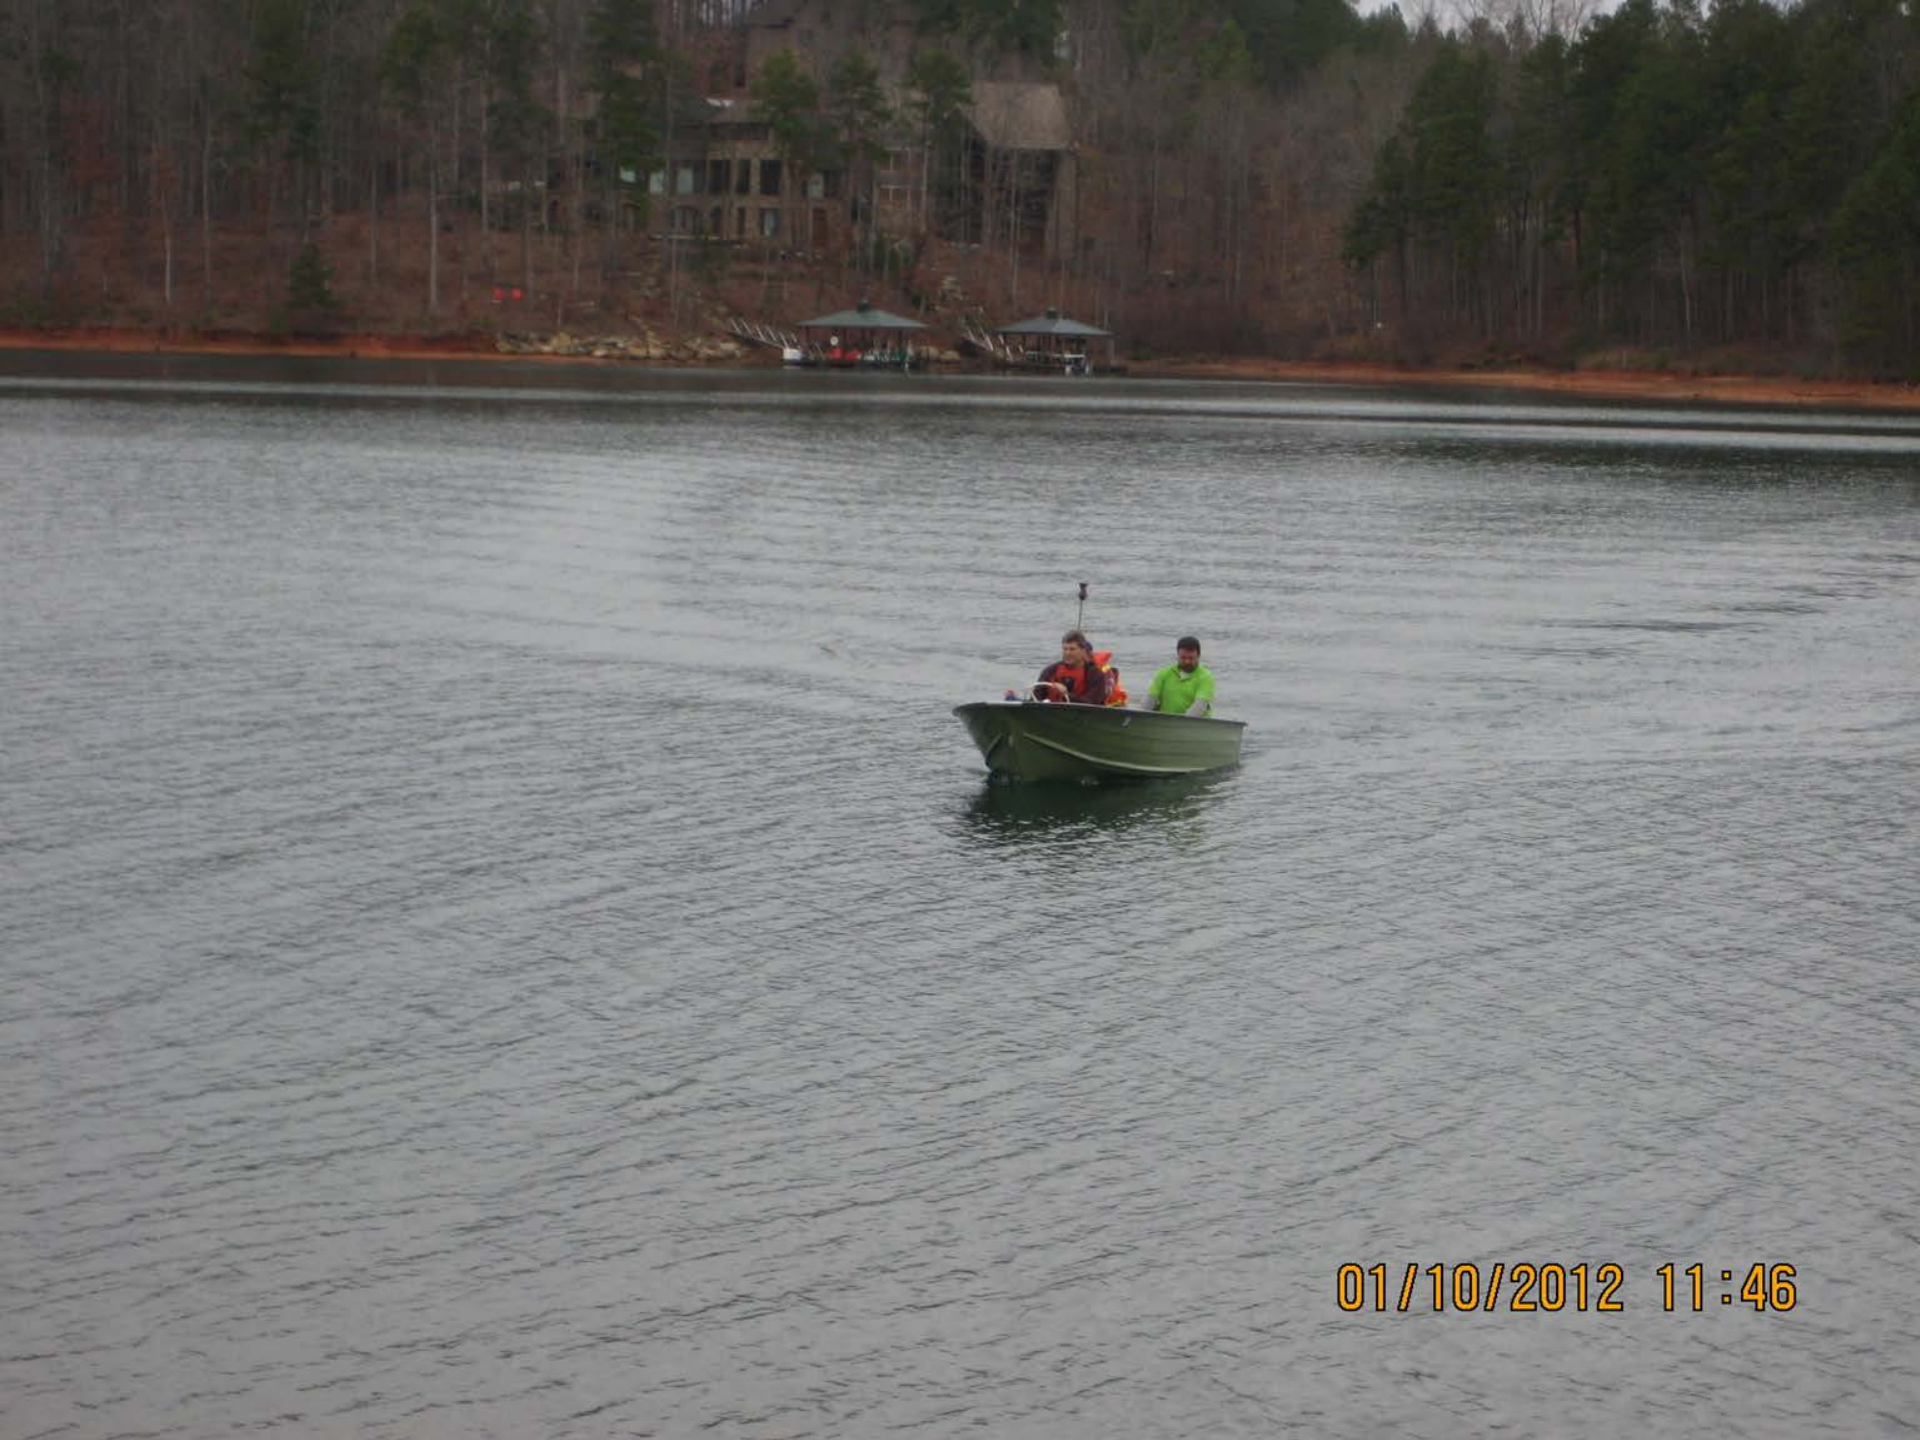
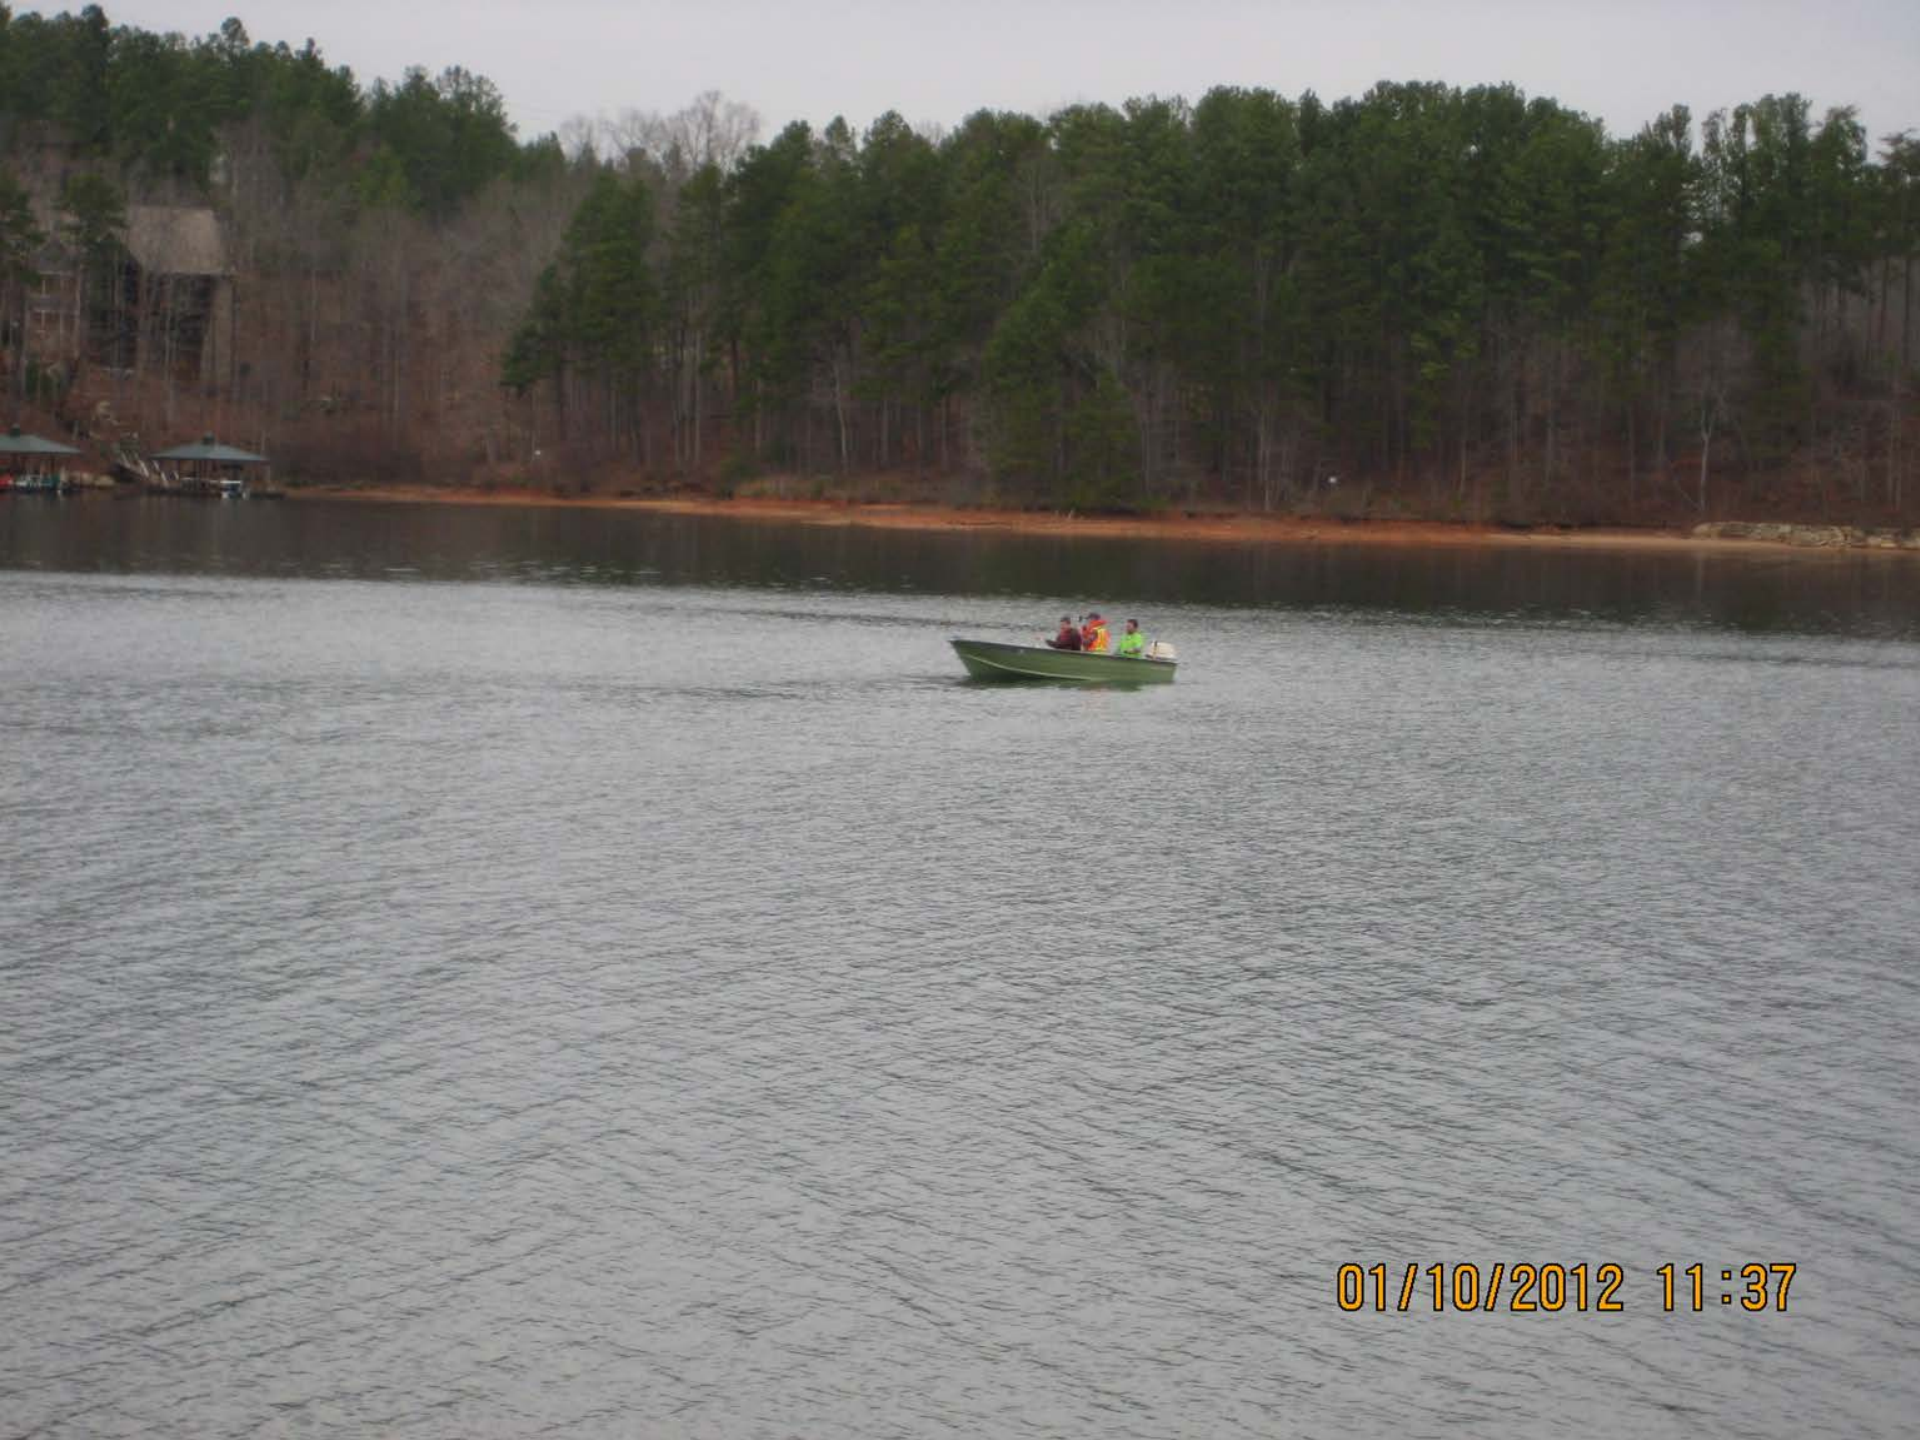
- Site 4 slide was repaired by WEC using battered micropiles with a concrete cap beam and tieback anchors.
- Site is being monitored with slope inclinometers.
- If movement continues, patterned ground anchors will additionally be installed.
- Slide was deep seated and extended into lake.
- Ground movement showed up as separation cracks in house.
- Ground was gently sloping.
- Slide encompasses adjacent lot where house was demolished.

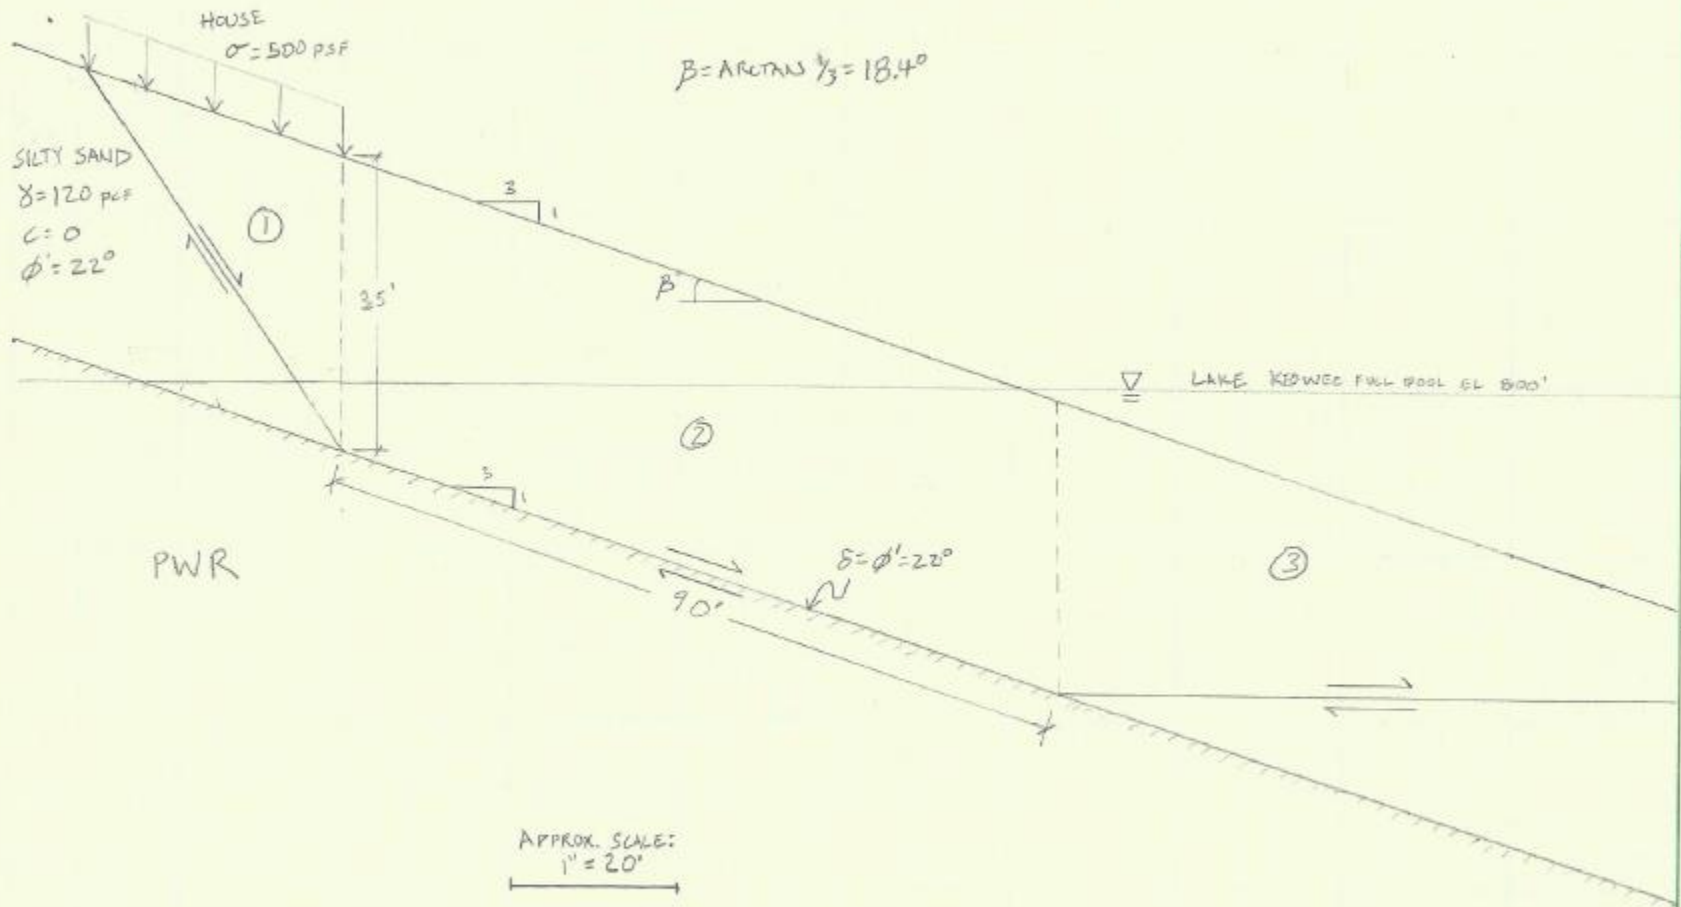
SKETCH FOR HAND CALC.
BLOCK STABILITY ANALYSIS

The results of the block analyses support that the existing factor-of-safety is near 1 assuming that the friction angle along the slide interface is 22 degrees.
