# Lessons Learned in the Repair of Failed Walls

Nate Beard

# Mechanically Stabilized Earth (MSE) Wall Failures

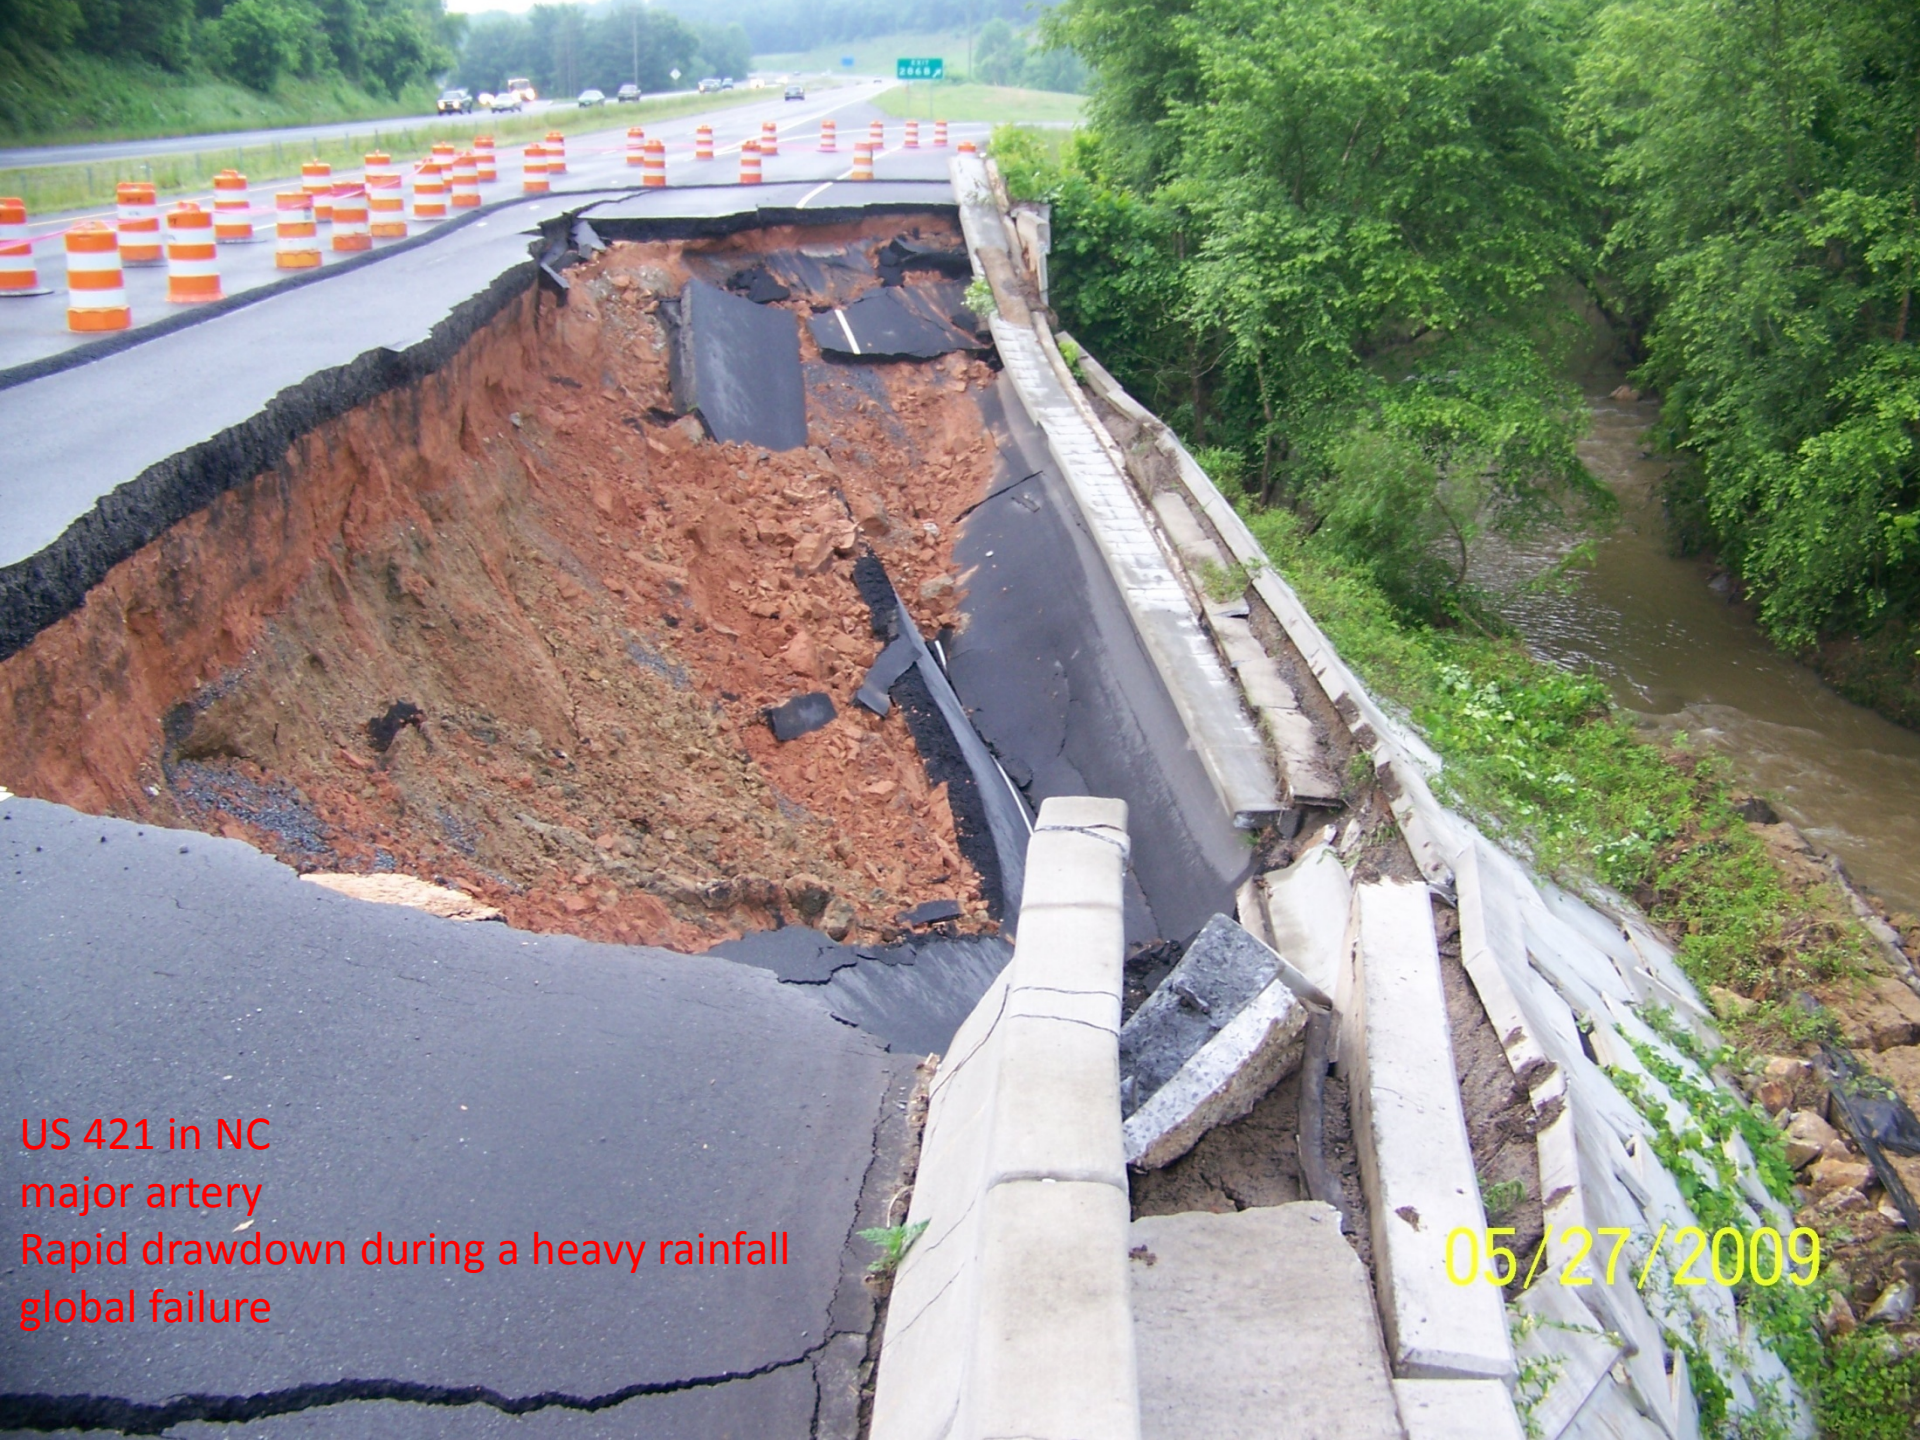
US 421 in NC  
major artery  
Rapid drawdown during a heavy rainfall  
global failure

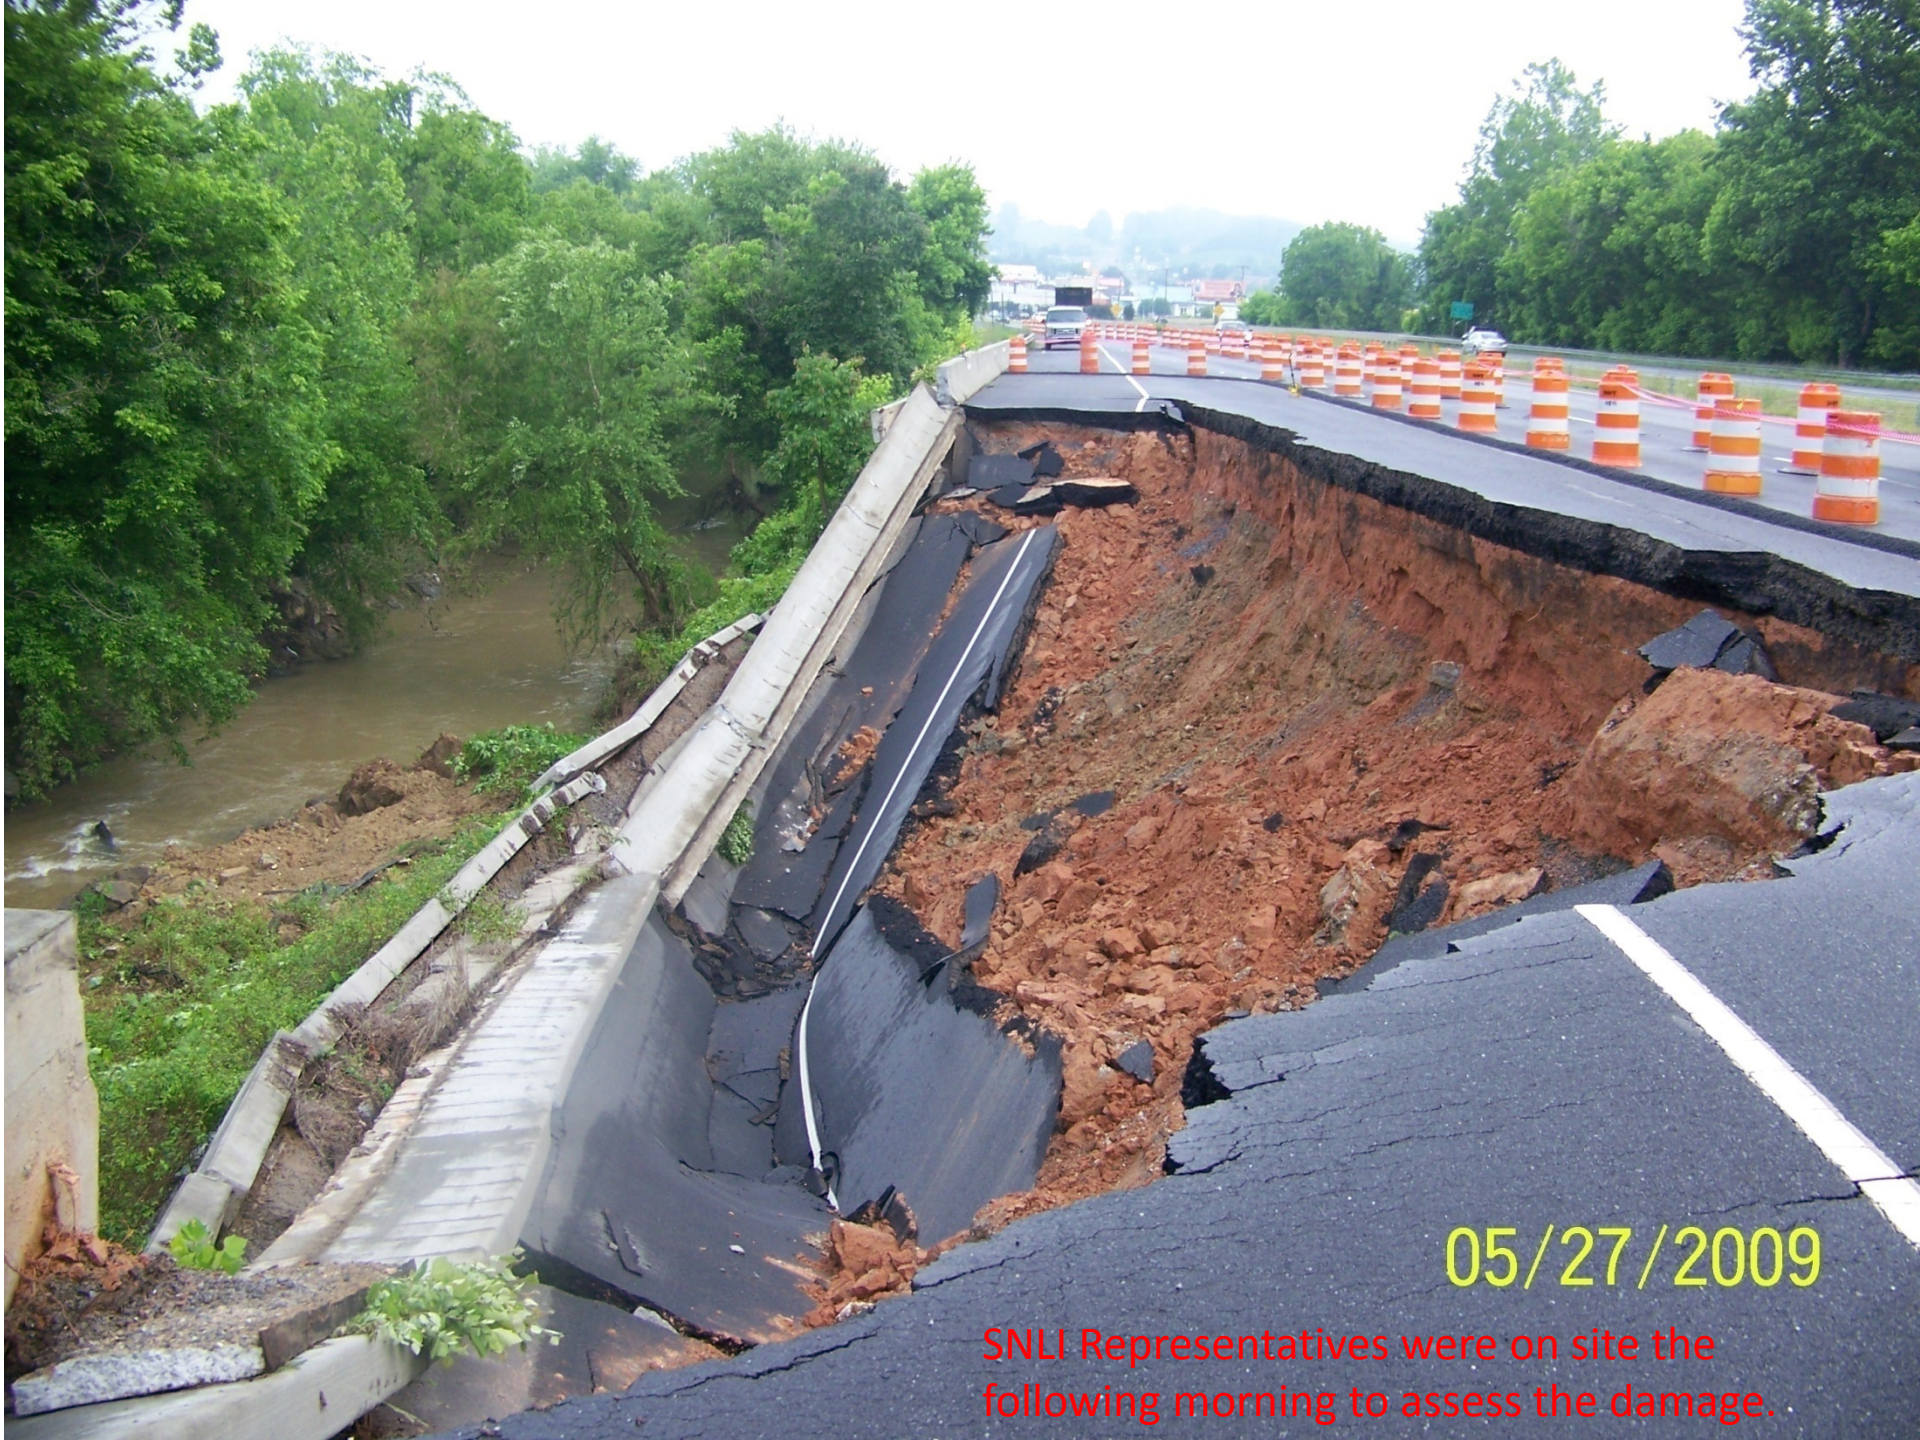
SNLI Representatives were on site the following morning to assess the damage.

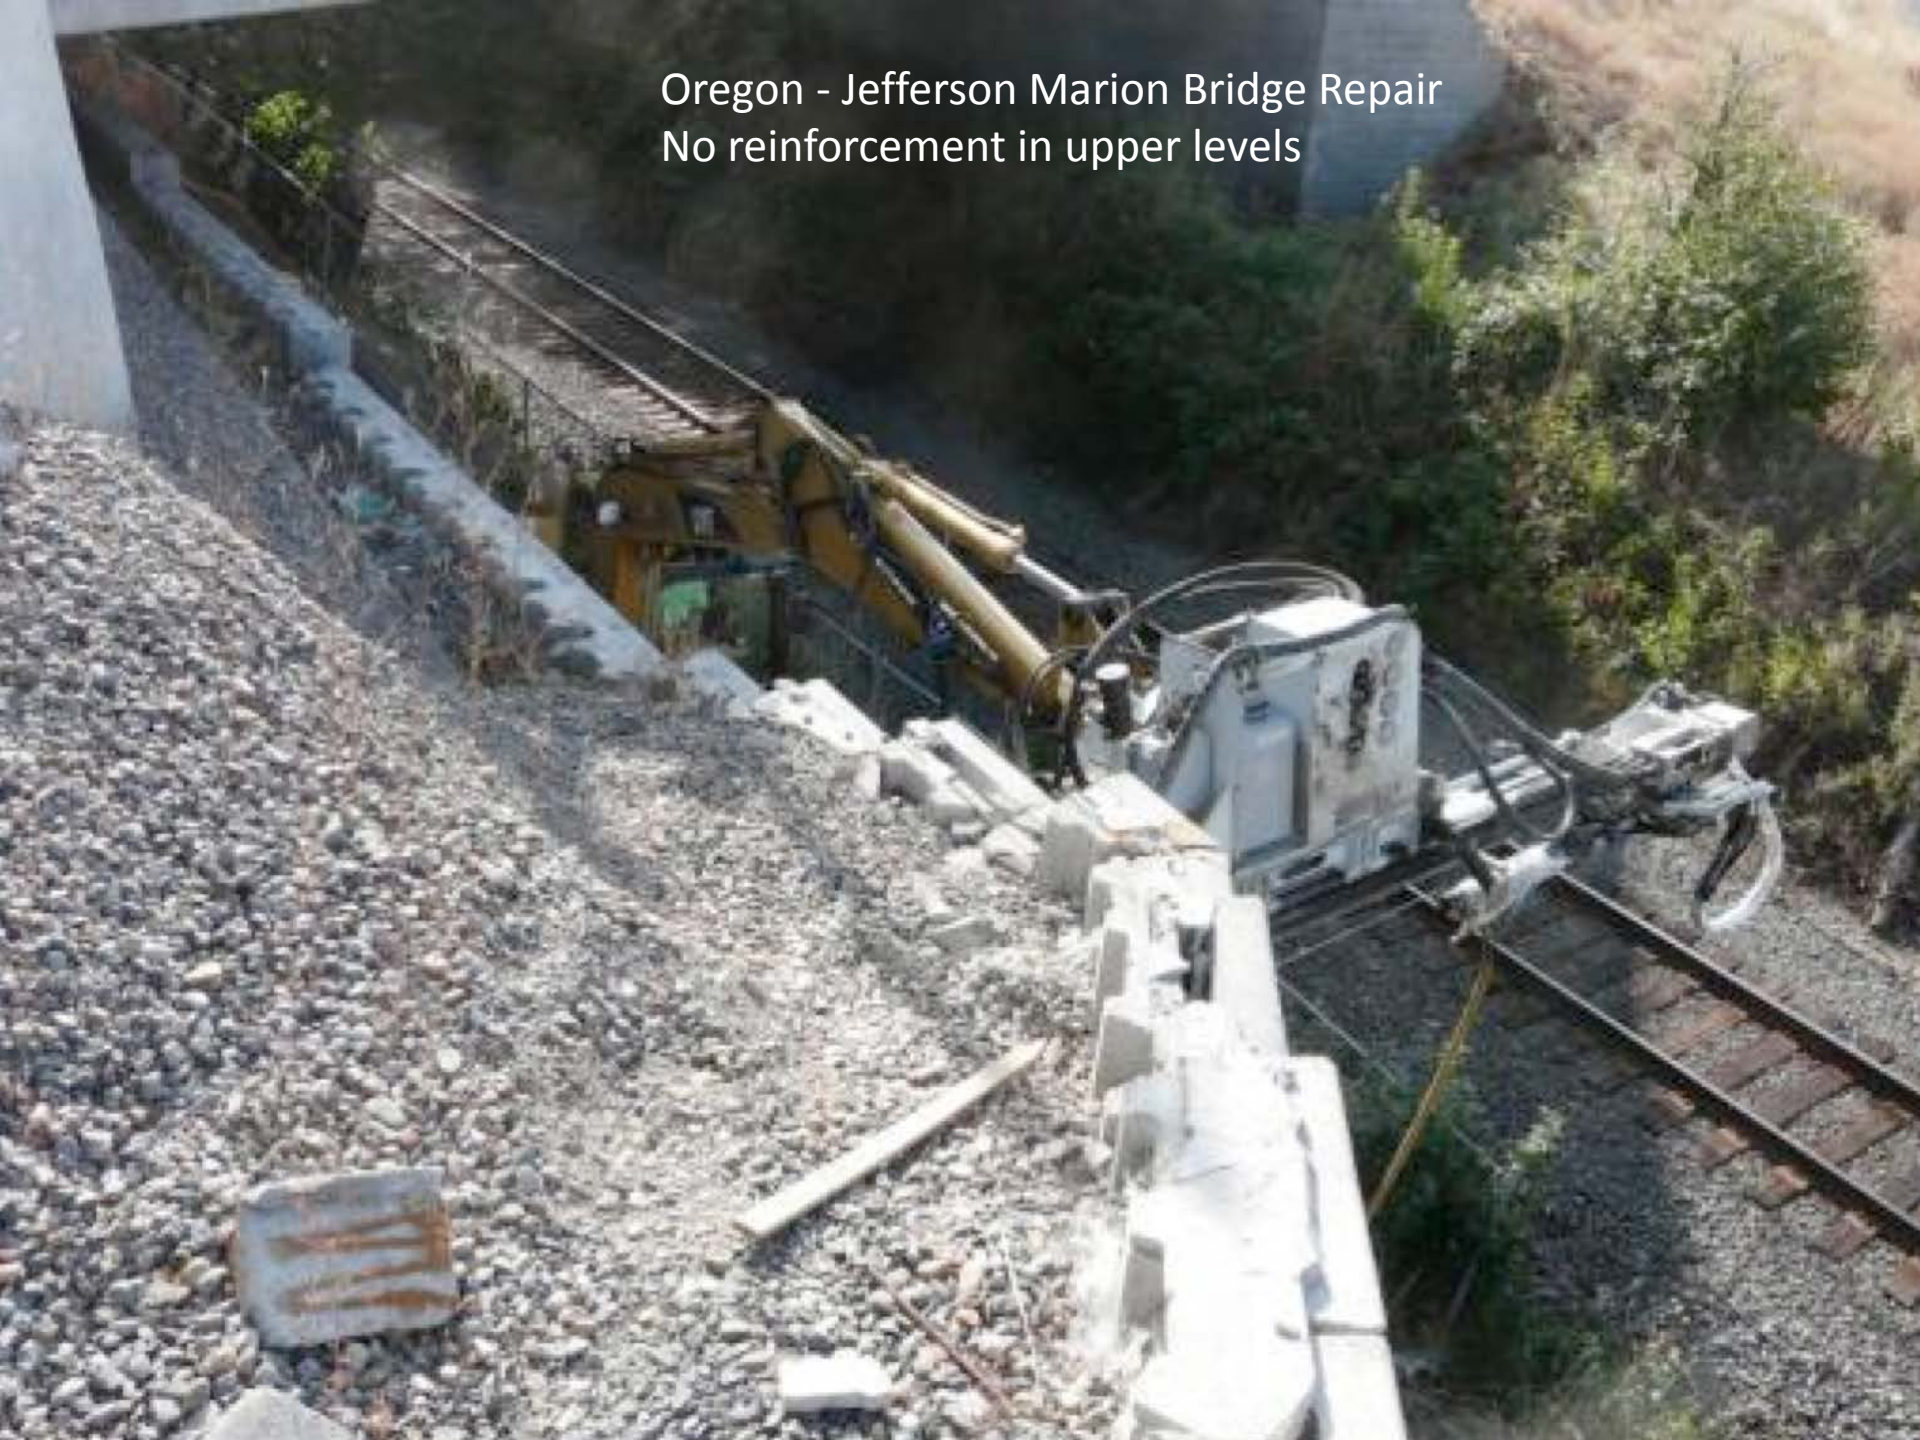
Oregon - Jefferson Marion Bridge Repair  
No reinforcement in upper levels
