Case Studies on Rockfall Mitigation & Rock Slope Stabilization in CA, TN, & VA

August 2, 2012

Nathan Beard, P.E.

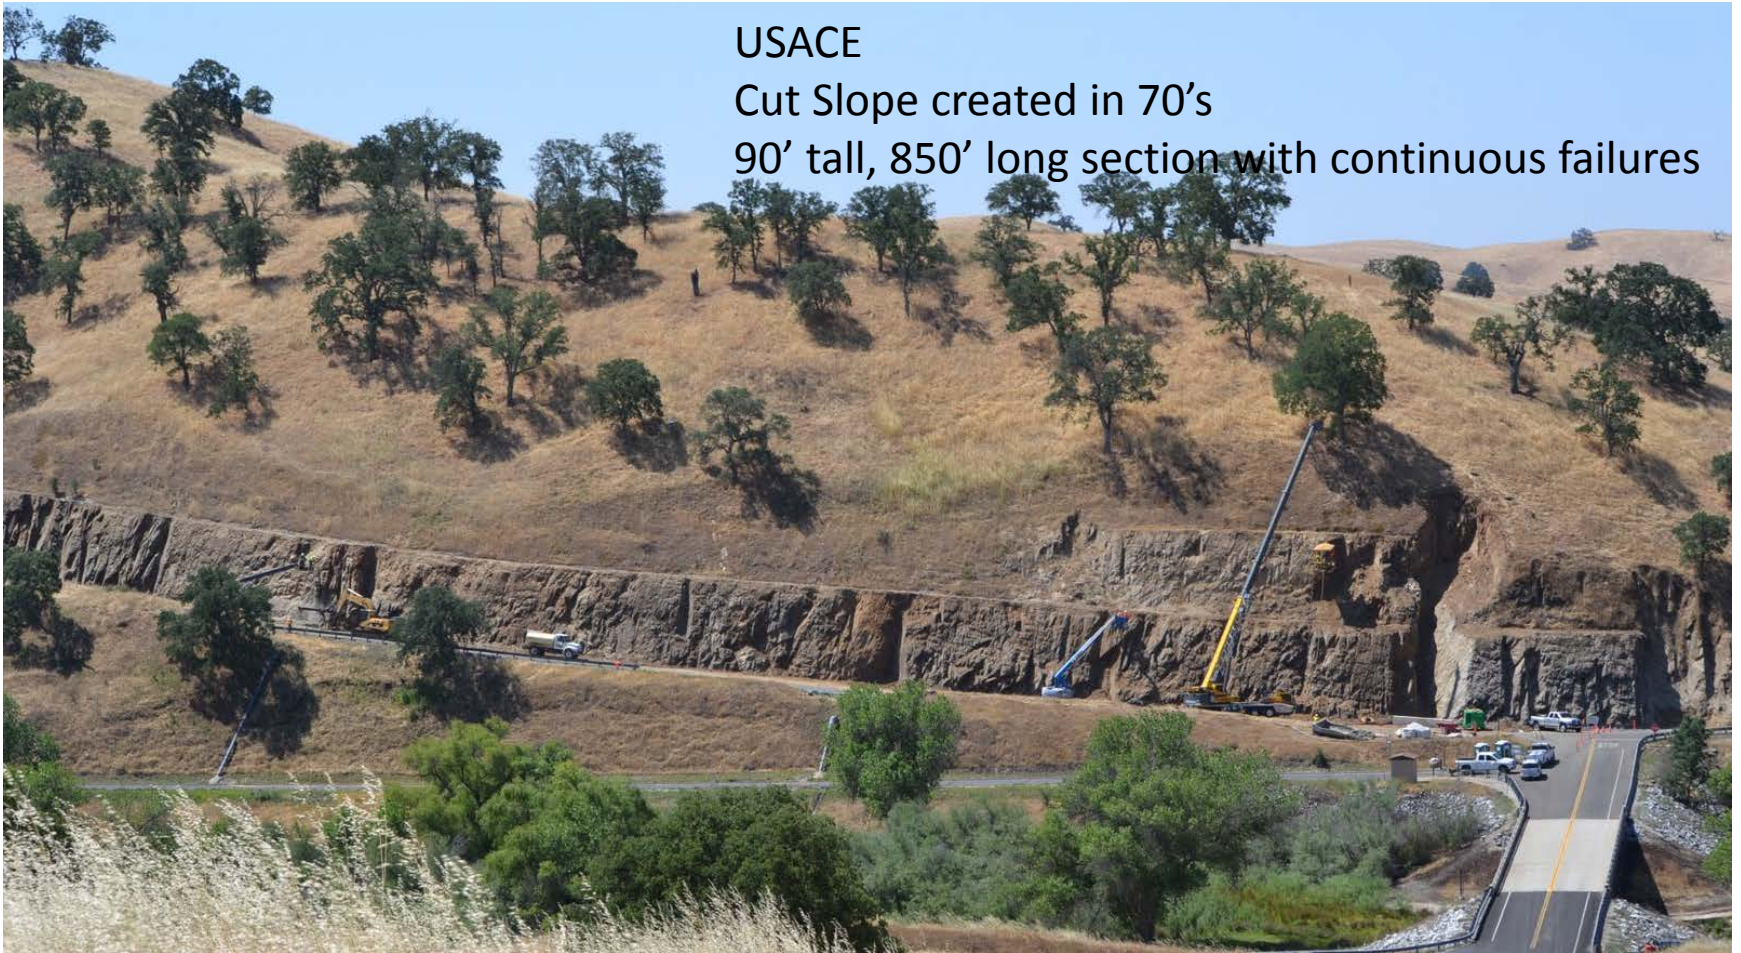
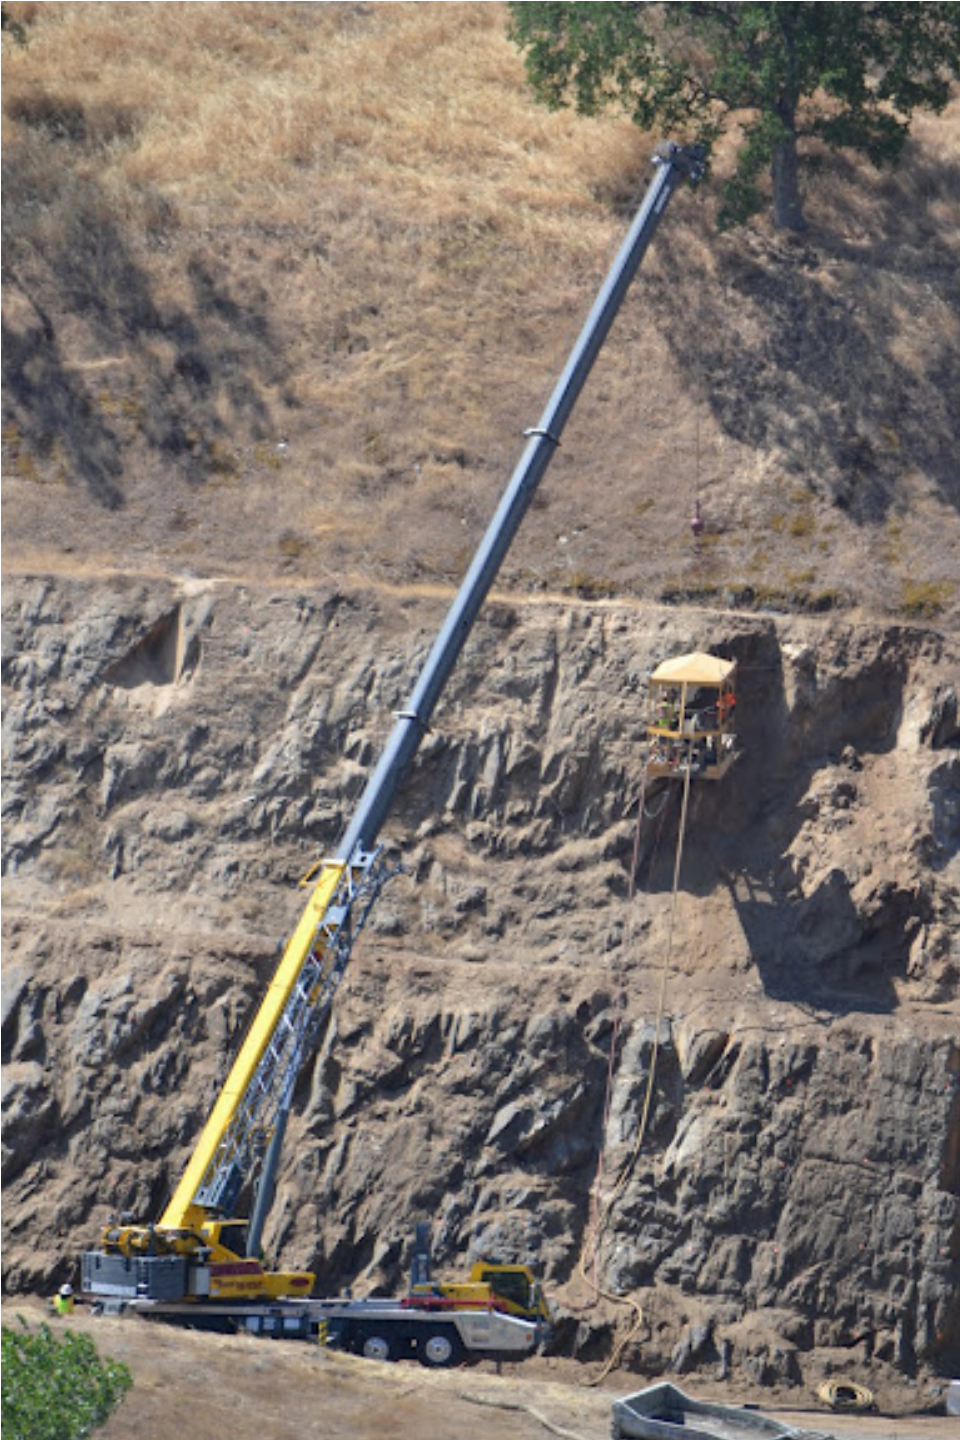
Cut Slope created in 70's

90' tall, 850' long section with continuous failures

- CR 29 in Eastman Lake Park
- Closely to moderately fractured with joint spacing between 3 to 10 feet.
- Heavy rains caused portions of the slope to fail in 1996-1997
- Winter of 2010-2011 large blocks (30'x20') had fallen on the road.
- Rock dowels vs. spin-lock
- 10'/14' to 20'/24'
- 42kips to 59.3 kips

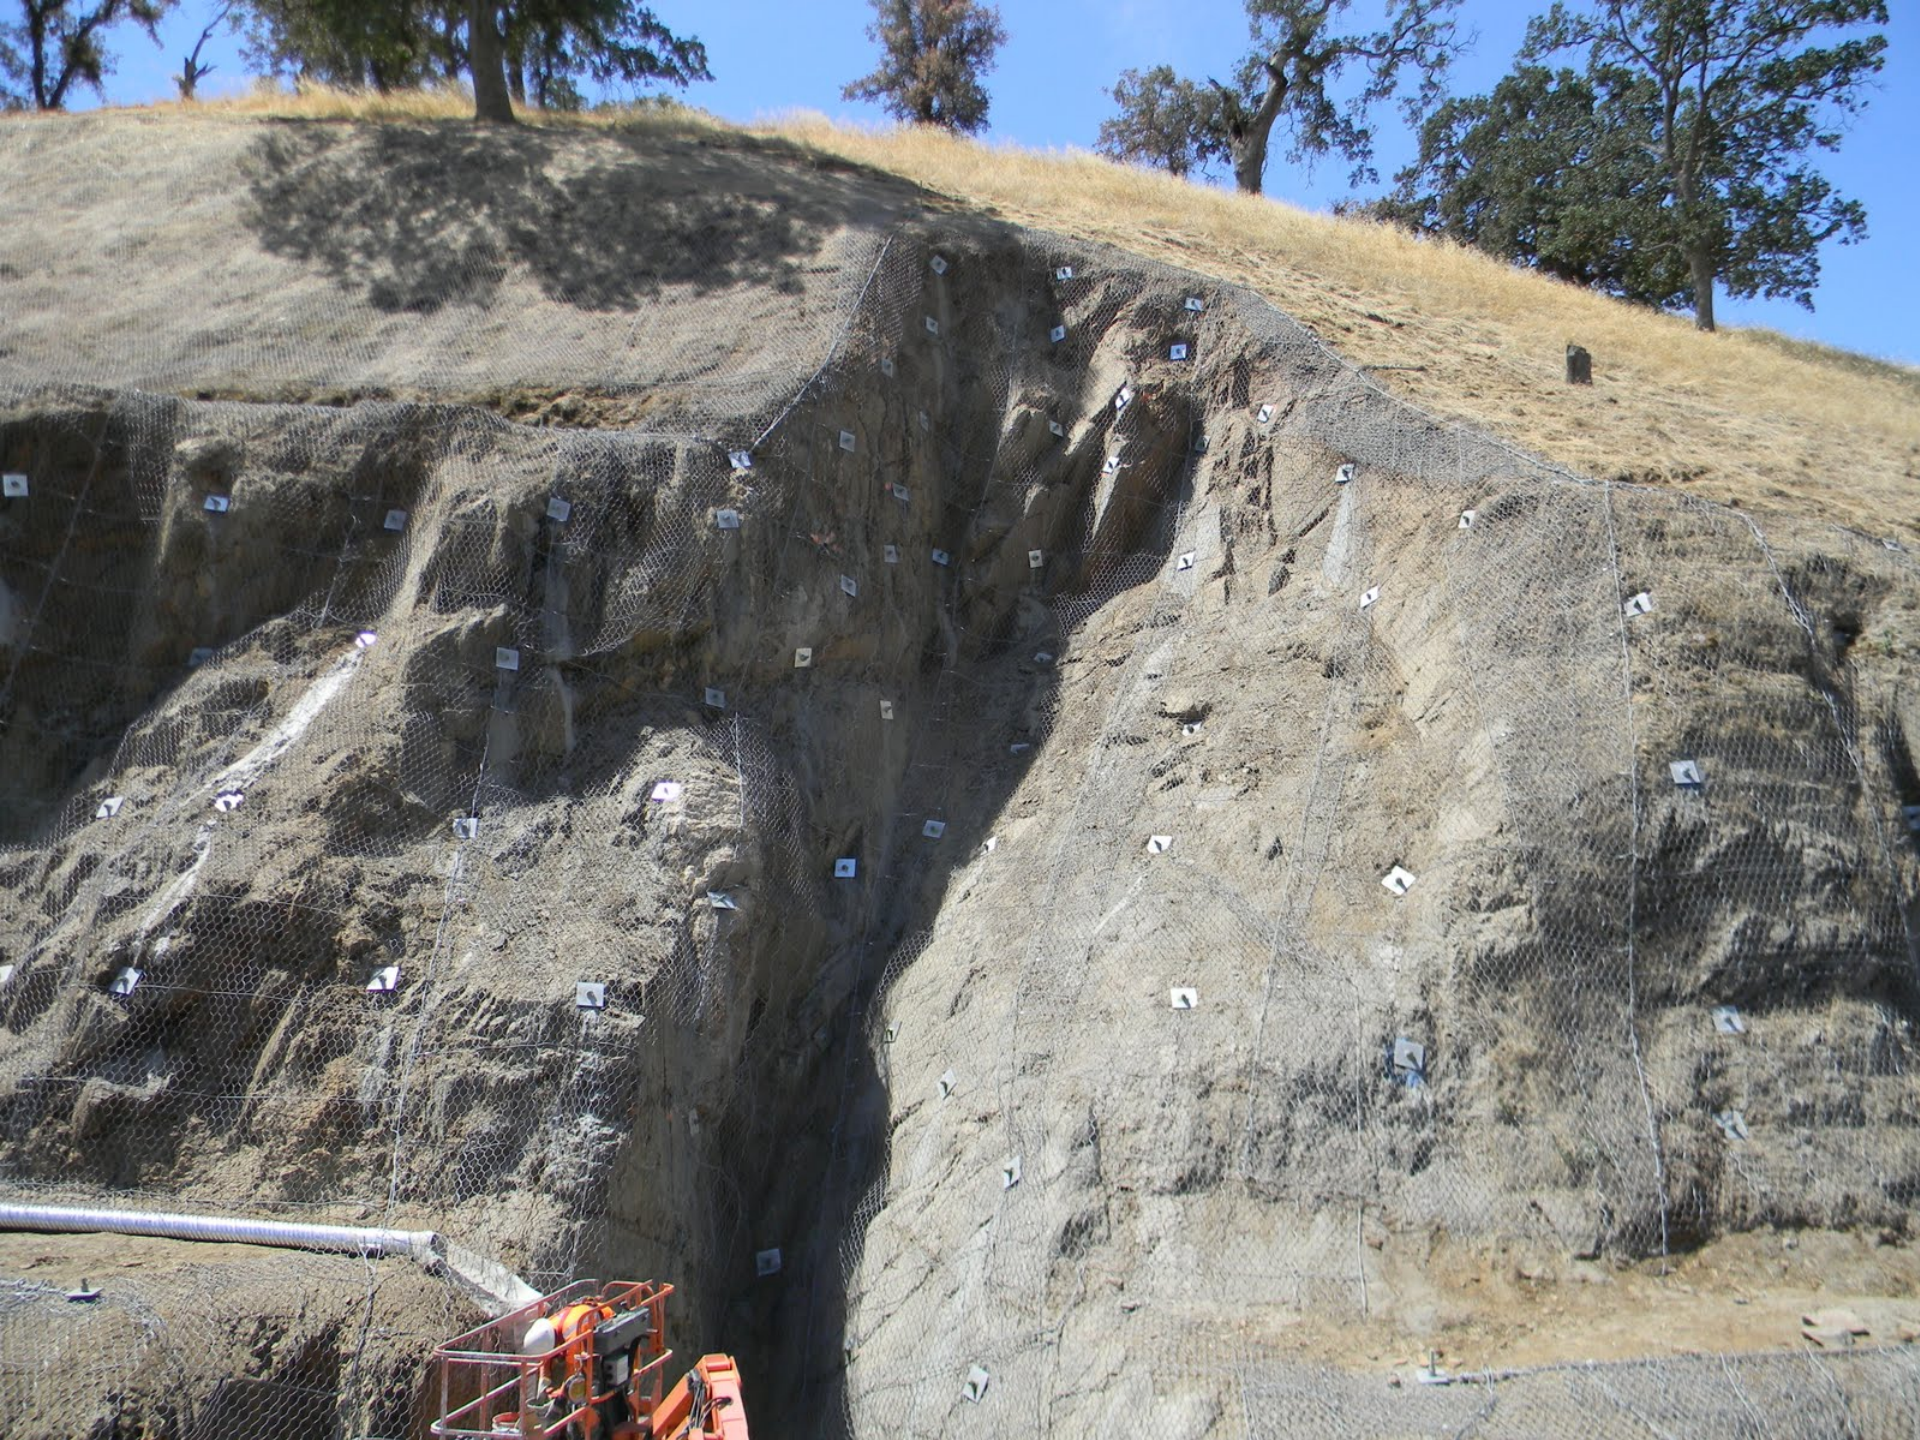
Army Corp predicted 316 bolts (4,108 LF) for the lower slope and 108 bolts (1,260 LF) for the mid slope.

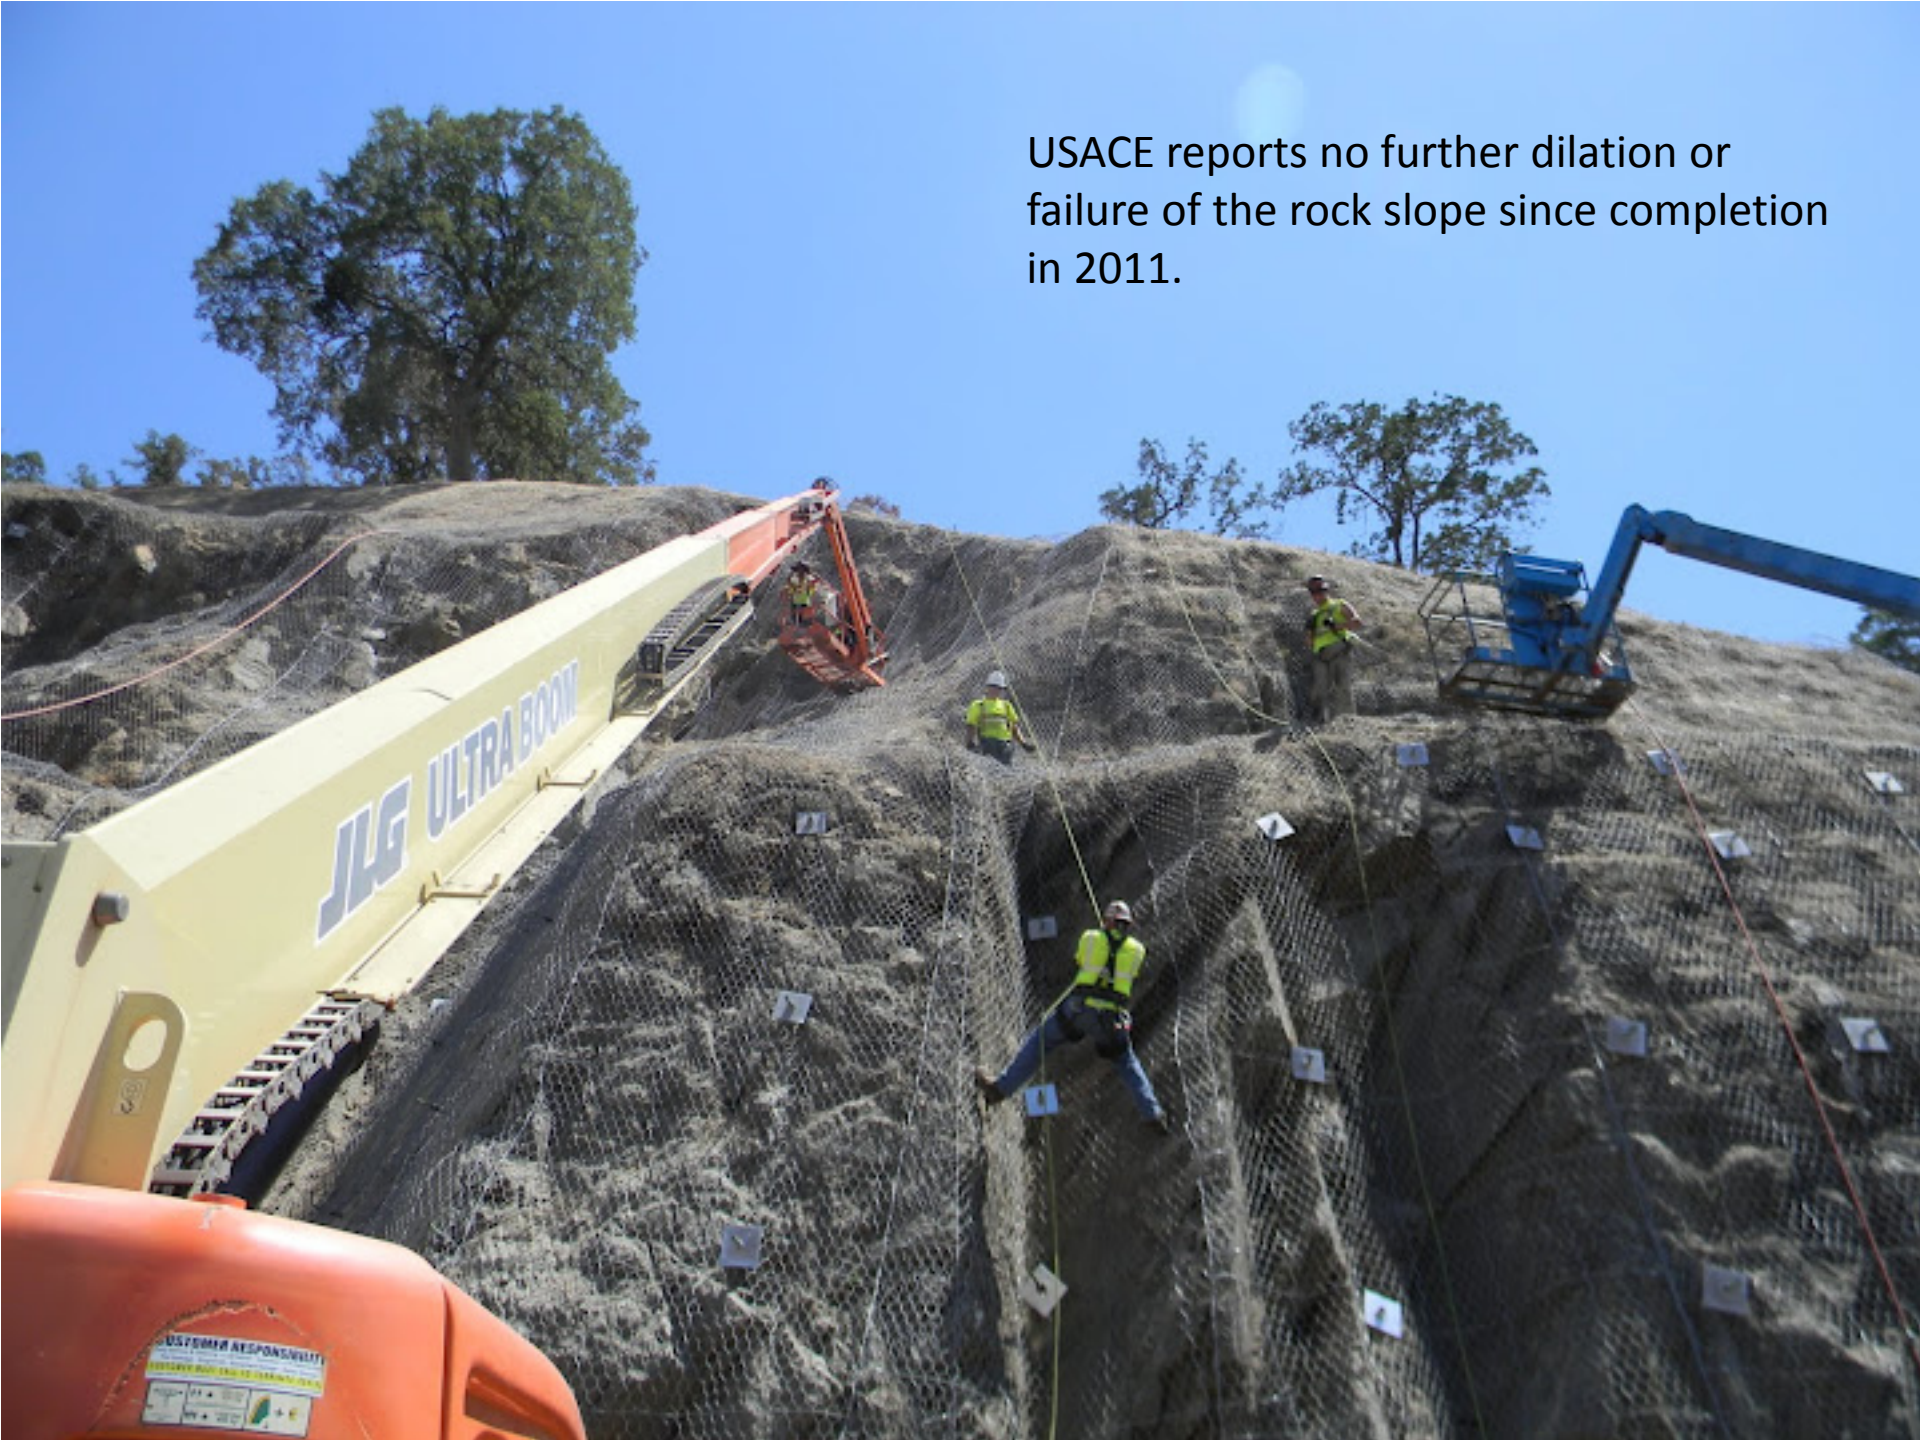
USACE reports no further dilation or failure of the rock slope since completion in 2011.

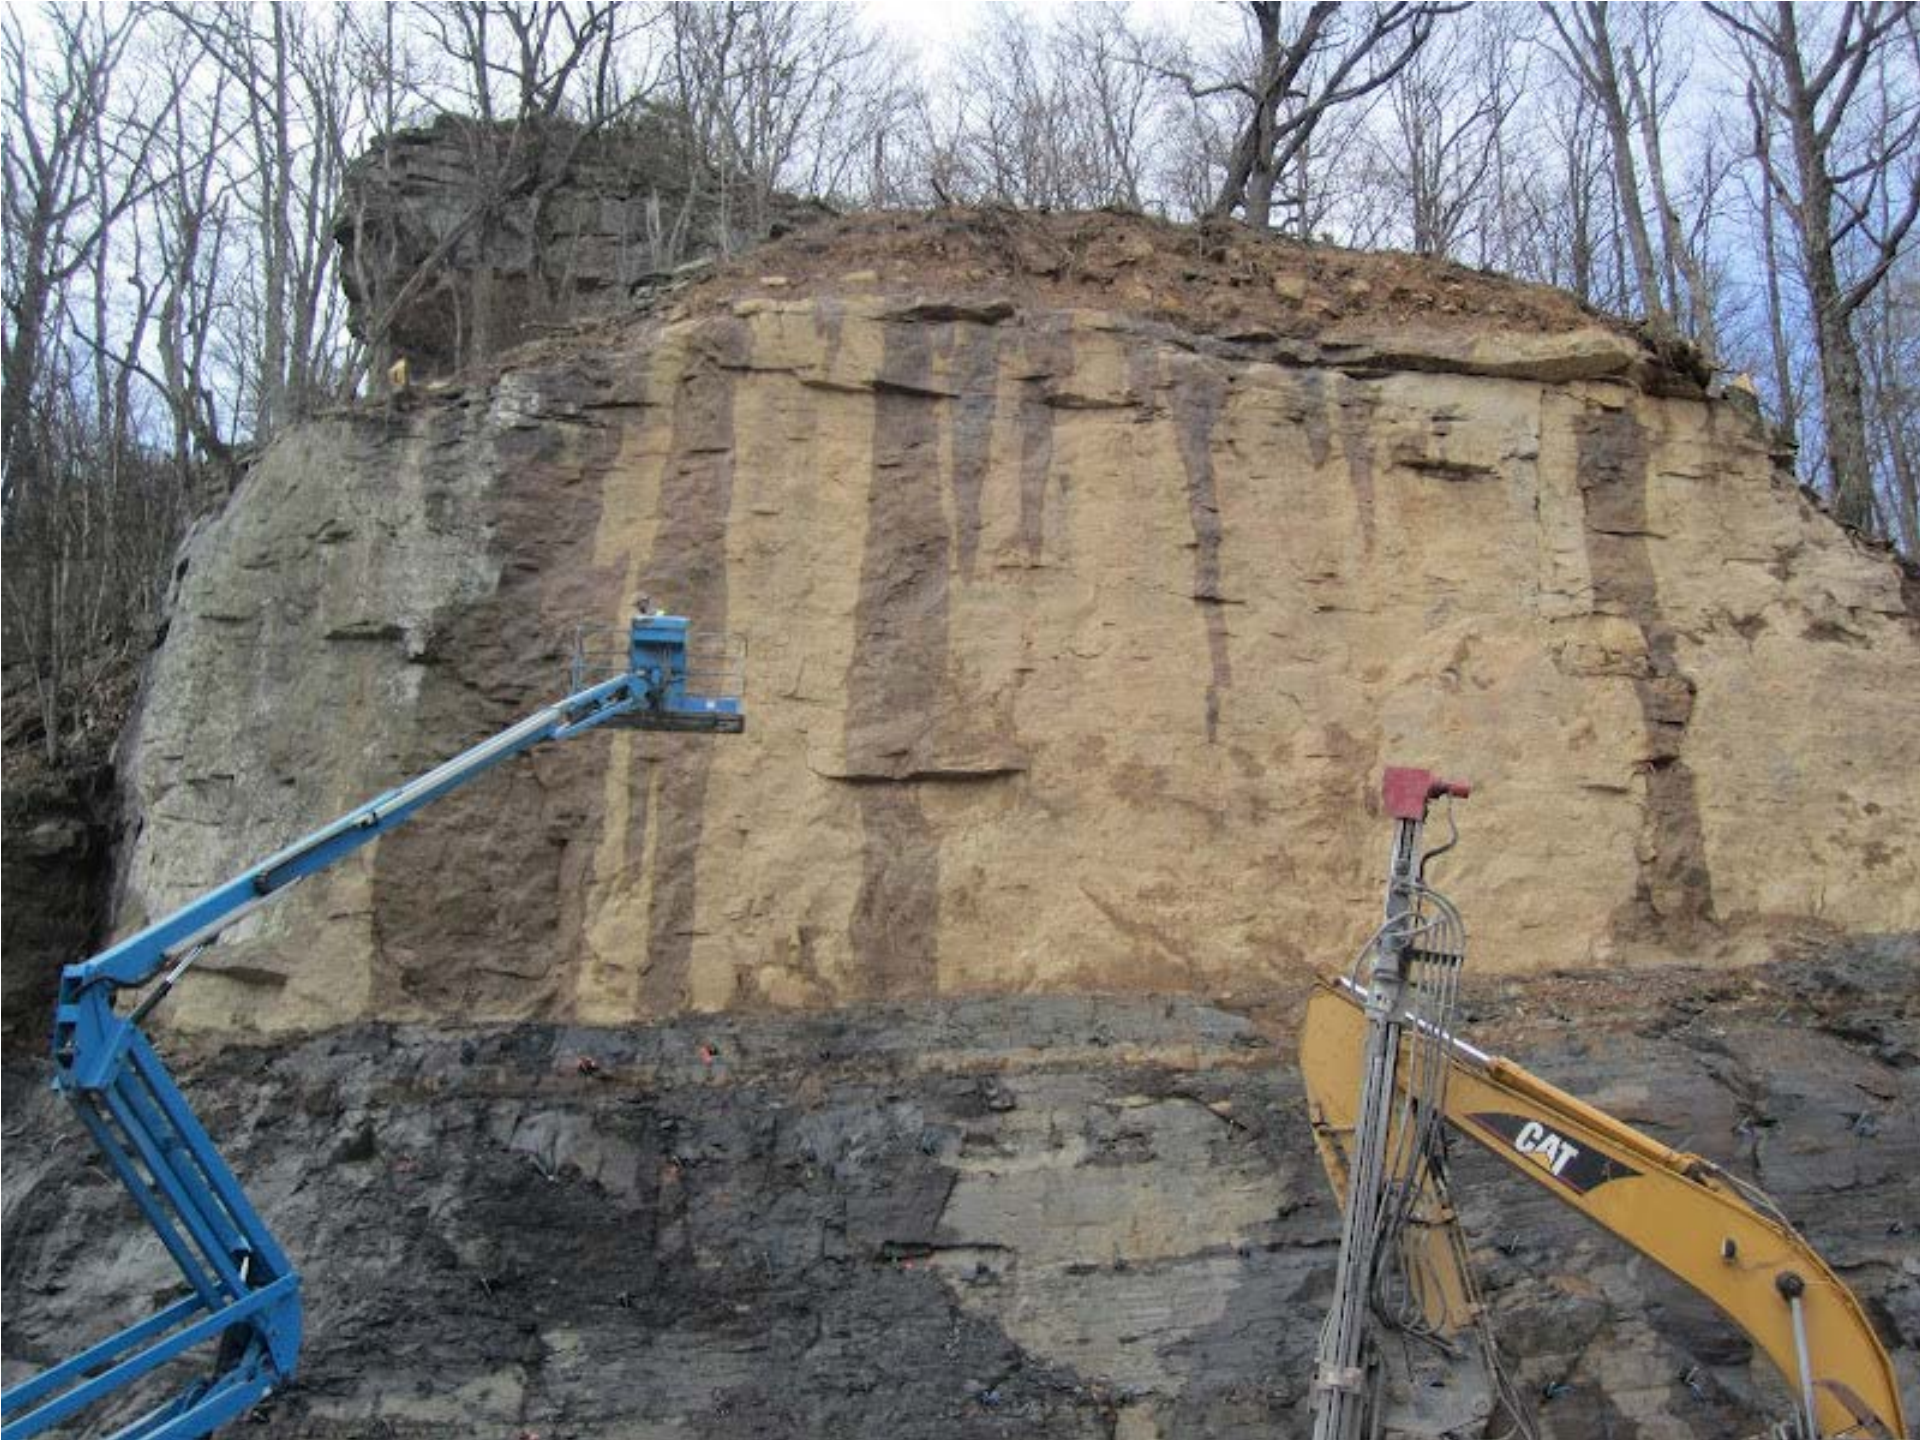
Sandstone underlain by a very soft, decomposed shale containing clay seams and coal layers

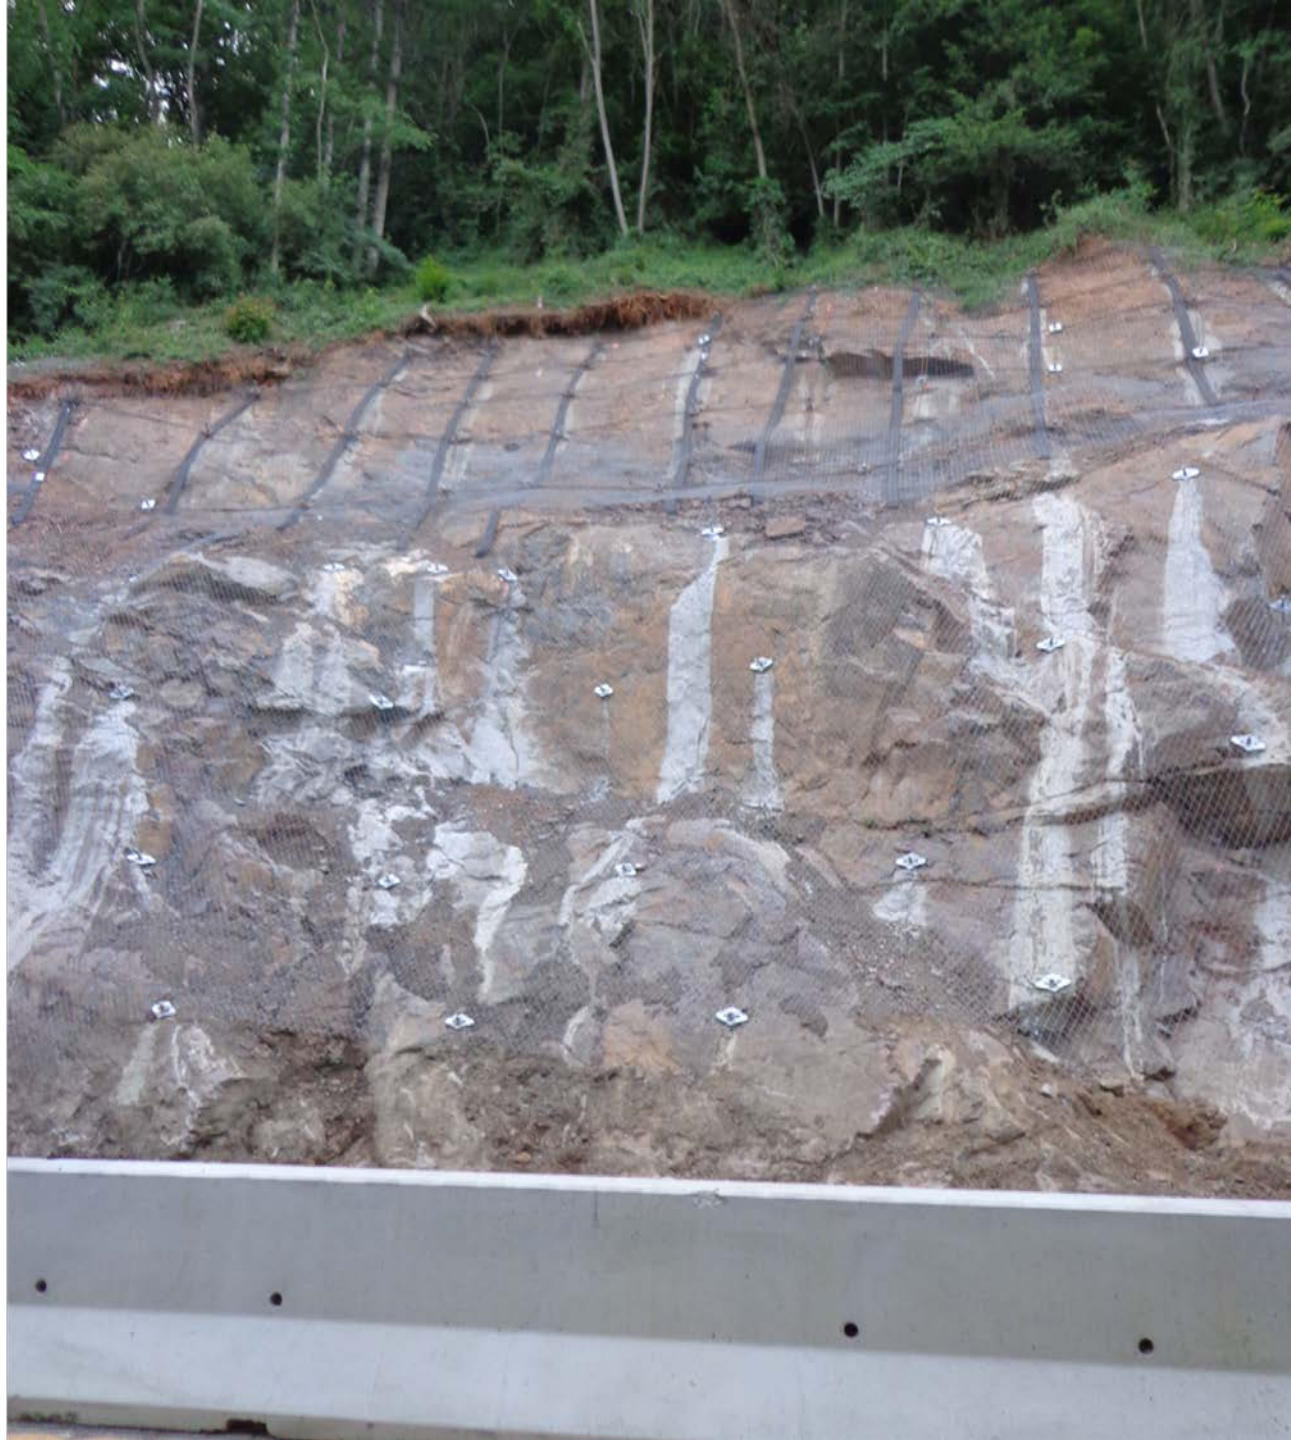
Height Increase:

- Increased 20' in some areas after scaling
- Called Frank Amend - Geobruigg Rush Shipped 10,000 SF of Tecco® Mesh to keep the project on schedule

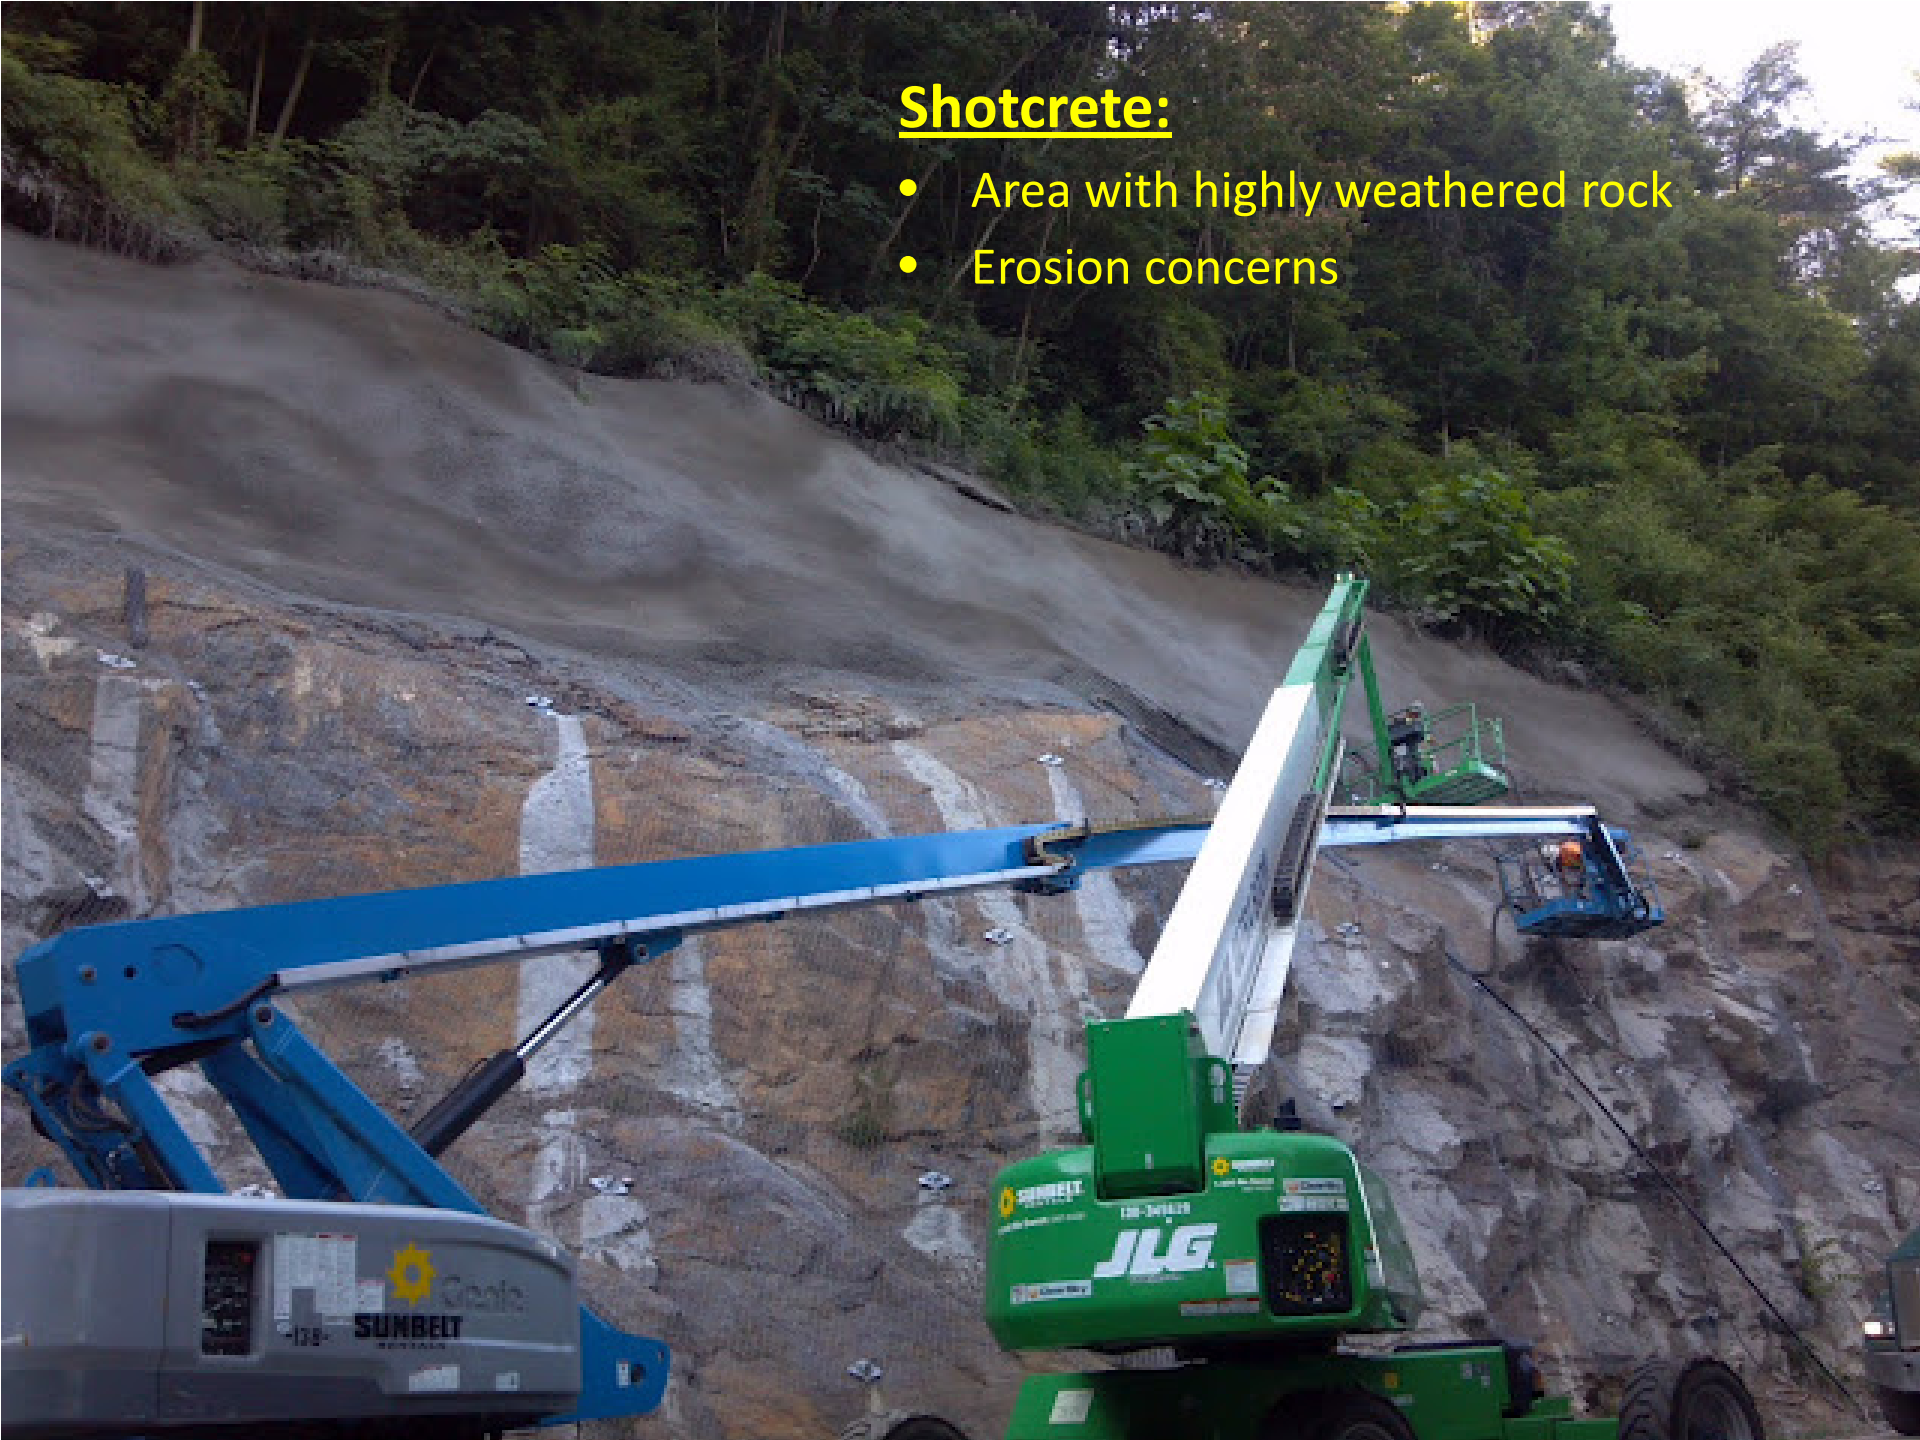
- Area with highly weathered rock
- Erosion concerns

Shotcrete:

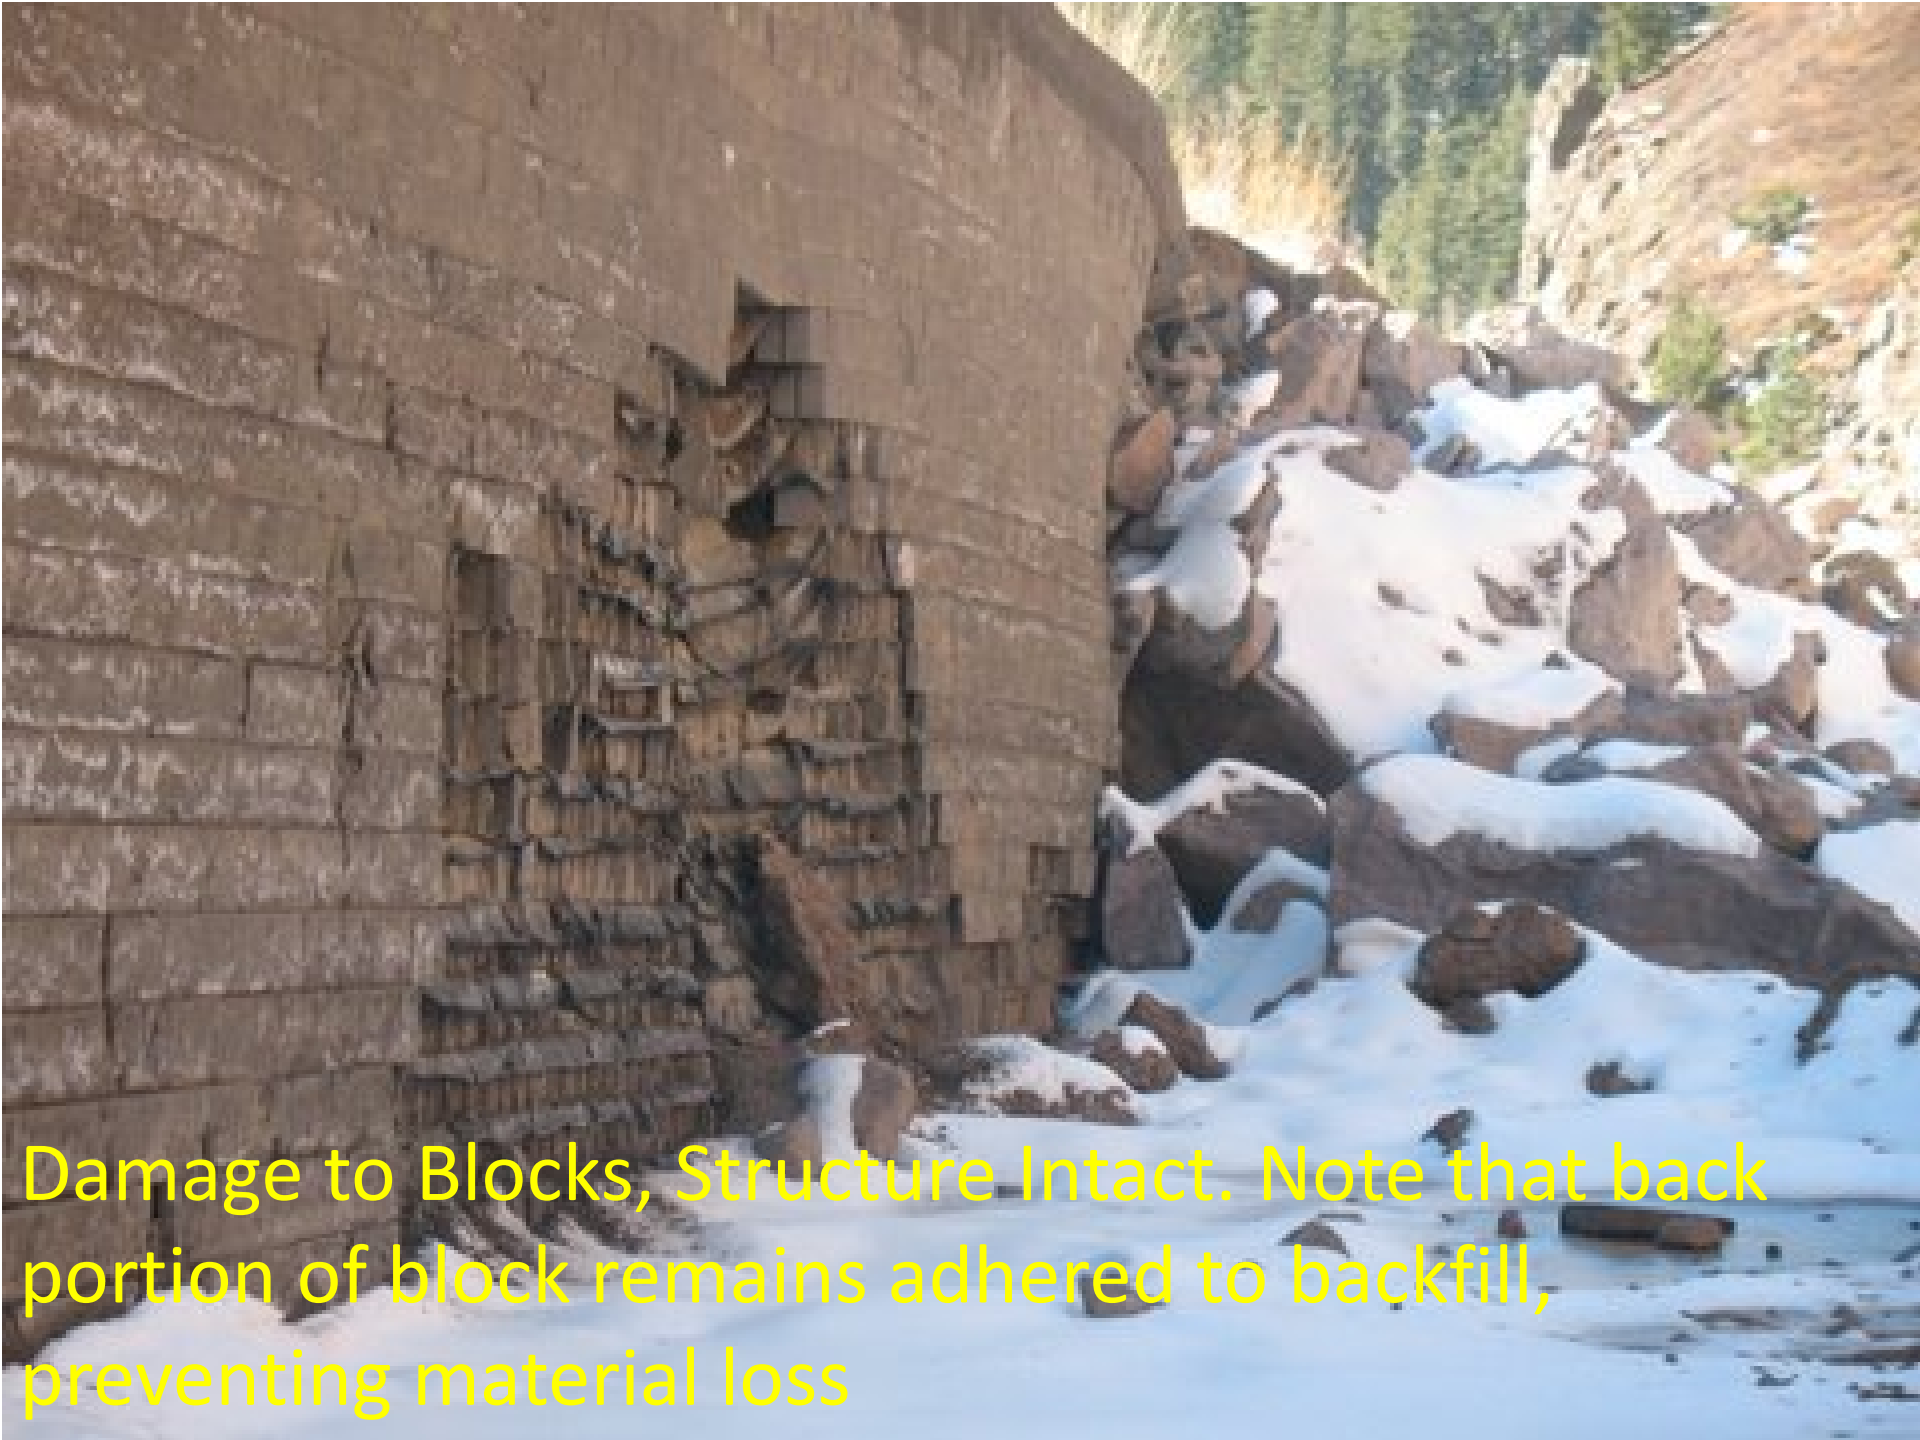
- 5+ Million Foot-pound Impact
- 12' Diameter
- Fell from 75-100' upslope

Damage to Blocks, Structure Intact. Note that back portion of block remains adhered to backfill, preventing material loss

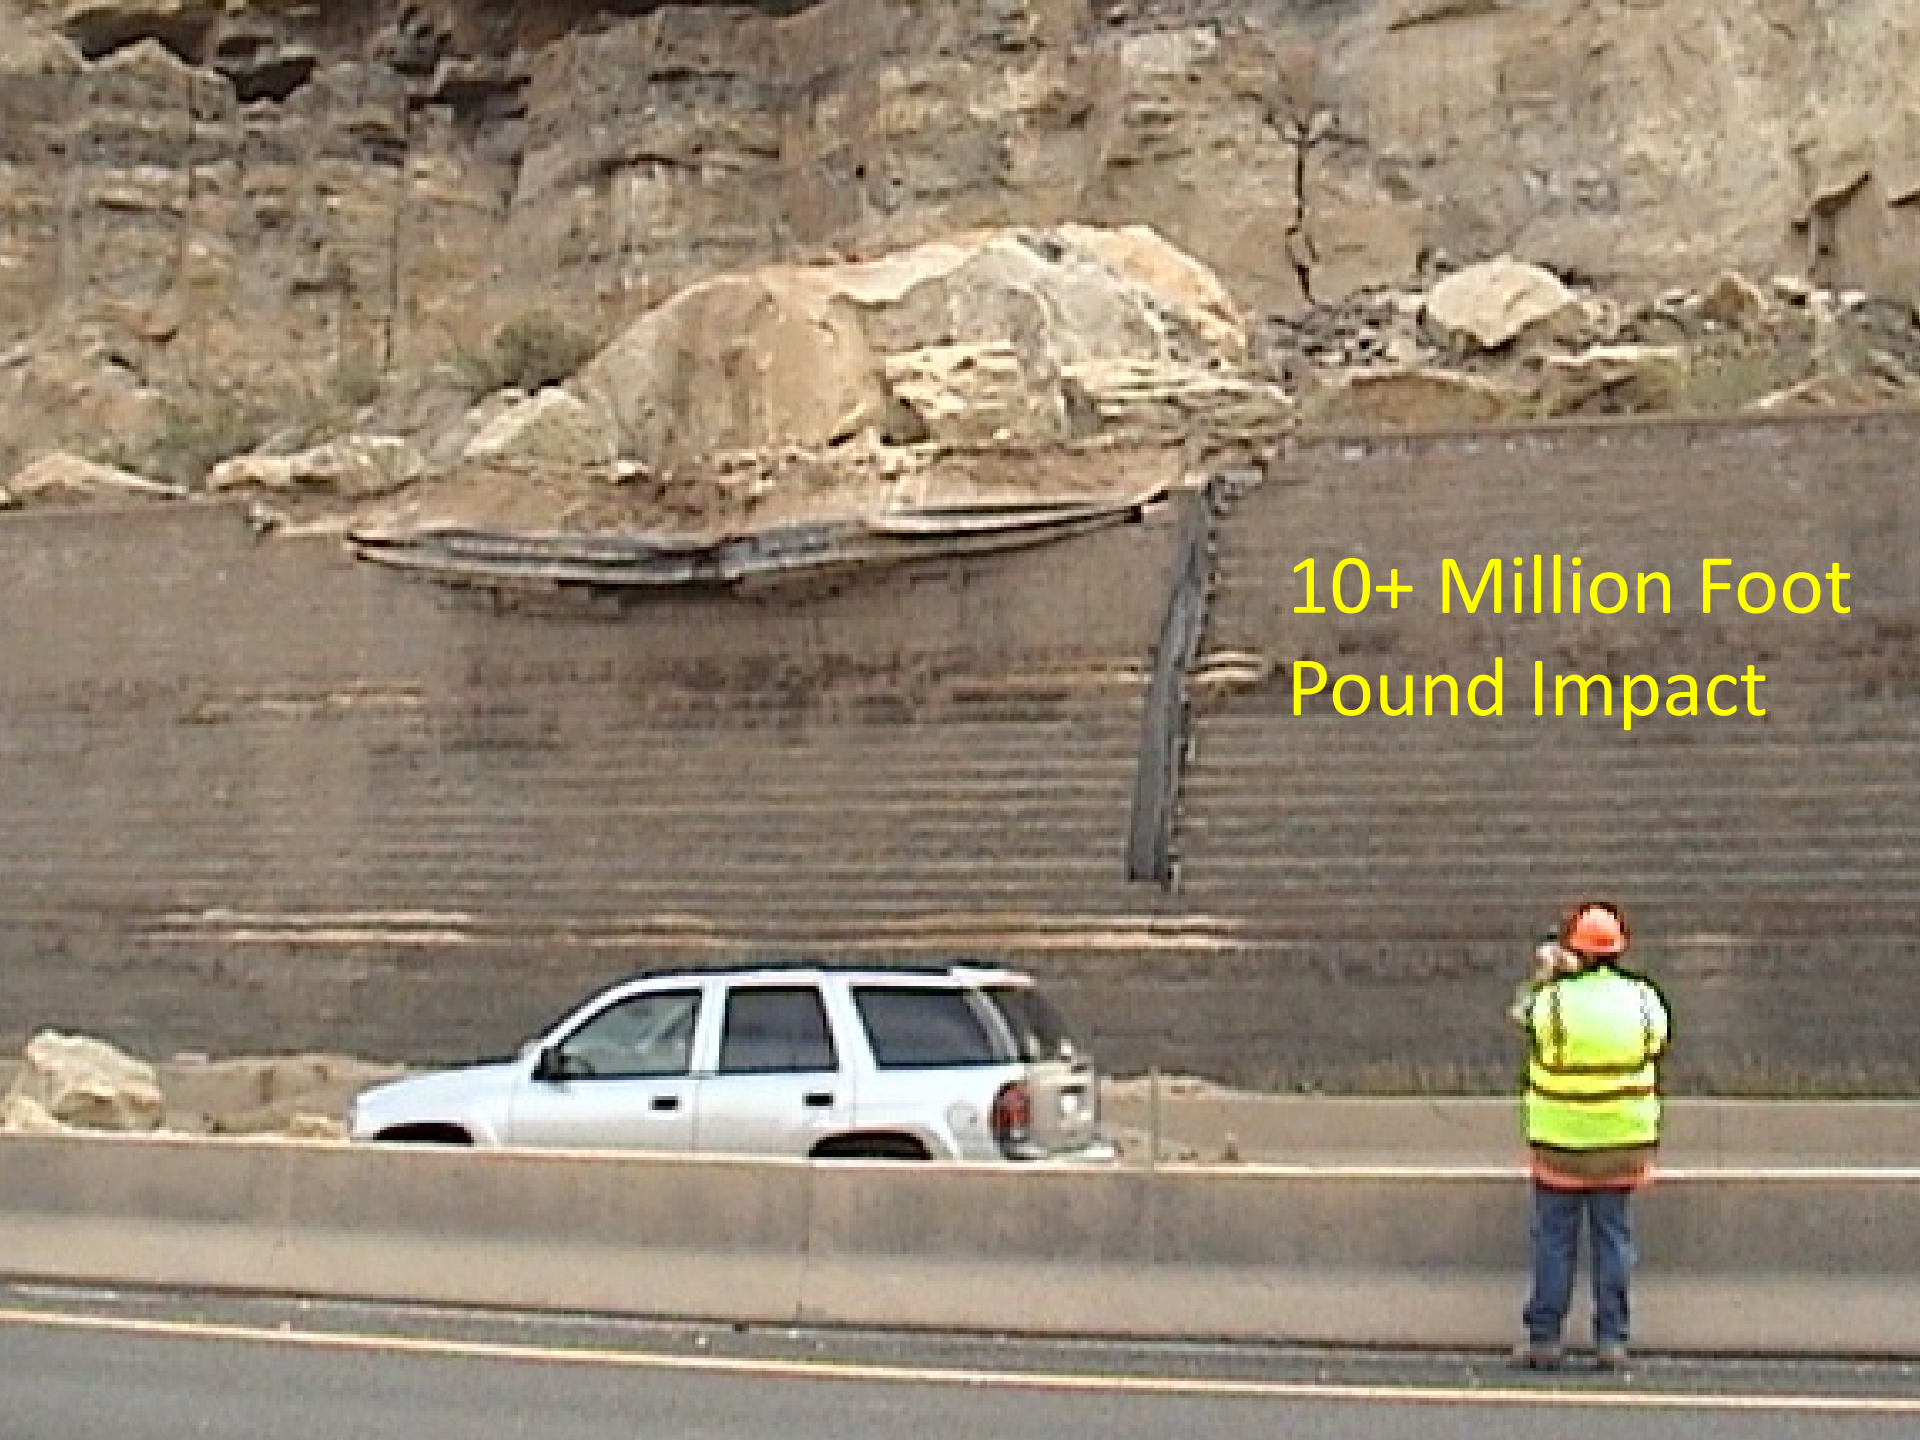
10+ Million Foot
Pound Impact

Structure impacted
by this rock falling
over 100 ft
