Case Studies on Rockfall Mitigation & Rock Slope Stabilization in CA, TN, & VA

August 2, 2012

Nathan Beard, P.E.

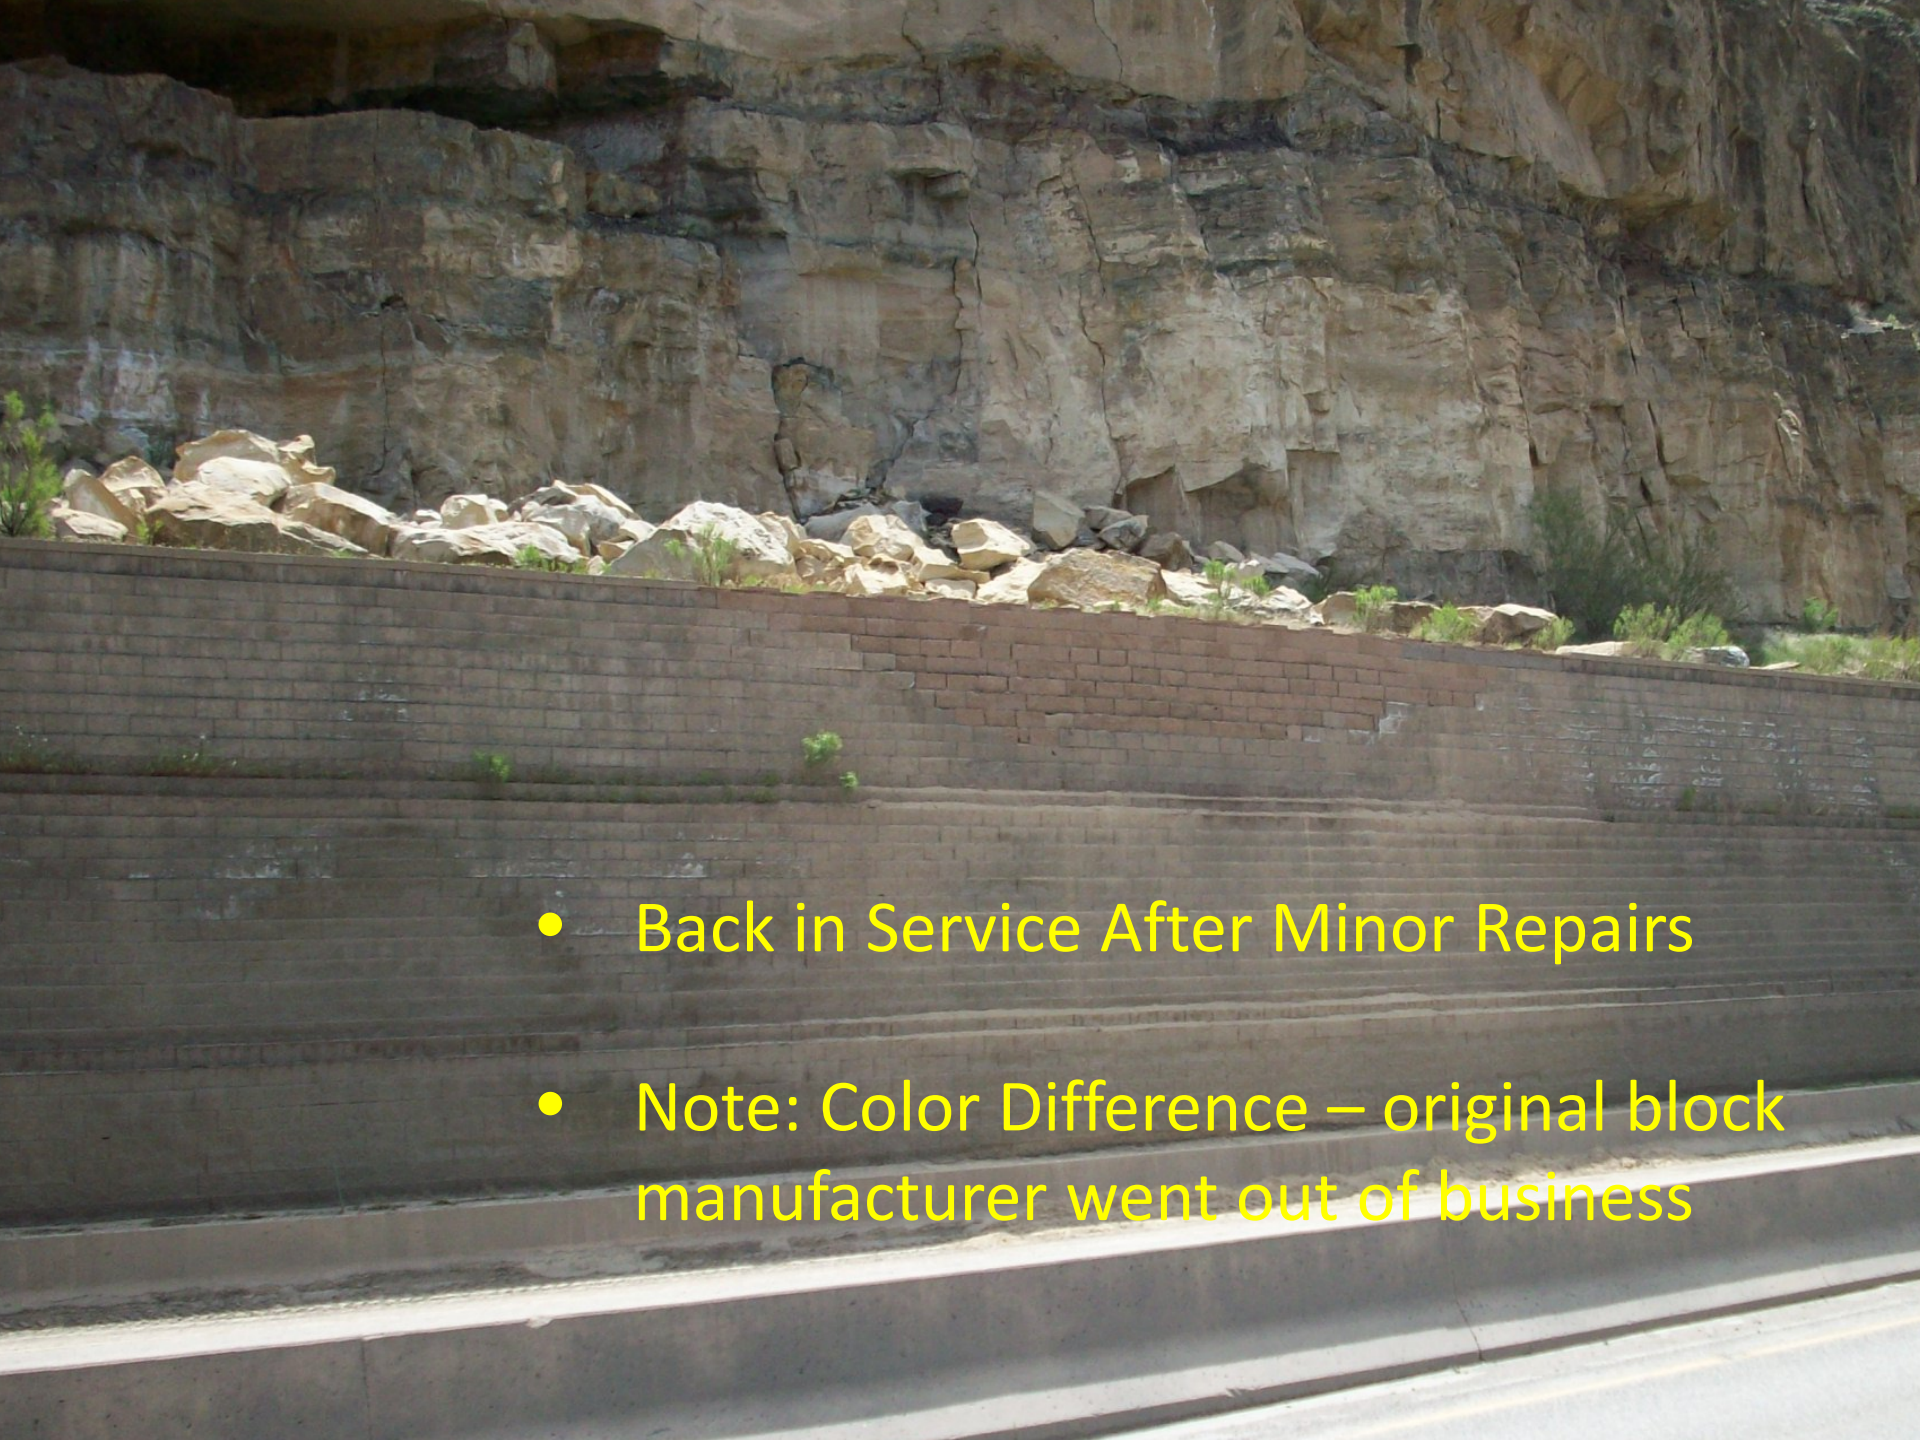
Minimal Damage to
Upper Rows

- Back in Service After Minor Repairs
- Note: Color Difference – original block manufacturer went out of business
