**Assessing Maryland's Largest Highway
Rock Cut Slope: Sideling Hill
Rock Slope Hazard Study**

**2013 Geohazards Forum
July 31, 2013**

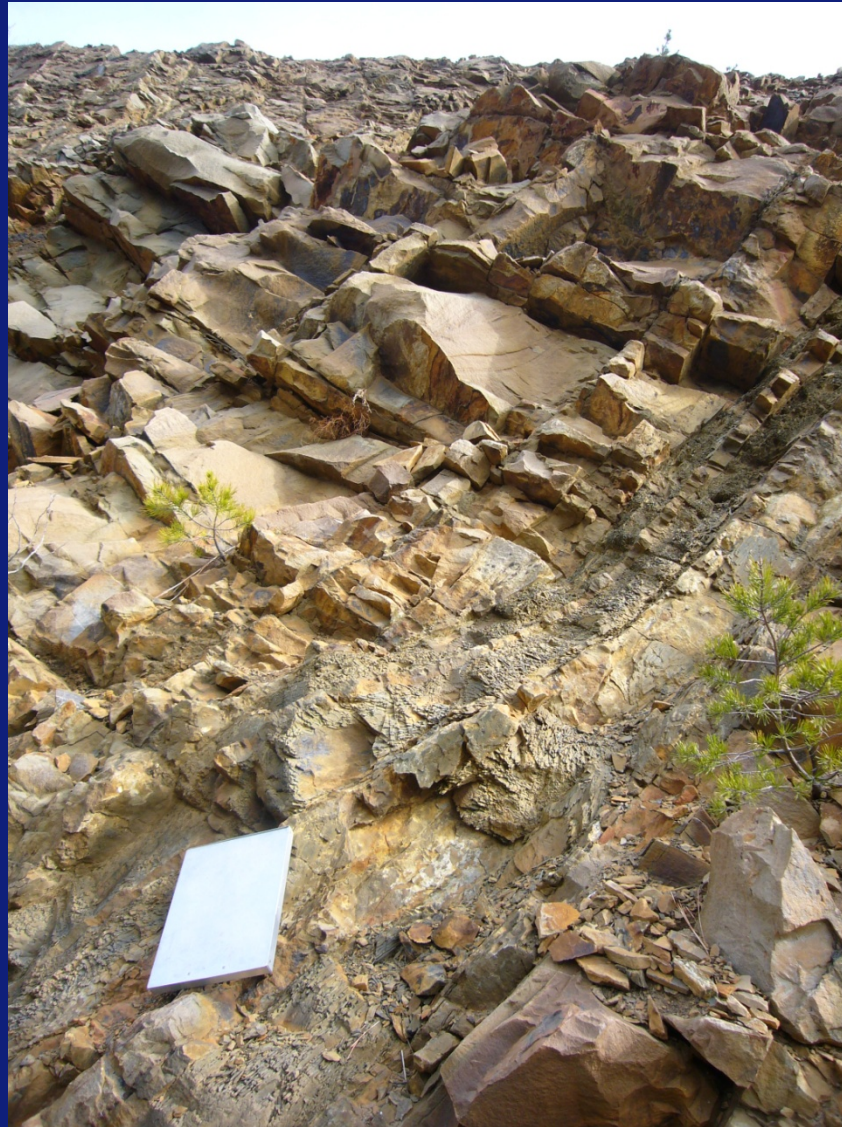
Highly Fractured, Loose Rock

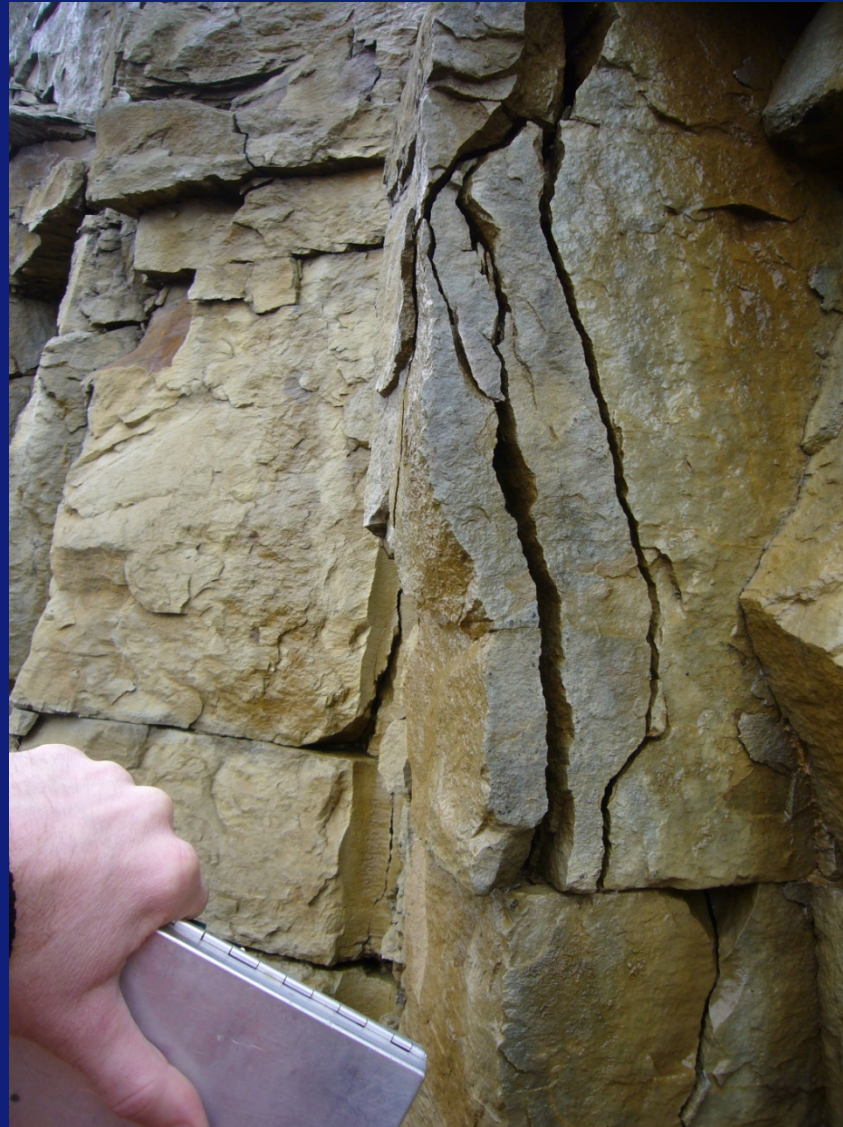
Loose Rock

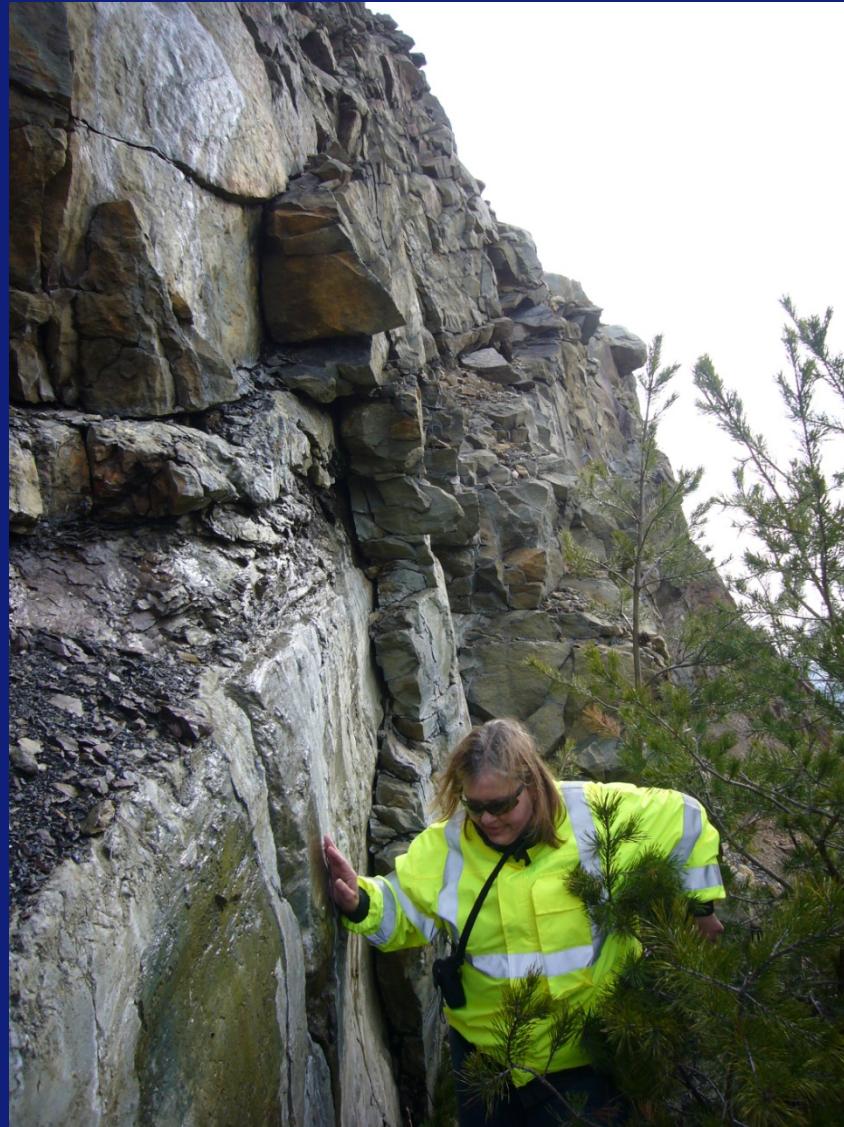
Thin Slabs at Face

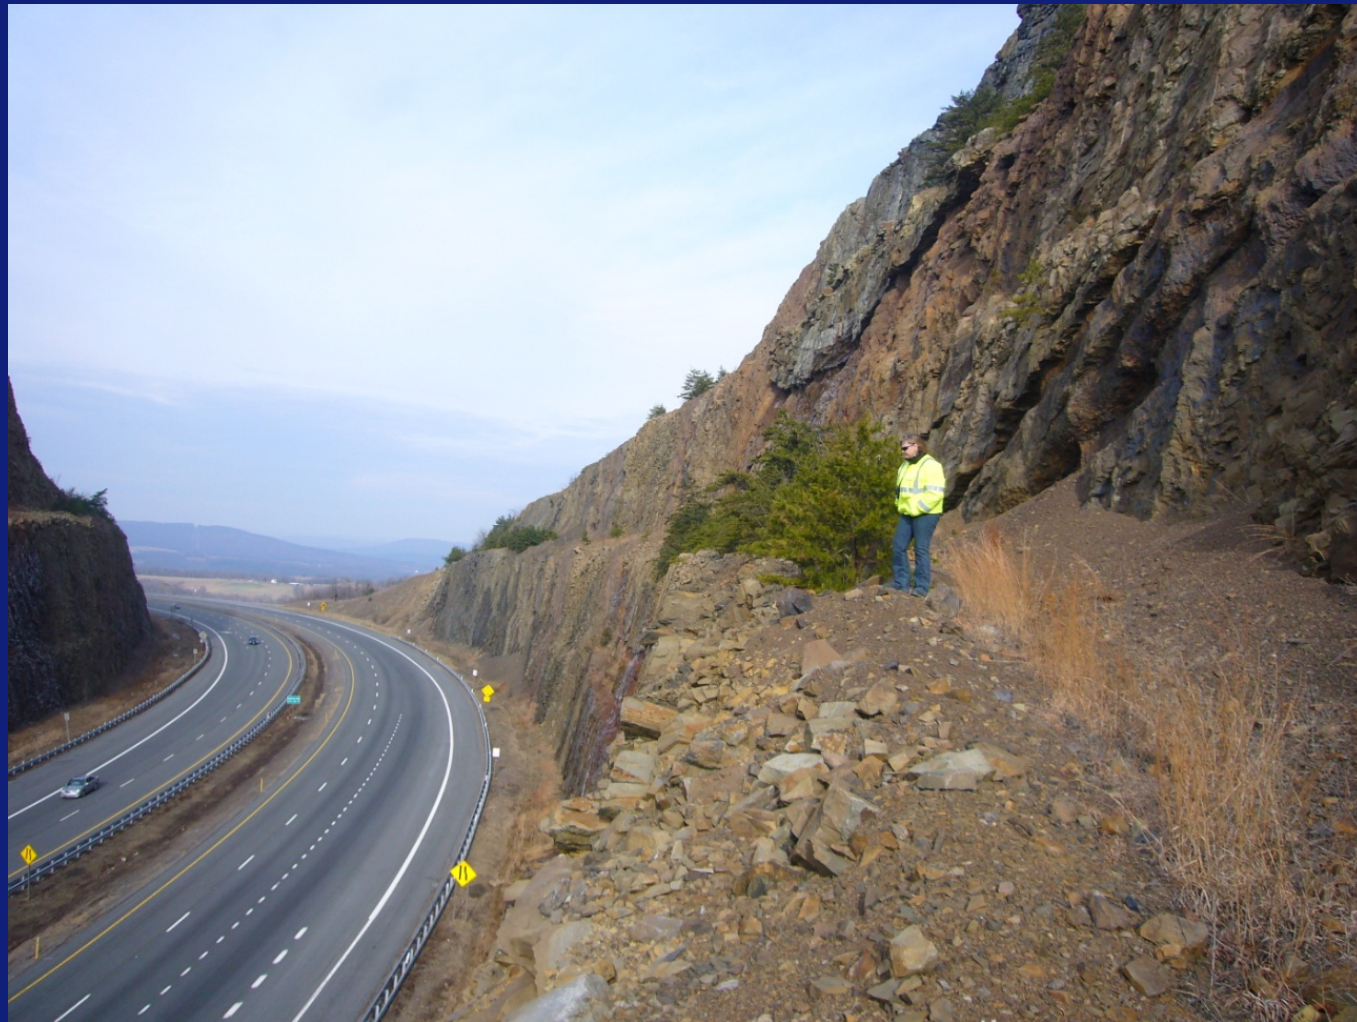
Raveling Bench Edge

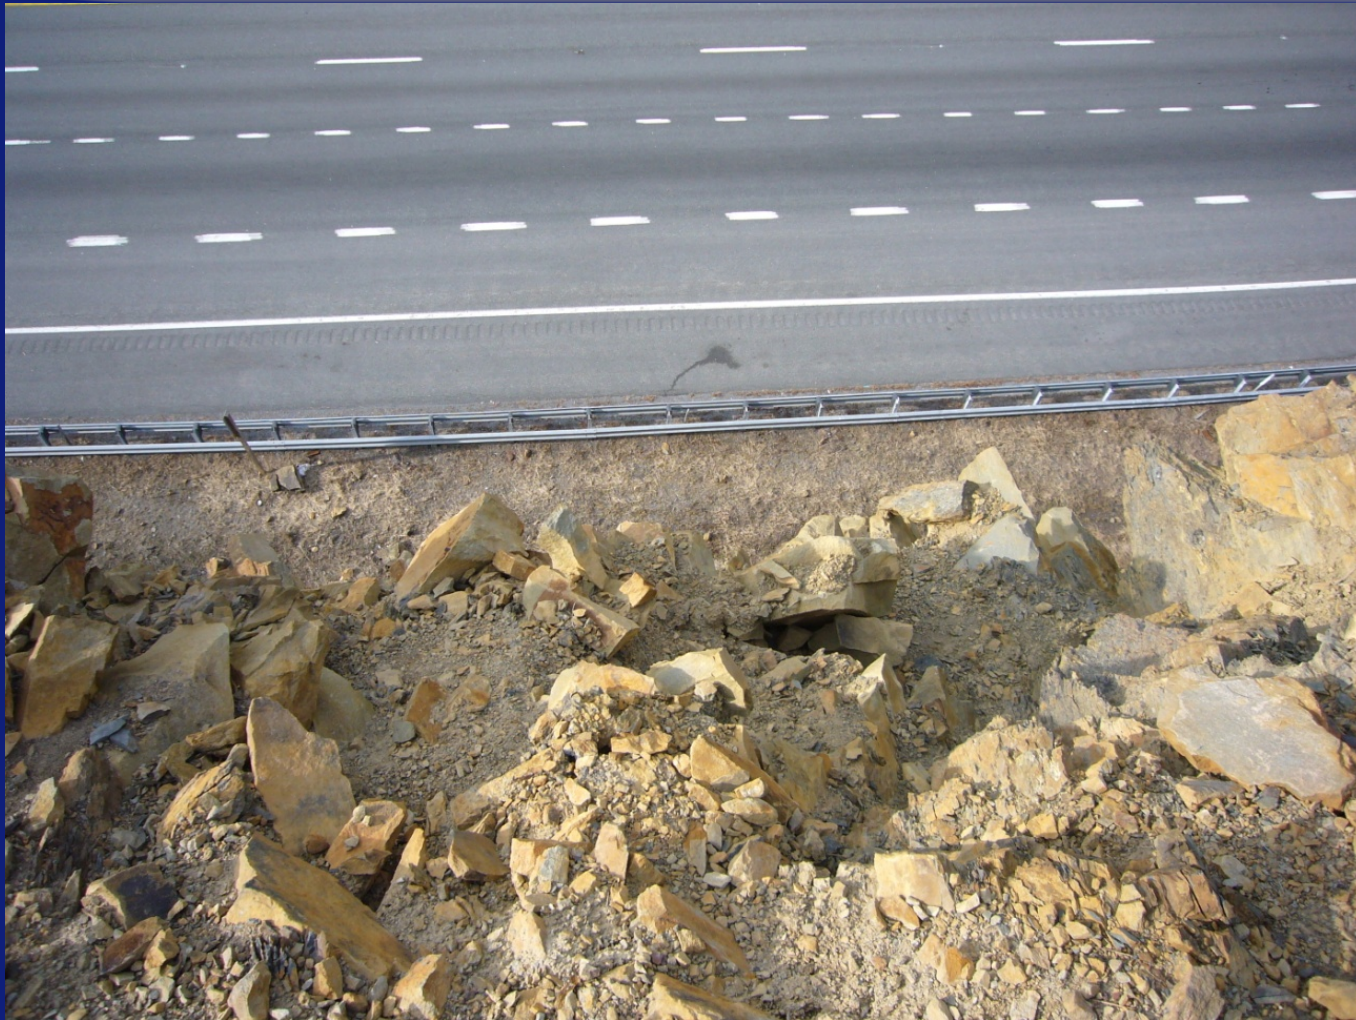
Raveling Bench Edge

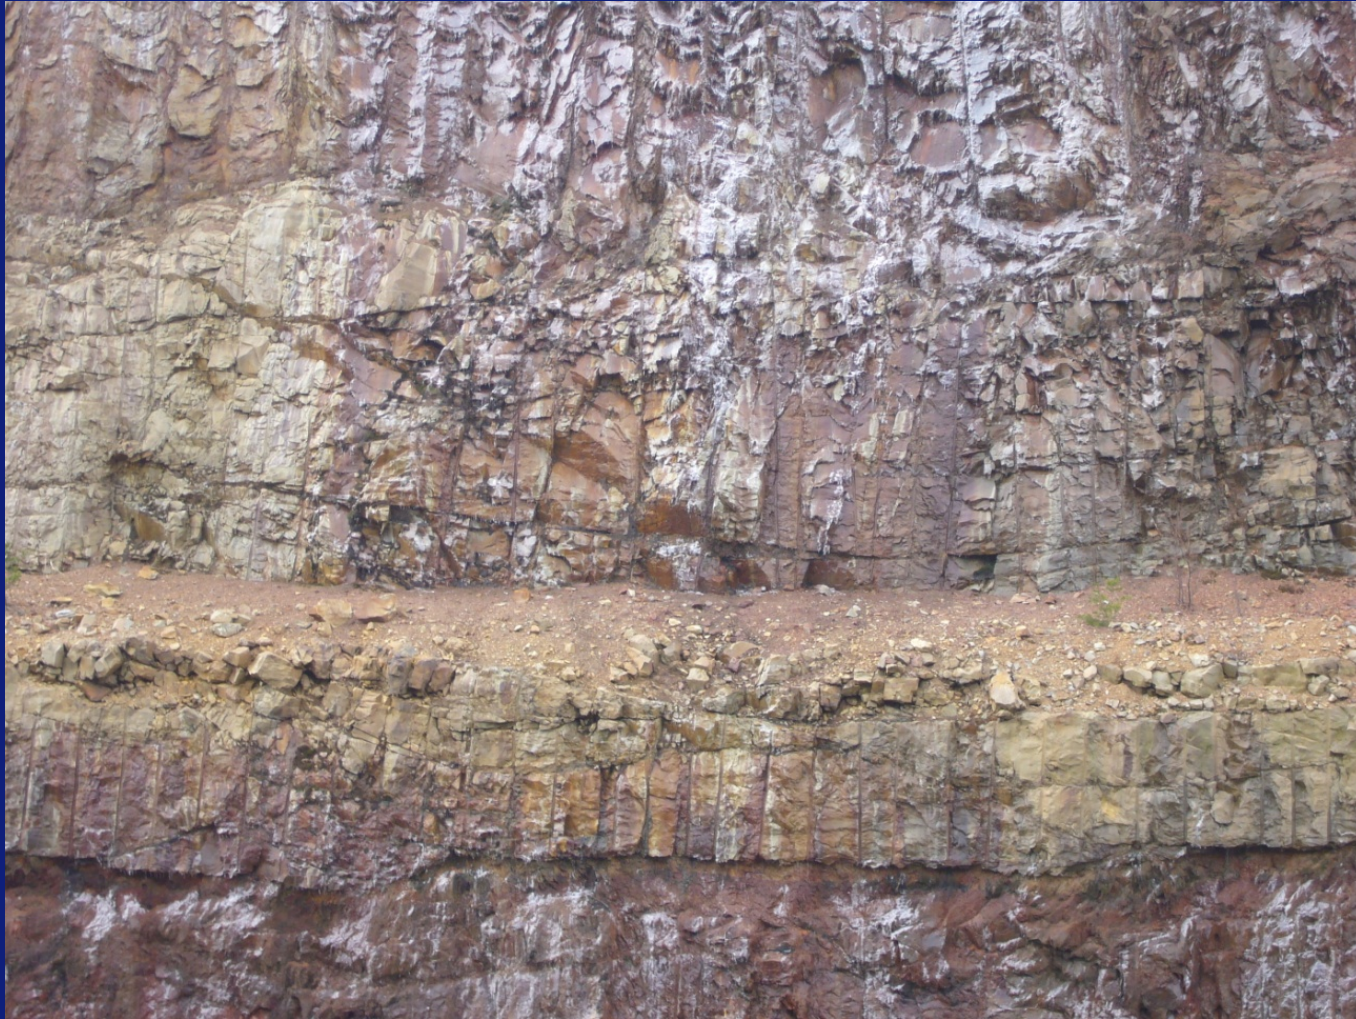
Raveling Bench Edge

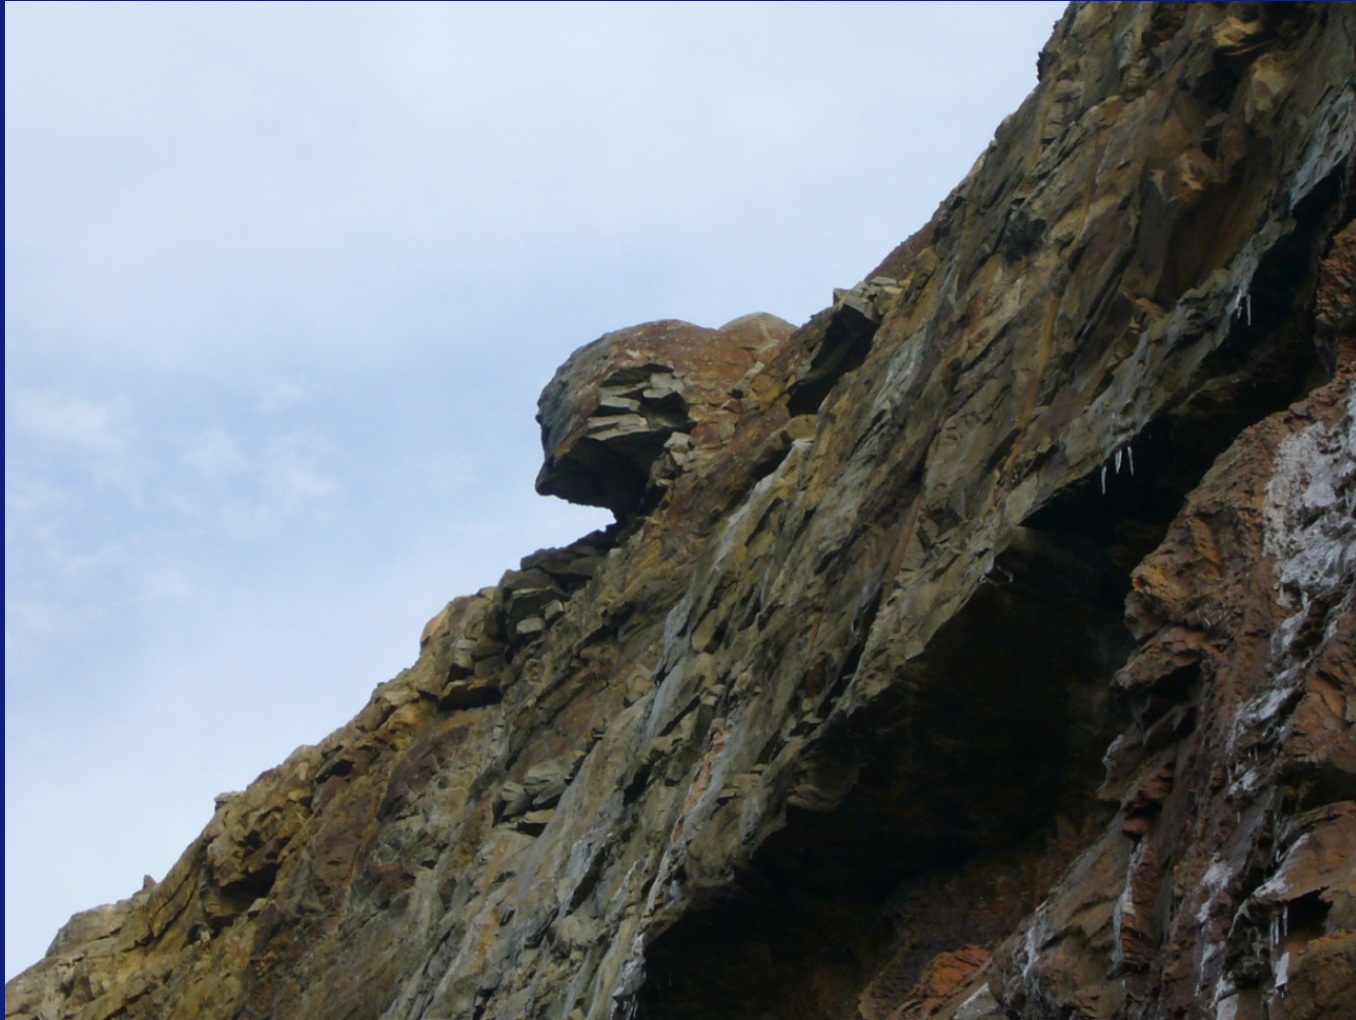
Overhanging Block

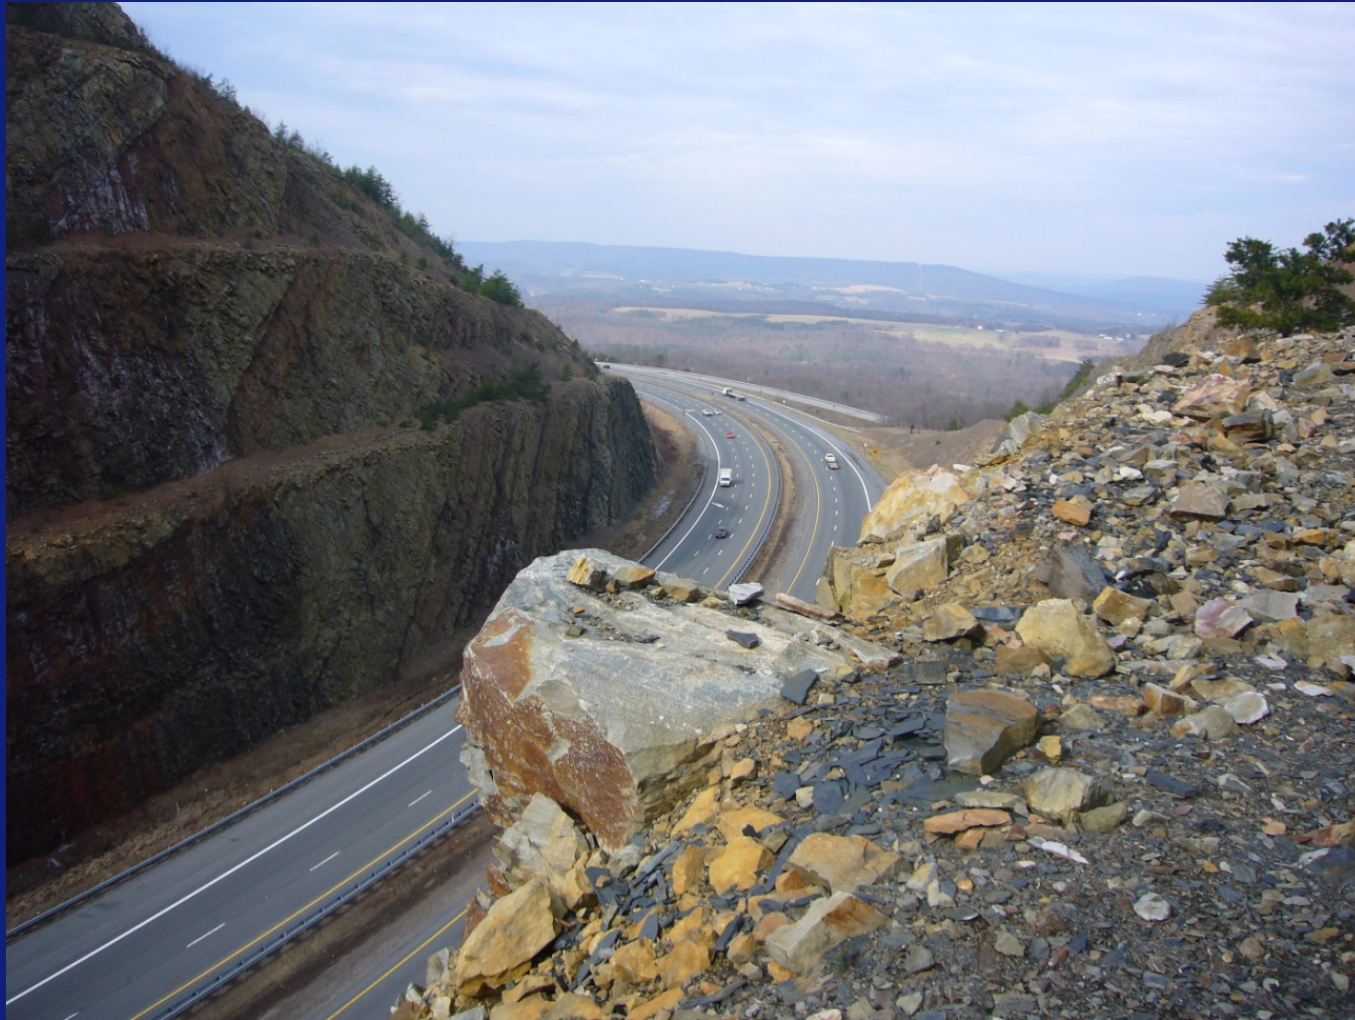
Overhanging Block

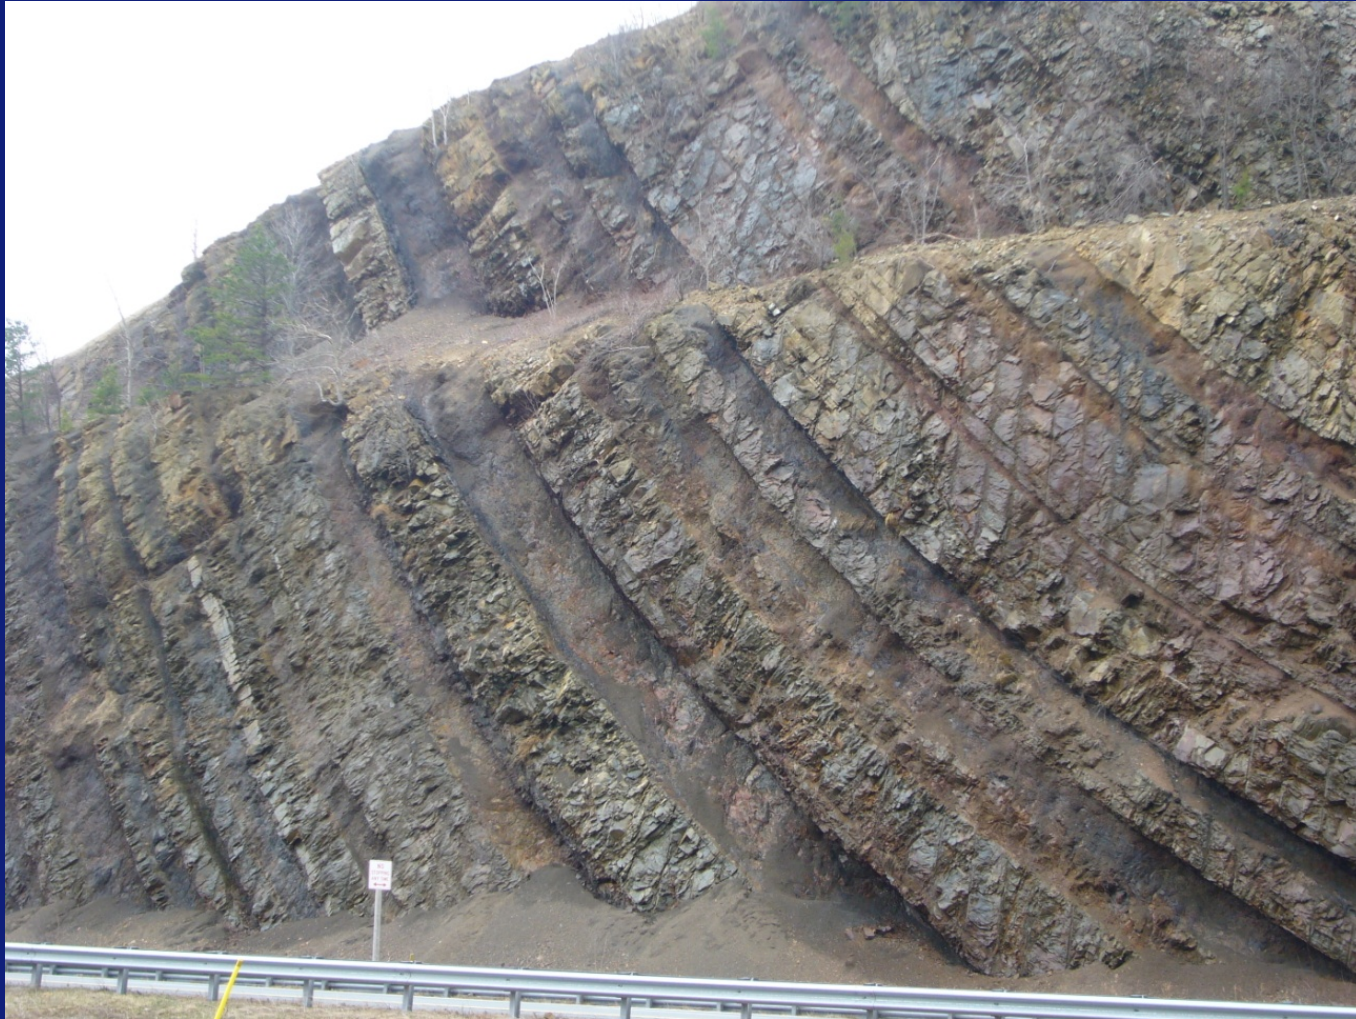
Differential Weathering

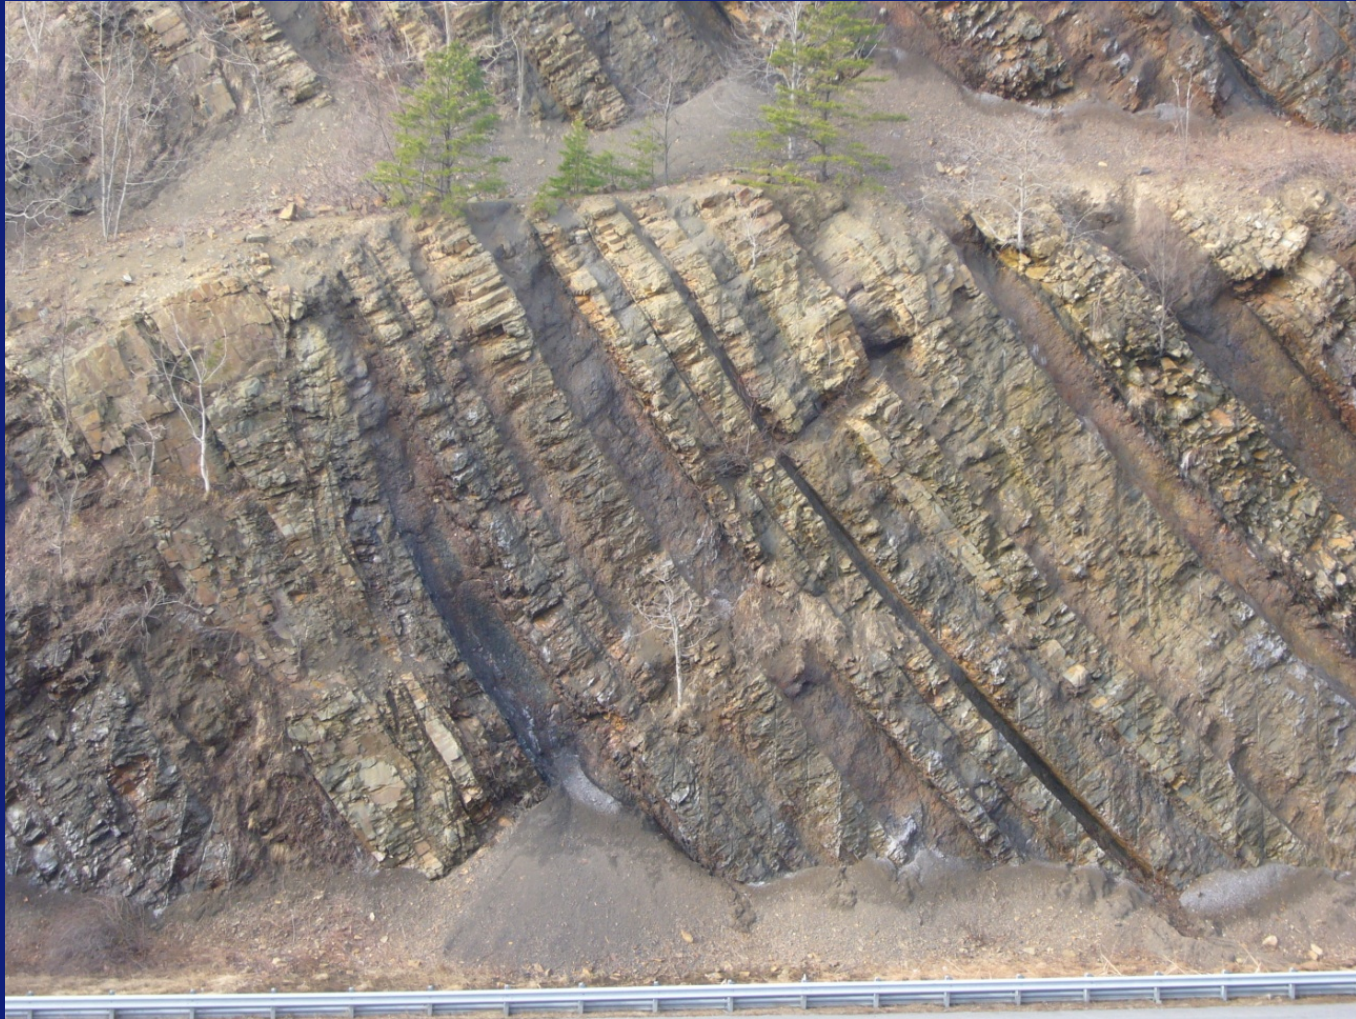
Differential Weathering

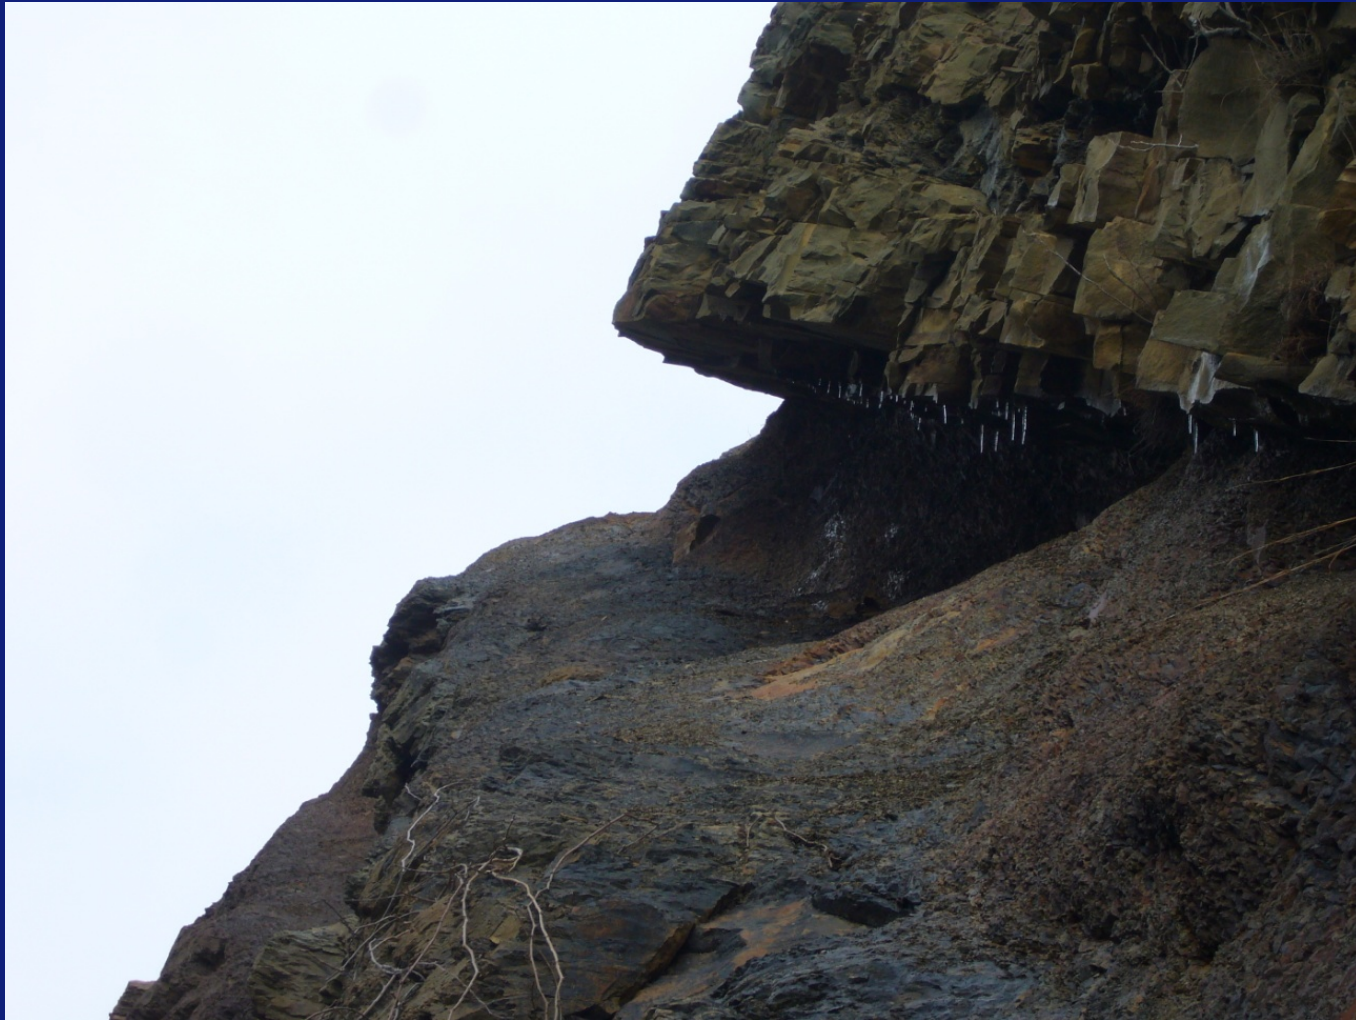
Overhang

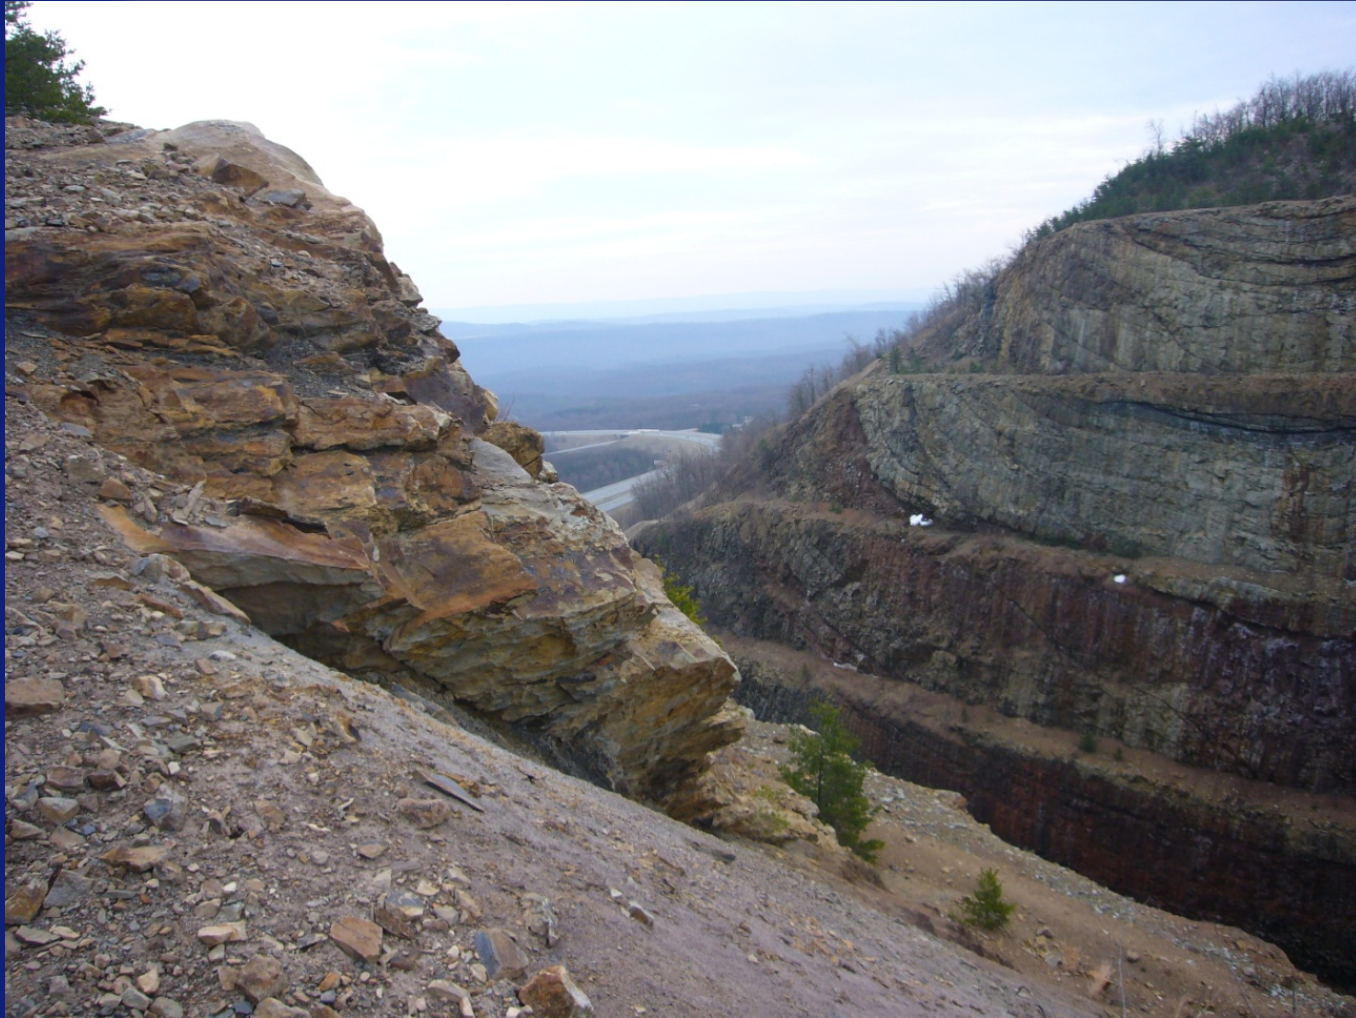
Overhang

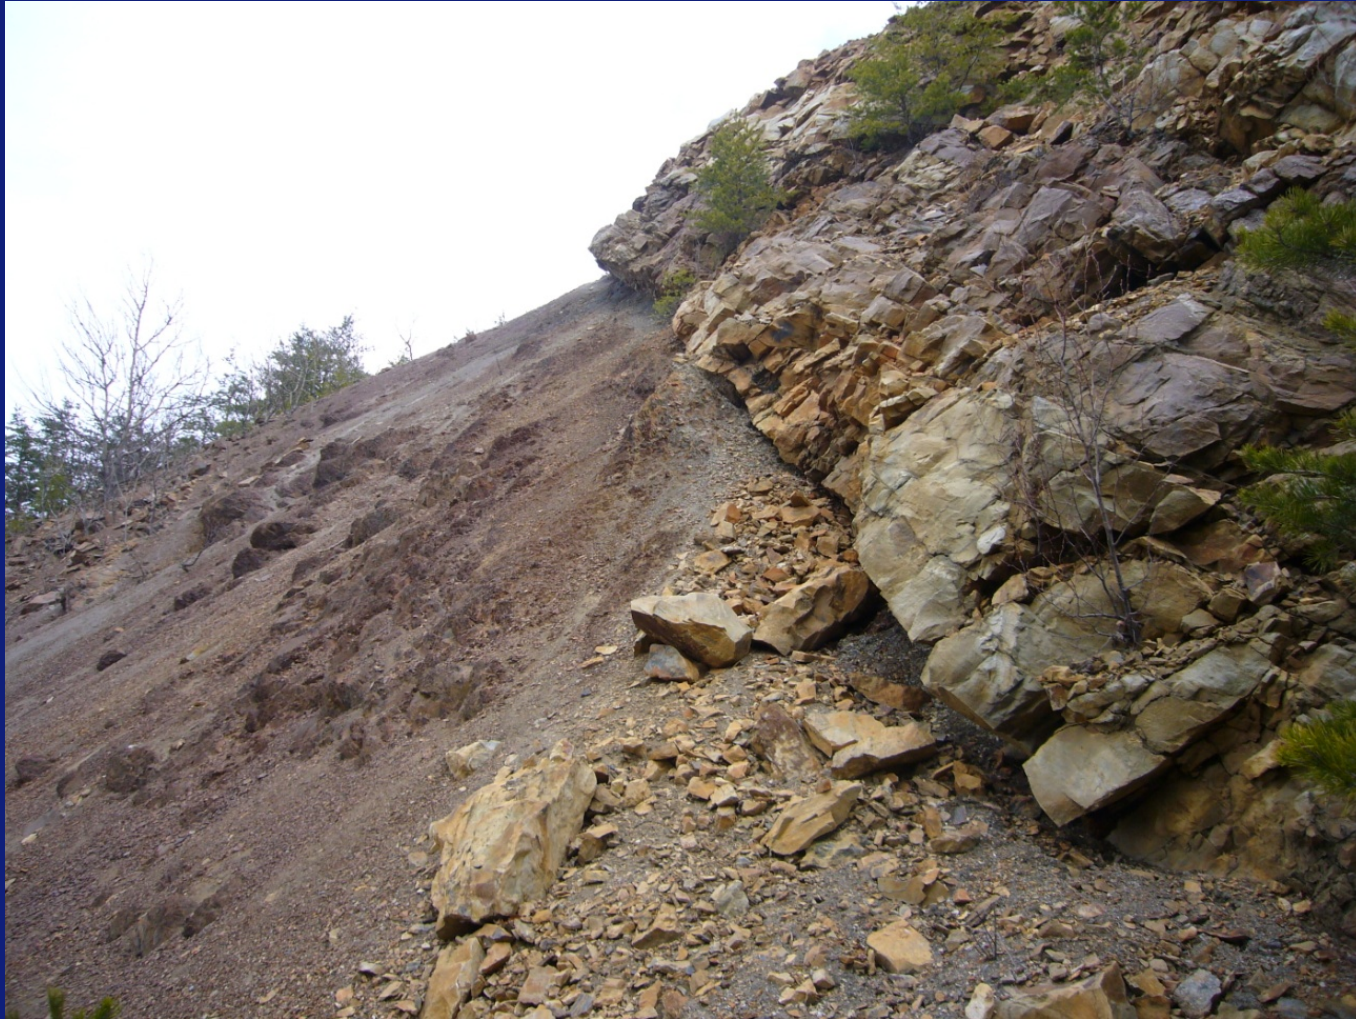
Overhang and Raveling

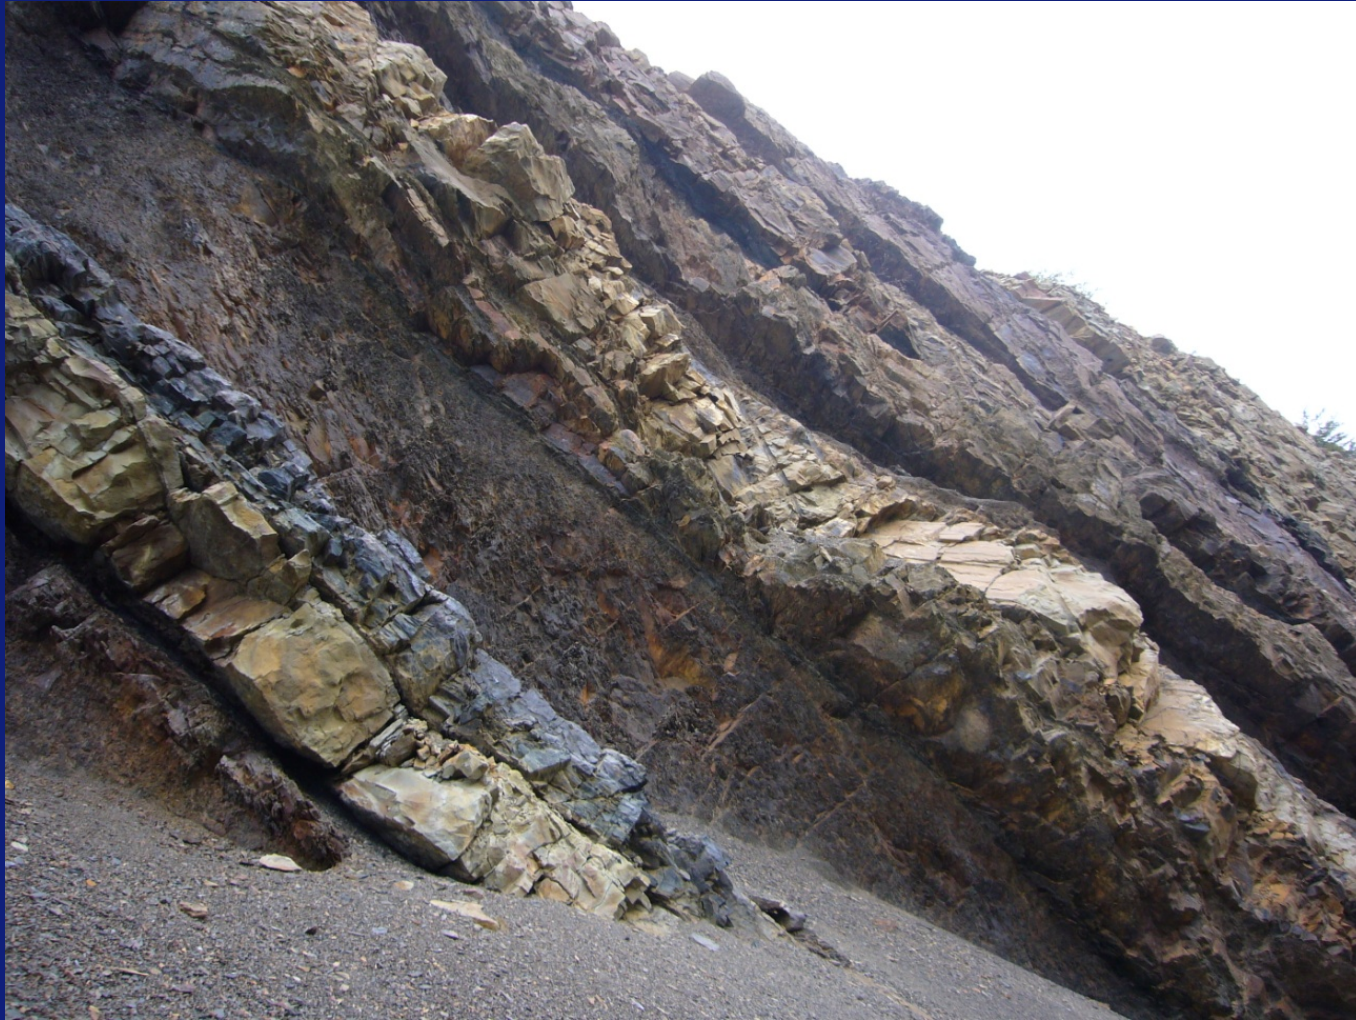
Overhangs

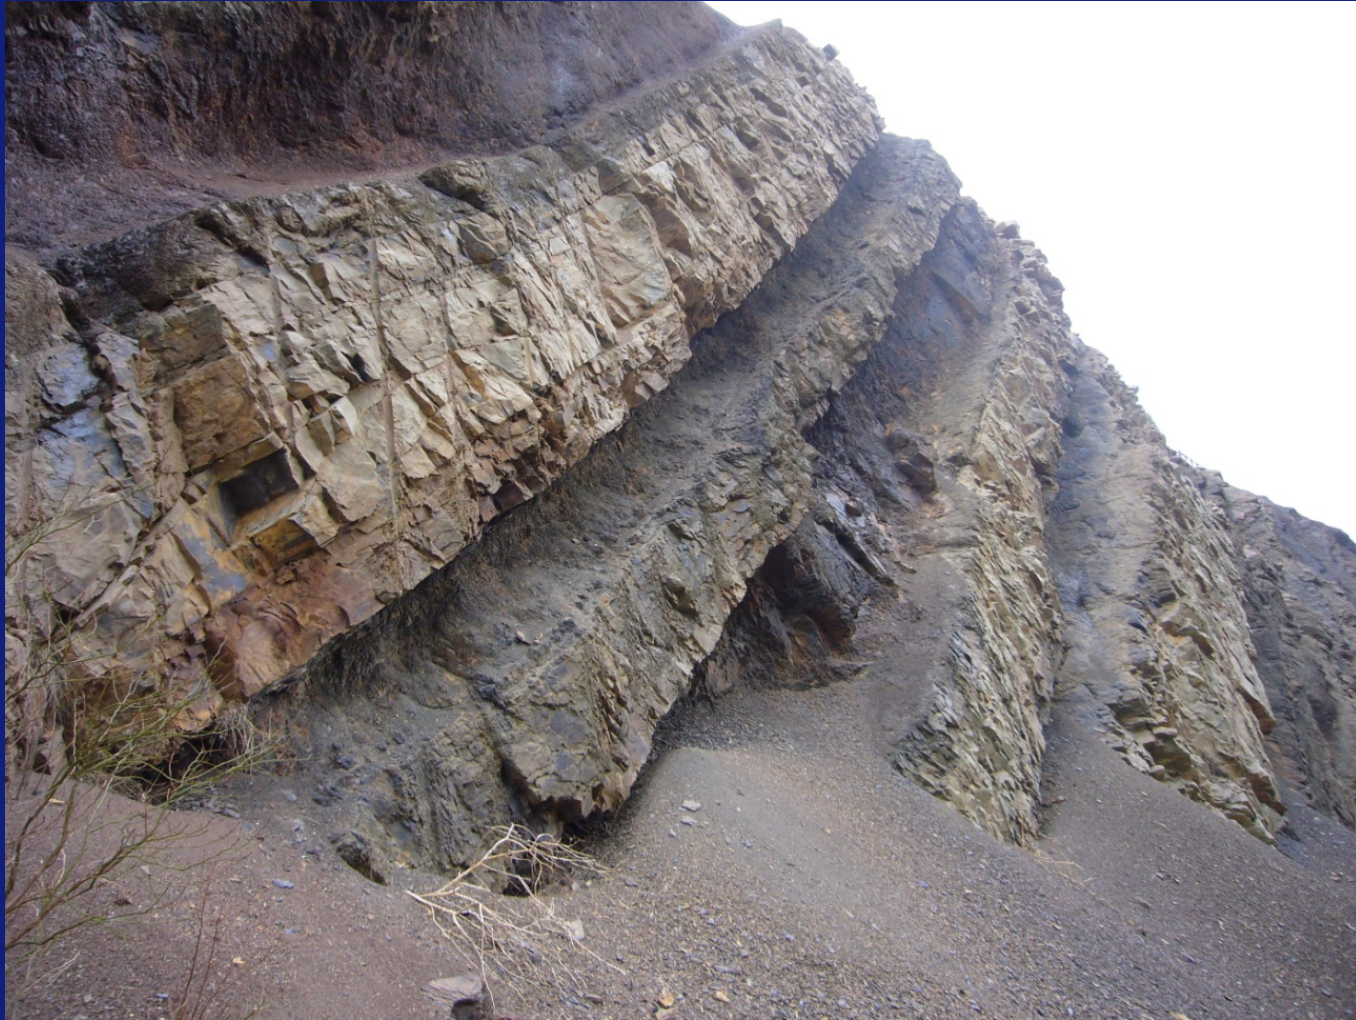
Overhangs

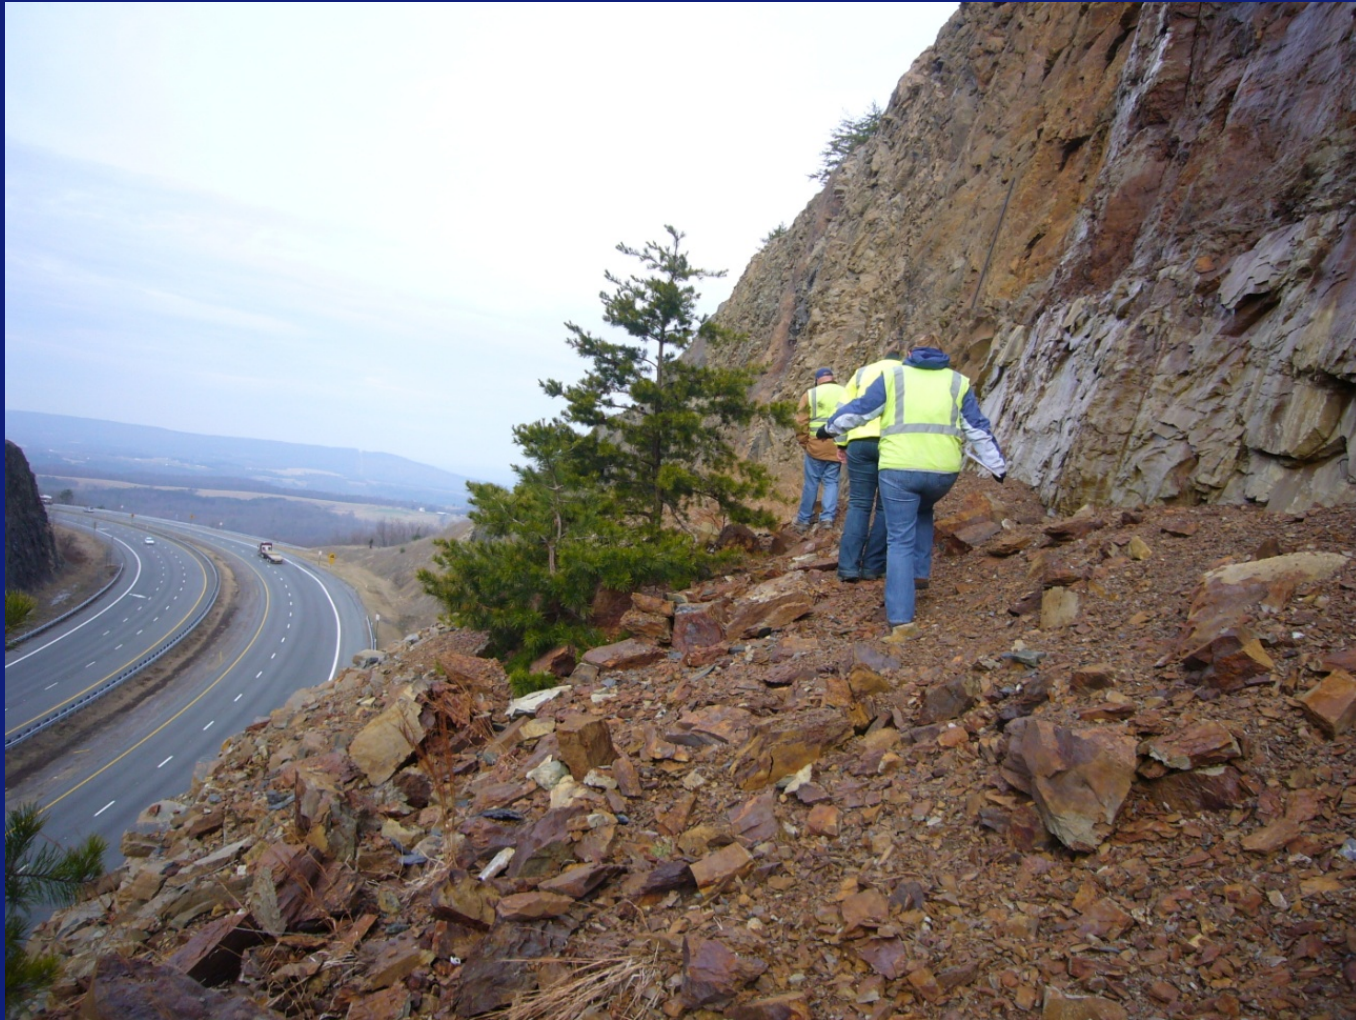
Debris Wedge

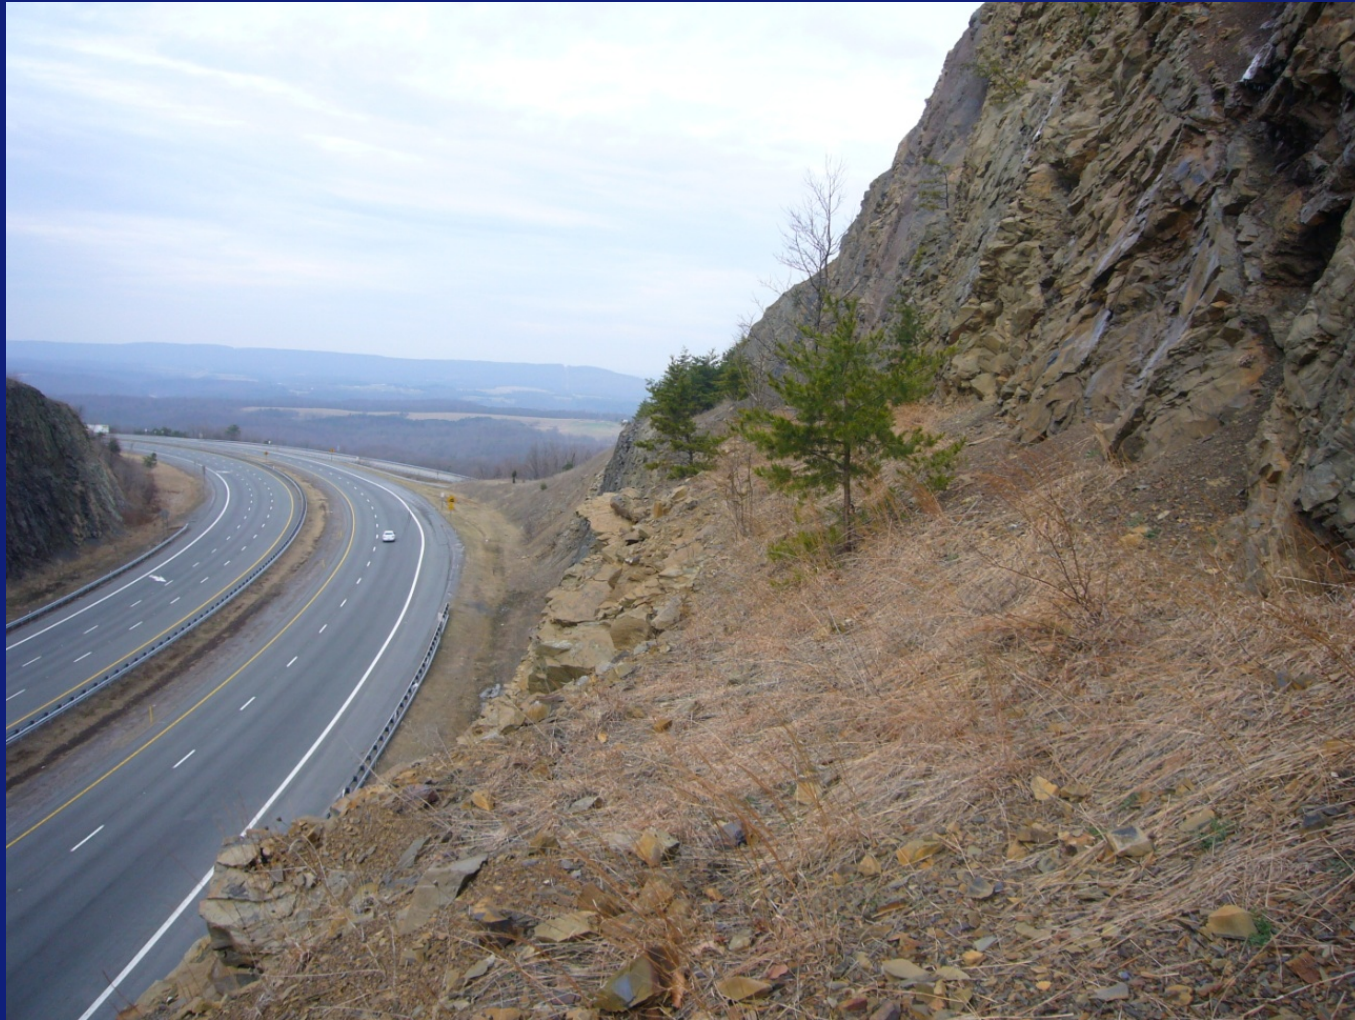
Debris Wedge
