**Assessing Maryland's Largest Highway
Rock Cut Slope: Sideling Hill
Rock Slope Hazard Study**

**2013 Geohazards Forum
July 31, 2013**

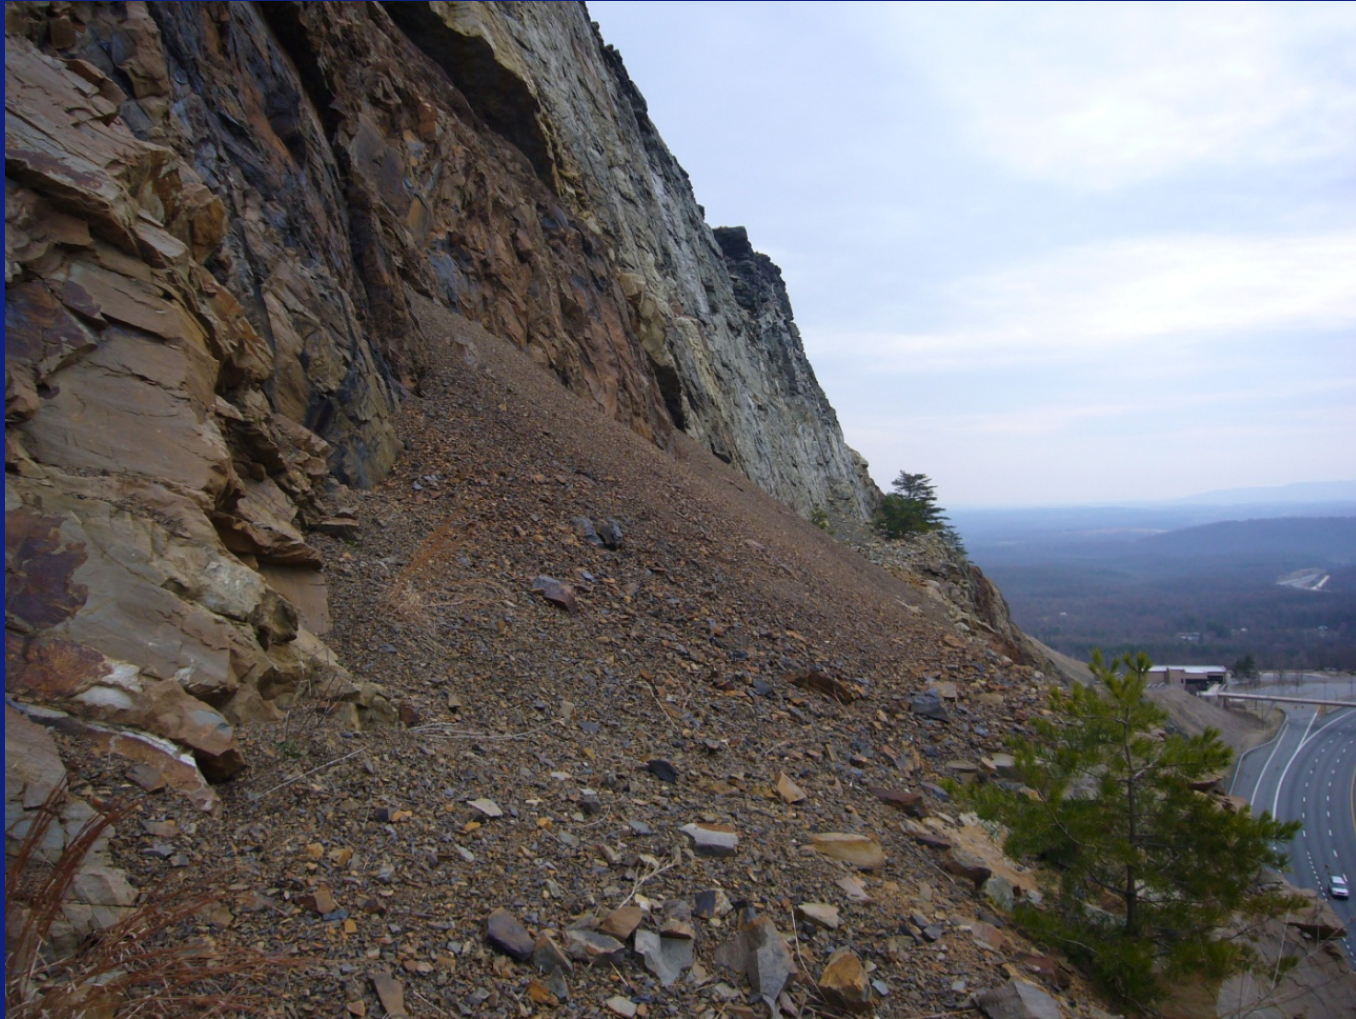
Debris Wedge

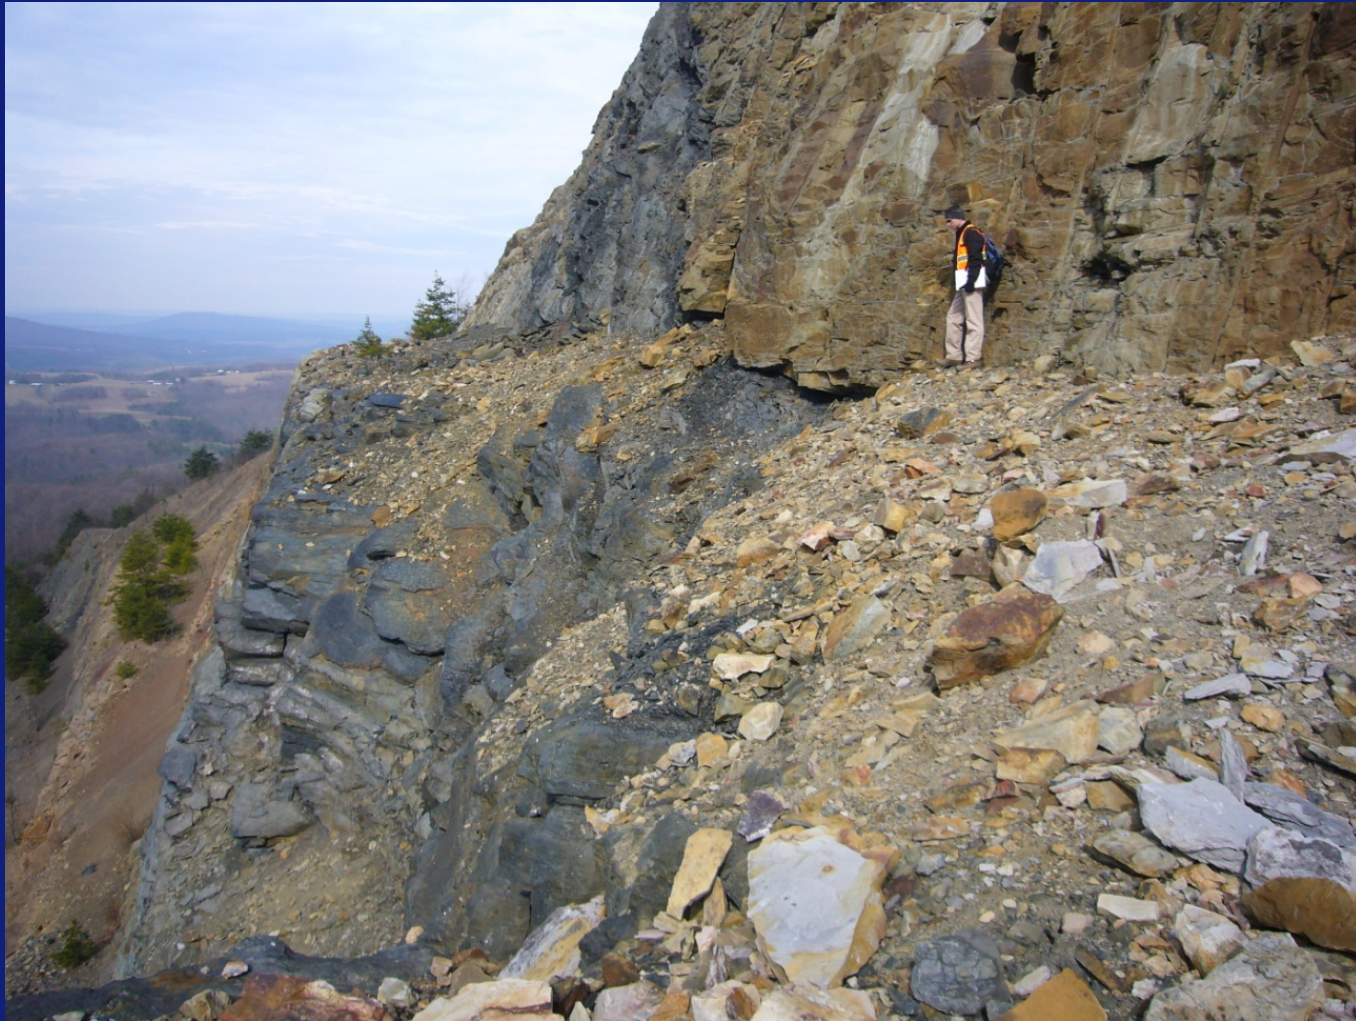
Undermined Bench

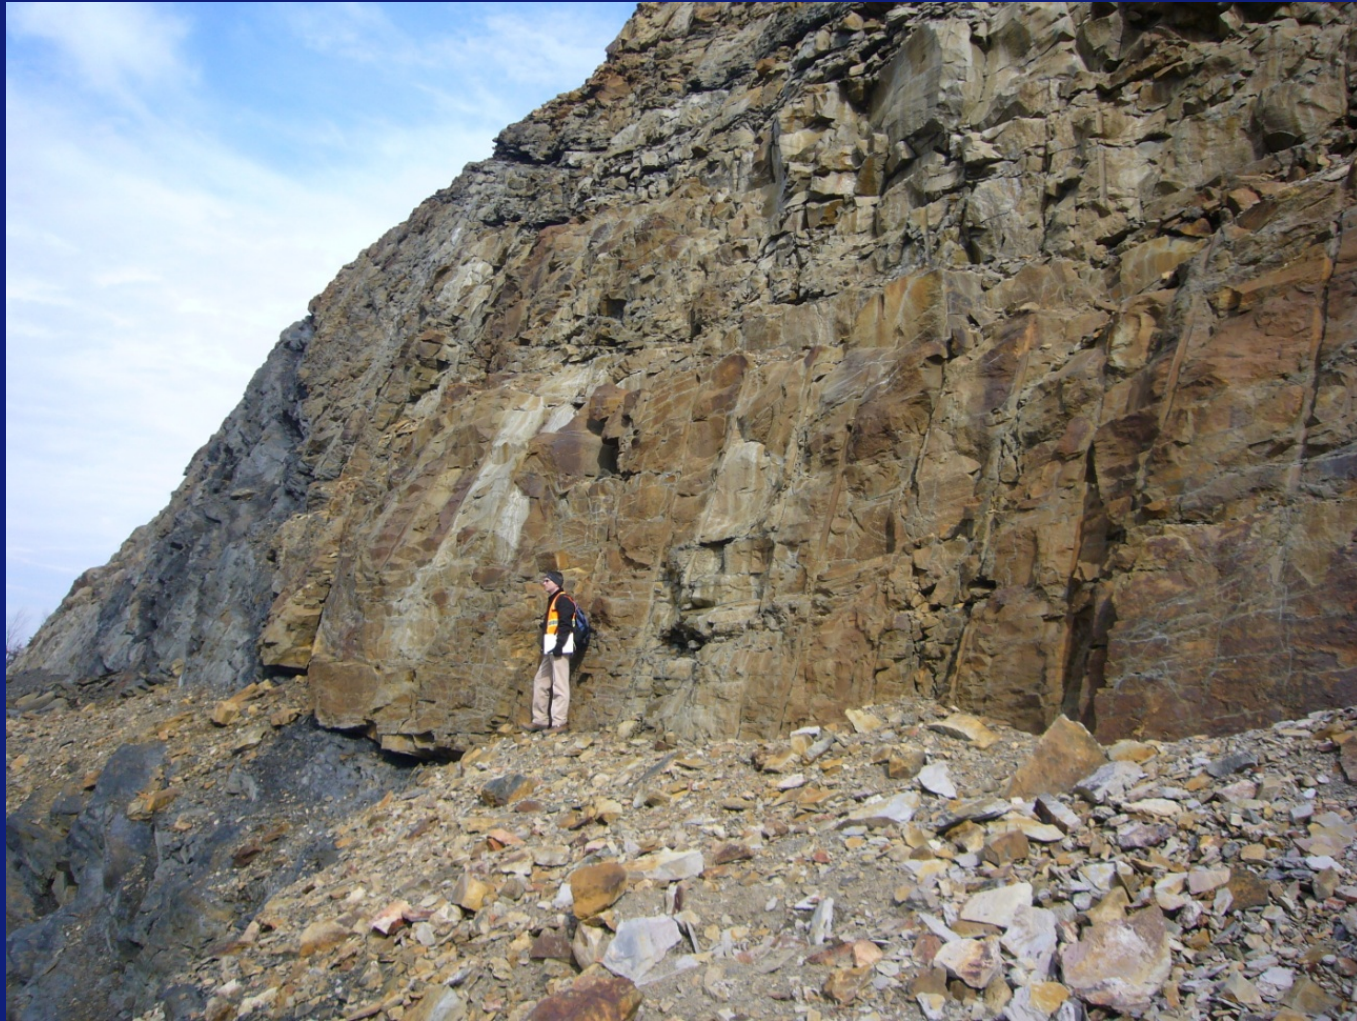
Wall above Undermined Bench

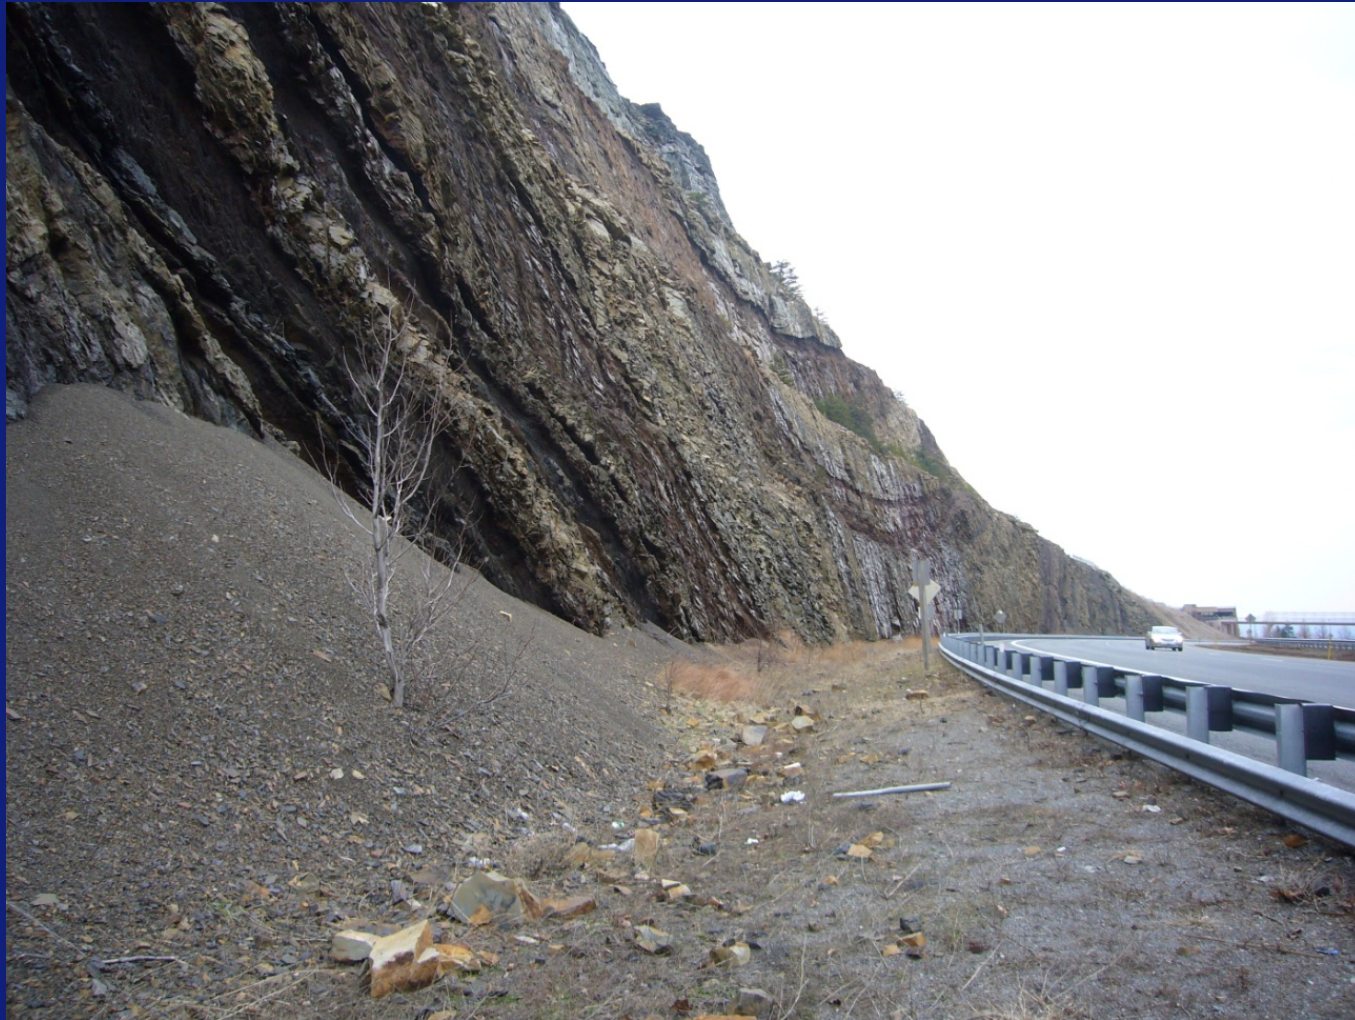
Rockfall Catchment Area

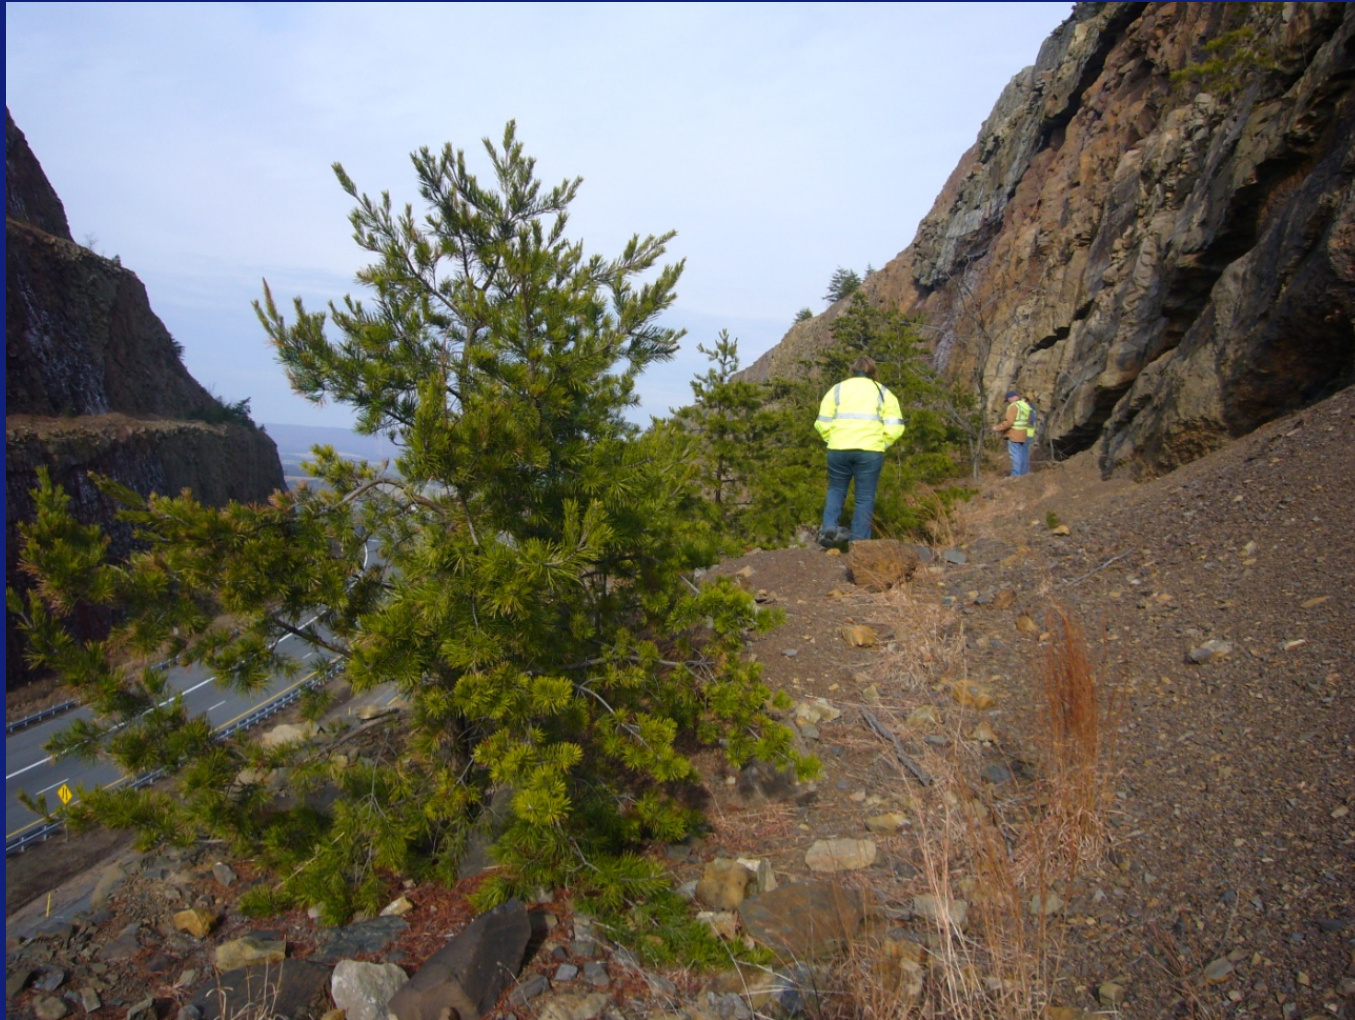
Vegetation

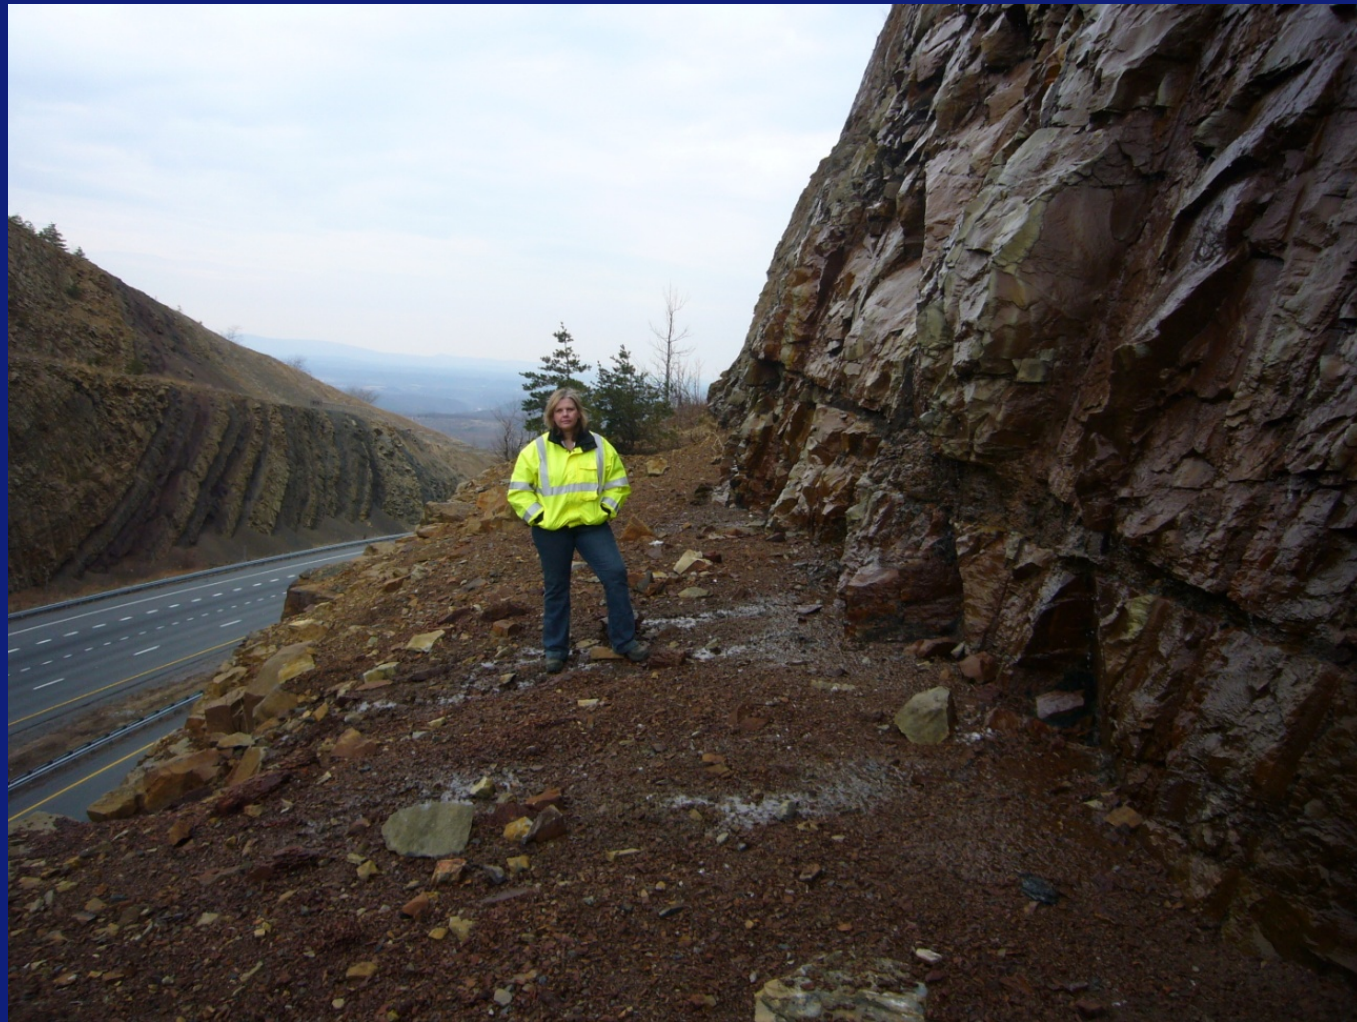
Seepage

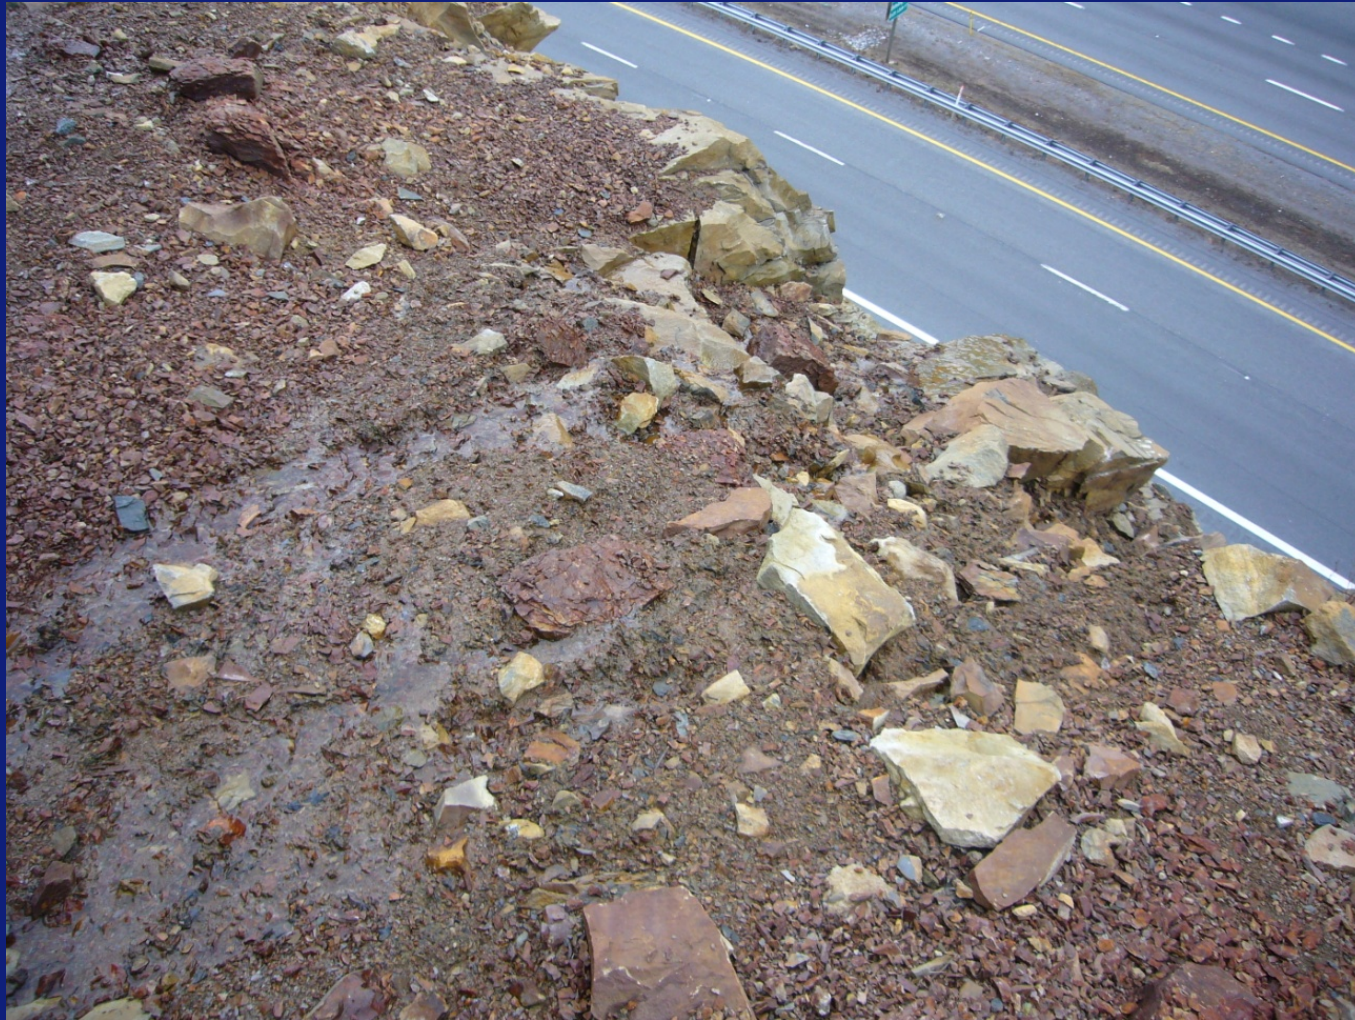
Seepage Flow over Bench Edge
