### Mitigation of Abandoned Mine Entries at Swanbank Enterprise Development, Ipswich, Australia

#### 10<sup>th</sup> Interstate Technical Group on Abandoned Underground Mines Workshop Harrisonburg, VA

# Rhondda No. 5 Colliery Entry Tunnels Disturbances 11, 13, and 15

# New Hill Colliery Entry Tunnels and Air Shaft Disturbances D1, D2, and D3

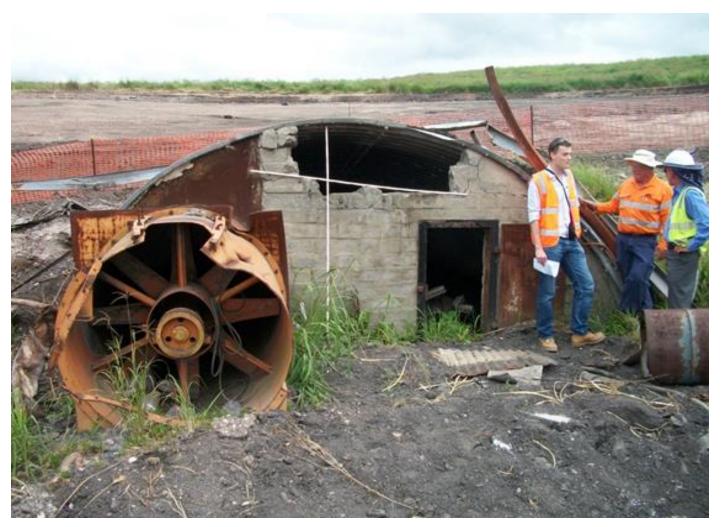
#### **Disturbance D13 - Entrance to Belt Tunnel**

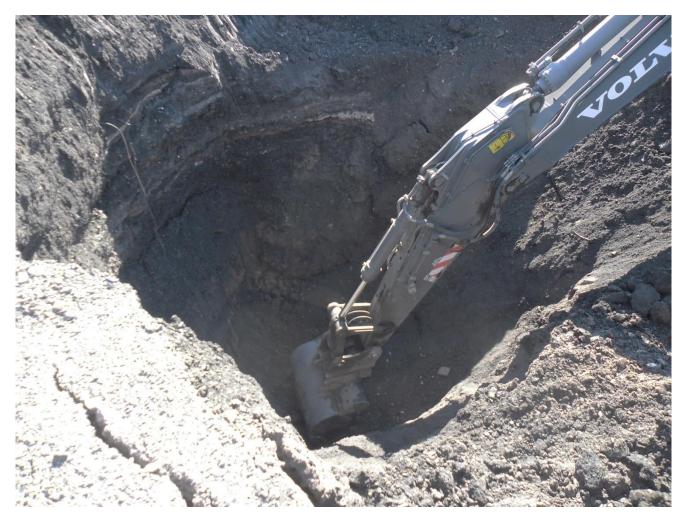
#### **Sinkhole views**

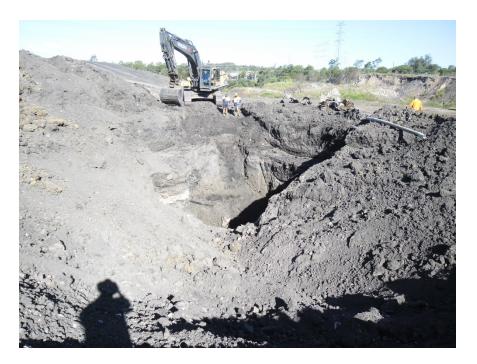
Sinkhole Test Pit con't

- Dug down to about 20ft (6m), just above arch, and could not dig deeper;
- Sinkhole may have been caused by disturbing backfill along the outsides of the arch or piping may have been occurring on the outside of the arch and the piping area collapsed.

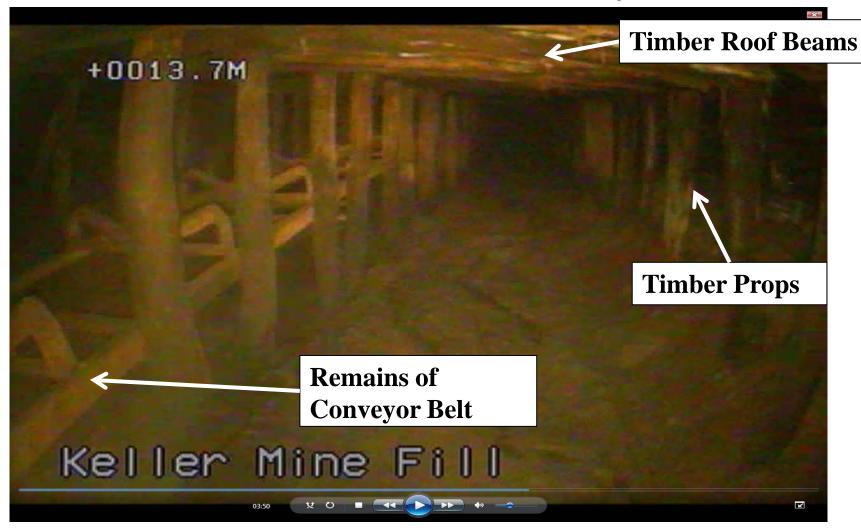
#### **View looking upslope in Belt Tunnel (D13) before grouting**

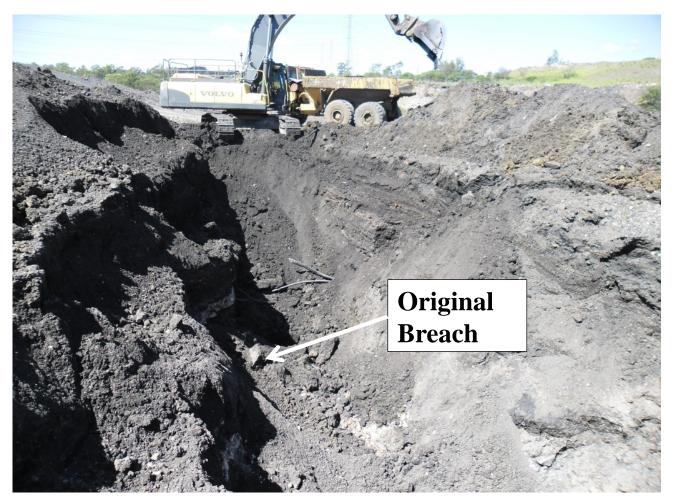
#### **Over - excavation of old Man & Supply Tunnel (D15) to remove Armco section, showing the original breach looking downslope**

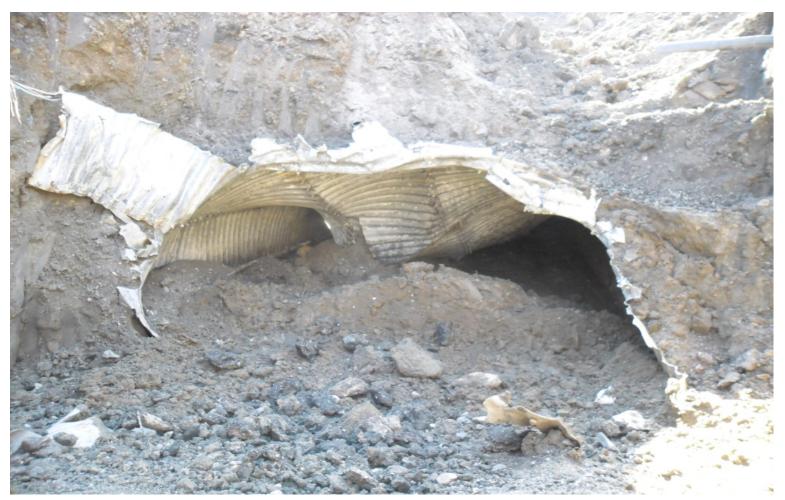
#### New breach and previous collapse in Old Man & Supply **Tunnel (D15) looking downslope**

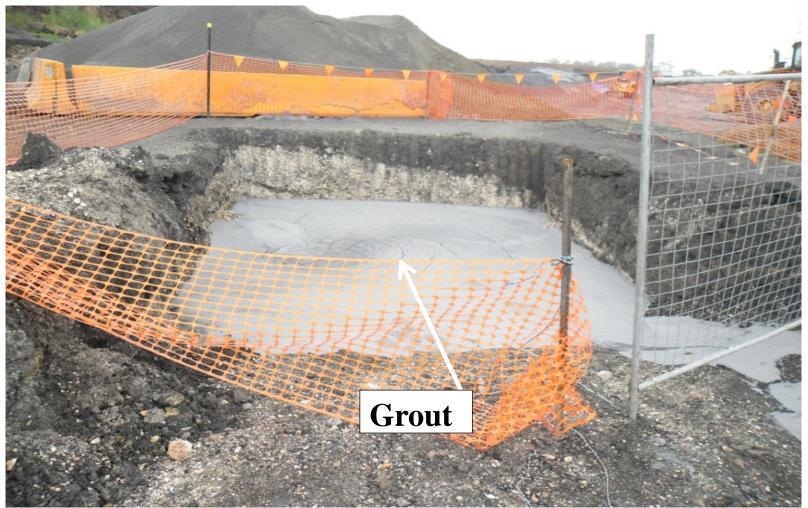
#### **Excavation filled with grout at New Man & Supply Tunnel (D11)**

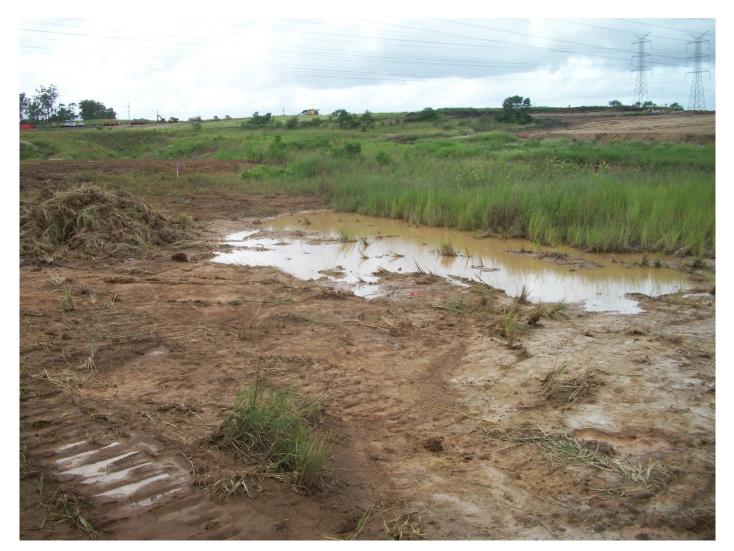
### Sinkhole over Belt Tunnel – May 2008 Approx. Dia = 26ft (8m) and Depth = 20ft (6m)

#### **Backfilled sinkhole area at Belt Tunnel prior to drilling**

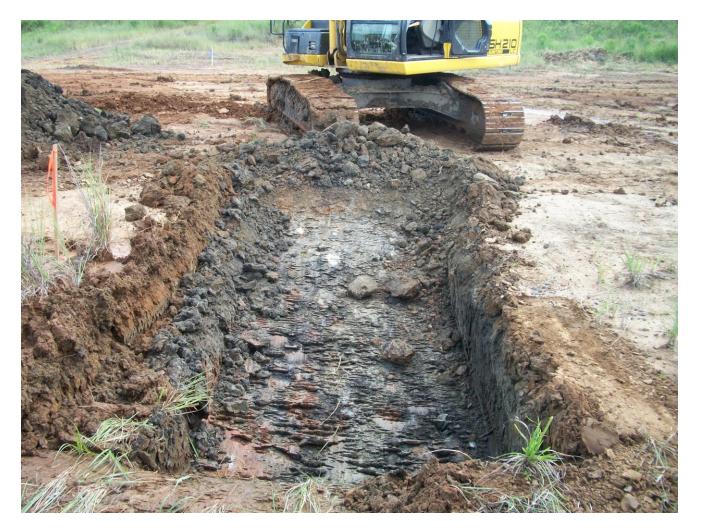
### **Poor Backfill**

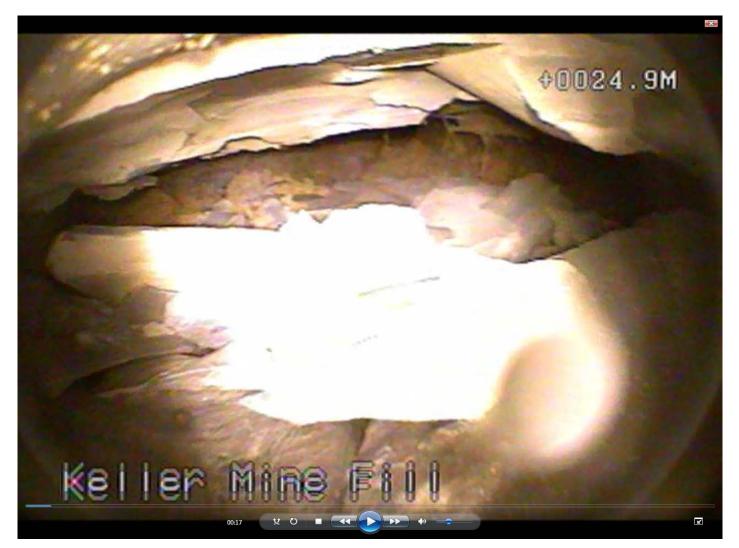
View from borehole camera looking upslope at material from sinkhole in rock tunnel portion of Belt Tunnel

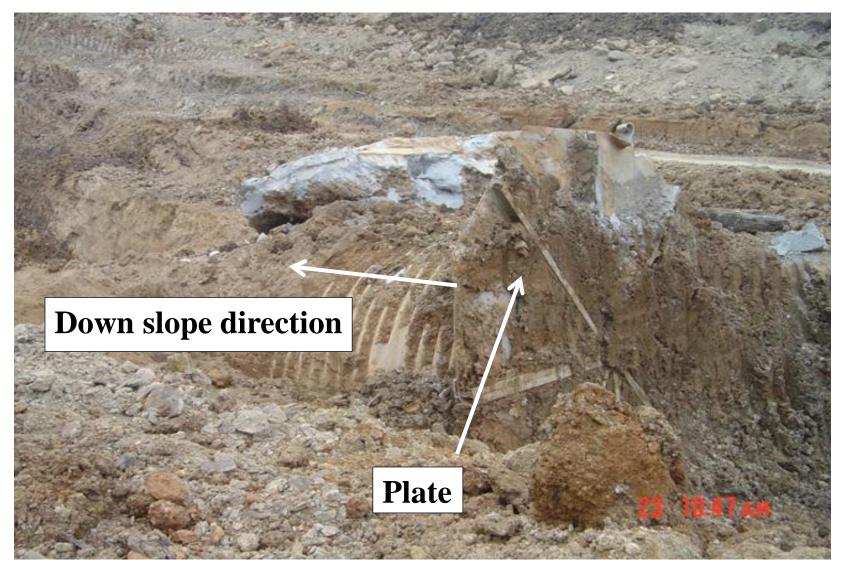
#### **Exposed Armco section & steel cover plate installed at mine closure**

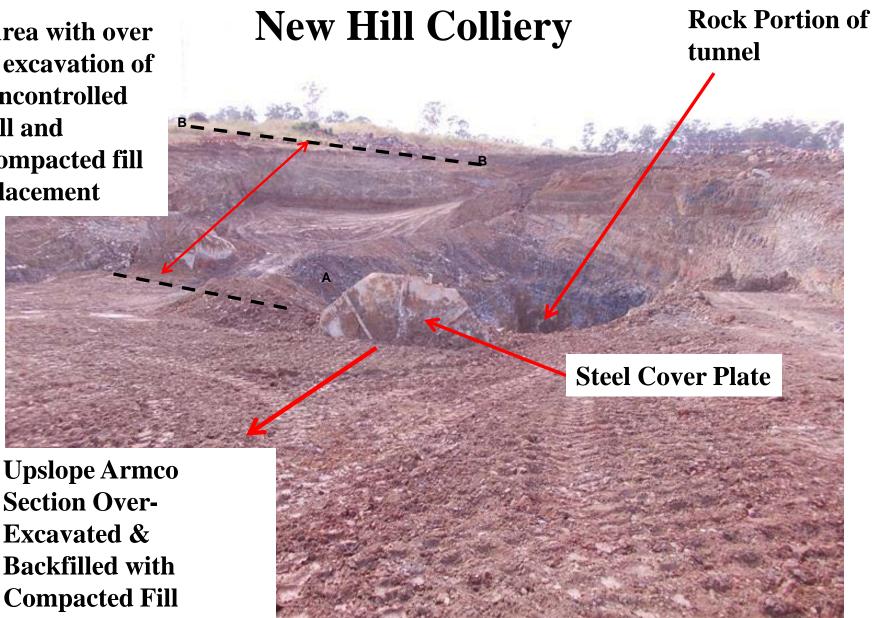
#### **Removal of uncontrolled fill in sinkhole over Belt Tunnel area**

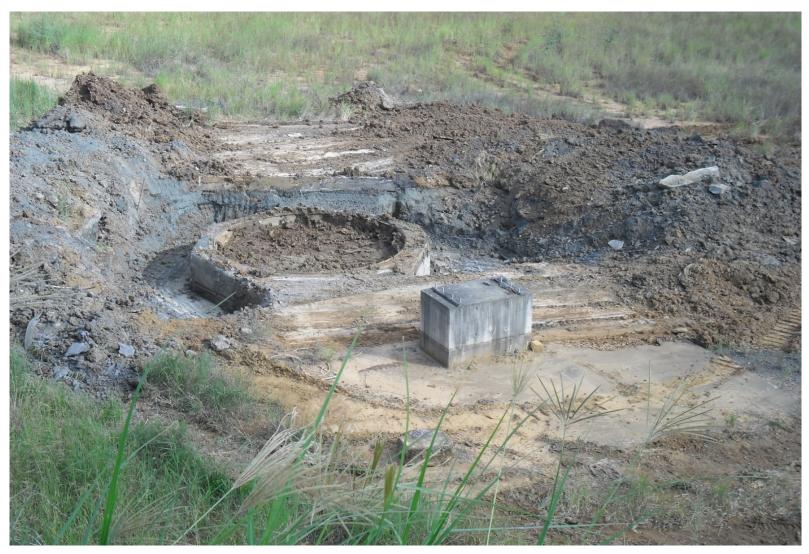
#### **Exposed air shaft looking South**

- 1. The ground around the shaft was raised to the top of the shaft collar level using compacted fill;
- 2. A trench was excavated around the outside perimeter of the shaft where it is in contact with the adjacent rock, to allow for the placement of a geosynthetic filter layer;

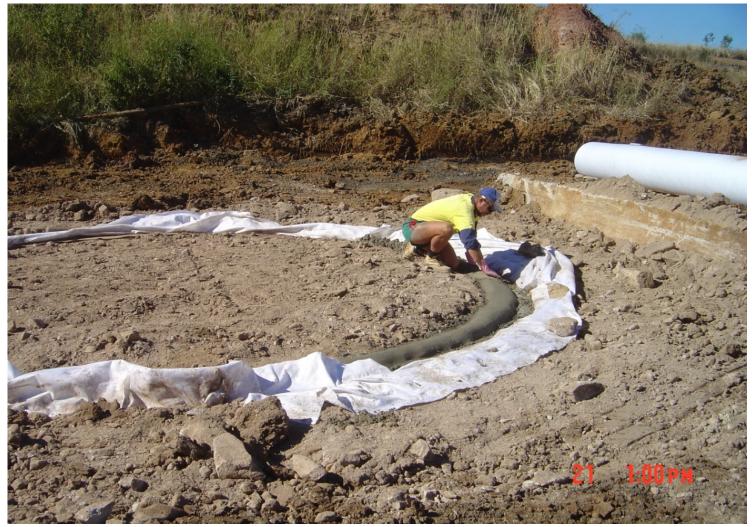
#### Metal lip on top of shaft covered by concrete layer to reduce potential for ripping of geotextile

- 3. A concrete layer was placed on top of the metal lip, located on the top of the shaft, to lessen damage to the geosynthetic filter layer that would have occurred if it had been in contact with the sharp mental lip;

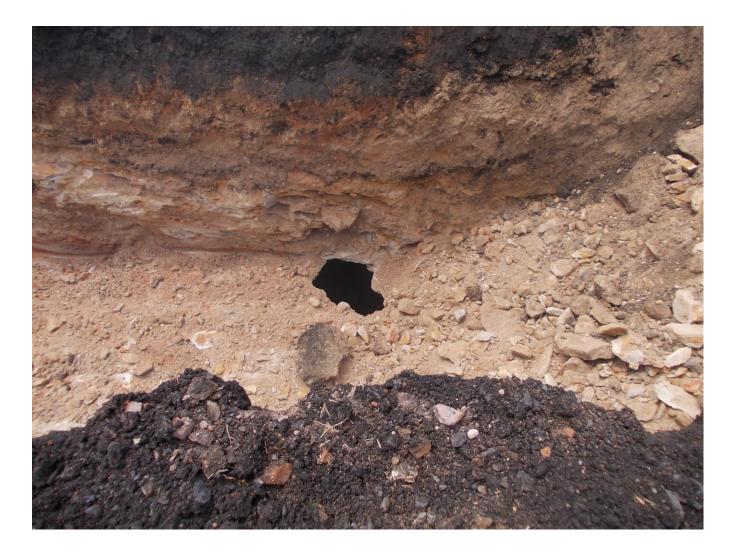
#### **Caving encountered during excavation at Tunnel 1**

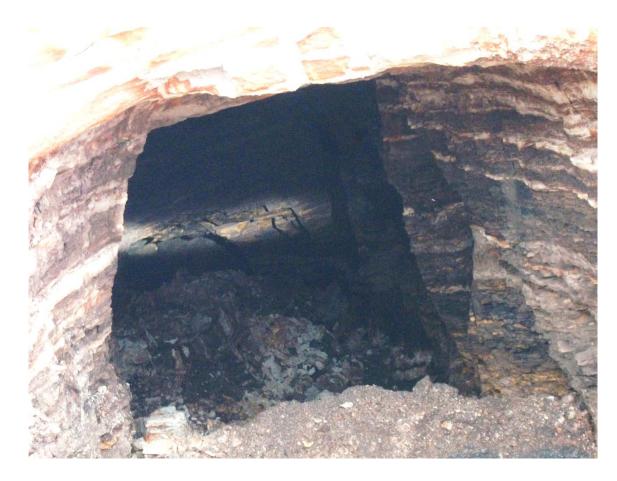
# View of caved material that appears to have fallen in one block

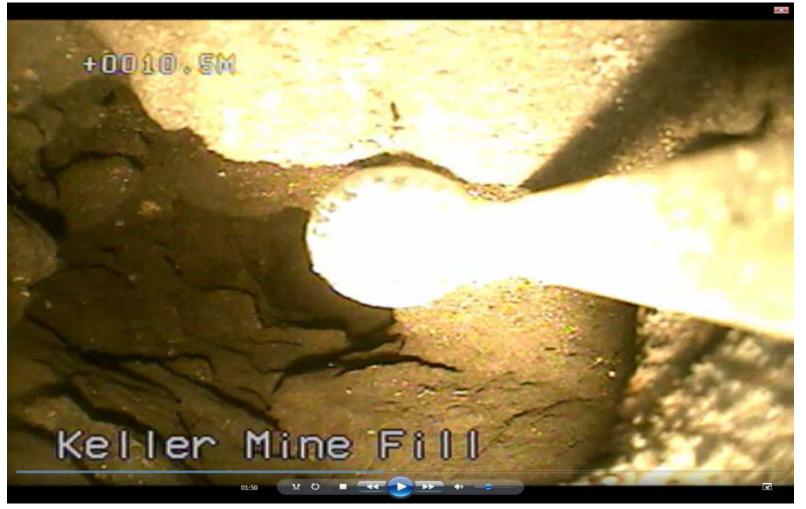
#### **Down looking view showing roof fall in Tunnel 2**
