Block Slide/Rockfall on I-75 Campbell County, TN

David Barker, PE
Tennessee DOT

February 26, 2016

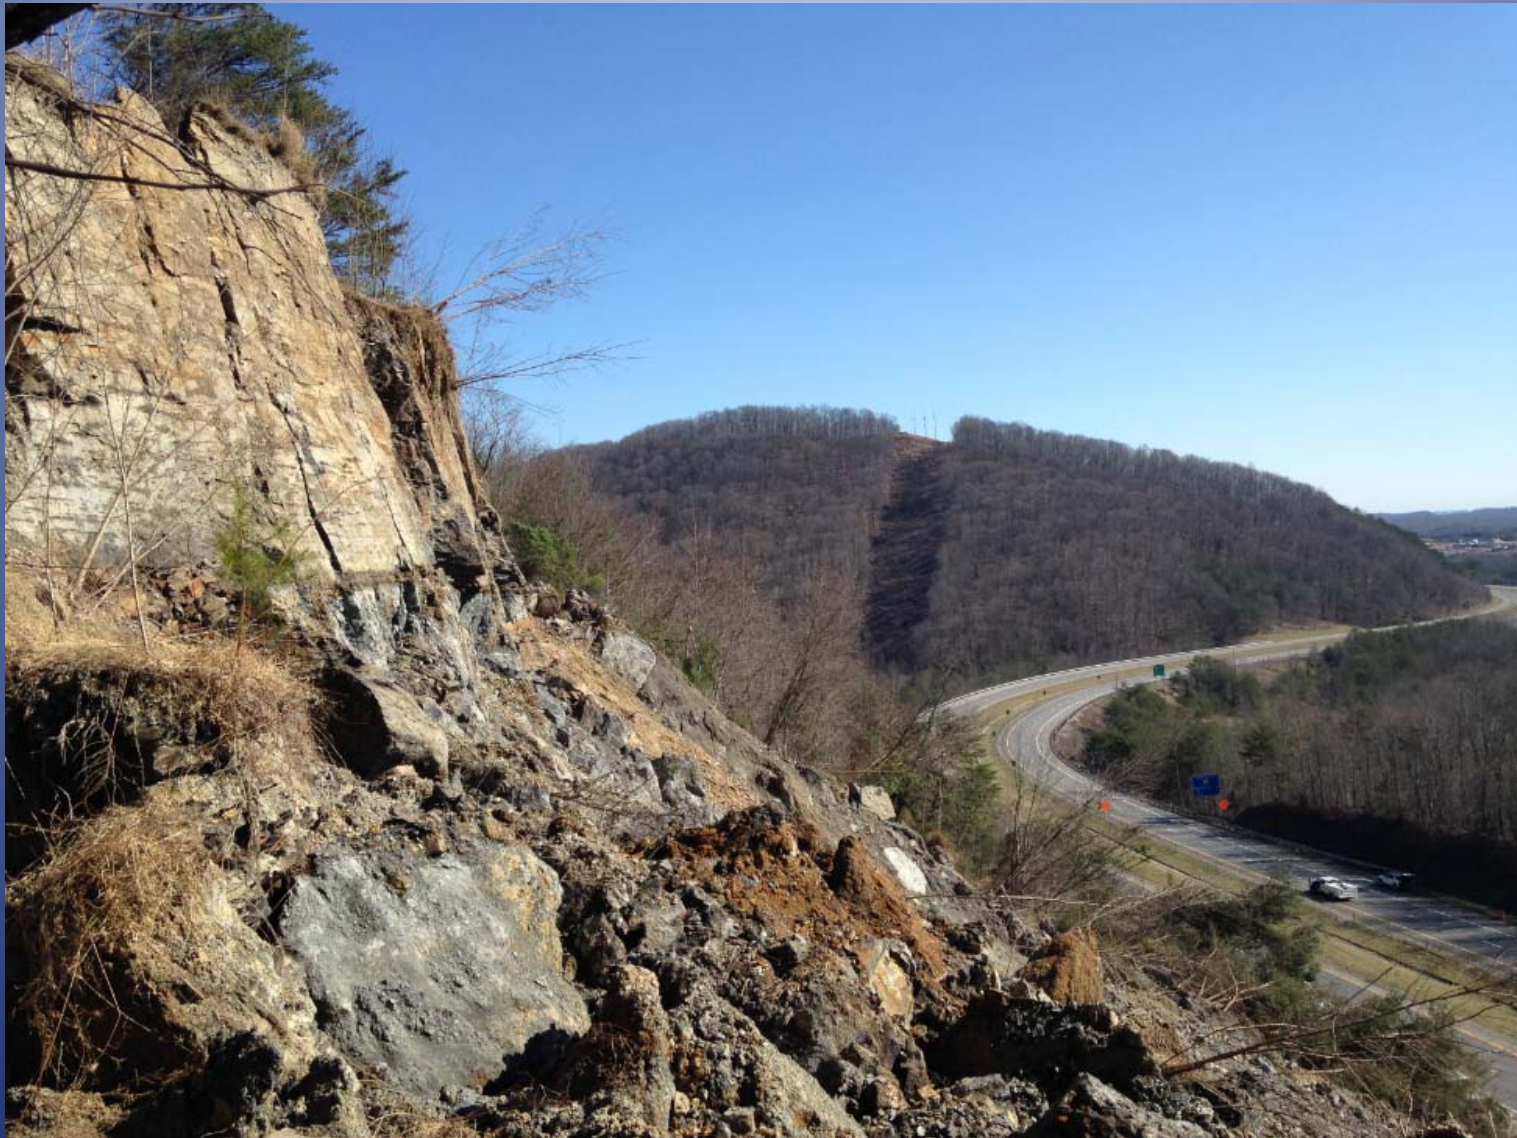
Toe of sliding block looking south

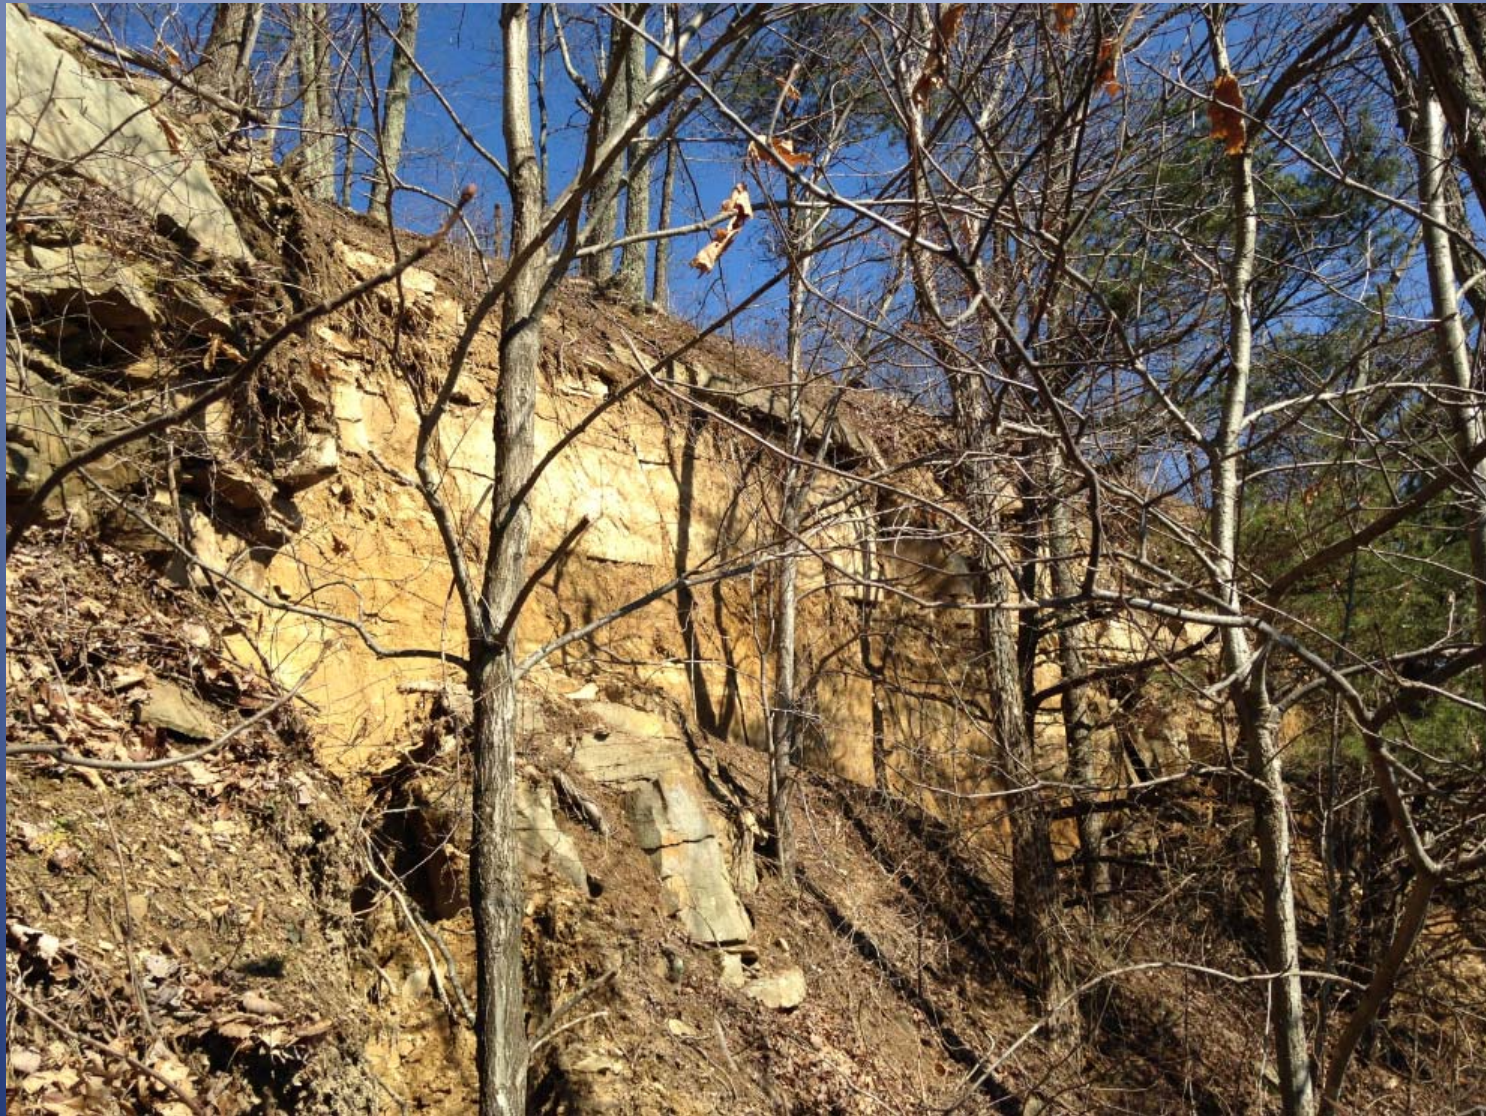
Head scarp/top of release joint/high wall

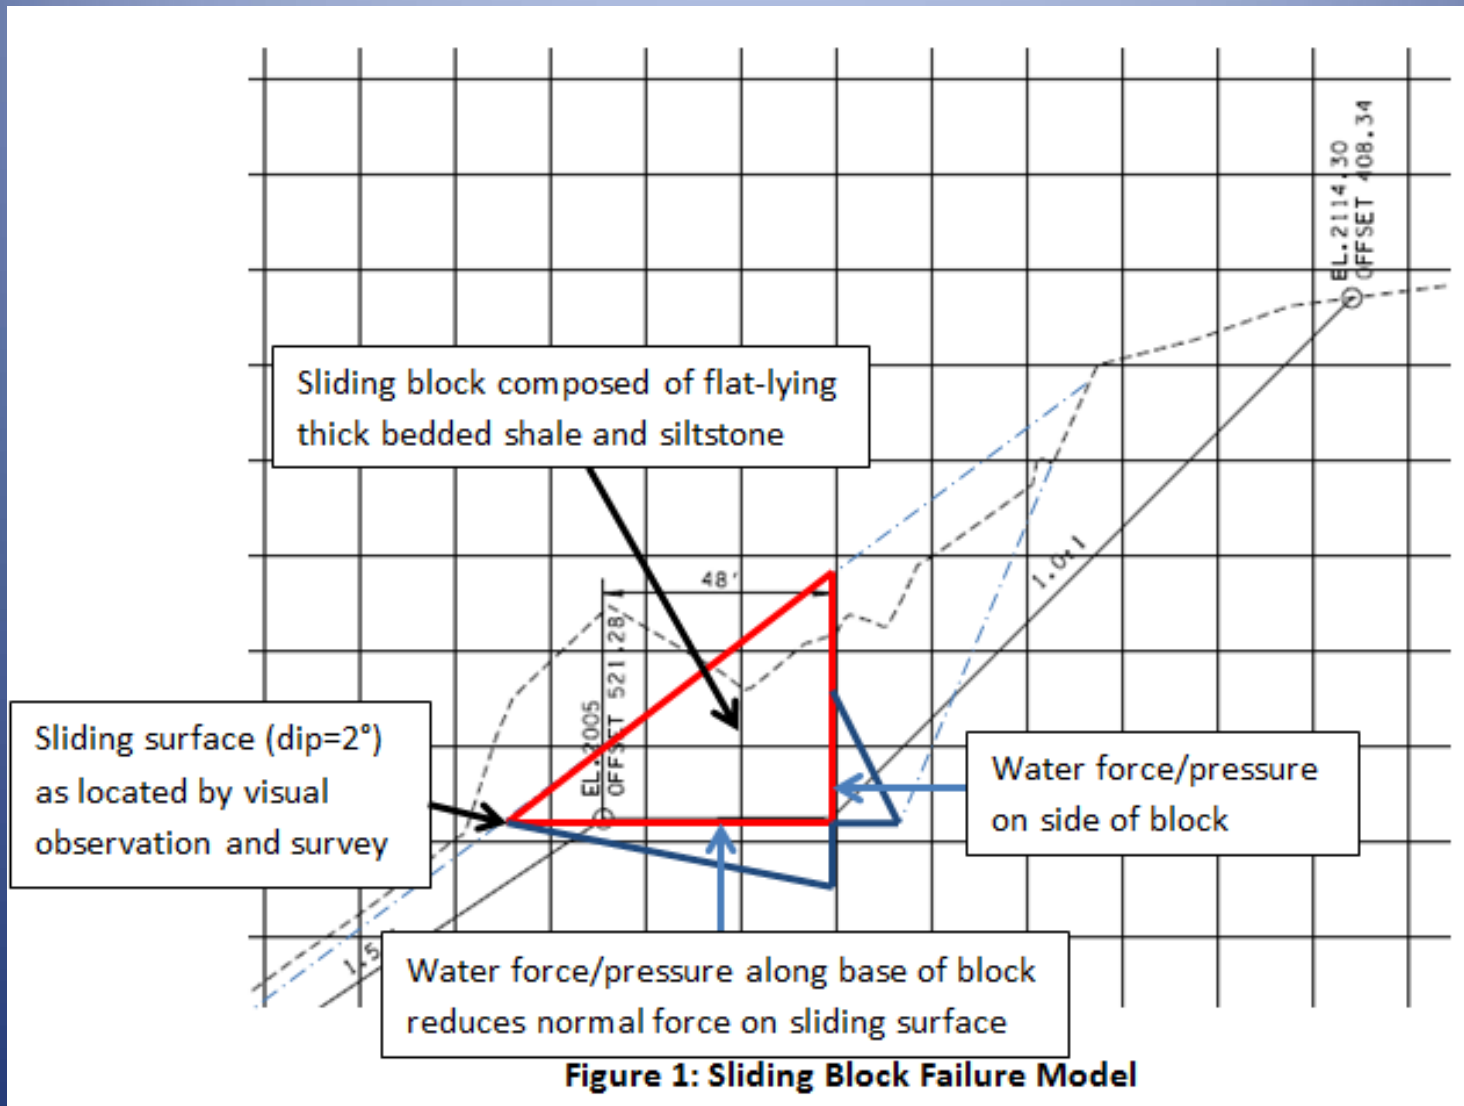
Low angle sliding block

- Large – Approximately 90 feet thick/high along near-vertical release joint
- Near horizontal bedding, dipping toward roadway at 5 degrees or less
- Very low shear strength failure surface; coal seam or highly weathered clay shale
- Water assumed in vertical joint, pressure in joint and along base at time of failure unknown
- Well-defined sliding surface, shear strength of surface to be back-calculated

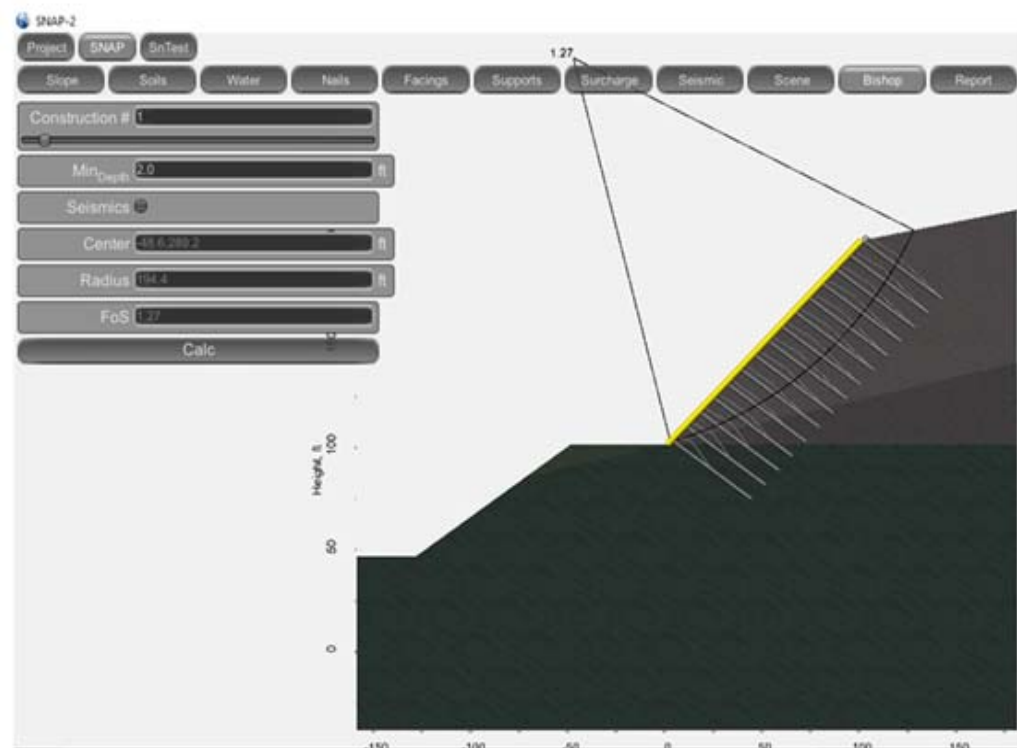
Modified Bishop Global Stability – Location of lowest FOS surface

It should be noted that decreasing the nail spacing/increasing the number of nails reduced the nail head force calculation but did not increase the Global FOS.

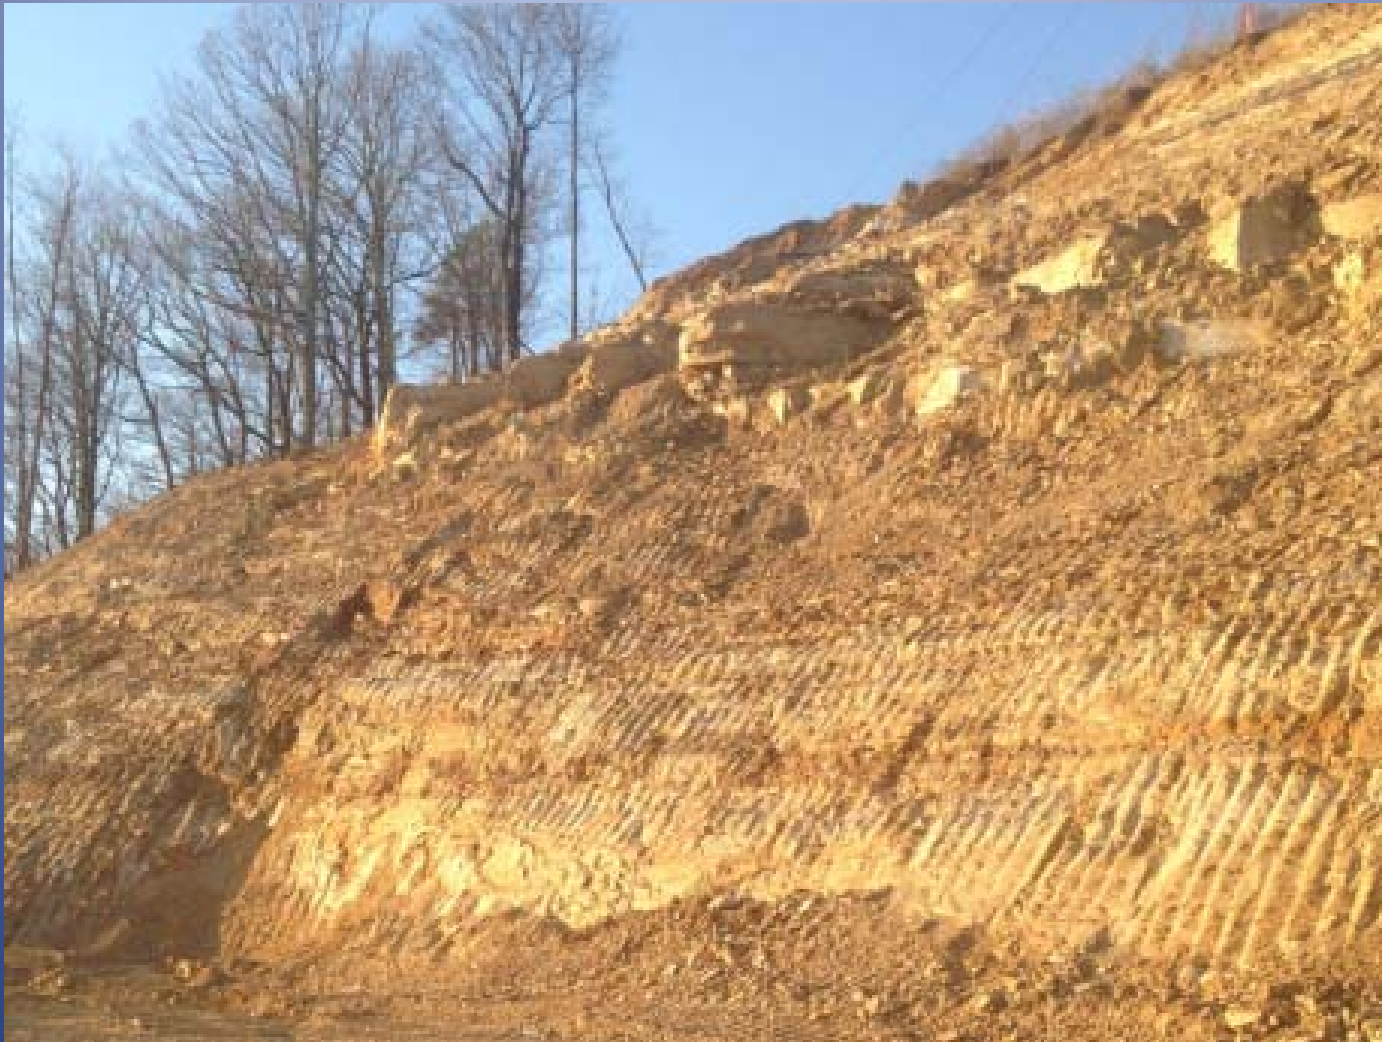
March 15, 2016, release joint exposed/intercepted

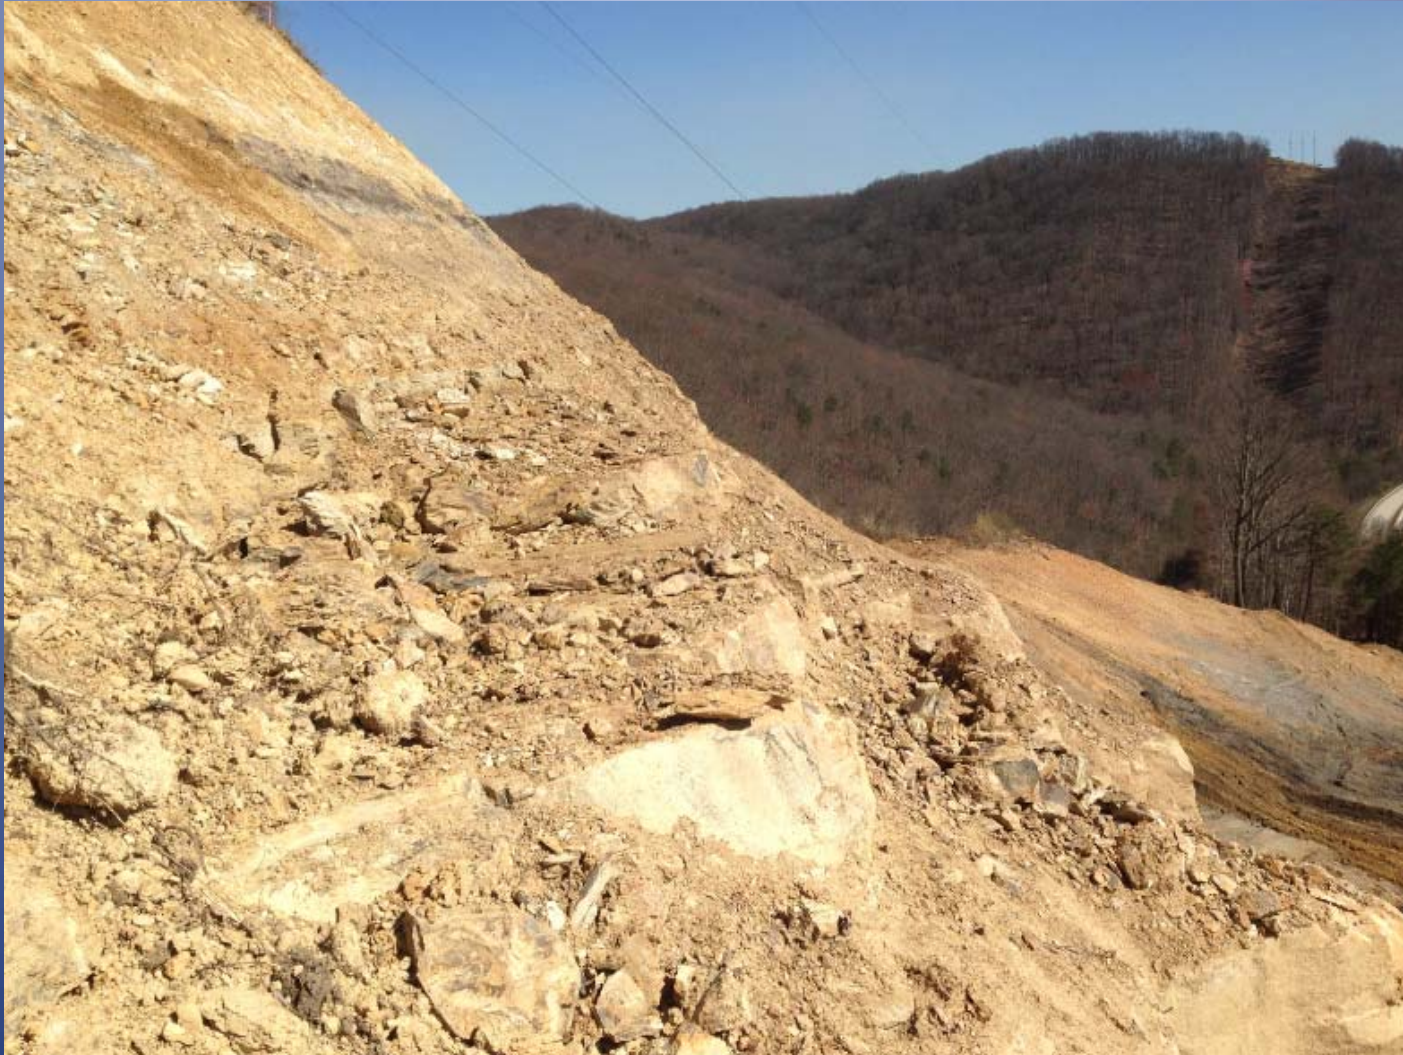
Sandstone layers near top of slope, note dip of strata
