# Emergency Response to Rockfall on Tennessee's Interstate 75

Presentation By: J. Reid Bailey, PE  
GeoStabilization International  
[reid@gsi.us](mailto:reid@gsi.us)

# I-75 MP 142.5 prior to February 26, 2016

# Failure onto I-75

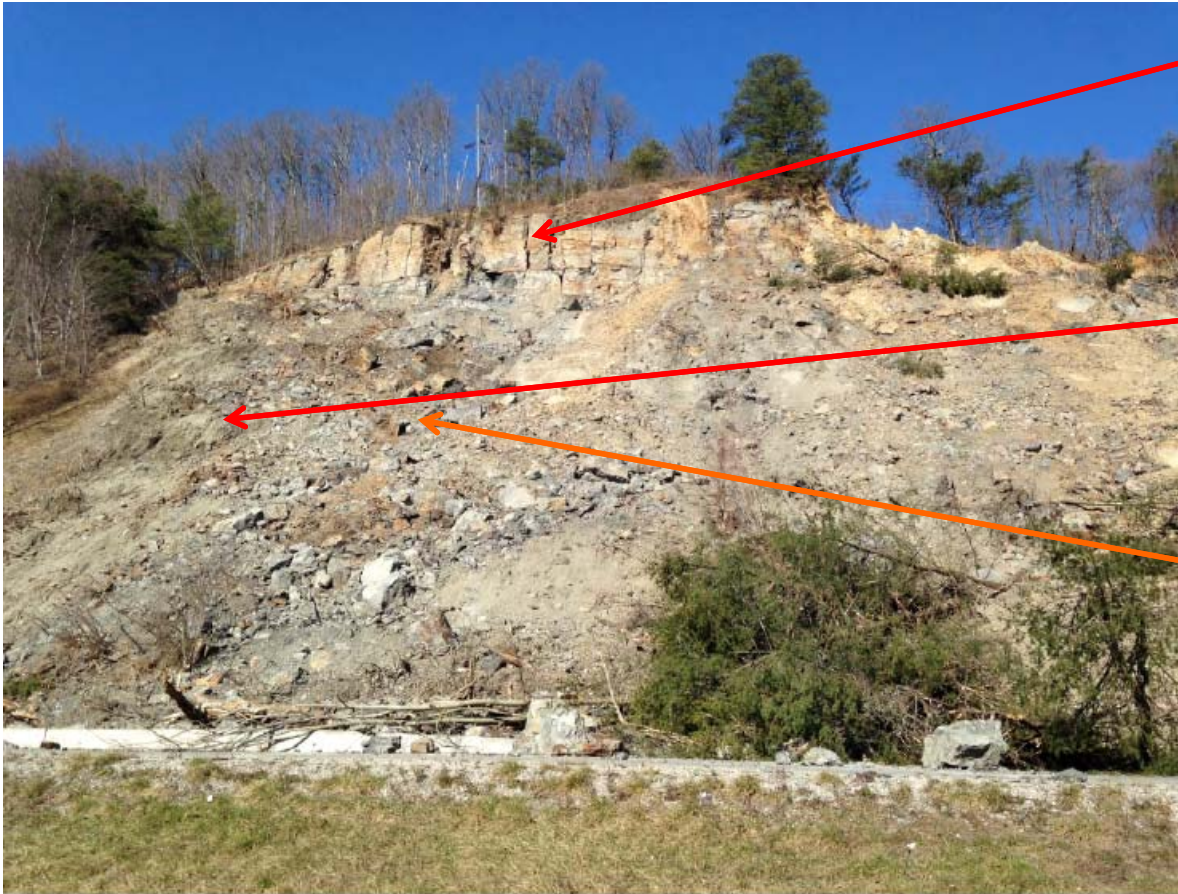
# I-75 Failure

Vertical Fractures  
(Related to Valley Stress  
Relief Joints)

Seep Zones

Weak Zones such as a  
claystone or underclay

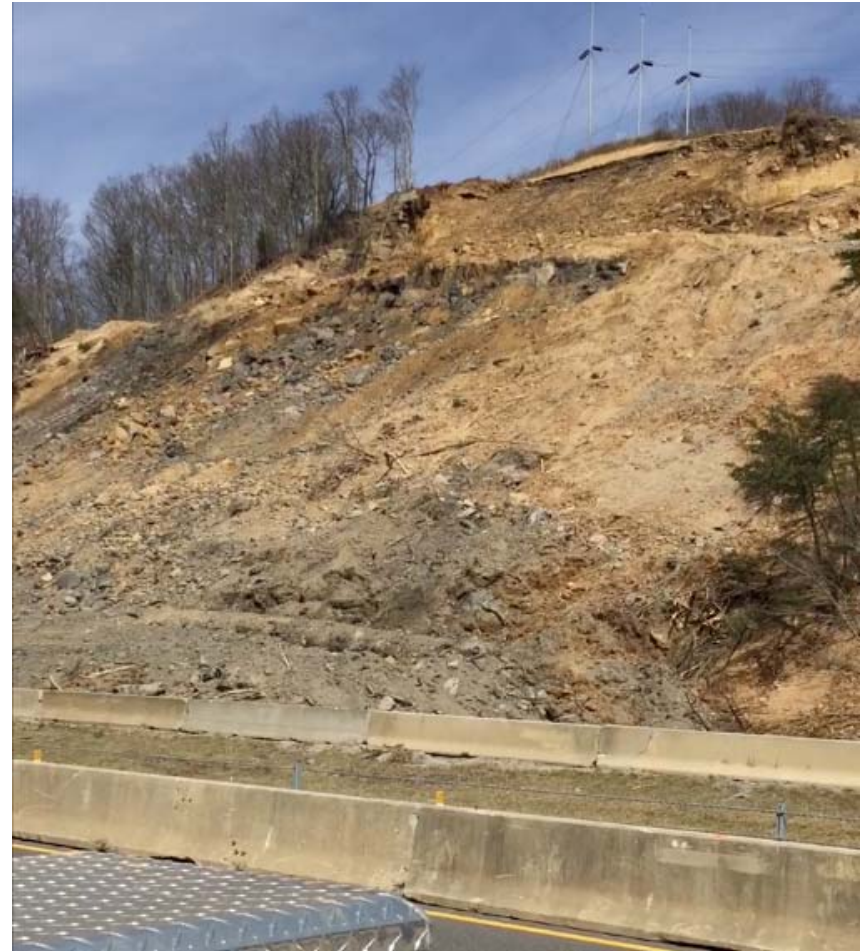
# Results of Blasting

- Top section 1H: 1V slope developed
- Rocks falling only onto Northbound Lanes
- Safe to open Southbound lanes to traffic in less than 1 week

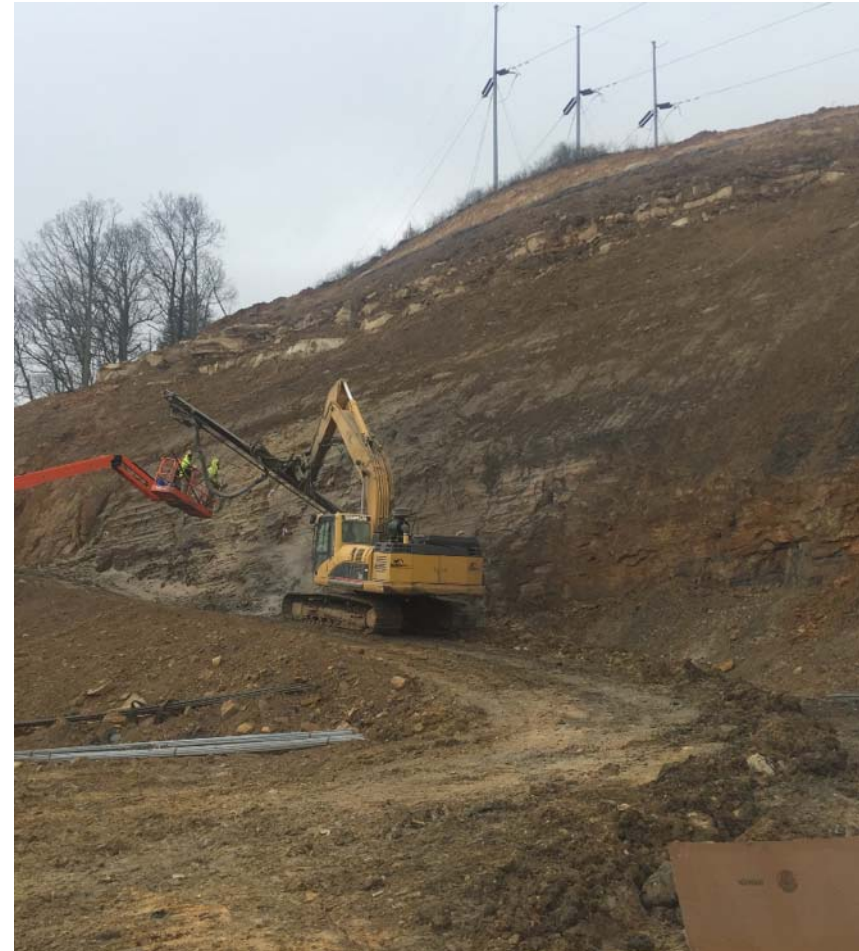
# Excavation of Failed material after blasting

- During excavation vertical structure noticed in middle of slope
- All failed material in front
- Can't continue 1H: 1V slope
- Valley Stress Relief Joint

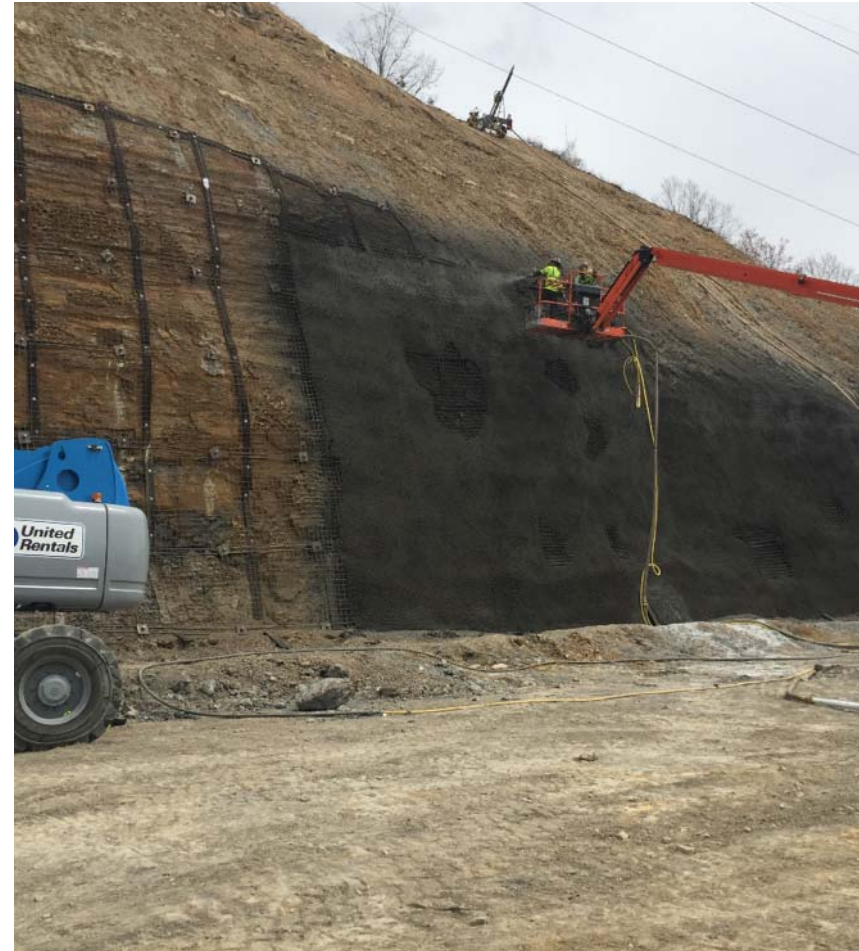
# Slope Protection

- Left with a vertical feature with a 1H:1V Slope above
- GeoBrugg Tecco G65 3mm - Pinned Mesh on 1H:1V Slope above
- Vertical Cut - Shotcrete Surface Protection – VSRJ Area
