Steeper is Cheaper, "Danger Falling Rocks!"

Geohazards Impacting Transportation in Appalachia 16th Annual Technical Forum Knoxville, Tennessee August 2016

Eric B. Rehwoldt, PE, PG Schnabel Engineering, Inc.

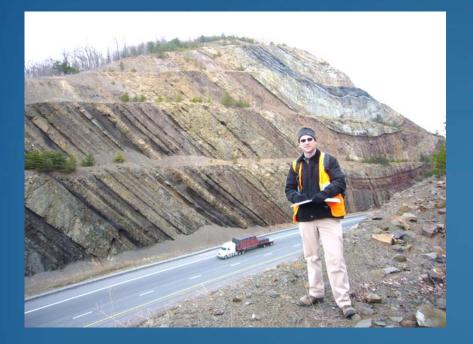
Sideling Hill, Interstate 68 Maryland

Construction in 1985

Deterioration of Benches & Rock Falls

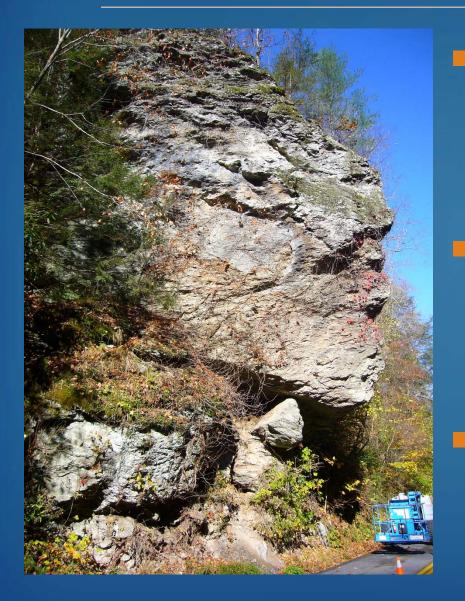
Little River Road Great Smokey Mountains, Tennessee

Response to Large Rock Fall from 'Big Rock'

Up to 7 ft. rock slabs on Little River Gorge Road During Storm

Provide Assessment and Concept Remedial Design

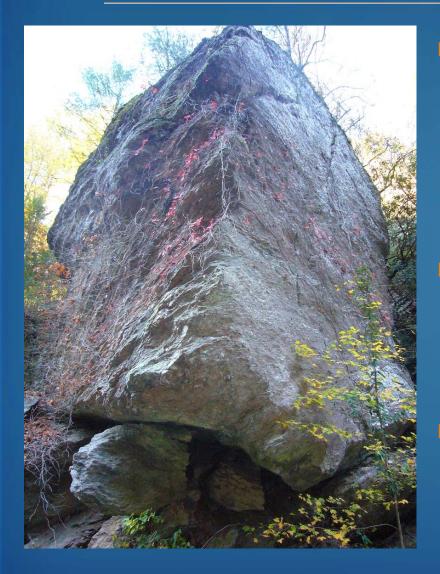
Little River Road Great Smokey Mountains, Tennessee

- Weathered and Fractured Mylonitic Phyillite with Strong Foliation
- Fault Gouge Zone at Base
- Potential Planar Sliding Along Foliation

Boulders at Base ('Key Block) 'holding up' Big Rock as Overhang 'Rotates' Toward Road

Options: 1) Remove the Iconic 'Big Rock'; or, Preserve In-Place
