Rock Slope Stability of the Smart Road Rock Cut in Blacksburg, Virginia

Robin E. Reed, PG August 16, 2017

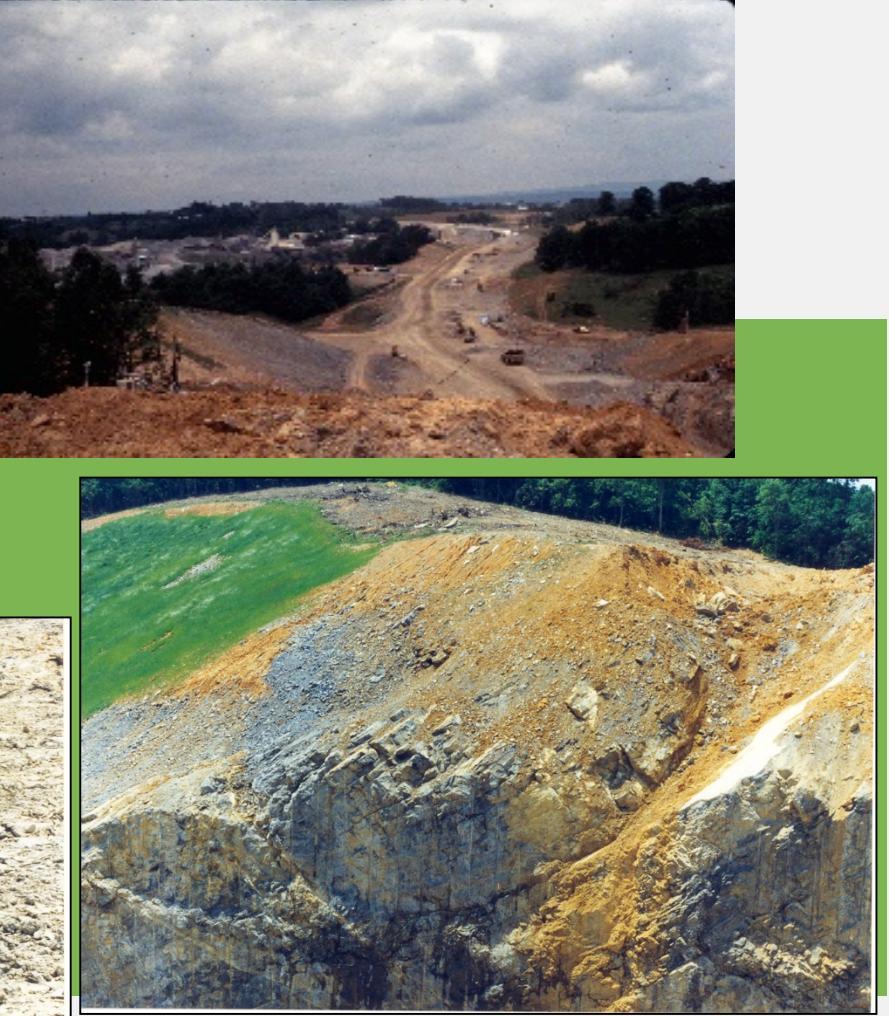
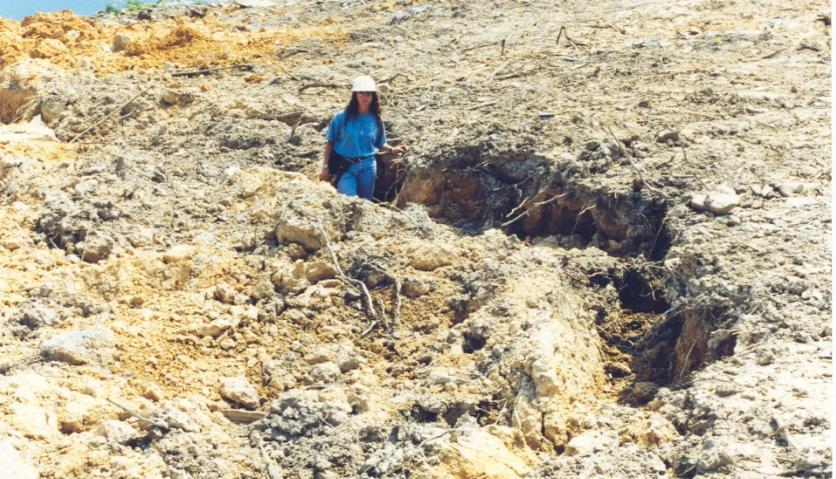
- Construction
 - June 1998
 - Rock Slides
 - Oozing
 - Rock Falls
 - Delays, stop work

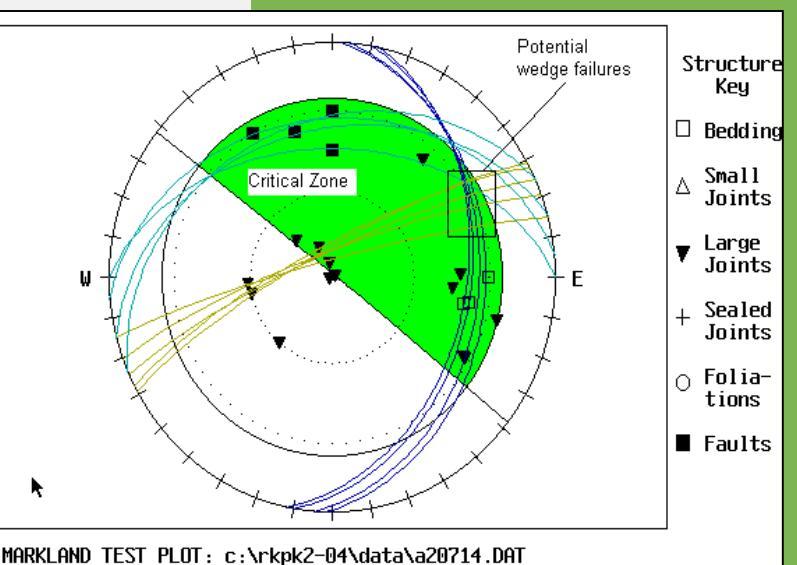
- Kinematics
 - Geometry
 - Potential for motion only
 - Mass and force not considered
 - Stereonets
- Discontinuities
 - Plot as clusters
 - Limiting equilibrium analysis
 - Friction Angle
 - Daylight

MARKLAND TEST PLOT: c:\rkpk2-04\data\a20714.DAT Friction Angle = 25 degrees Slope dip direction = 38 degrees, Dip = 90 degrees Number of Stations = 21

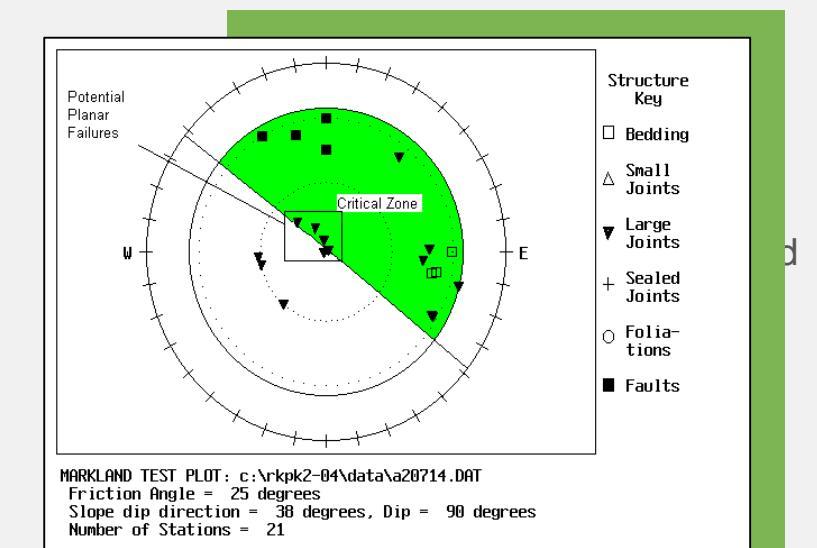
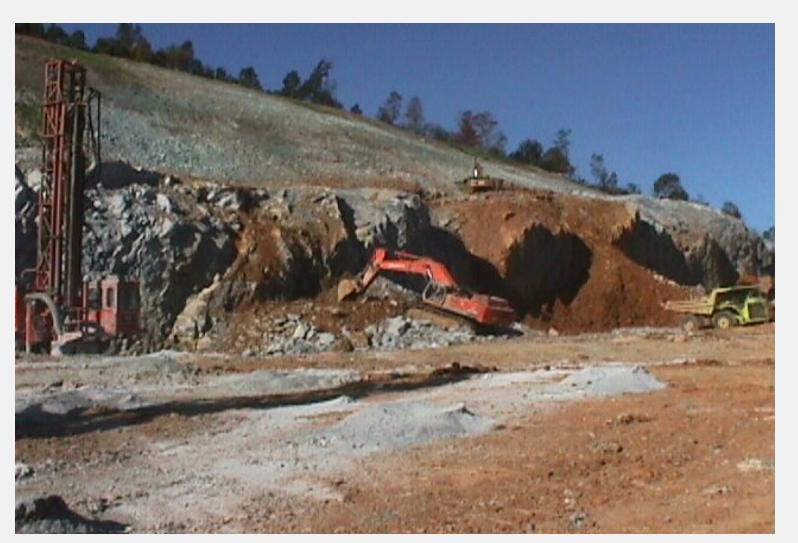
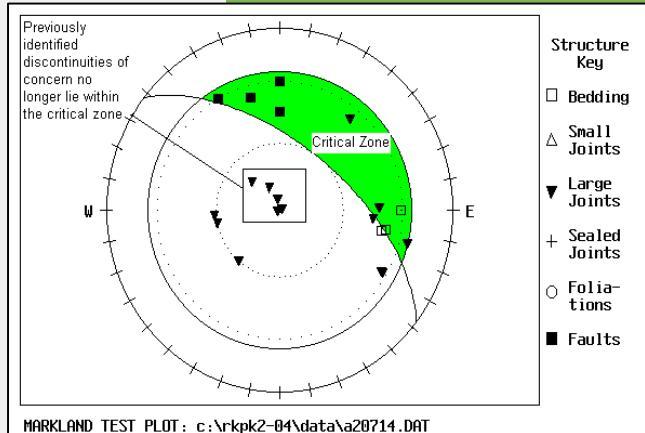
- 90 Degree Slope
 - Planar Failures
 - Large, steeply dipping joints
- 60 Degree Slope
 - Planar failures
 - Significantly reduced

HARKLAND ICST FLOT: C:STRPRZ=04A0a1a3a20714.DHT Friction Angle = 25 degrees Slope dip direction = 38 degrees, Dip = 60 degrees Number of Stations = 21

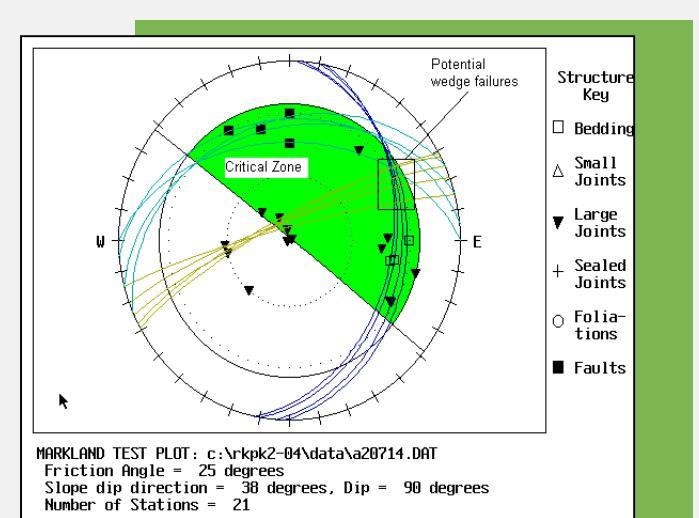
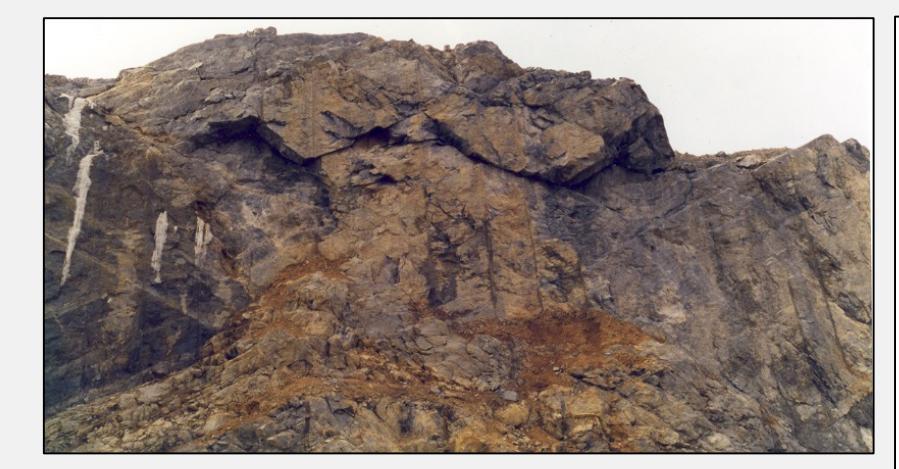
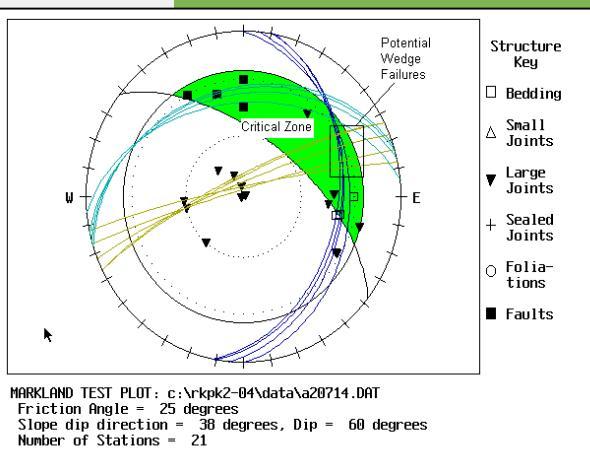
- 90 Degree Slope
 - Wedge Failures
 - Bedding
 - Large Joints
- 60 Degree Slope
 - Wedge Failures not eliminated

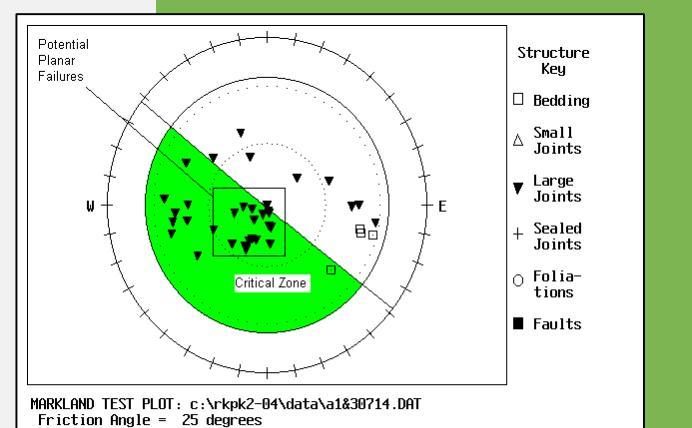
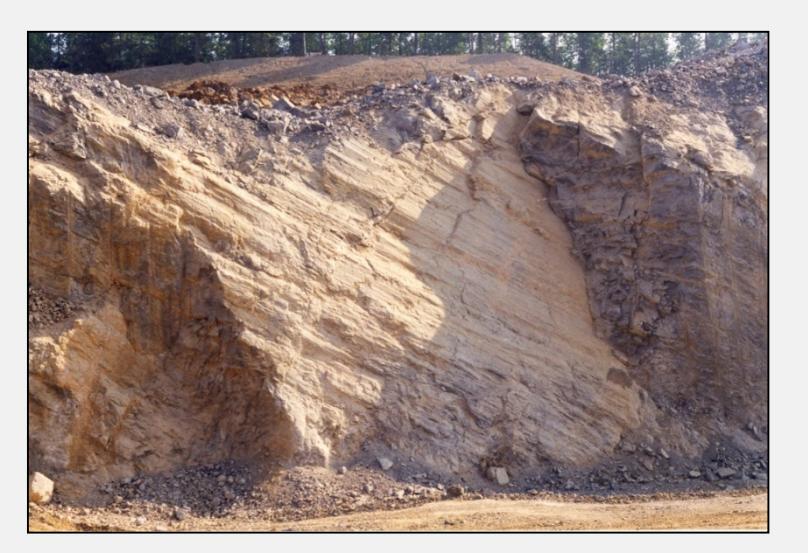
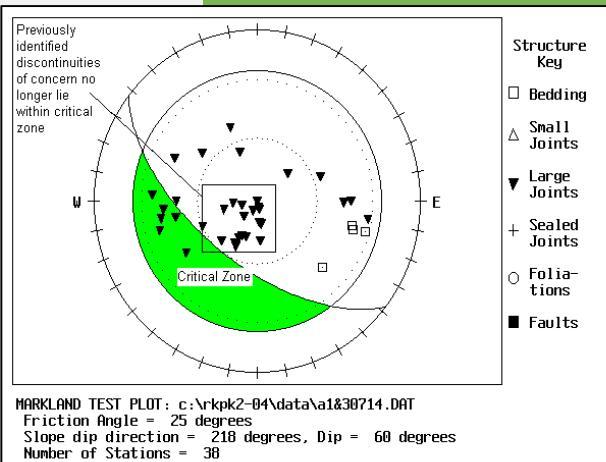
- 90 Degree Slope
 - Planar Failures
 - Large, steeply dipping joints
- 60 Degree Slope
 - Significantly reduced

Friction Angle = 25 degrees Slope dip direction = 218 degrees, Dip = 90 degrees Number of Stations = 38

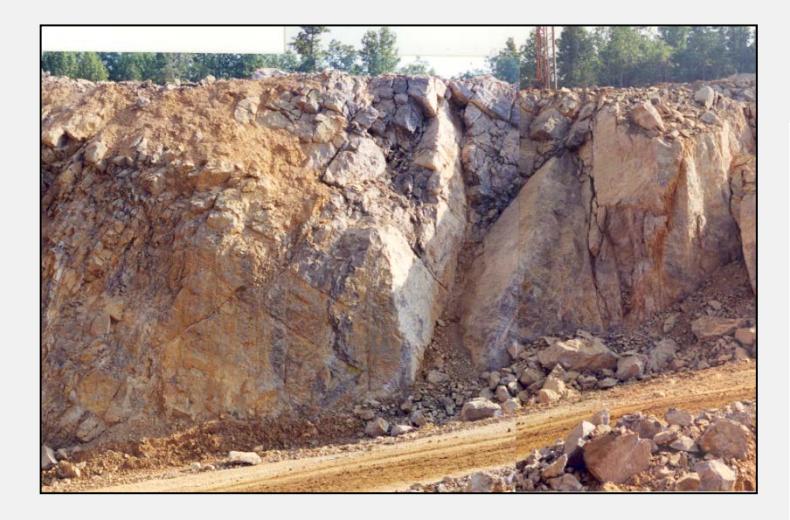
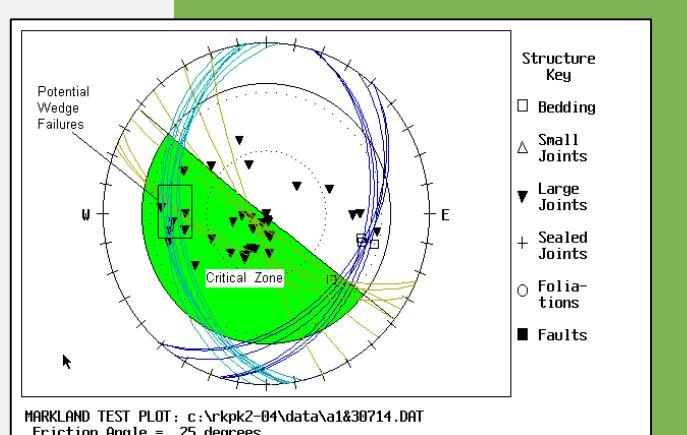
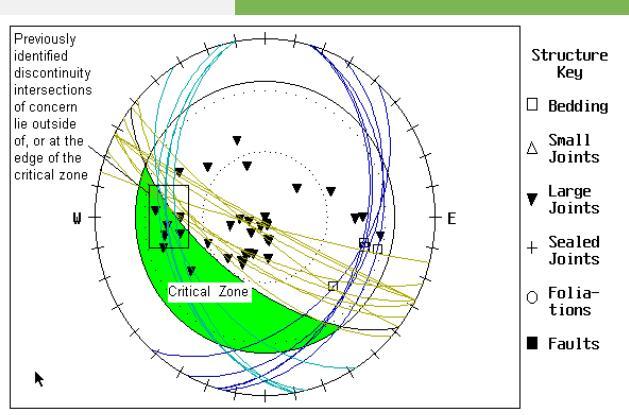
- 90 Degree Slope
 - Planar Failures
 - Large, steeply dipping joints
- 60 Degree Slope
 - Slightly reduced potential

MARKLAND TEST PLOT: c:\rkpk2-04\data\a1&30714.DAT Friction Angle = 25 degrees Slope dip direction = 218 degrees, Dip = 60 degrees Number of Stations = 38

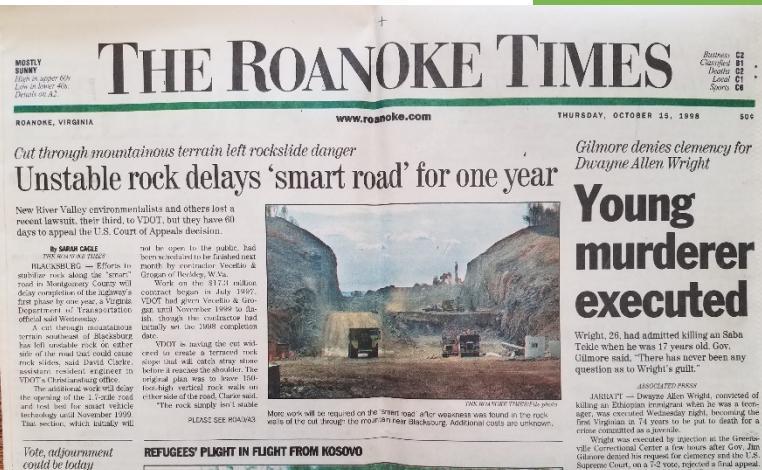
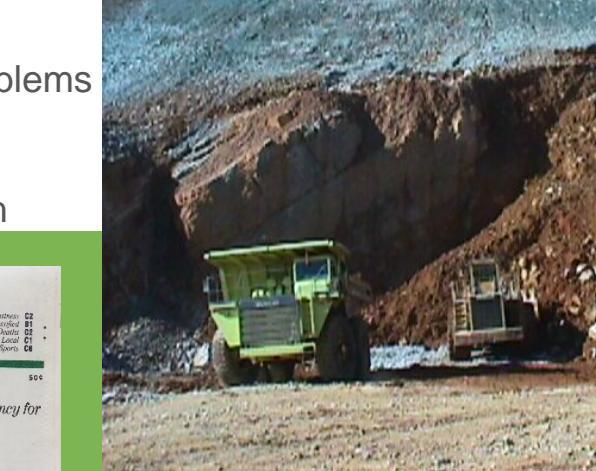
- ID problem areas
 - Safety Factor Calculations
 - Some as low as .86/1.3
- One third of planned depth
 - Significant potential for continued problems
- October 1998
 - Delayed for redesign and construction

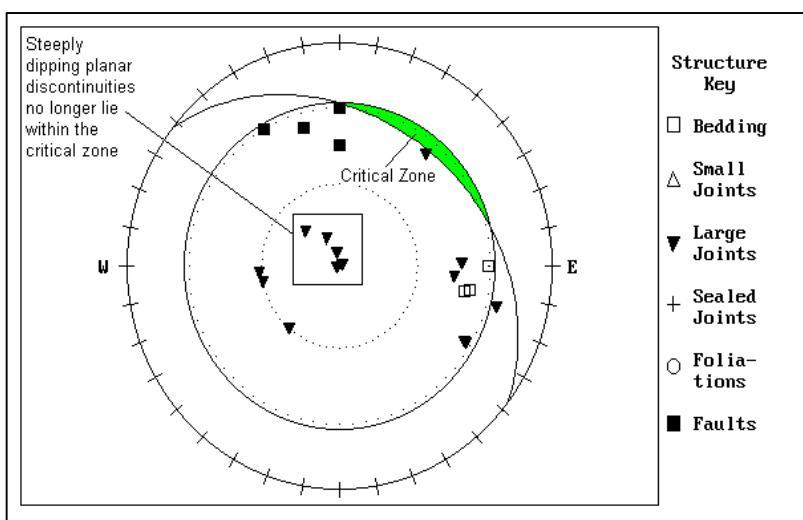
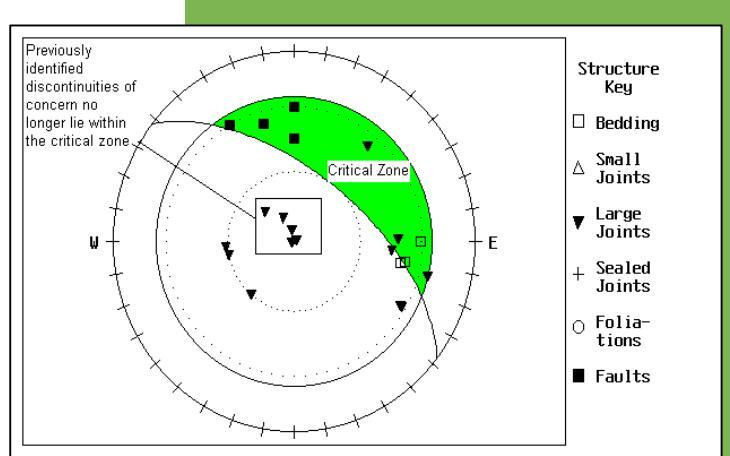
- 34 degree Slope
 - Planar virtually eliminated

MARKLAND TEST PLOT: c:\rkpk2-04\data\a20714.DAT Friction Angle = 28 degrees Slope dip direction = 38 degrees, Dip = 34 degrees Number of Stations = 21

MARKLAND TEST PLOT: c:\rkpk2-04\data\a20714.DAT Friction Angle = 25 degrees Slope dip direction = 38 degrees, Dip = 60 degrees Number of Stations = 21

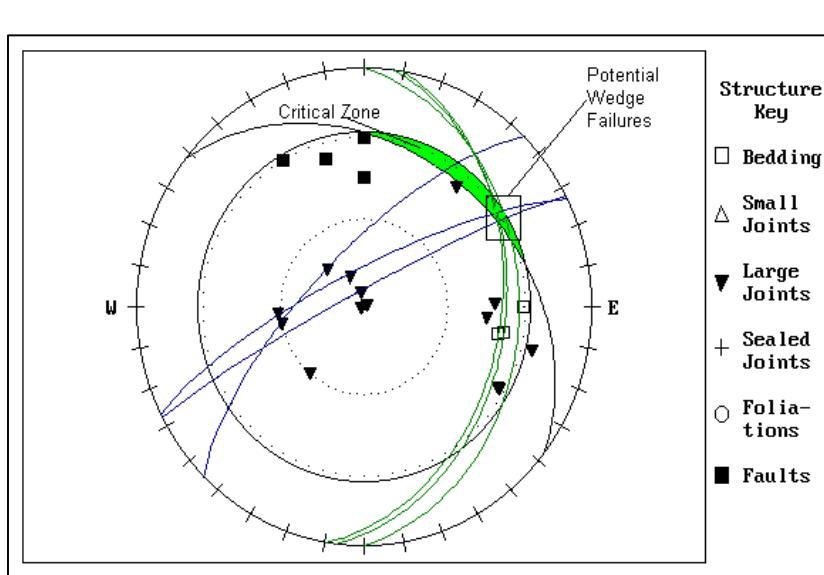
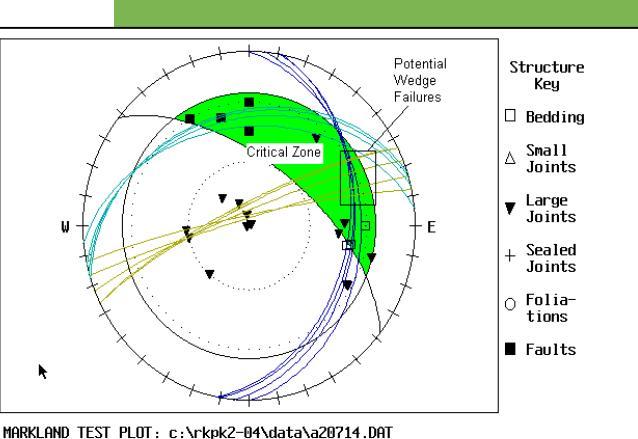
34 Degree SlopePesky wedgies

MARKLAND TEST PLOT: c:\rkpk2-04\data\a20714.DAT Friction Angle = 28 degrees Slope dip direction = 38 degrees, Dip = 34 degrees Number of Stations = 21

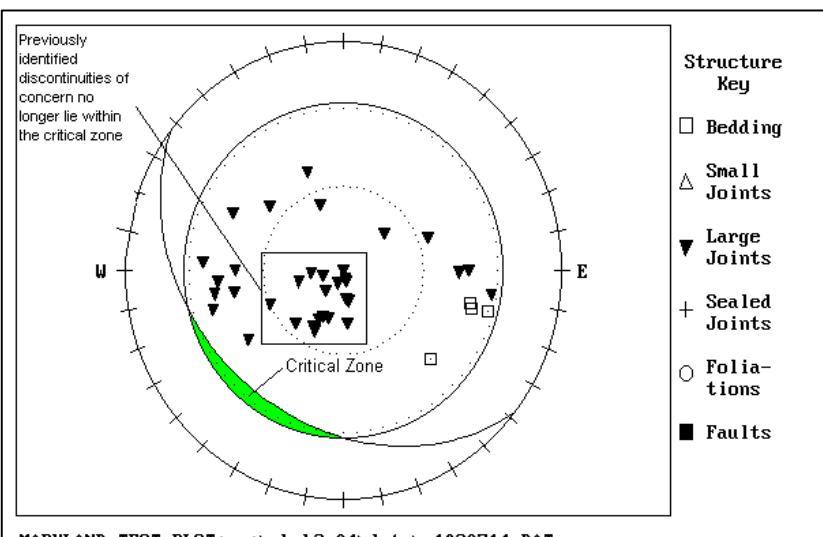
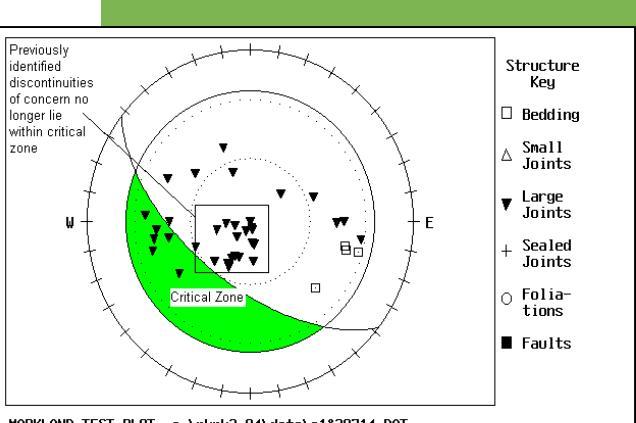
- 34 Degree Slope
 - Planar Failures
 - Virtually eliminated

MARKLAND TEST PLOT: c:\rkpk2-04\data\a1&30714.DAT Friction Angle = 28 degrees Slope dip direction = 218 degrees, Dip = 34 degrees Number of Stations = 38

MARKLAND TEST PLOT: c:\rkpk2-04\data\a1&30714.DAT Friction Angle = 25 degrees Slope dip direction = 218 degrees, Dip = 60 degrees Number of Stations = 38

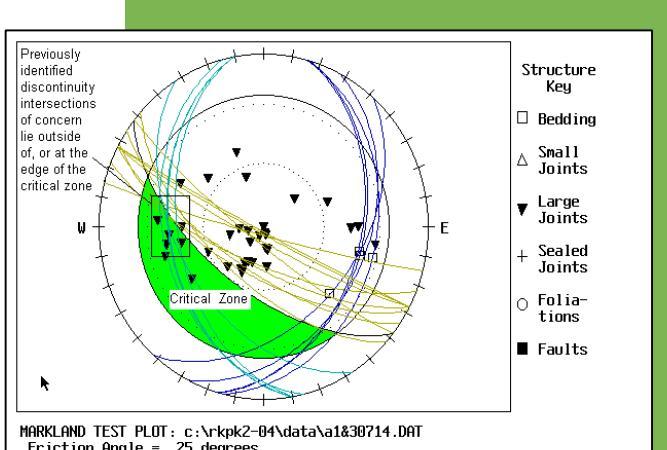
Virtually eliminated Previously Structure identified Key discontinuity intersections □ Bedding no longer lie within the Small Joints critical zone Δ ▼ Large Joints E Sealed Joints 🔿 Folia-Critical Zone tions Faults

Wedge Failures

MARKLAND TEST PLOT: c:\rkpk2-04\data\a1&30714.DAT Friction Angle = 28 degrees Slope dip direction = 218 degrees, Dip = 34 degrees Number of Stations = 38

Friction Angle = 25 degrees Slope dip direction = 218 degrees, Dip = 60 degrees Number of Stations = 38
