MAN MADE GEOHAZARDS

John W. Fowler, Geotechnical Liaison, Compaction
Coordinator – WV Division of Highways, Materials
Division, 190 Dry Branch Drive, Charleston, WV 25306, 304
-558-9889, John.W.Fowler@wv.gov

- ▣ **ABSTRACT:** Numerous slope/fill failures occur every year on our highways in Appalachia. Some of these failures are caused by manmade reasons. This presentation explores some of the manmade causes of slope/fill failures and excessive movement within highway embankments. Examples of slope/fill failures within highway embankments will be presented in the following photographs.

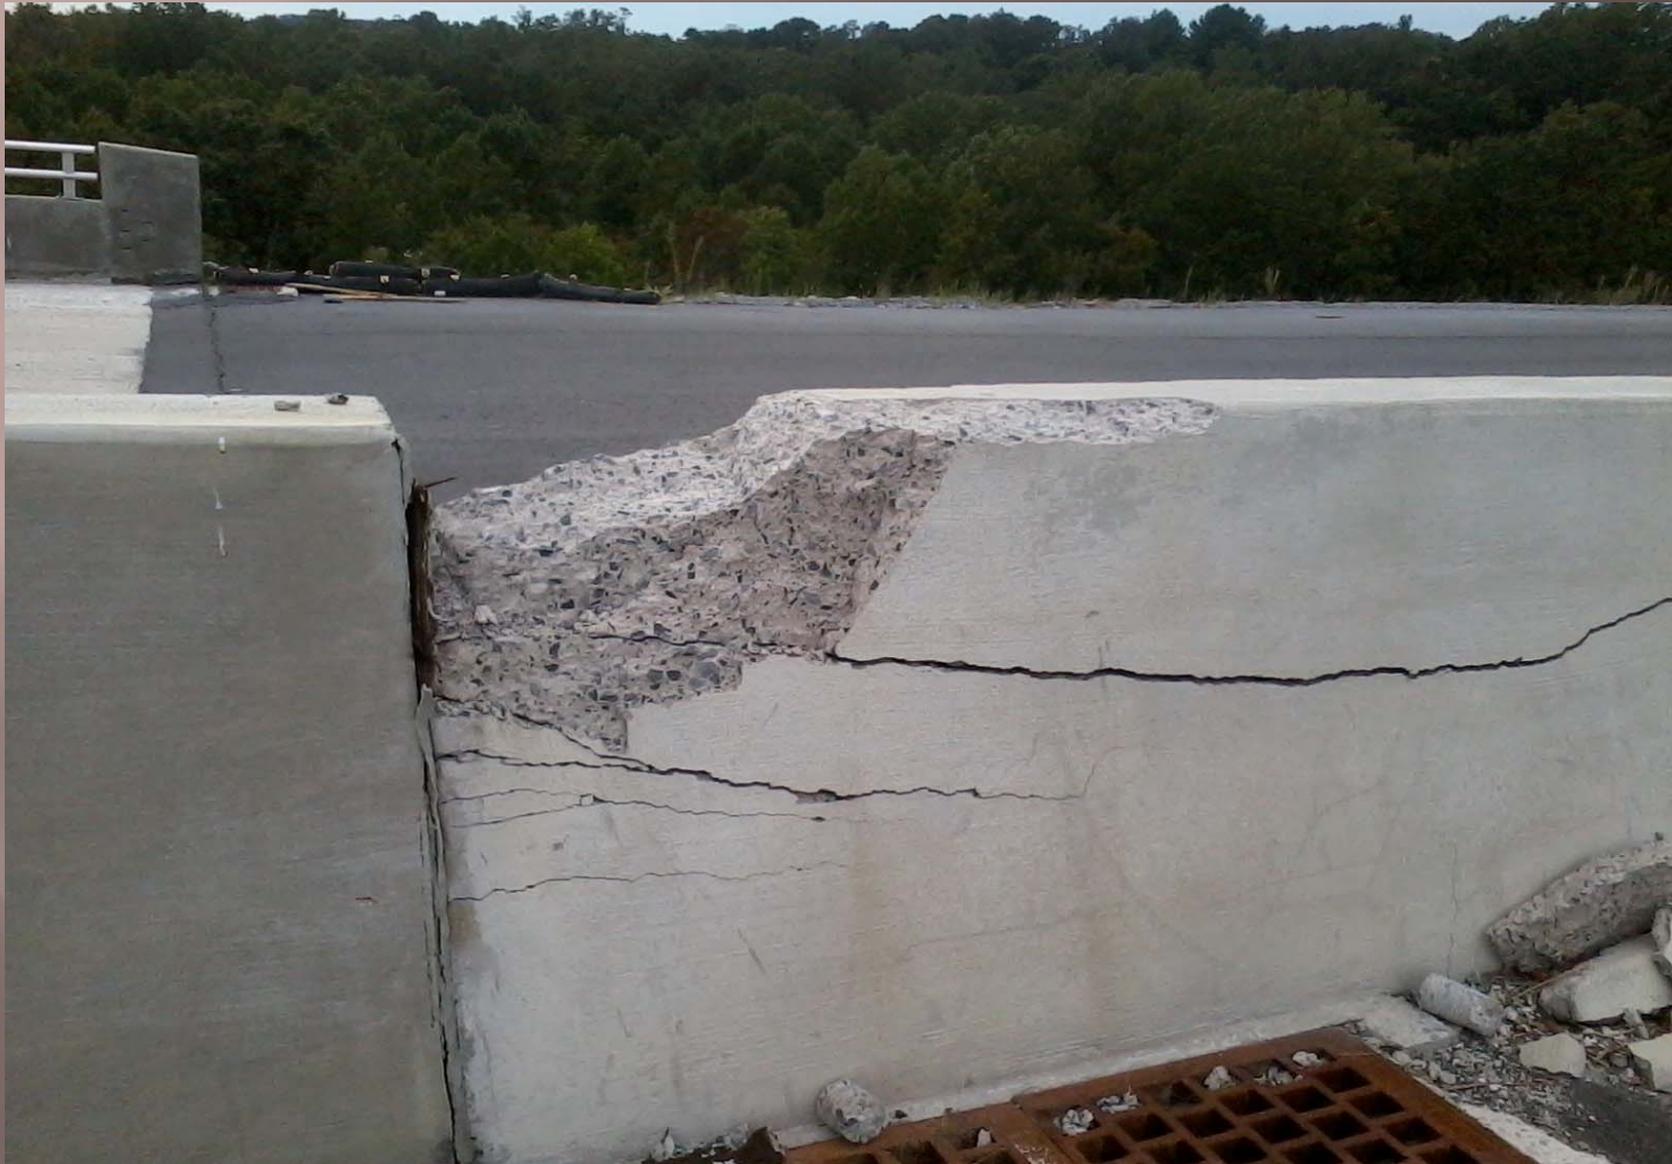
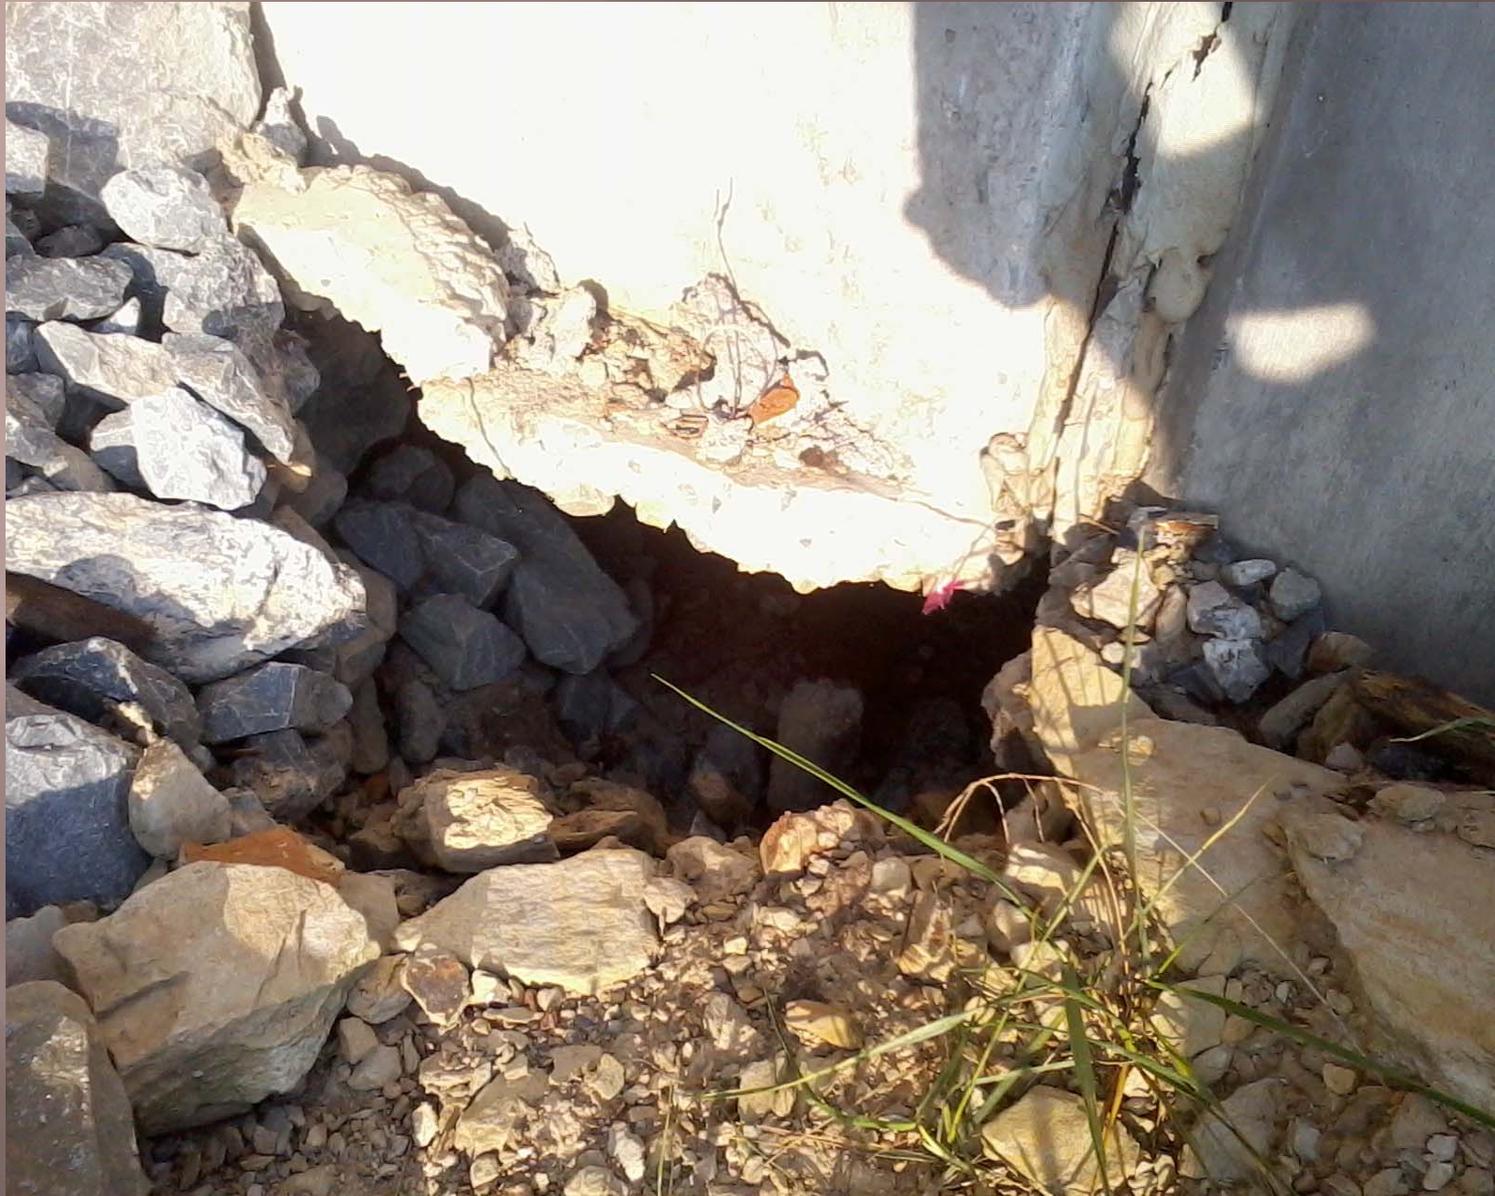
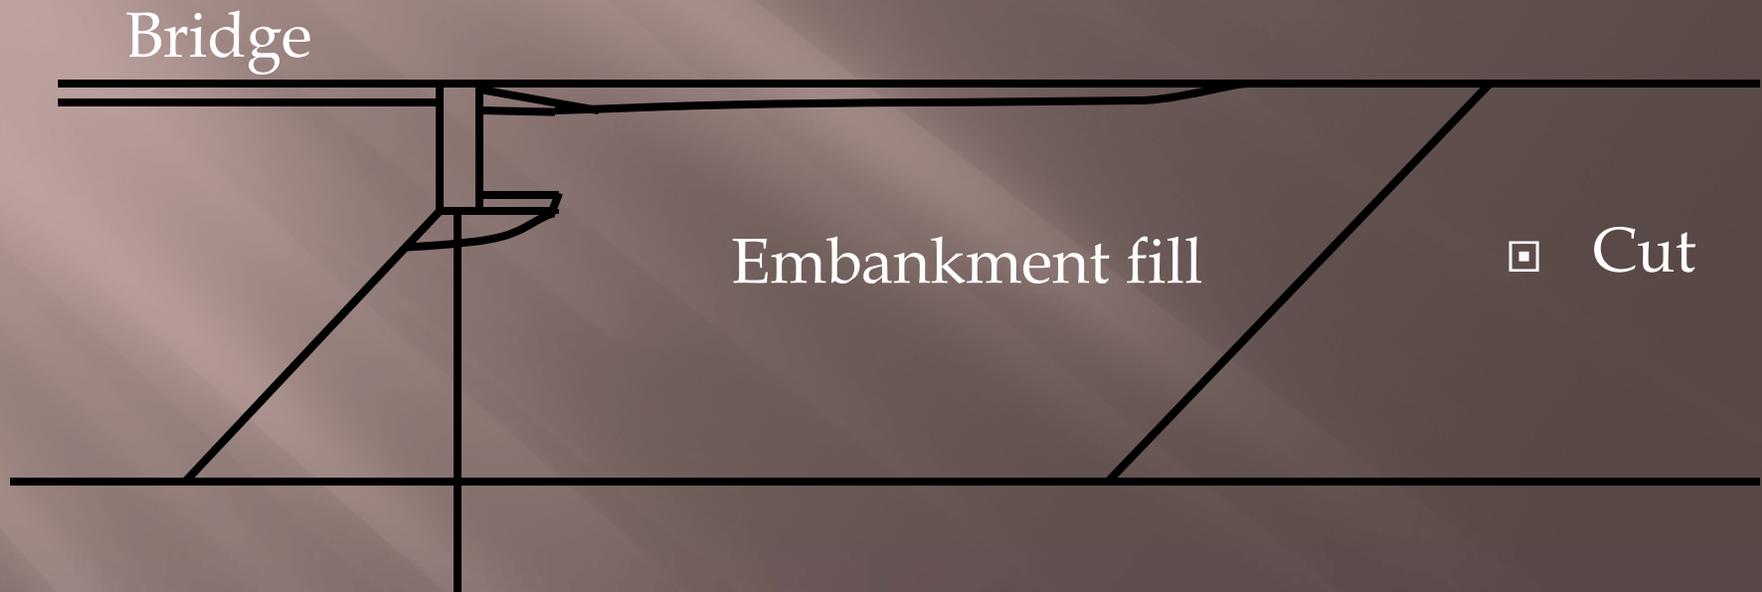
ROUTE 9 CHARLESTOWN, WV

- ▣ Conclusion: The on-site fill material was classified by project personnel as hard shale and placed in accordance with the specifications that govern durable rock fill. The on-site fill material actually consisted of soft sandy shale and should have been placed with the specifications that govern random (soil) fill.

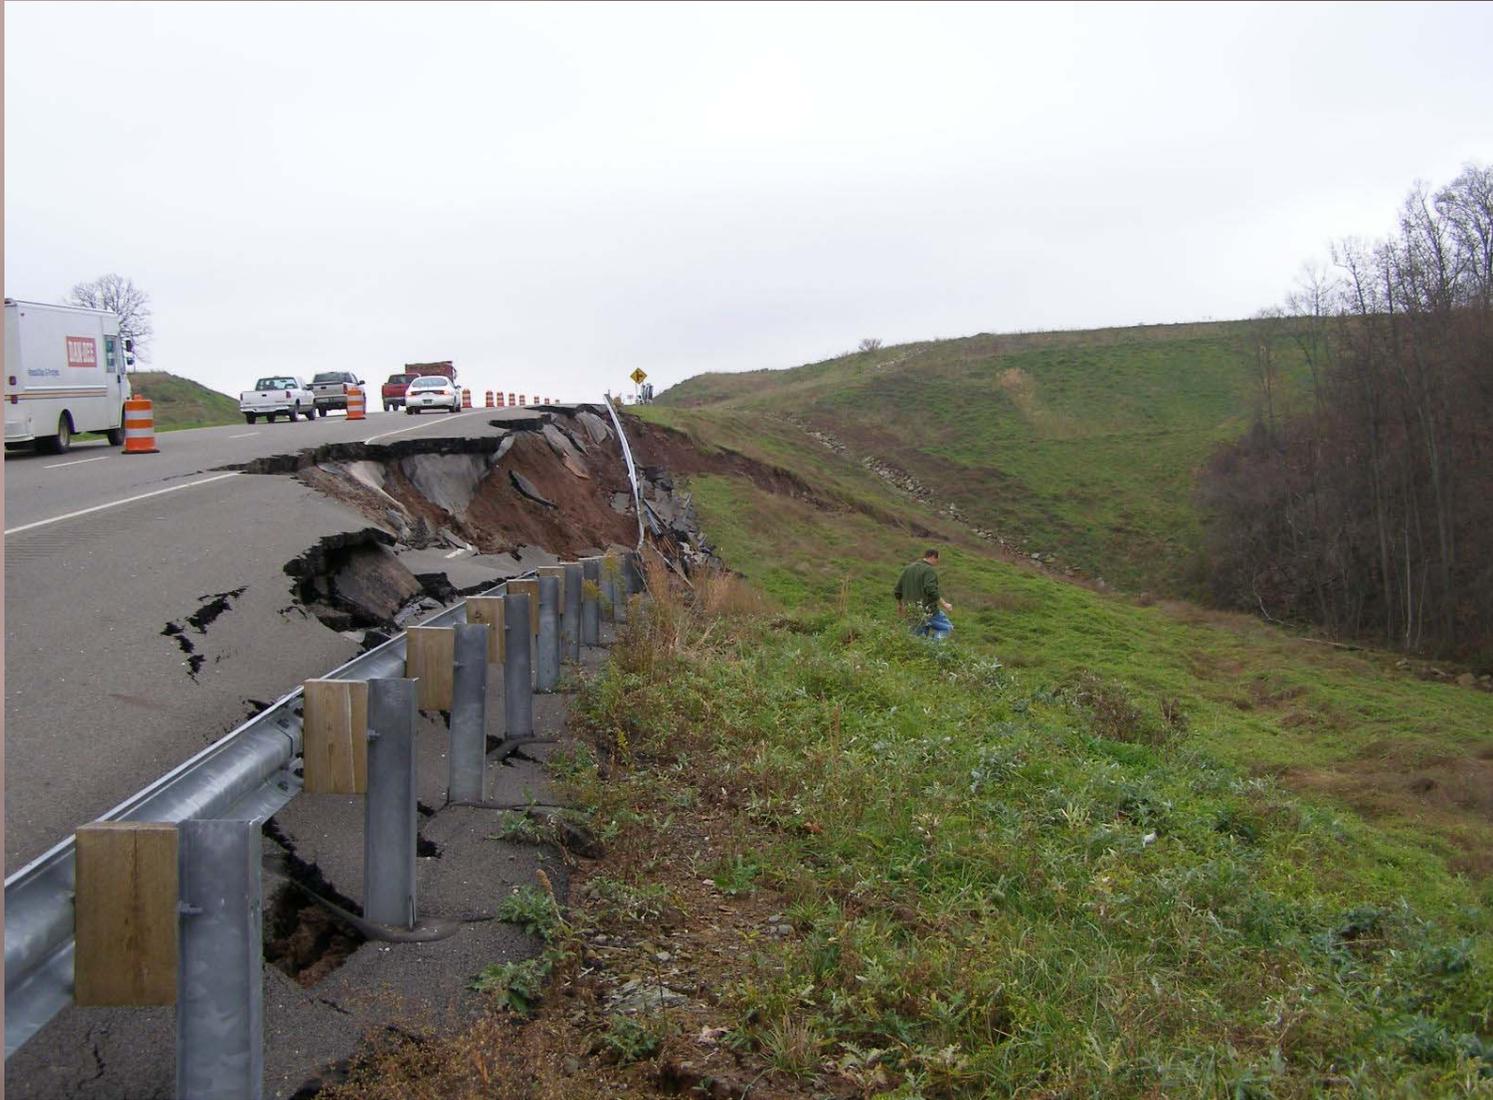
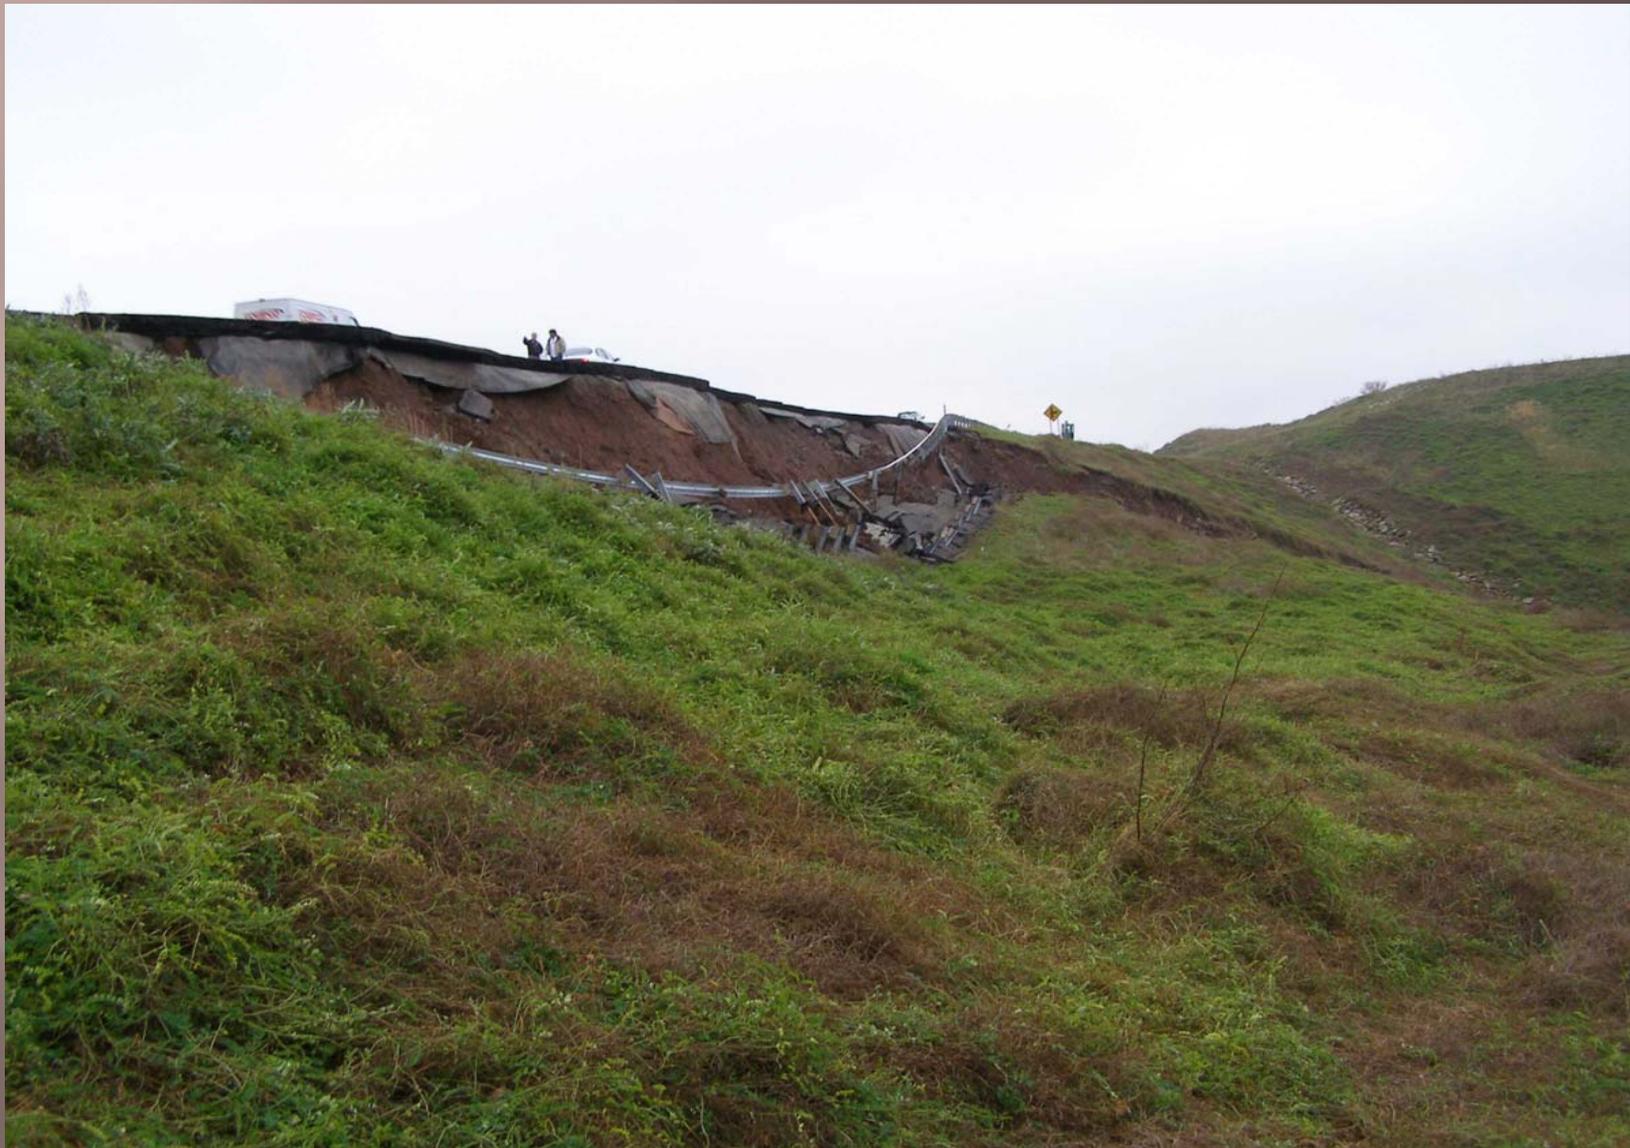
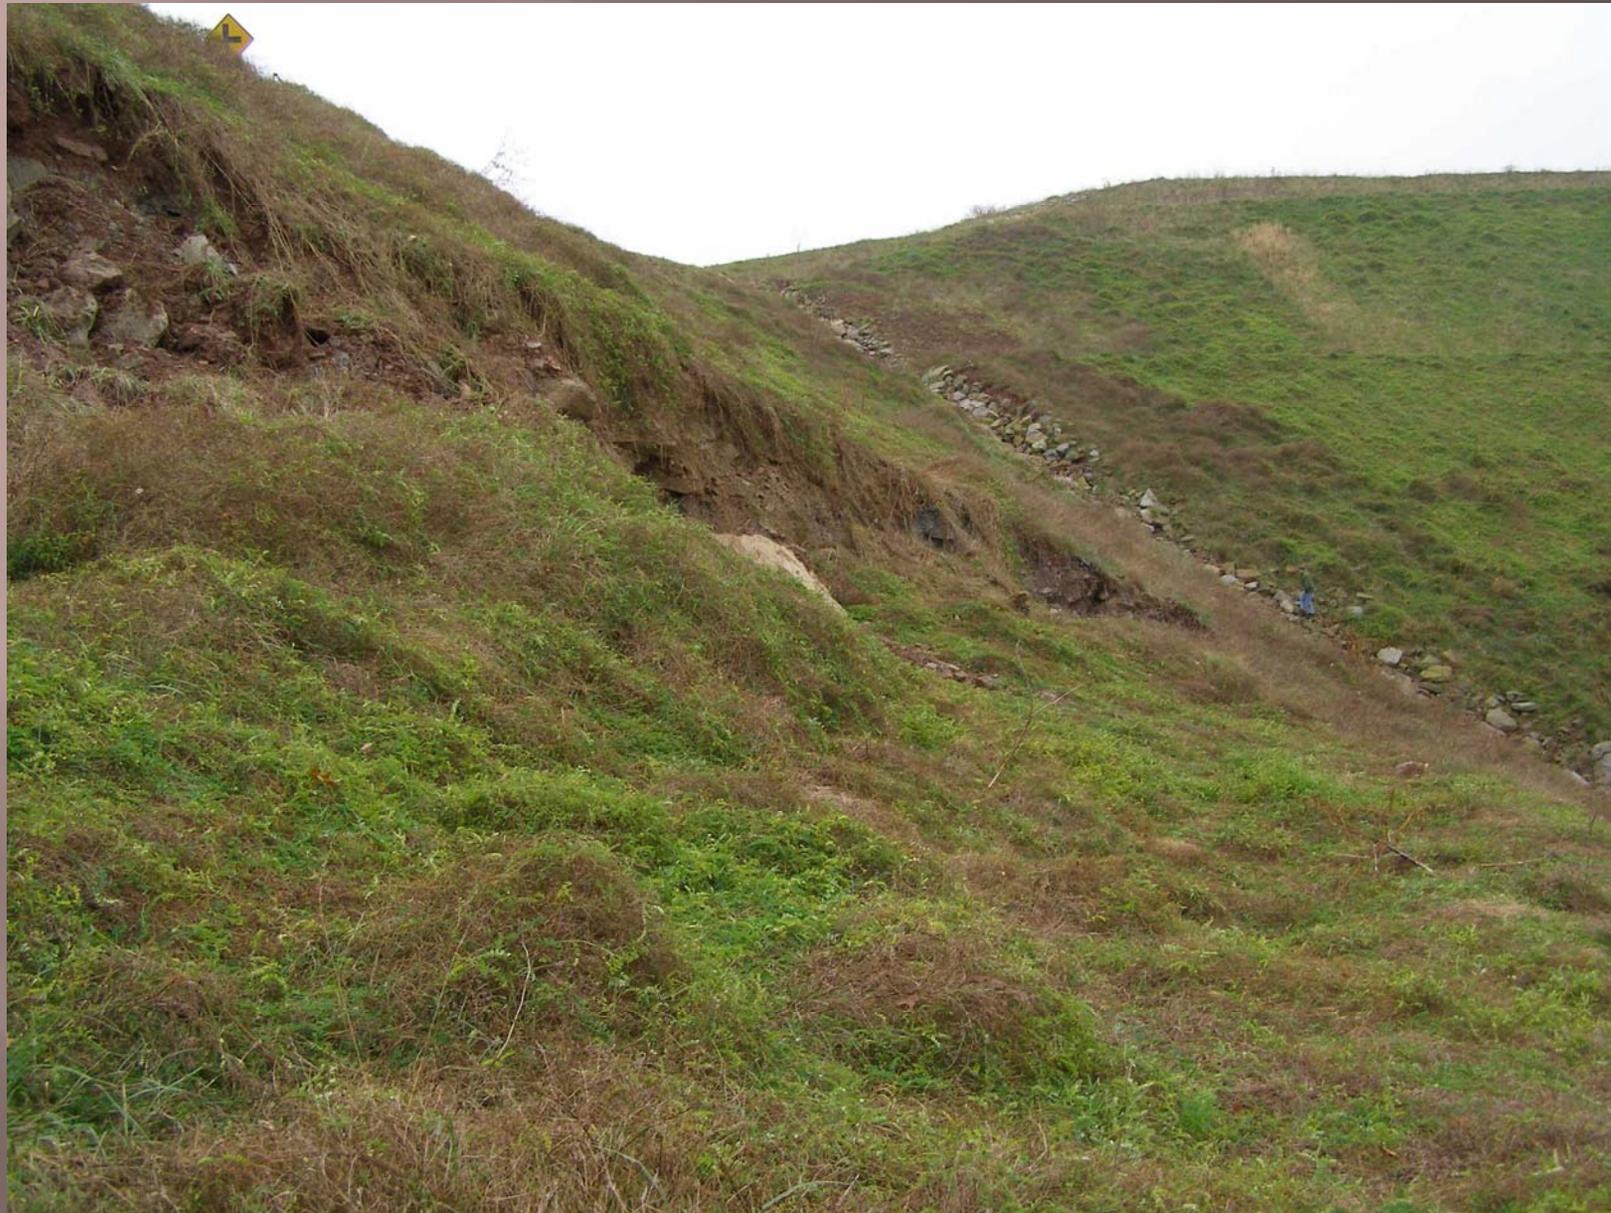
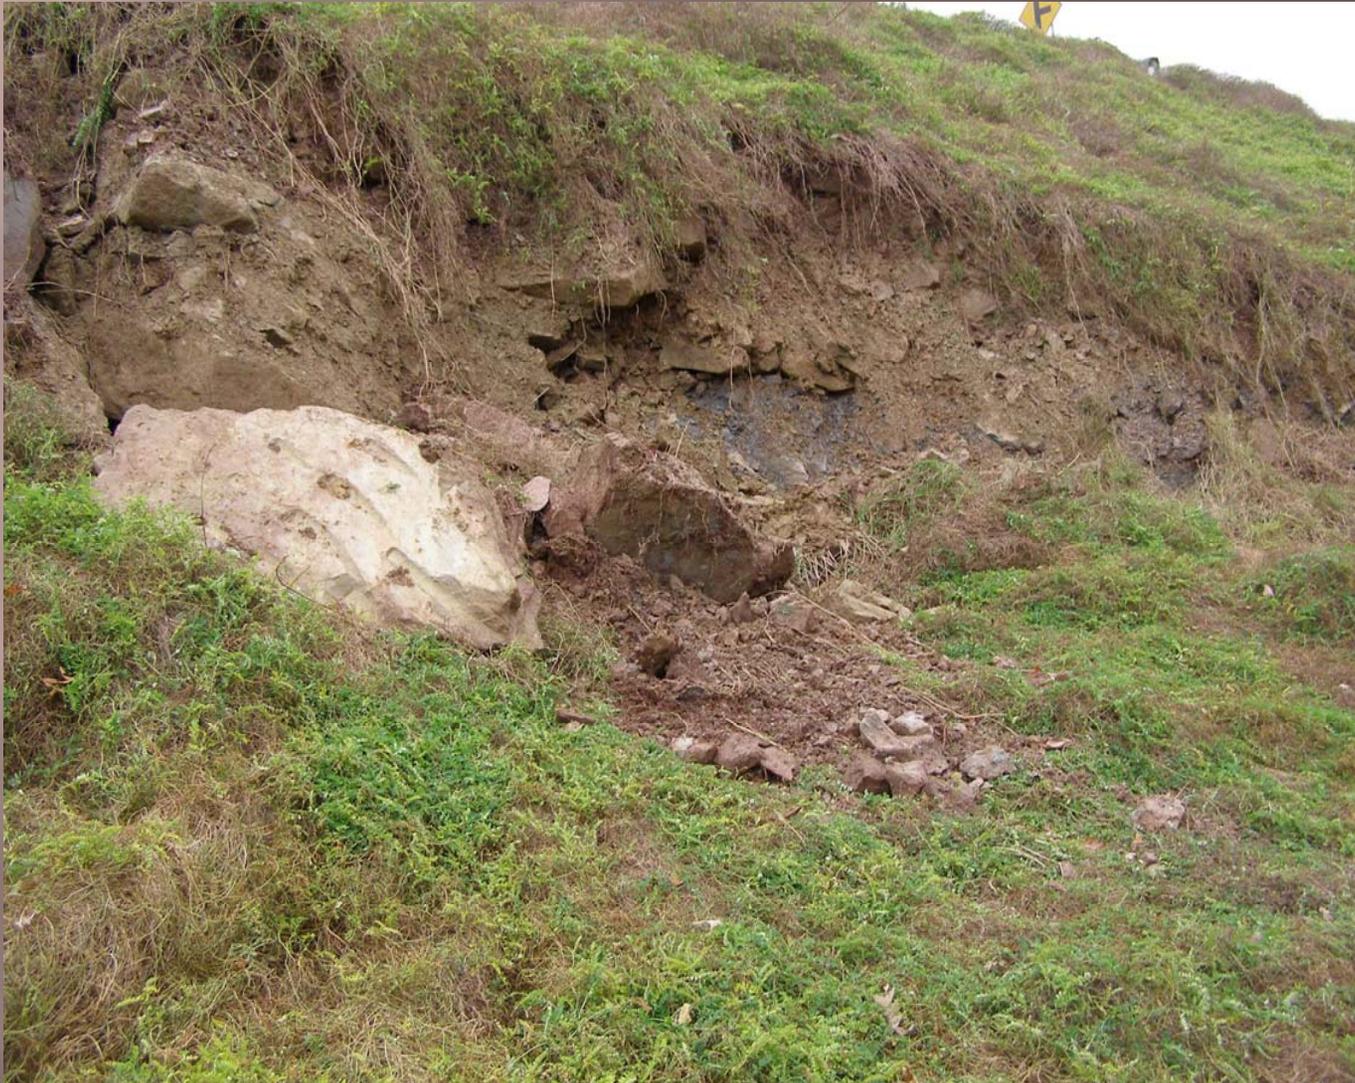
ROUTE 14 MINERAL WELLS, WV

- ▣ Conclusion: Durable rock for select embankment was not available on-site. Project personnel opted to use the less durable on-site rock as select embankment. The softer rock used as select embankment broke down due to weathering and the weight of the fill and jeopardized the integrity of the fill toe. Additionally, many on-site springs in the existing slopes did not have proper drainage installed to divert the ground water away from the fill.

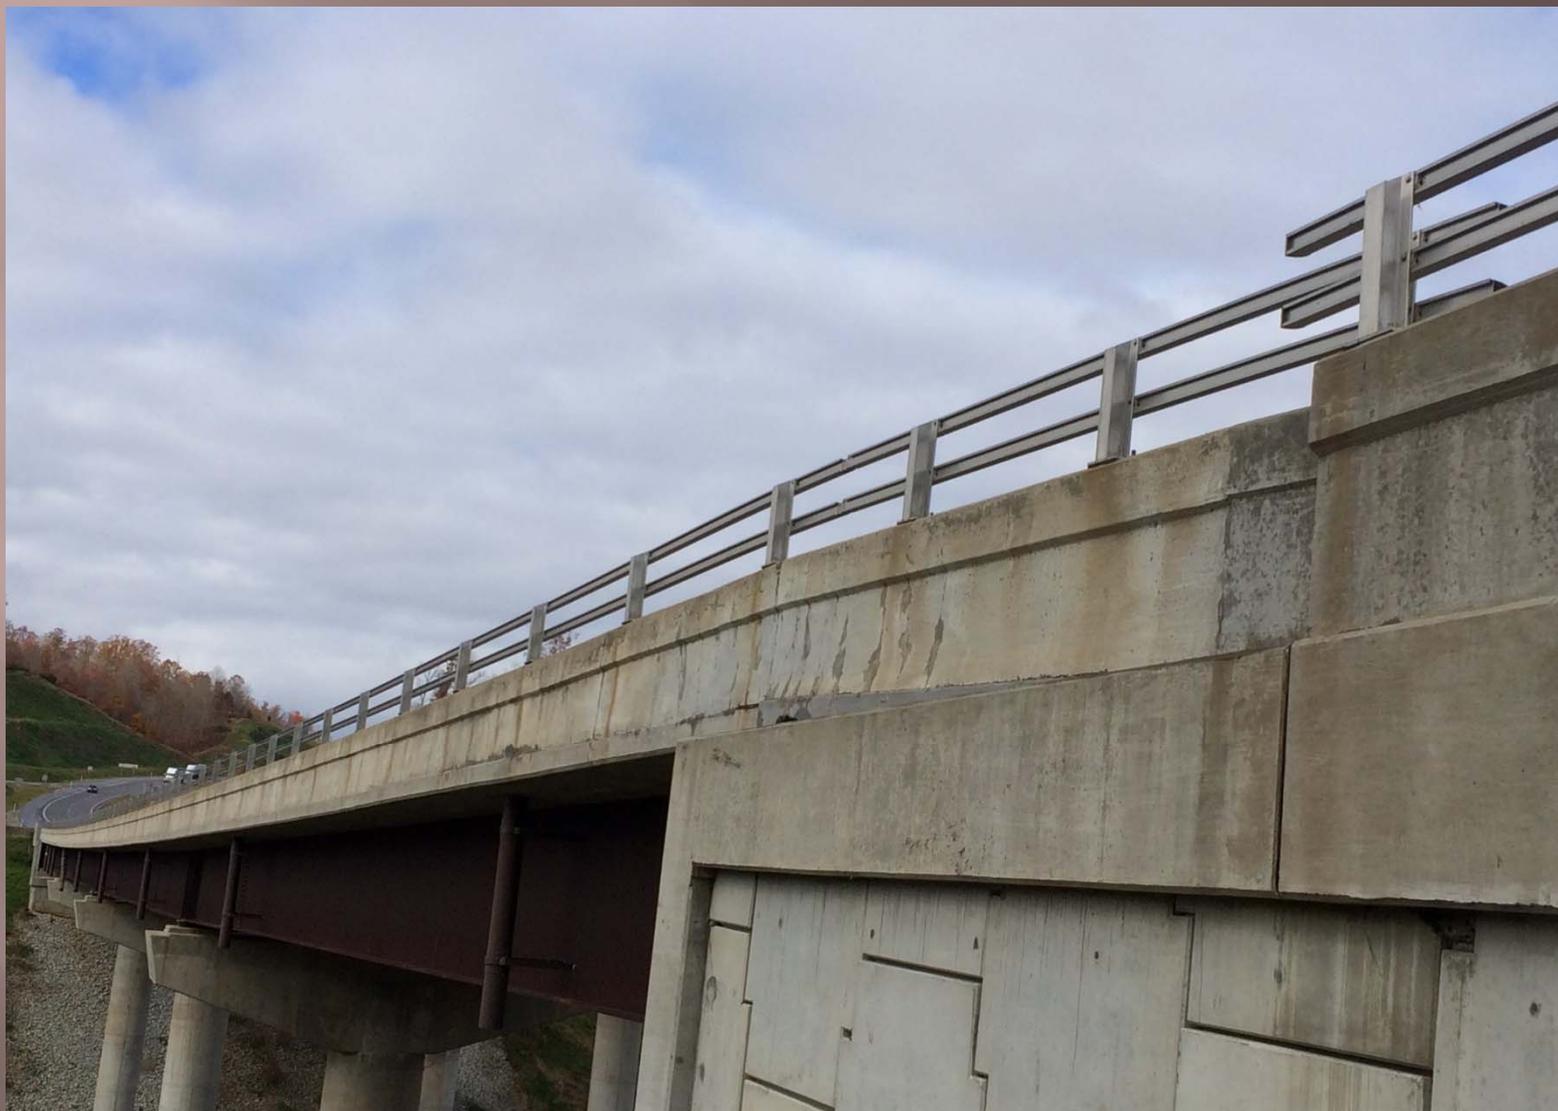
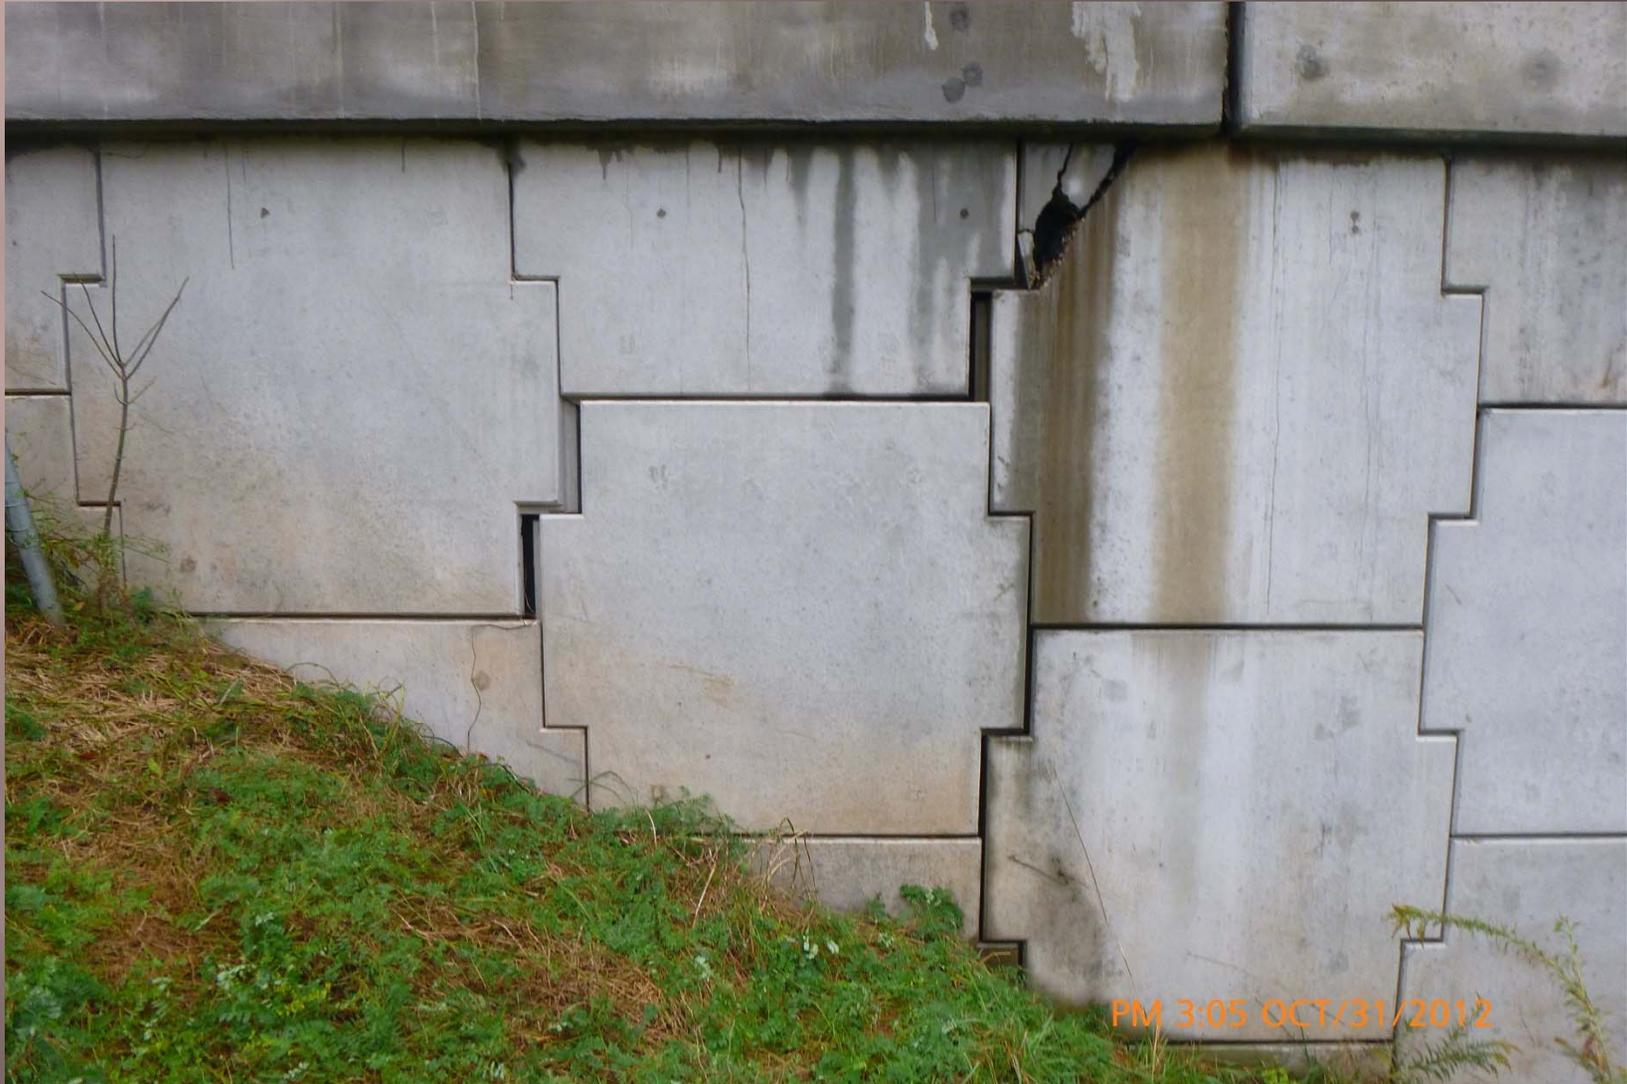
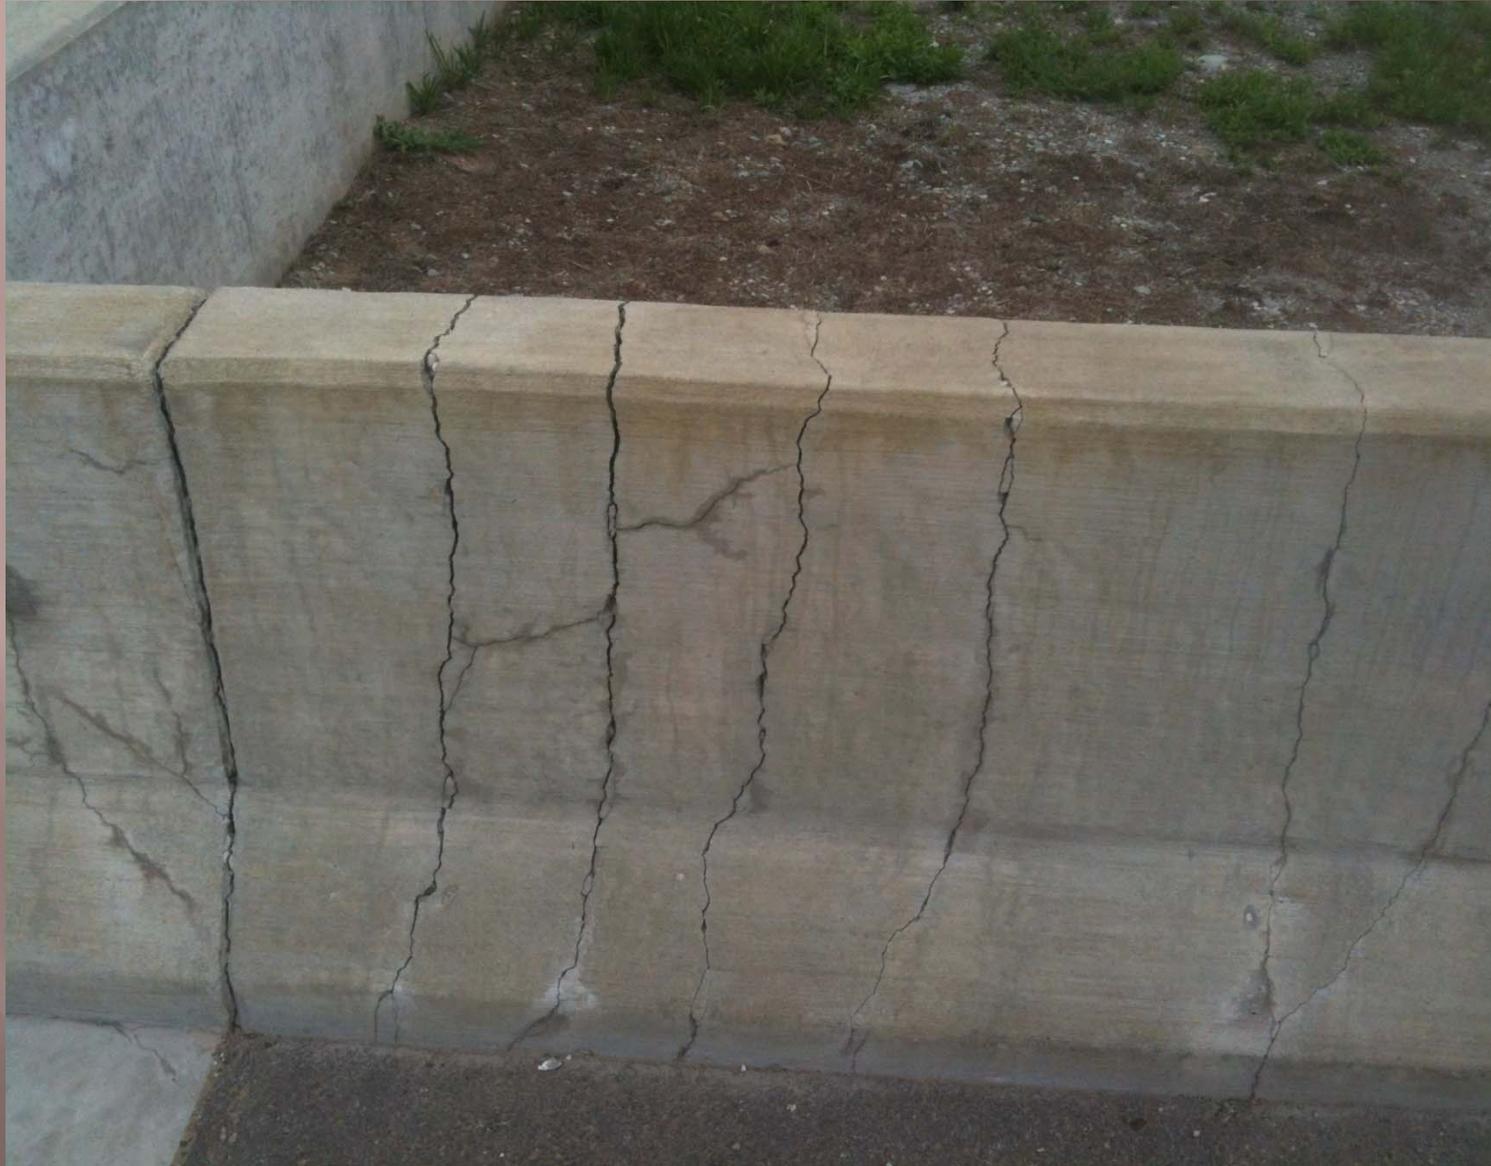
ROUTE 35 PUTNAM COUNTY, WV

- ▣ Conclusion: The on-site fill material was classified by project personnel as rock and placed in accordance with the specifications that govern durable rock fill. The on-site fill material actually consisted of soft claystone and should have been placed with the specifications that govern random (soil) fill.
