Rockfall and Geohazard Site Characterization Using UAVs, Photogrammetry and LiDAR

Ryan Preston, P. Eng

Randy Post, PE

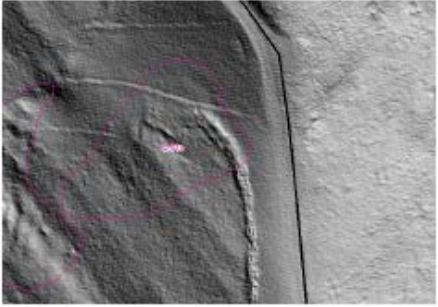
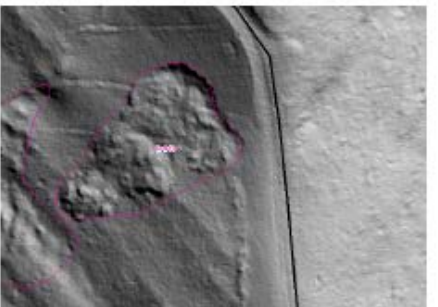
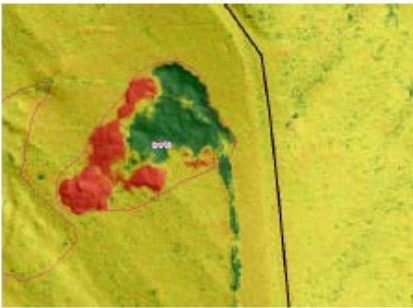
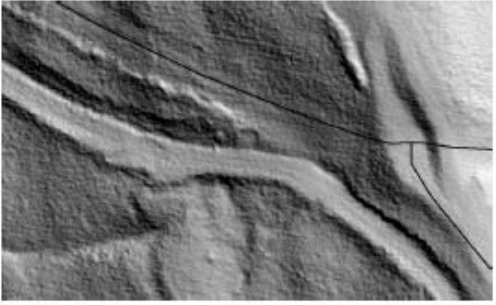
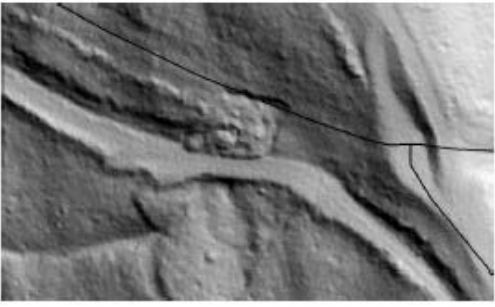
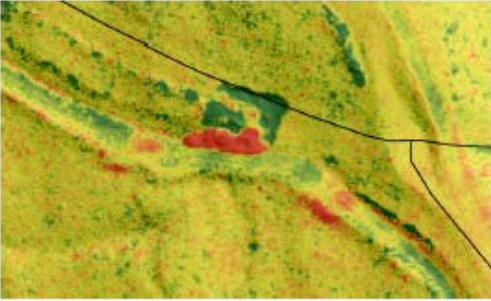
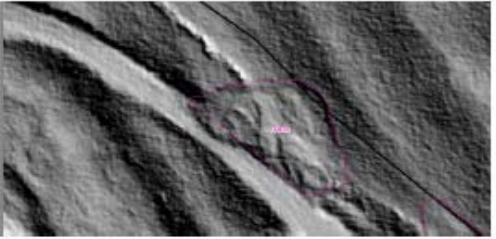
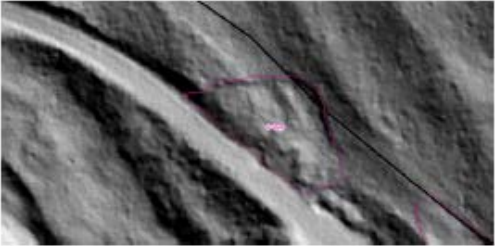
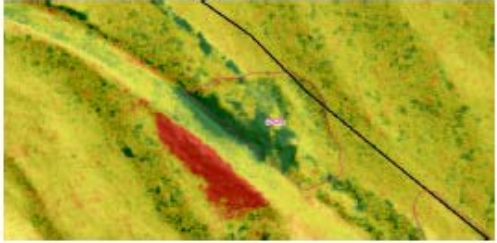
Change Detection Case Study – Aerial LiDAR

2013 LIDAR	2015 LIDAR	ELEVATION CHANGE

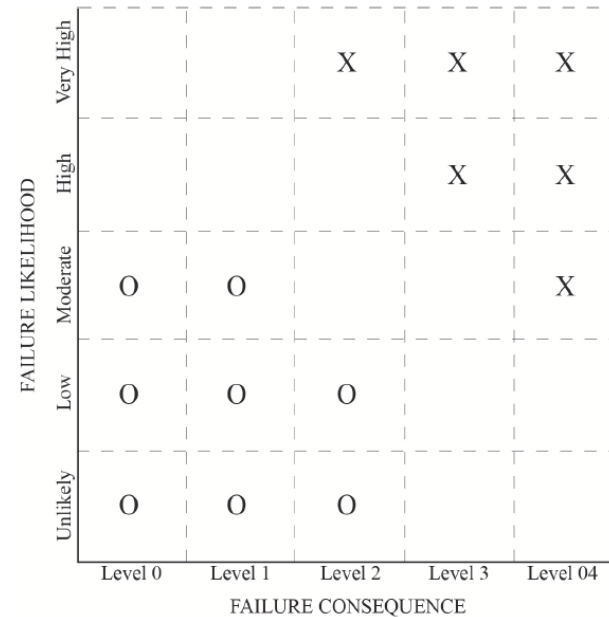
Unlikely	Likely	Very Likely
Major	Medium	High	Extreme
Moderate	Low	Medium	High
Minor	Low	Low	Medium

LEGEND
 X - Geotechnical features that present greatest risk to corridor performance and require further assessment.
 O - Low priority features based on risk screening

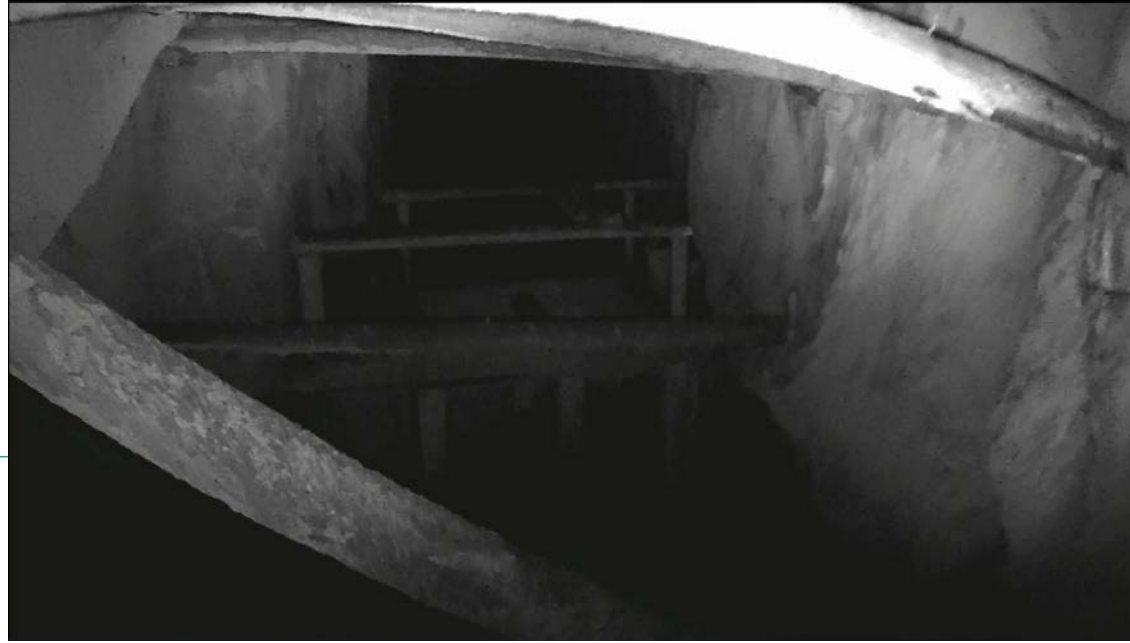
Breakthrough between C5-08
upper and lower stopes

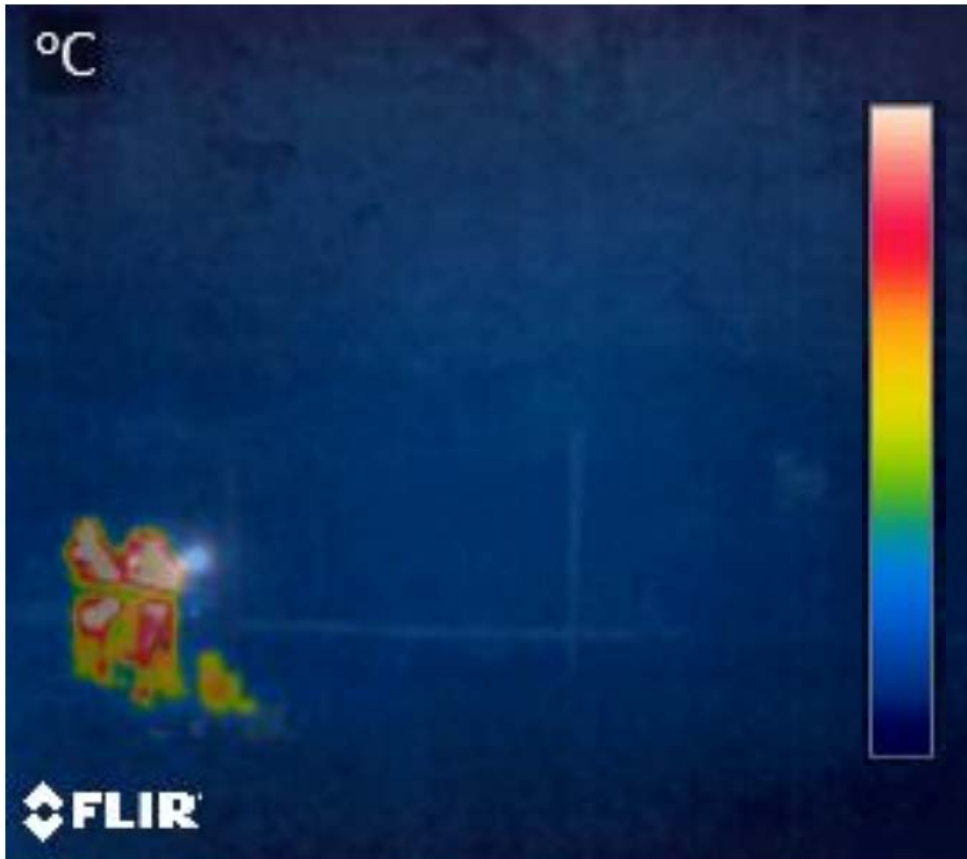
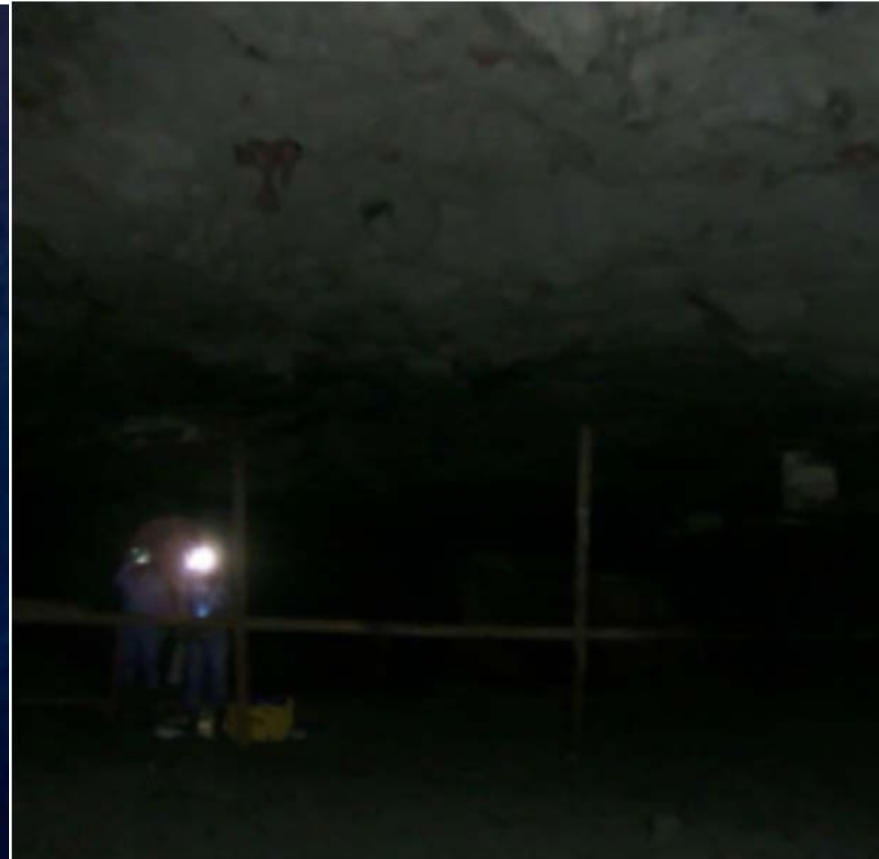
Emerging Applications– Drones Underground – Looking for Seepage with Thermal Imager

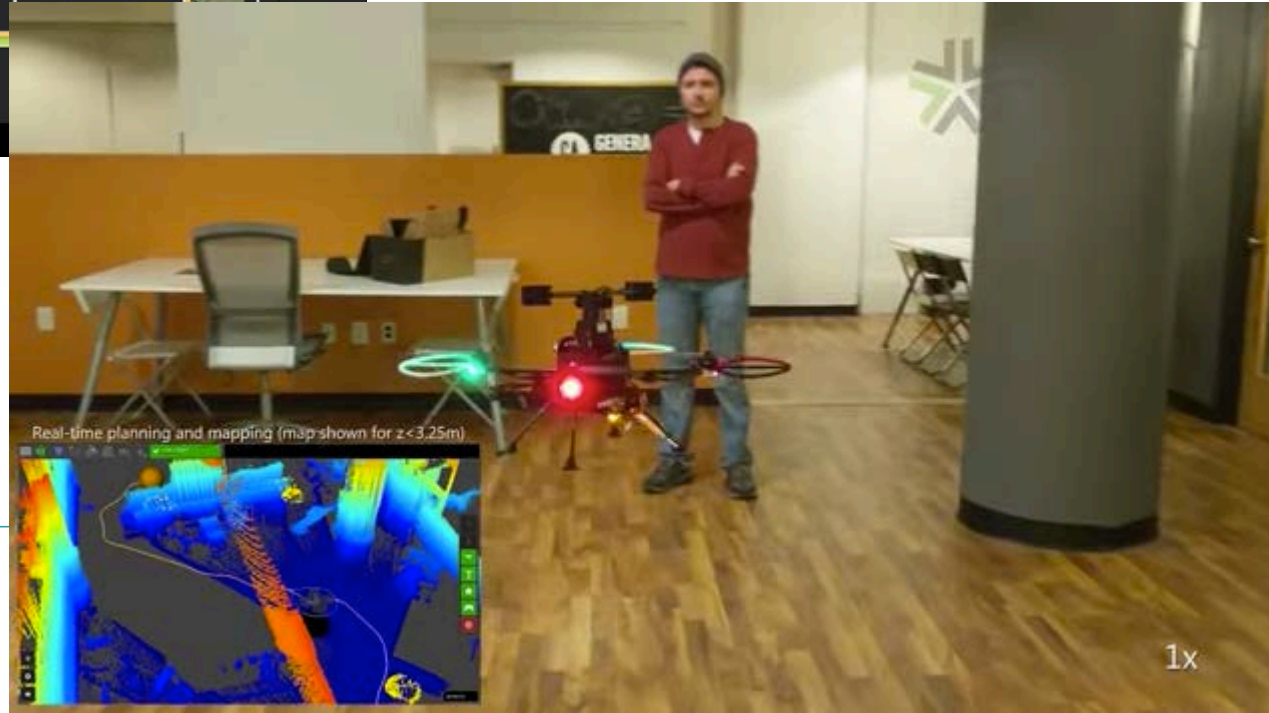
Emerging Applications - Automation

State:
Area: 15064 m² Pictures: 42 Flight Time (est): 3:55 Minutes
Distance: 0.54 km No. of Steps: 72 Photo every (est): 3.45 Seconds
Distance between images: 17 m Footprint: 86.2 x 57.5 m
Ground Resolution: 1.76 cm Dist. between lines: 17.24 m
