Using LAHARZ to determine potential inundation associated with a surface mining-related debris flow in the Appalachian coalfields of southwestern Virginia, USA.

Geohazards in Transportation in
Appalachia Technical Forum

Anne Carter Witt

VA Department of Mines, Minerals & Energy

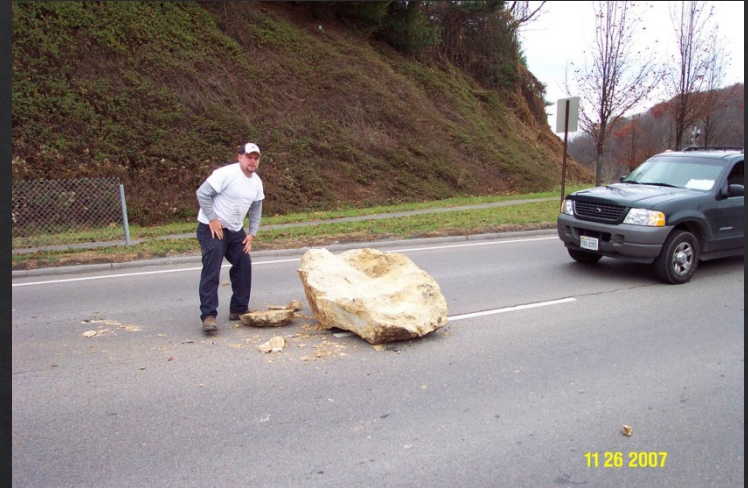
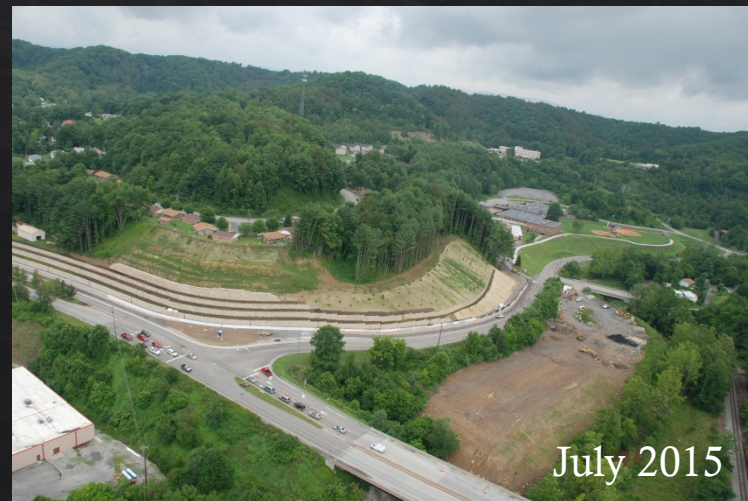
Fawn Branch
Lee County, VA
March 2015

Debris Slide

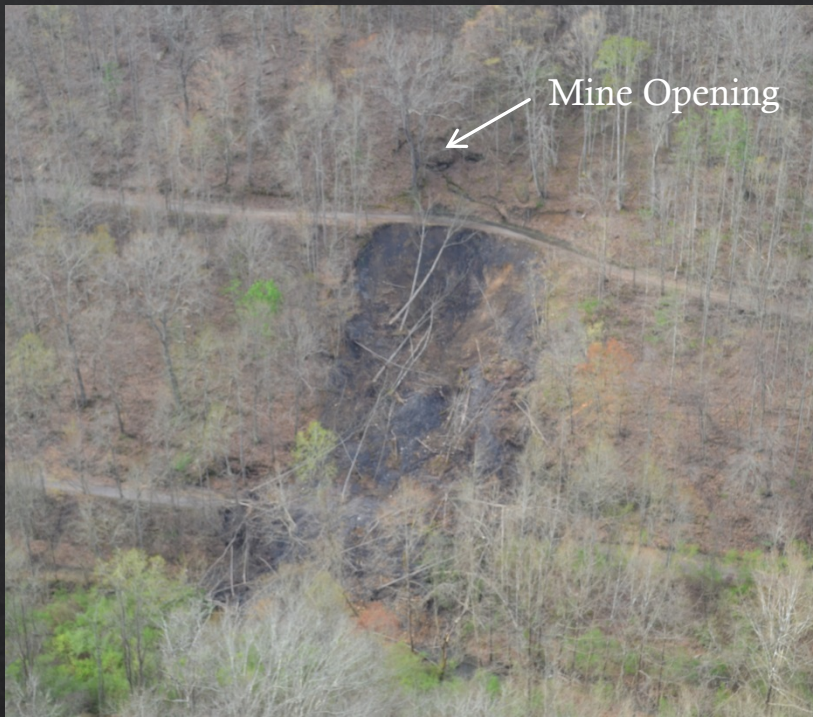
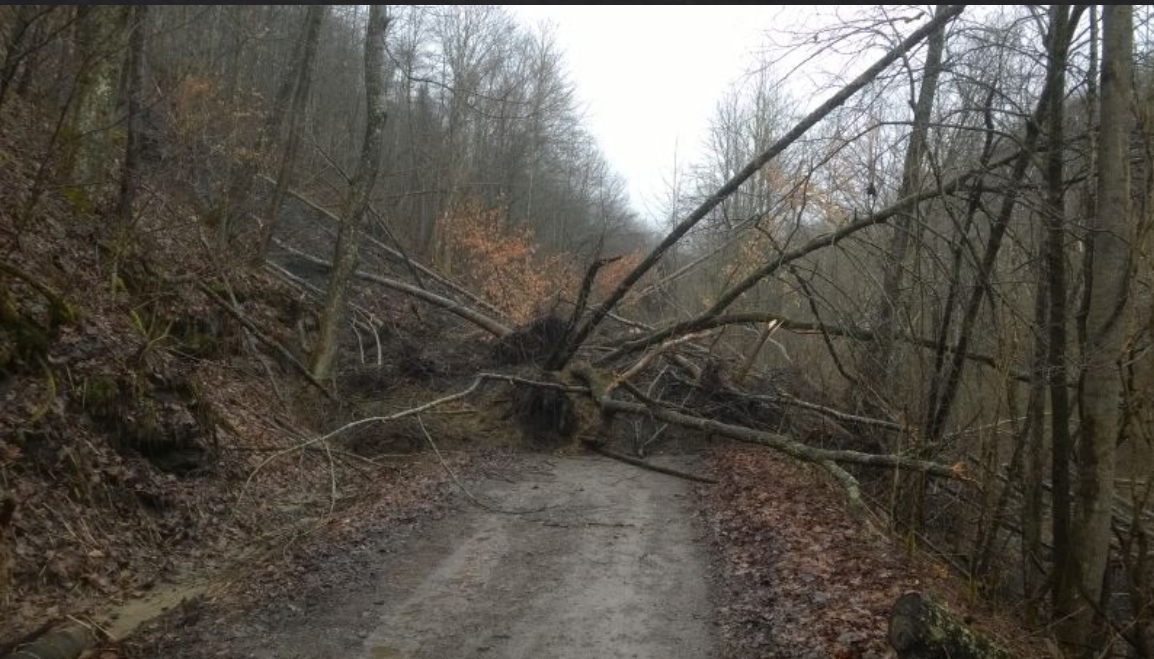
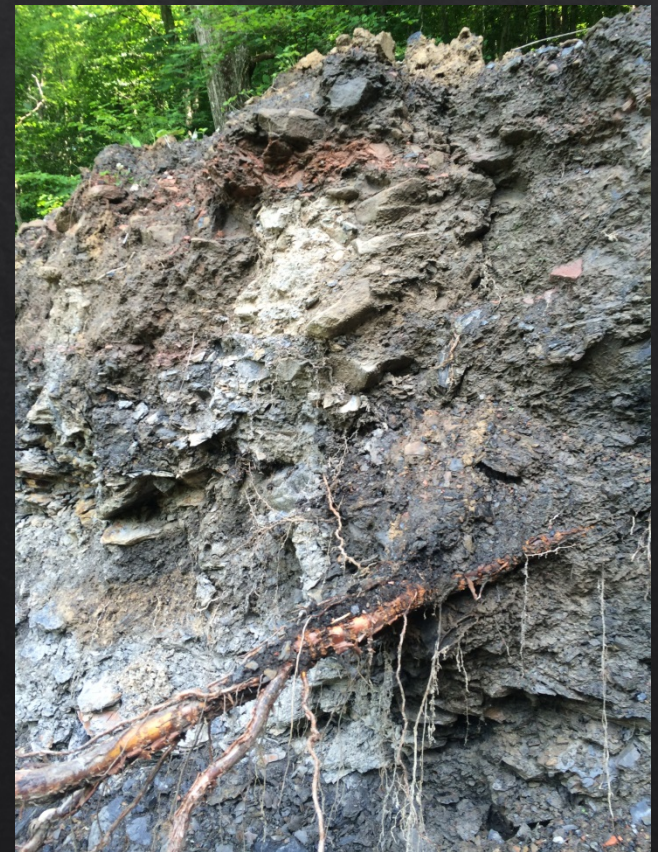
Debris Slide
Jakes Branch
Dickenson County, VA
May 2015???

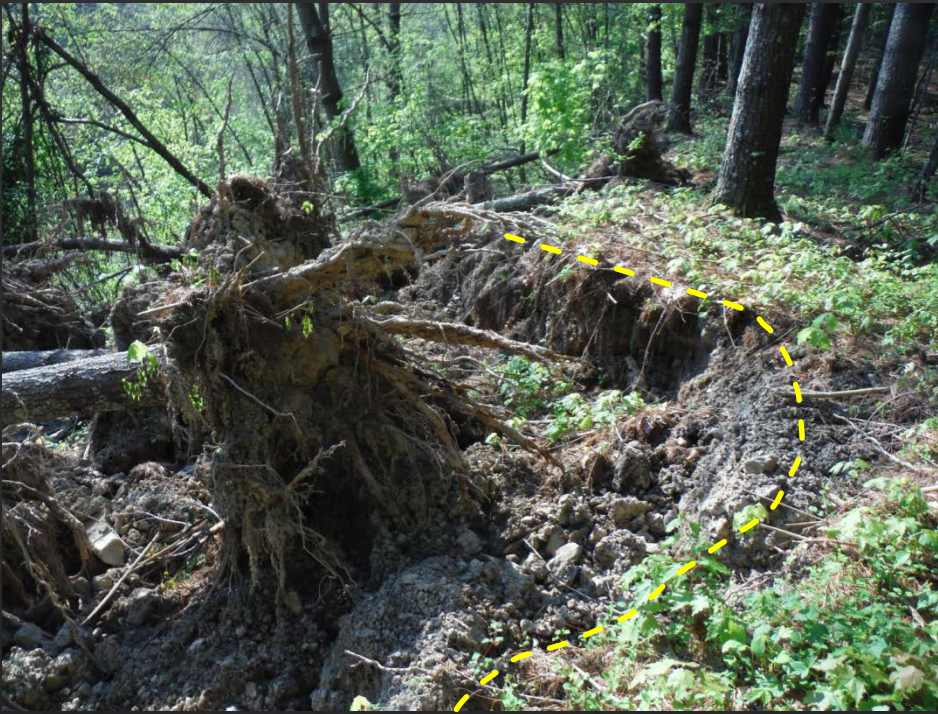
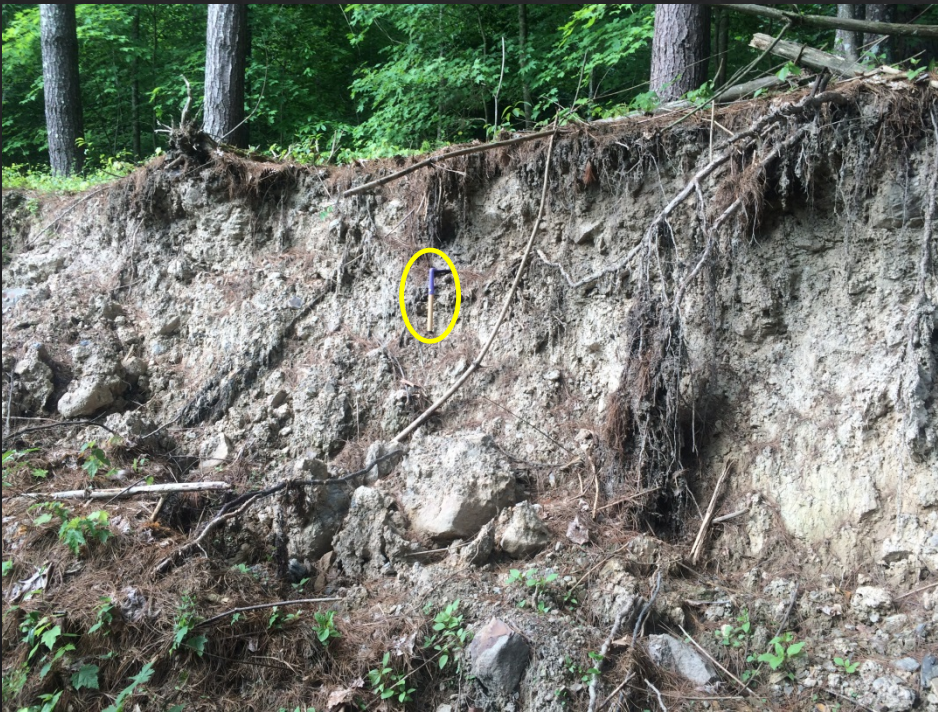
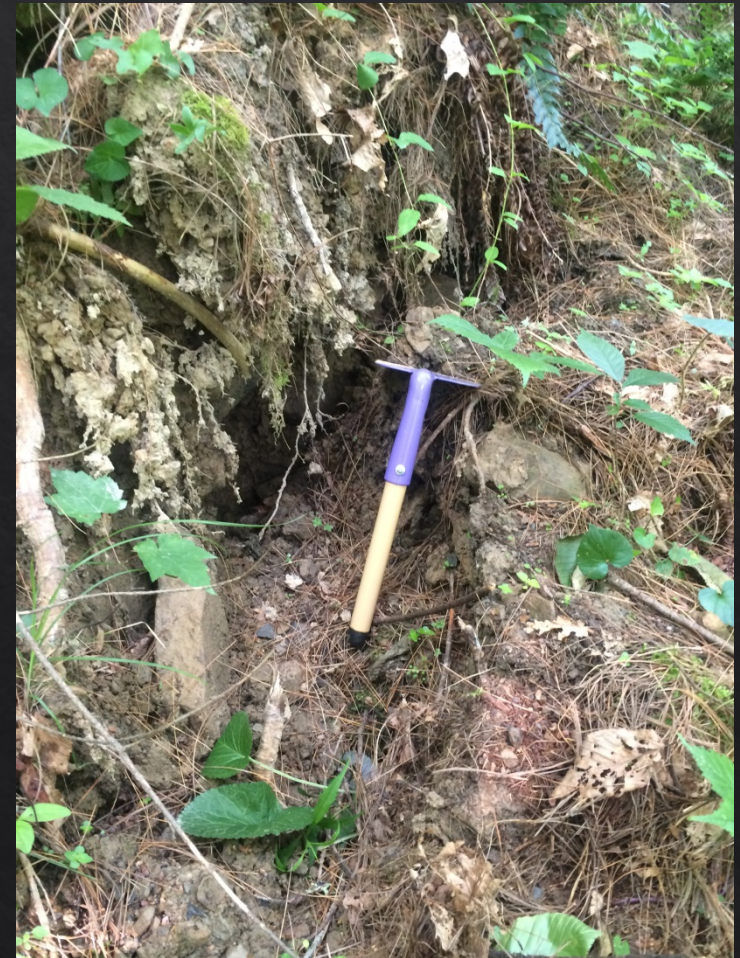
Pound, VA; Wise County

Debris Slide

Bolling Slide

March 2015

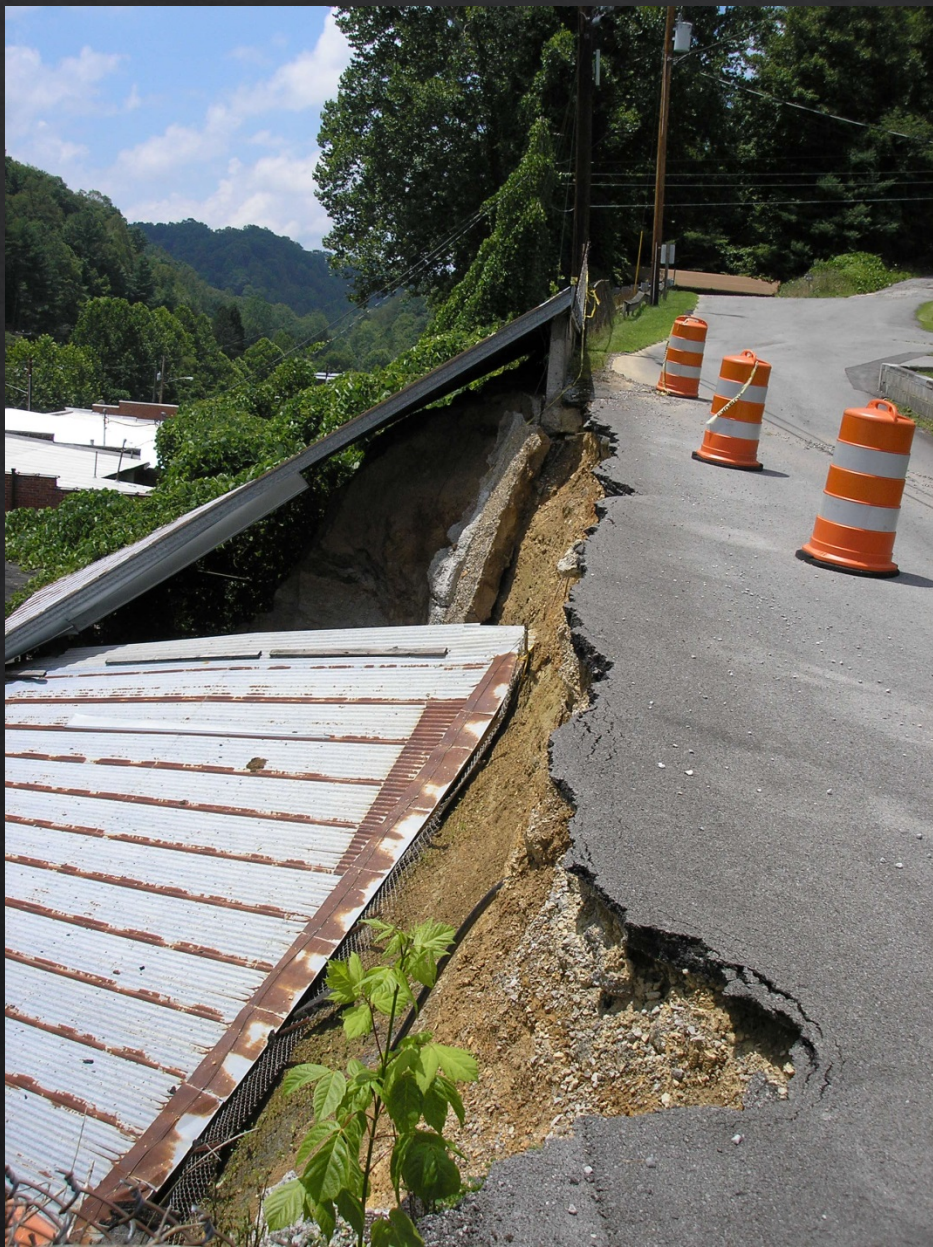
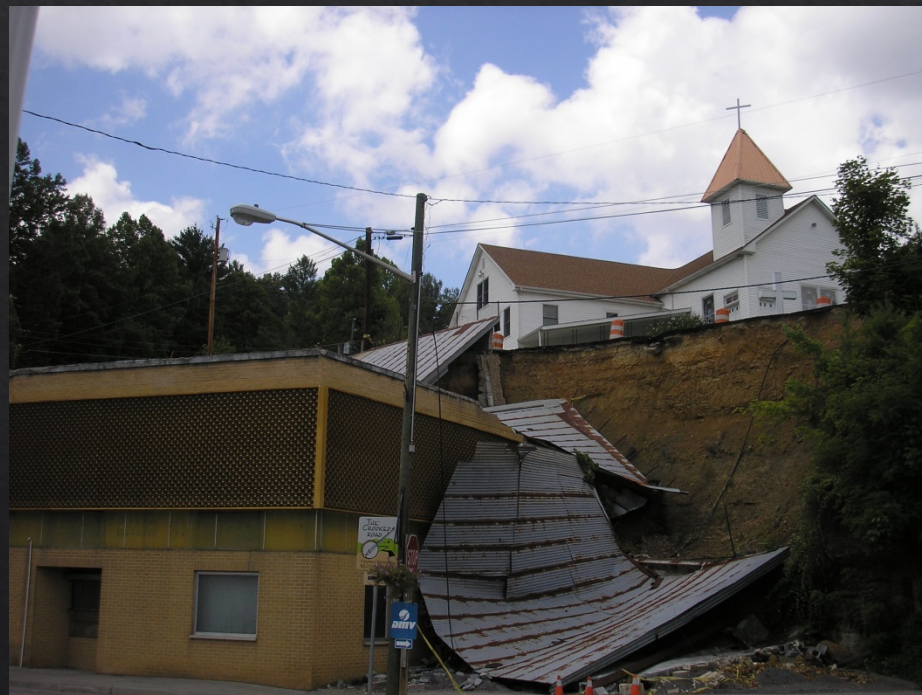
Elkins Branch

Debris Slide-Flow

Buchanan County

March 2015

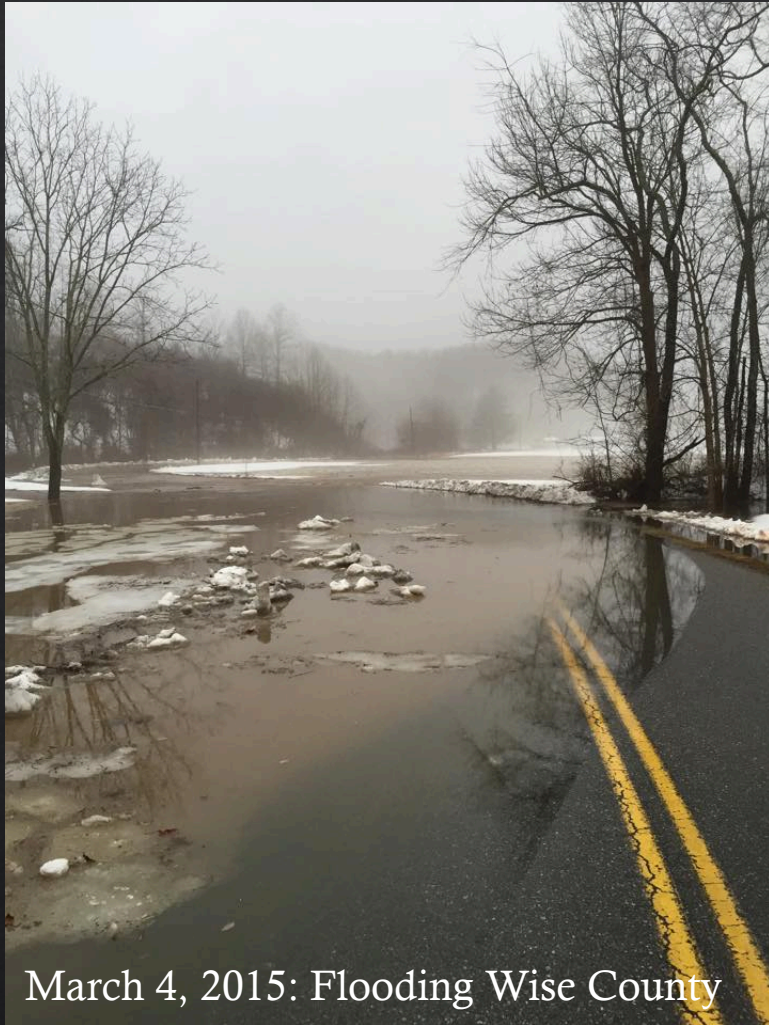
Meteorological Conditions

March 3-6 Rainfall/snowmelt was a likely trigger for numerous slides across SW Virginia

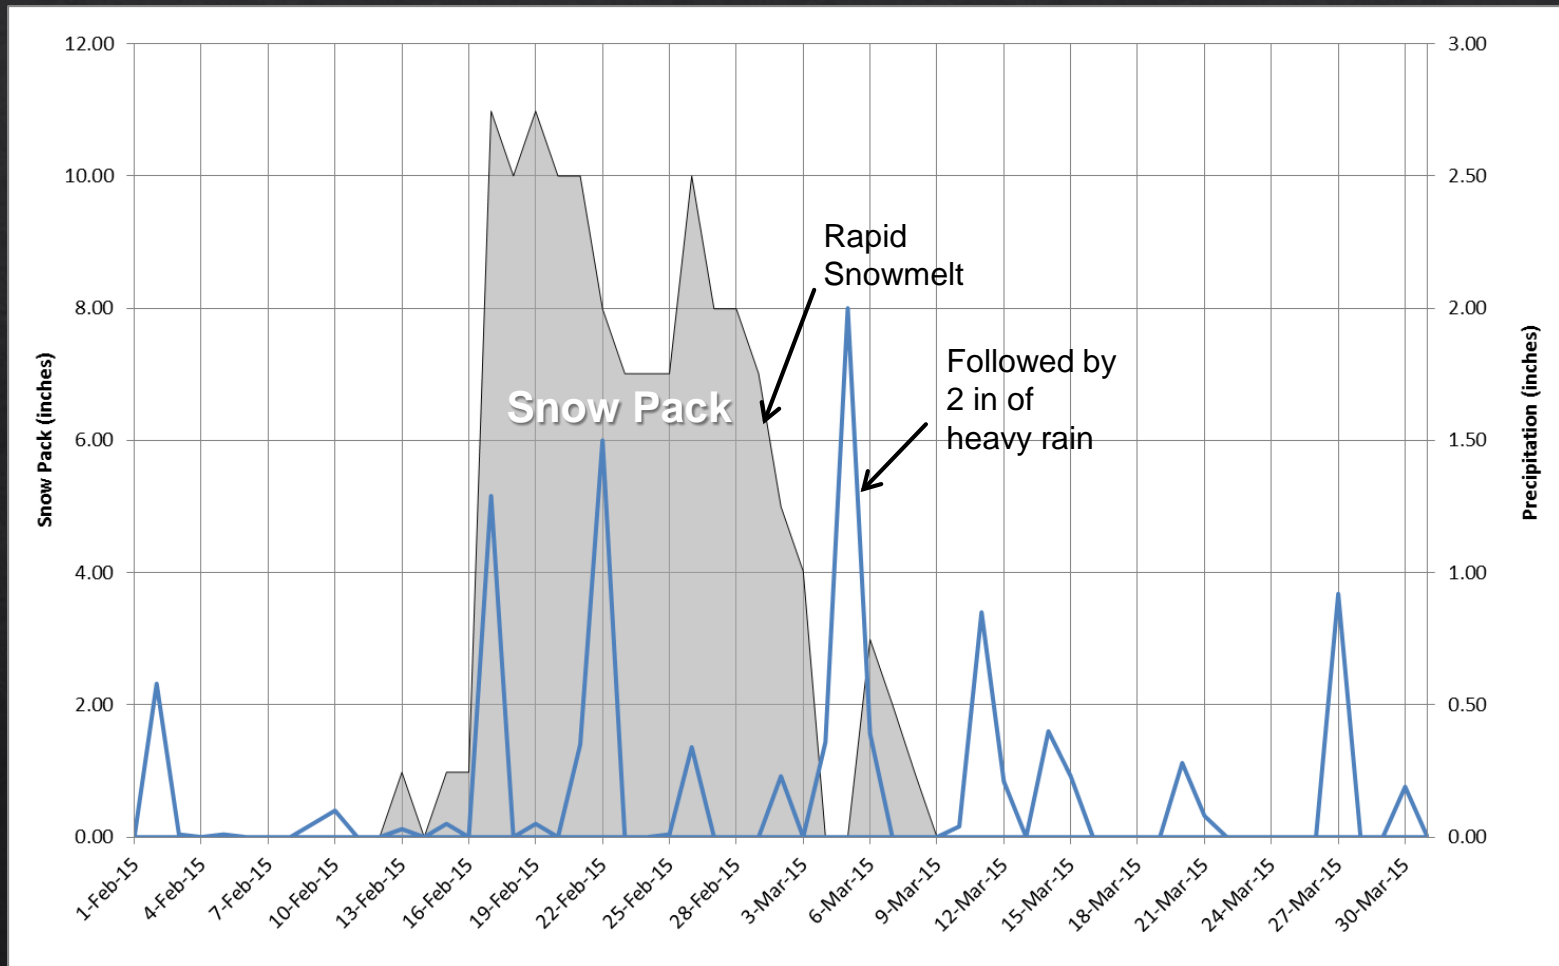
Meteorological Conditions Grundy Station

March 3-6 Rainfall/snowmelt was a likely trigger for the reactivation of this landslide

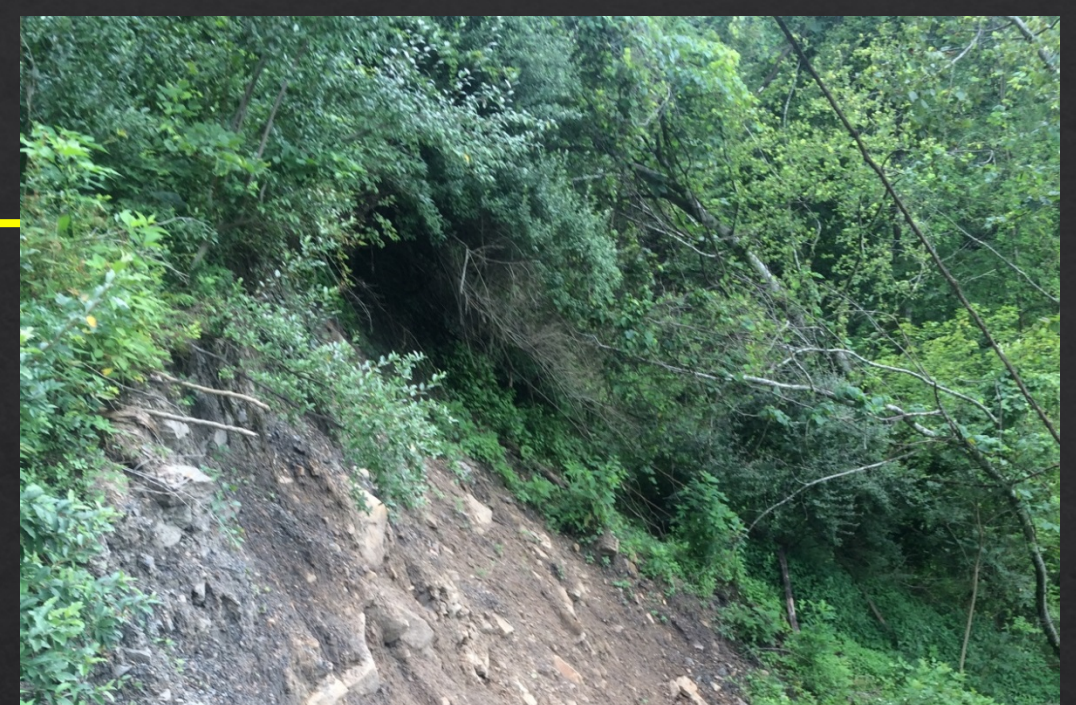
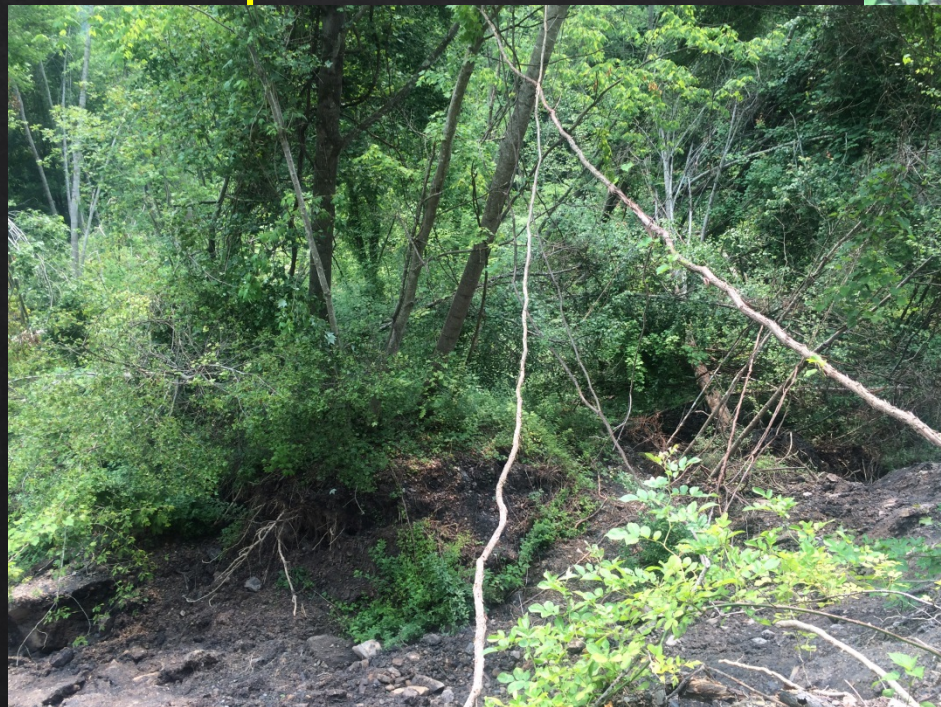
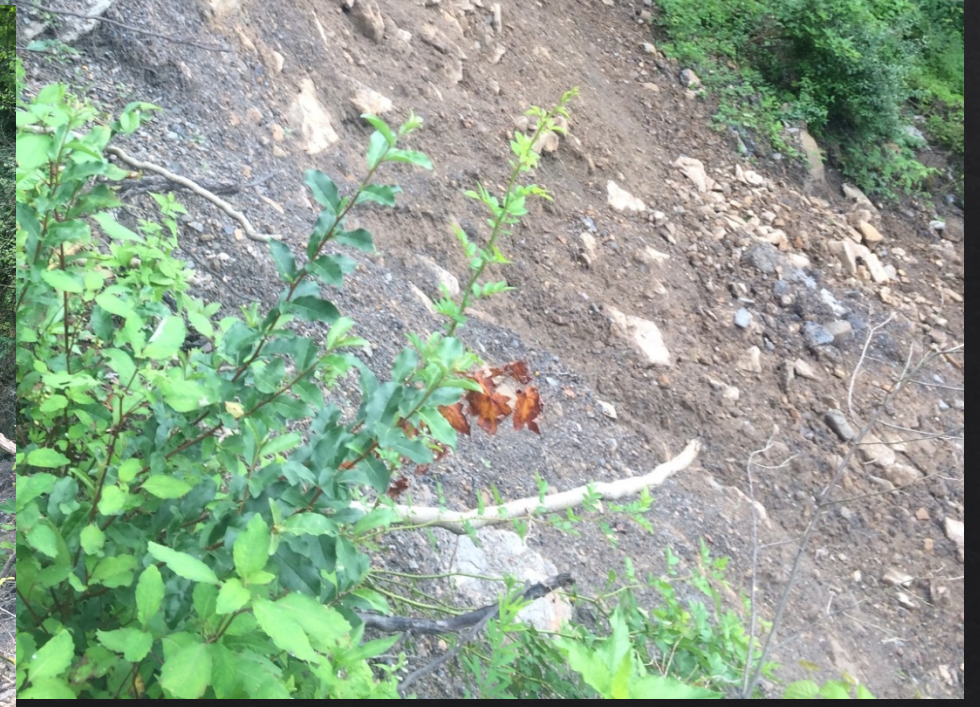
- ◇ Originated within mine spoil related to pre-1977 surface mining
- ◇ Scarping worsened between site visits in June, July, & September, probably due to heavy rain in mid-August
- ◇ Movement is occurring within the main body of the slide and along scarping to the south, actively shedding debris into Elkins Branch

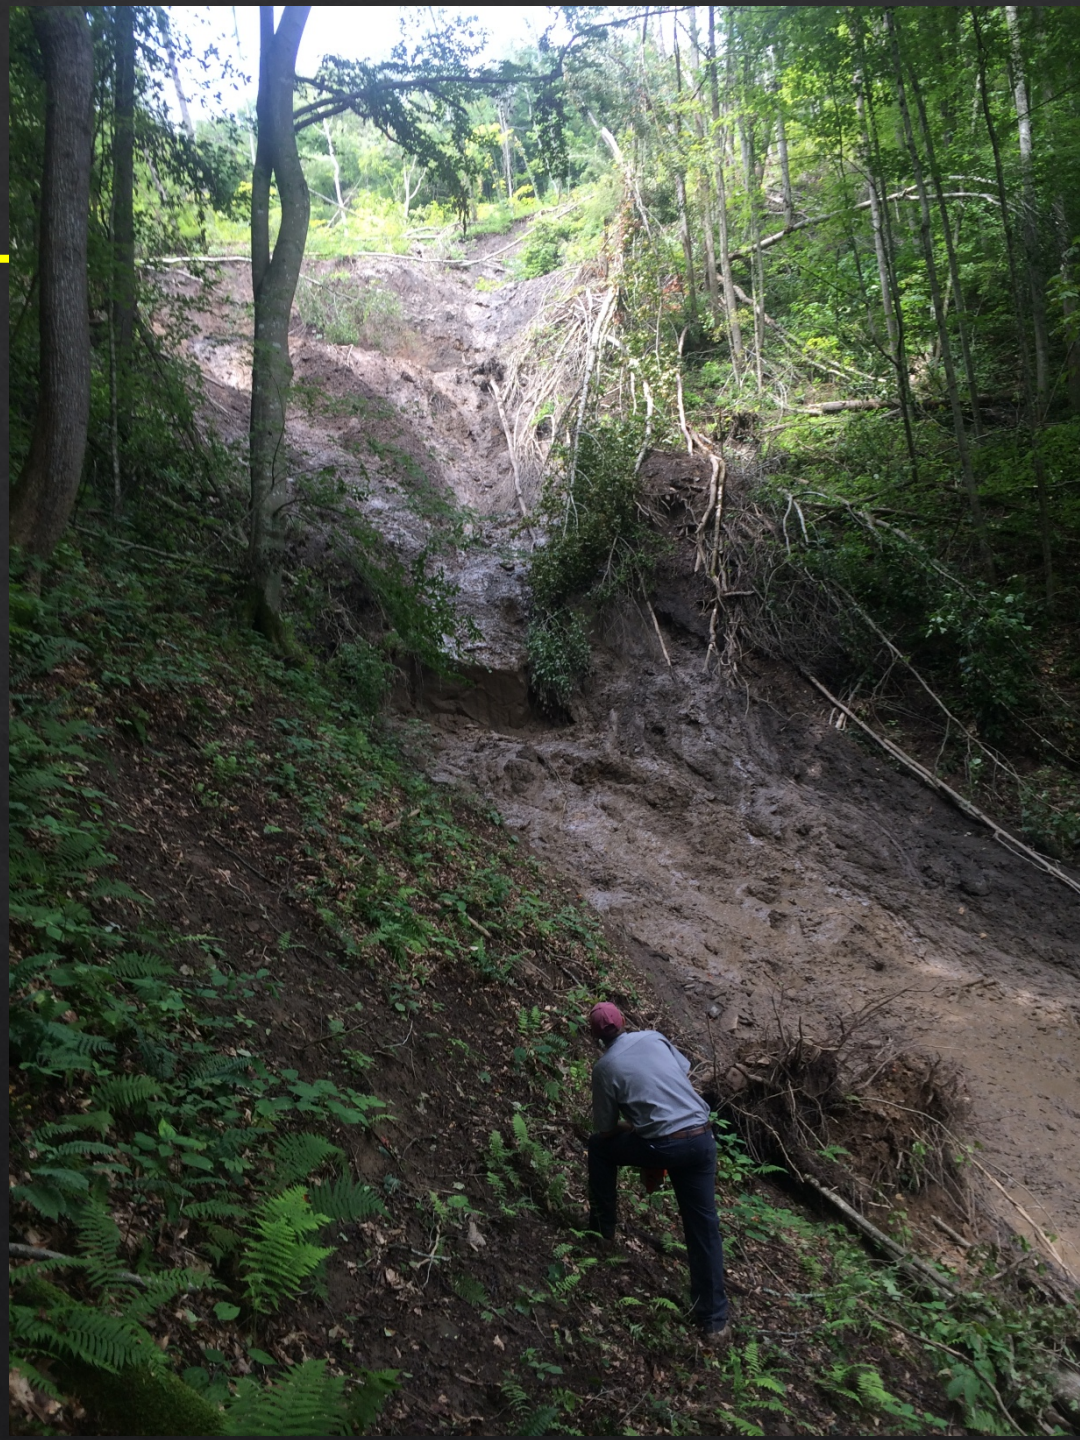
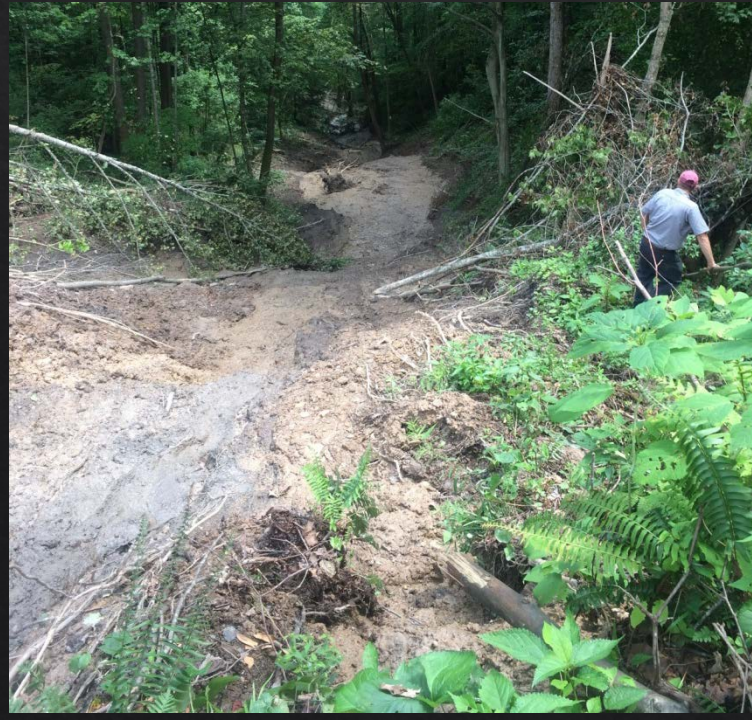
Geological Conditions

- ◆ Slide material: medium-to-fine-grained soil/spoil material with coarse, angular fragments of sandstone, siltstone and coal
- ◆ Included boulders up to 3 feet
- ◆ Underlain by Norton Fm. - Pennsylvanian-aged sedimentary unit

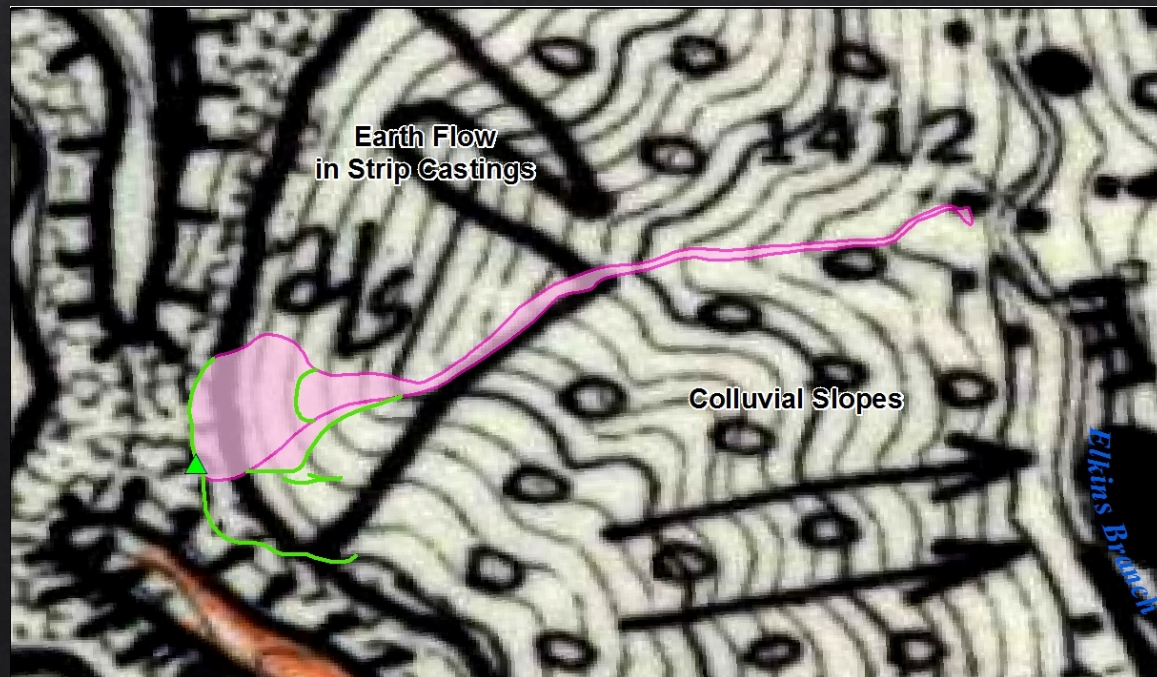
From: Outerbridge, W.F., 1979, Landslides and Related Features of the Grundy, VA. Quadrangle: U.S. Geological Survey, Open-File Report OF-79-714 (C-16)

- ◇ Outerbridge (1979) used a combination of aerial photography interpretation and field mapping to identify surficial features
- ◇ Upper slide area noted as “earth flow in strip castings” indicating this area may have been active as early as 1979

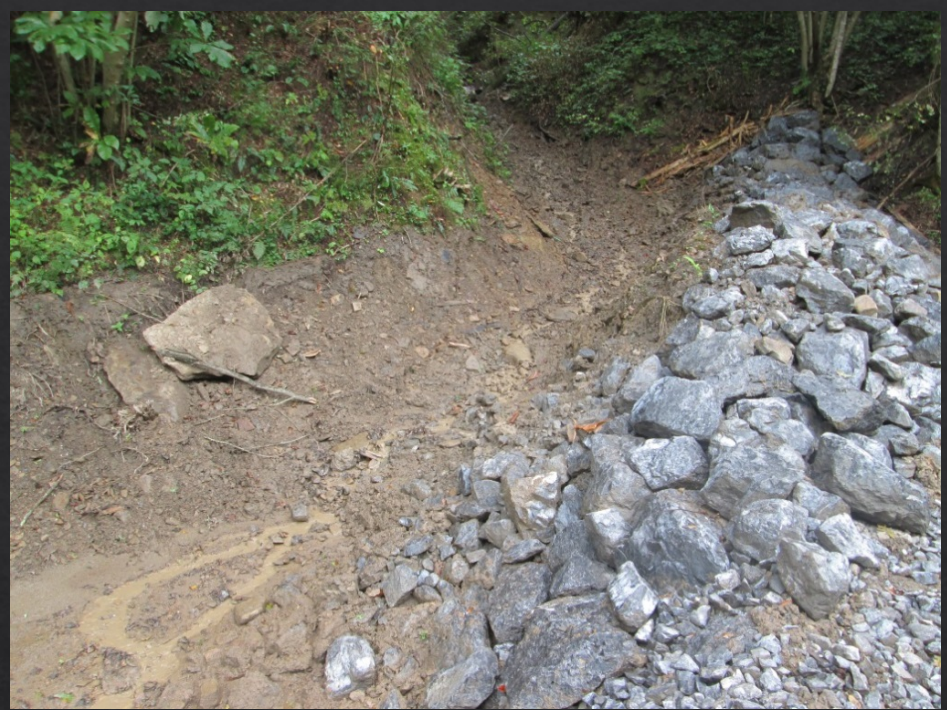
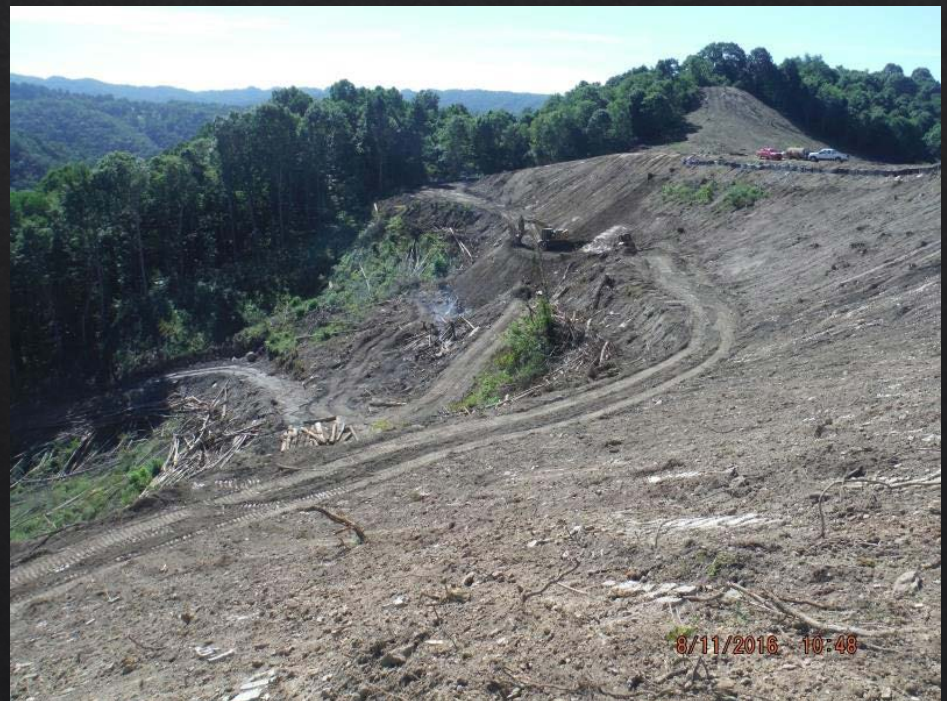
Update

- ◆ Excavation of toe and stream began in Aug 2015
- ◆ Temporary berm installed to protect church at toe
- ◆ Repairs are currently underway and estimated at \$1.3 million with a completion date of October 2017
- ◆ Current plan is to remove all slide material to competent bedrock; slide material will be placed on ridge
