Mine Closures in New Jersey

By: Joseph A. Fischer and Joseph J. Fischer
Geoscience Services

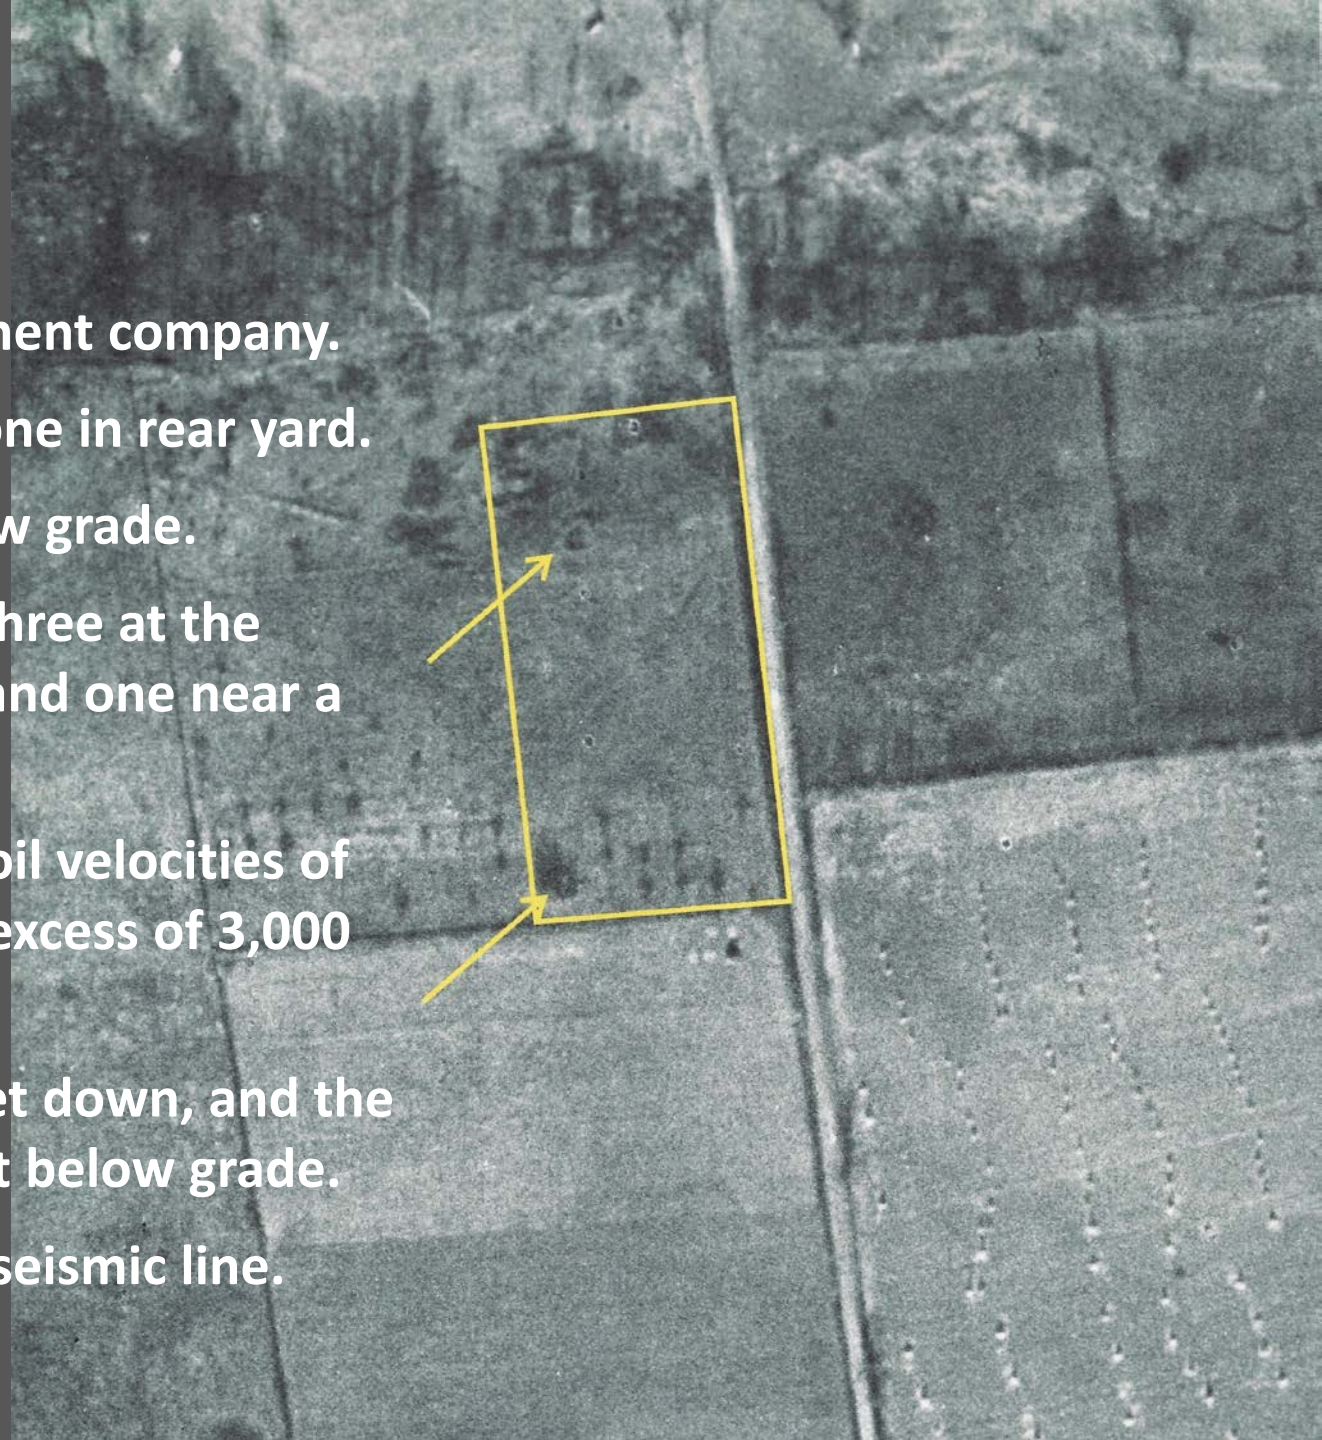
- Well-known geophysical firm hired by development company.
- Four GPR survey lines in subsidence areas and one in rear yard.
- Depth of GPR signal was some 7 to 11 feet below grade.
- In addition, four seismic lines were surveyed. Three at the location of a likely mine shaft in the front yard and one near a depression in the rear yard.
- The three seismic lines in front yard indicated soil velocities of 600 to 1,200 feet/sec and bedrock velocities in excess of 3,000 feet/sec.
- Survey indicated bedrock was some 20 to 30 feet down, and the bottom of the depression was at 102 to 103 feet below grade.
- “No useful data” was reported from the fourth seismic line.

- Authors asked by owners to develop a remediation plan.
- 38 probes holes were drilled by the developer's consultant and monitored by the authors.
- Representatives of the DoL visited the site.
- Probe holes encountered cavities and other evidence of mining activity.
- It is likely that a shallow water table hindered further exploration for ore in the area.

- The shaft backfill was removed with a clamshell excavator to as deep as possible without sending anyone down into the shaft.
- The depression had obviously been used for dumping.
- Several feet of $\frac{1}{2}$ " - $\frac{3}{4}$ " crushed stone was placed across the bottom of excavation and pushed/pressed into small shaft extending from the side of the shaft.
- Cement slurry (roughly 1:1 Portland cement to water with about 5% bentonite for shrinkage) was introduced.
- Filter fabric was placed atop the stone/cement slurry and the area returned to grade with granular fill and topped with 2 feet of topsoil.

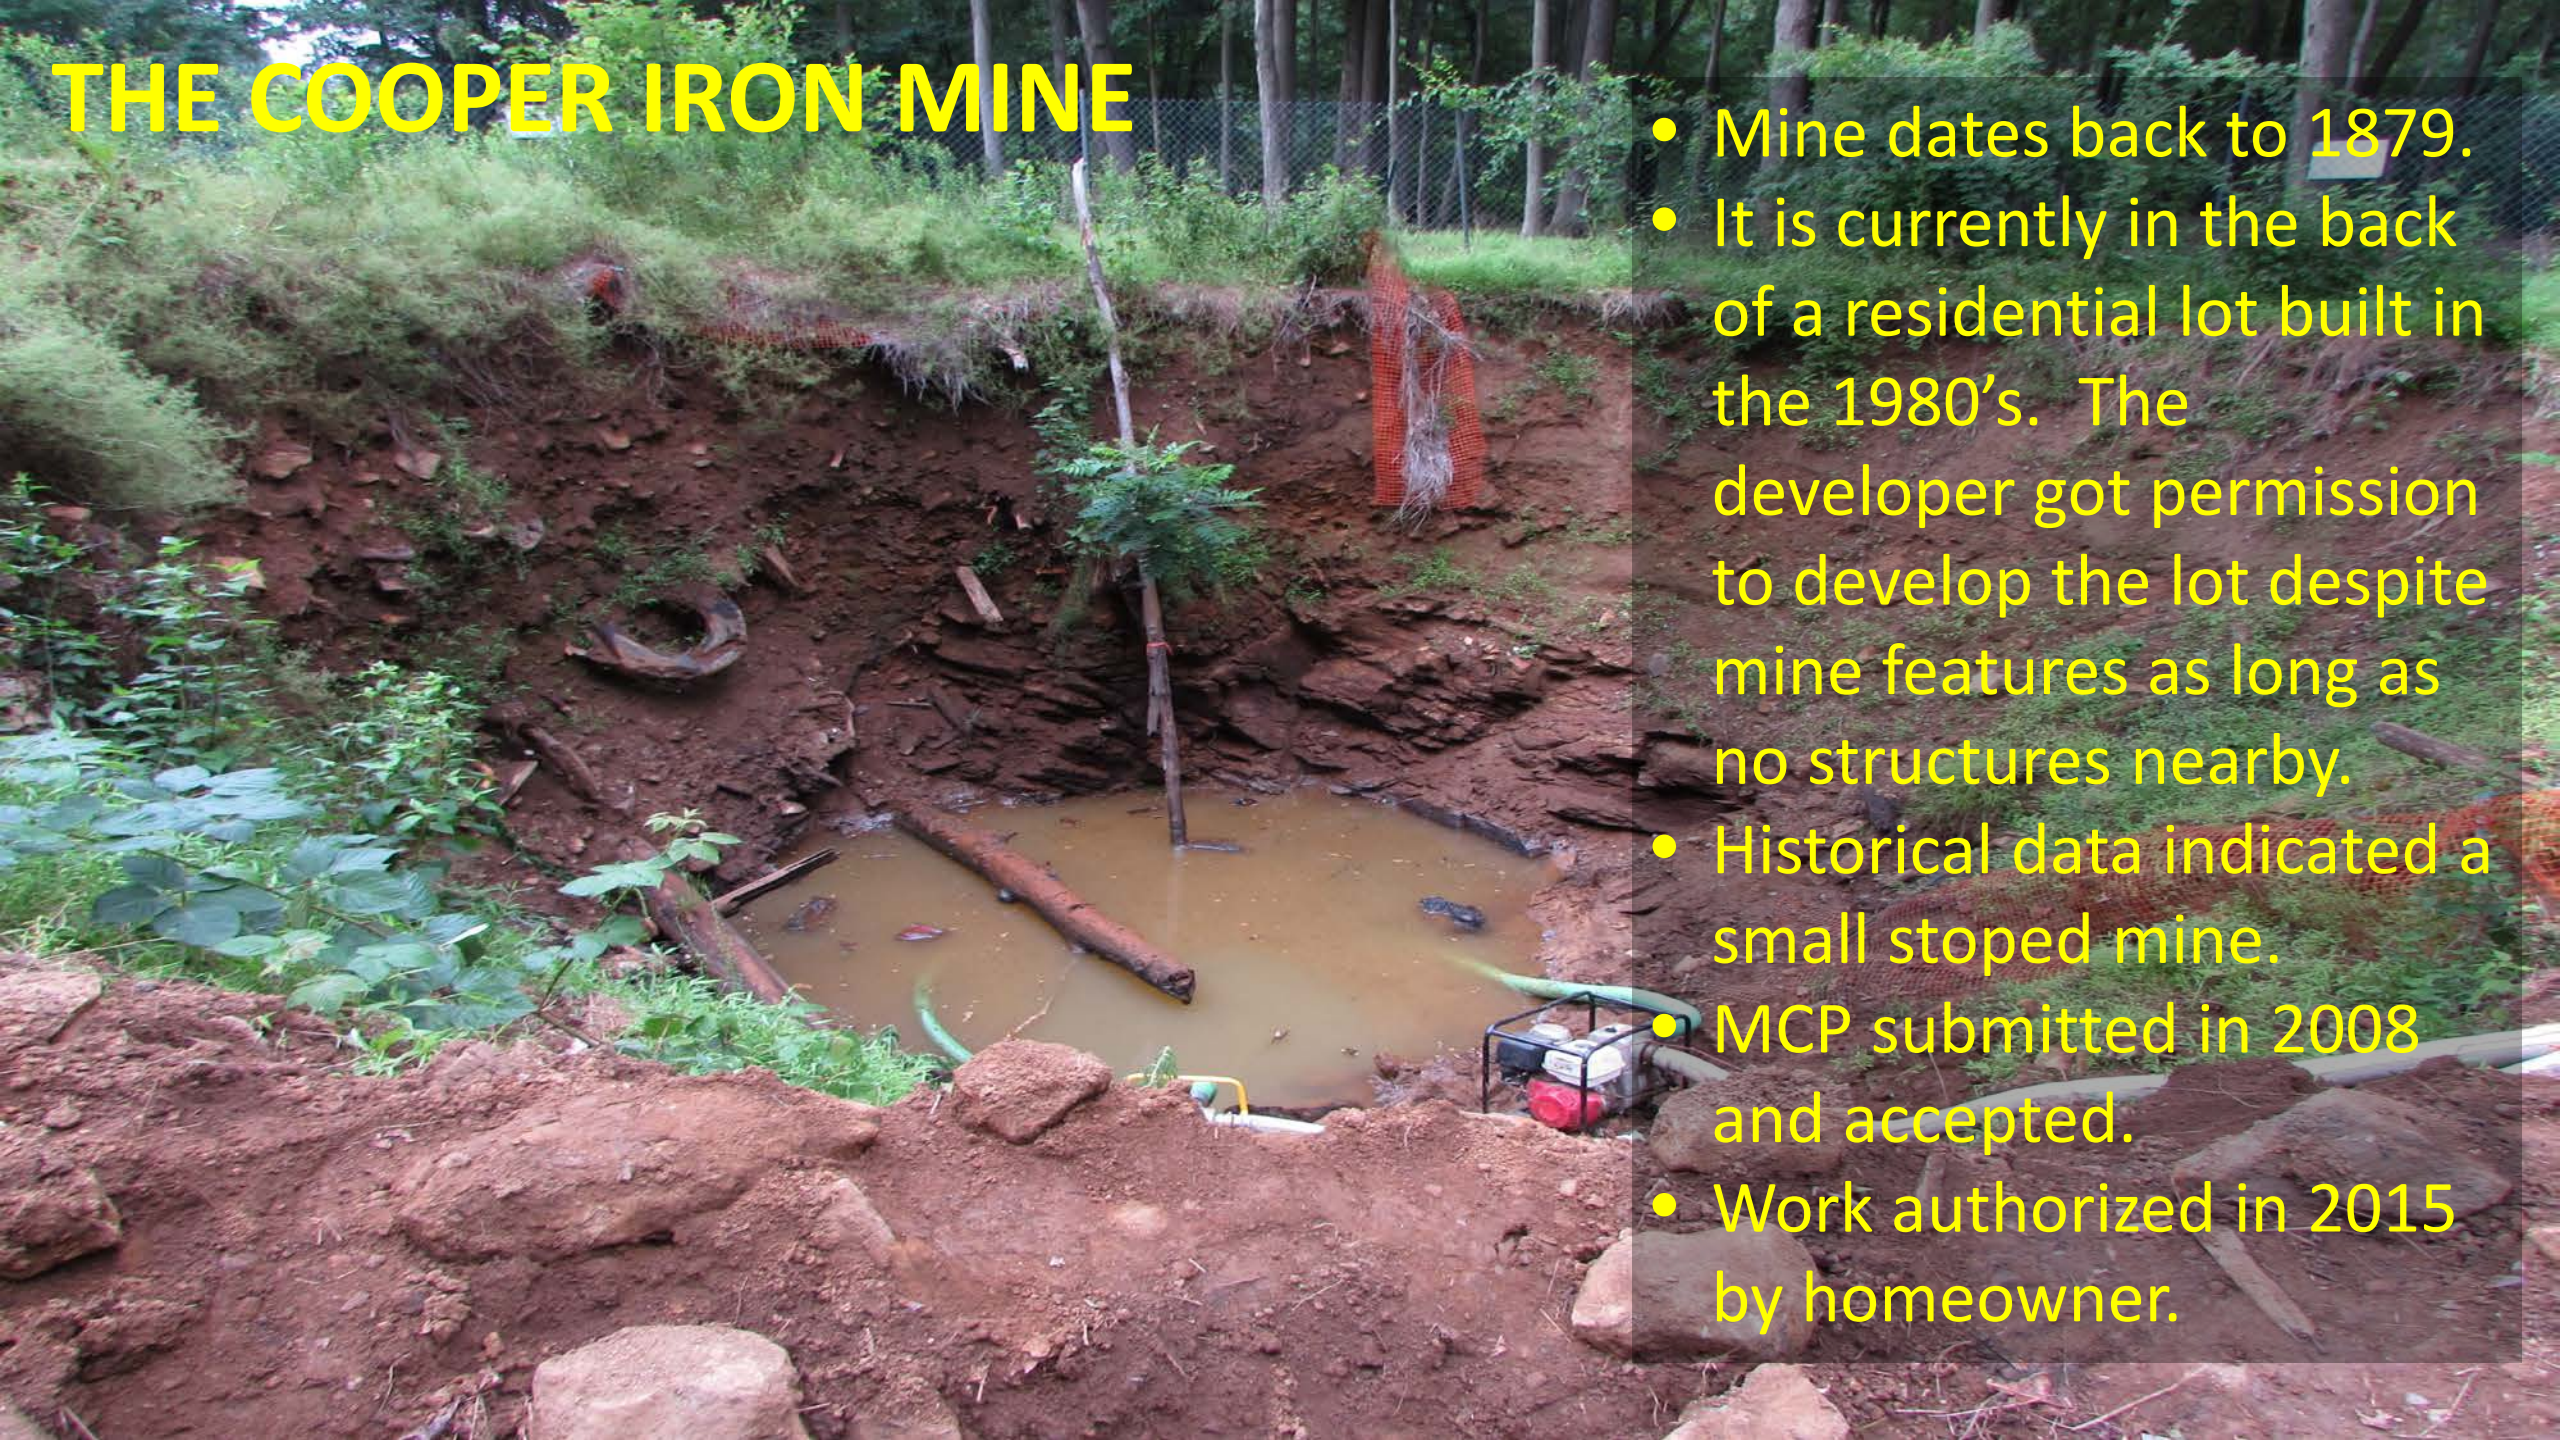
THE COOPER IRON MINE

- Plan was to block entrance to stope with large boulders, then reduce material size to choke opening.
- Reached the mine opening by dewatering with 2 large pumps for more than a week, excavation and timber cutting.
- Timber shoring, either for the mine or to close the mine was revealed.
- Dispute over costs with contractor, resulting from underestimating material costs causes cessation of work.
