S.R. 11/15 Rock Slope Safety Improvement Project

Marysville, Pennsylvania

Outline

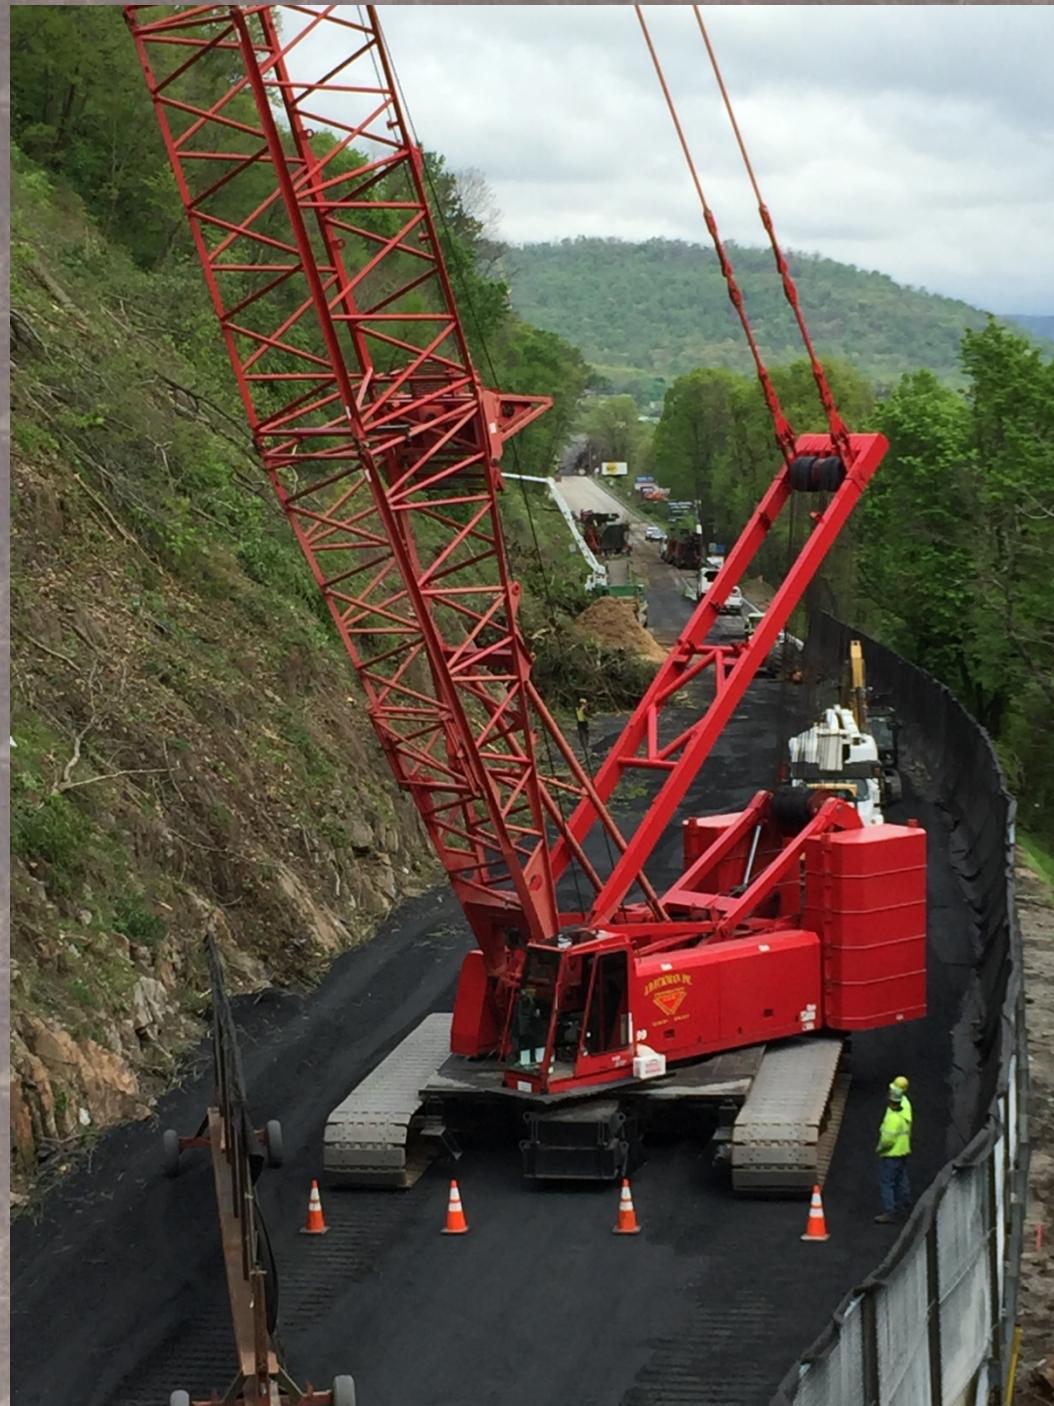
A 200-ton crane was needed not only to reach 200 feet up, but also to extend a significant distance horizontally away from the roadway to reach top of slope.

The roadway was covered with a 24" gravel mat for protection from the weight of the crane and from falling rocks and debris.

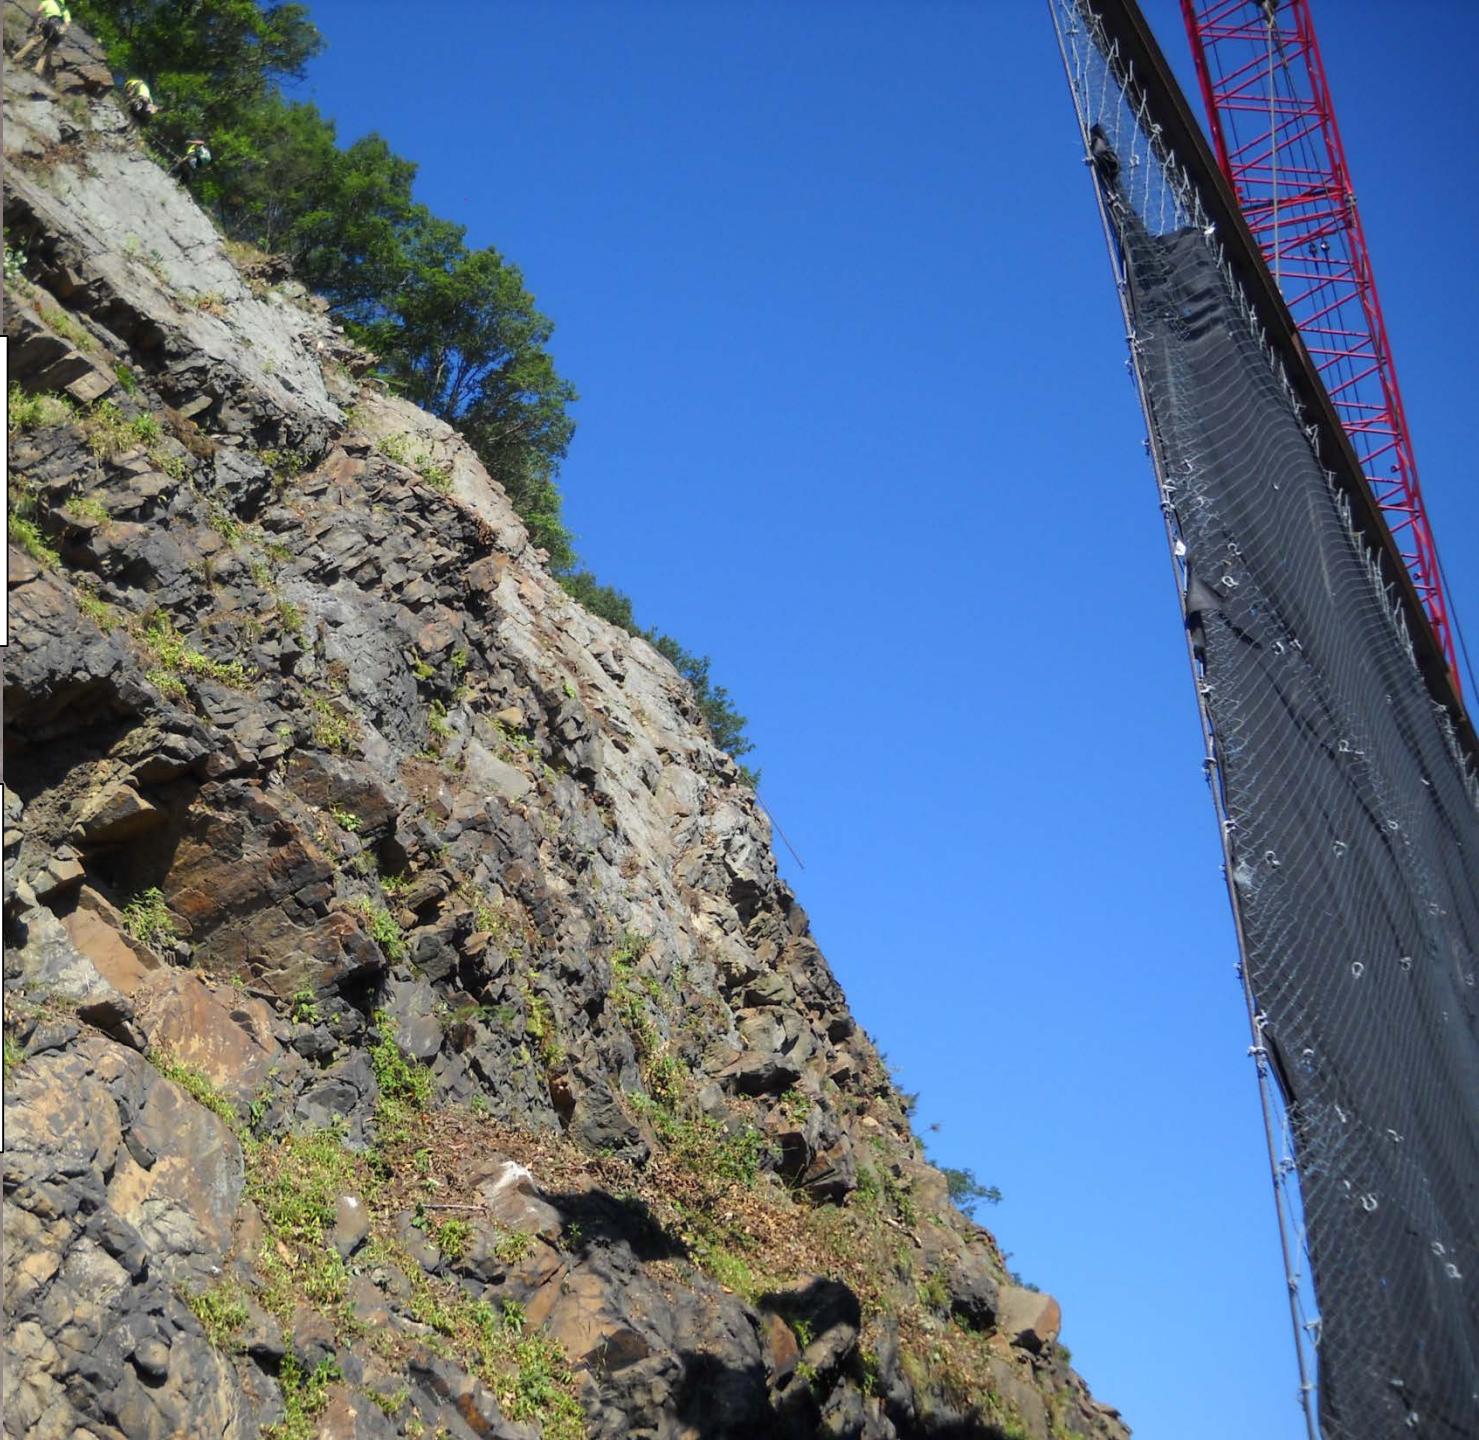
Temporary Shielding

Designed to contain falling rock and debris, especially during rock scaling

Analysis required to verify that crane and shield had capacity to withstand energy from falling rock

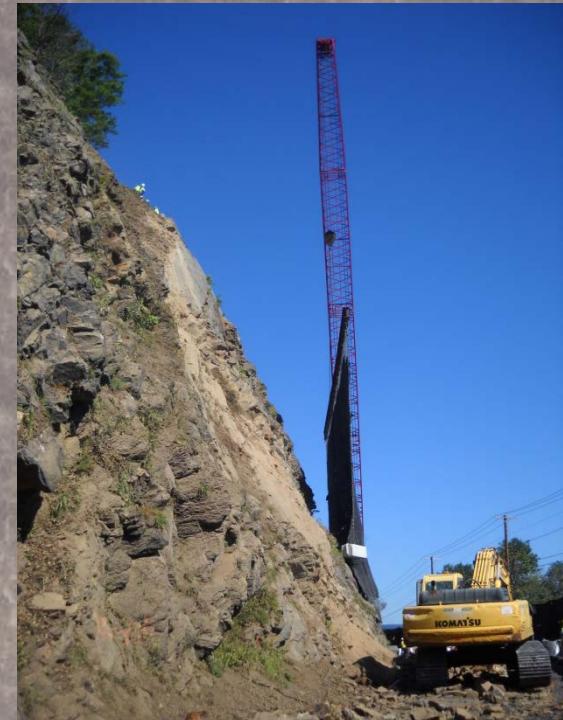
Rock Scaling

- The purpose of rock scaling is to remove loose or unstable rock to create a uniform surface, typically prior to the placement of wire mesh
- The removal of vegetation is usually required prior to performing effective rock scaling.

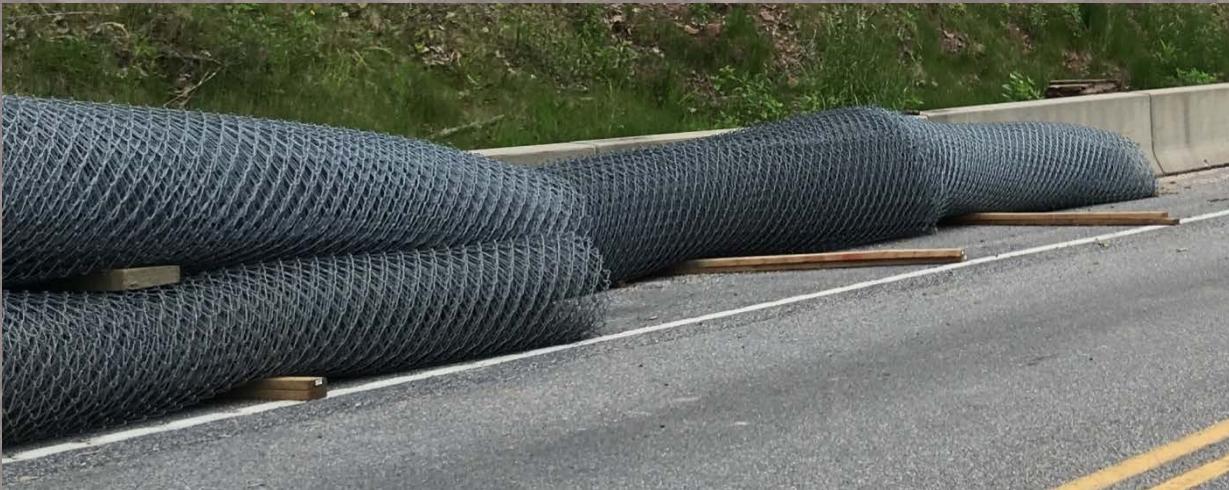
The Tecco® mesh was used as a draped mesh, which is anchored at the top of the slope.

The draped mesh was used as the treatment option on the highest slopes and covered a large, pre-determined area.

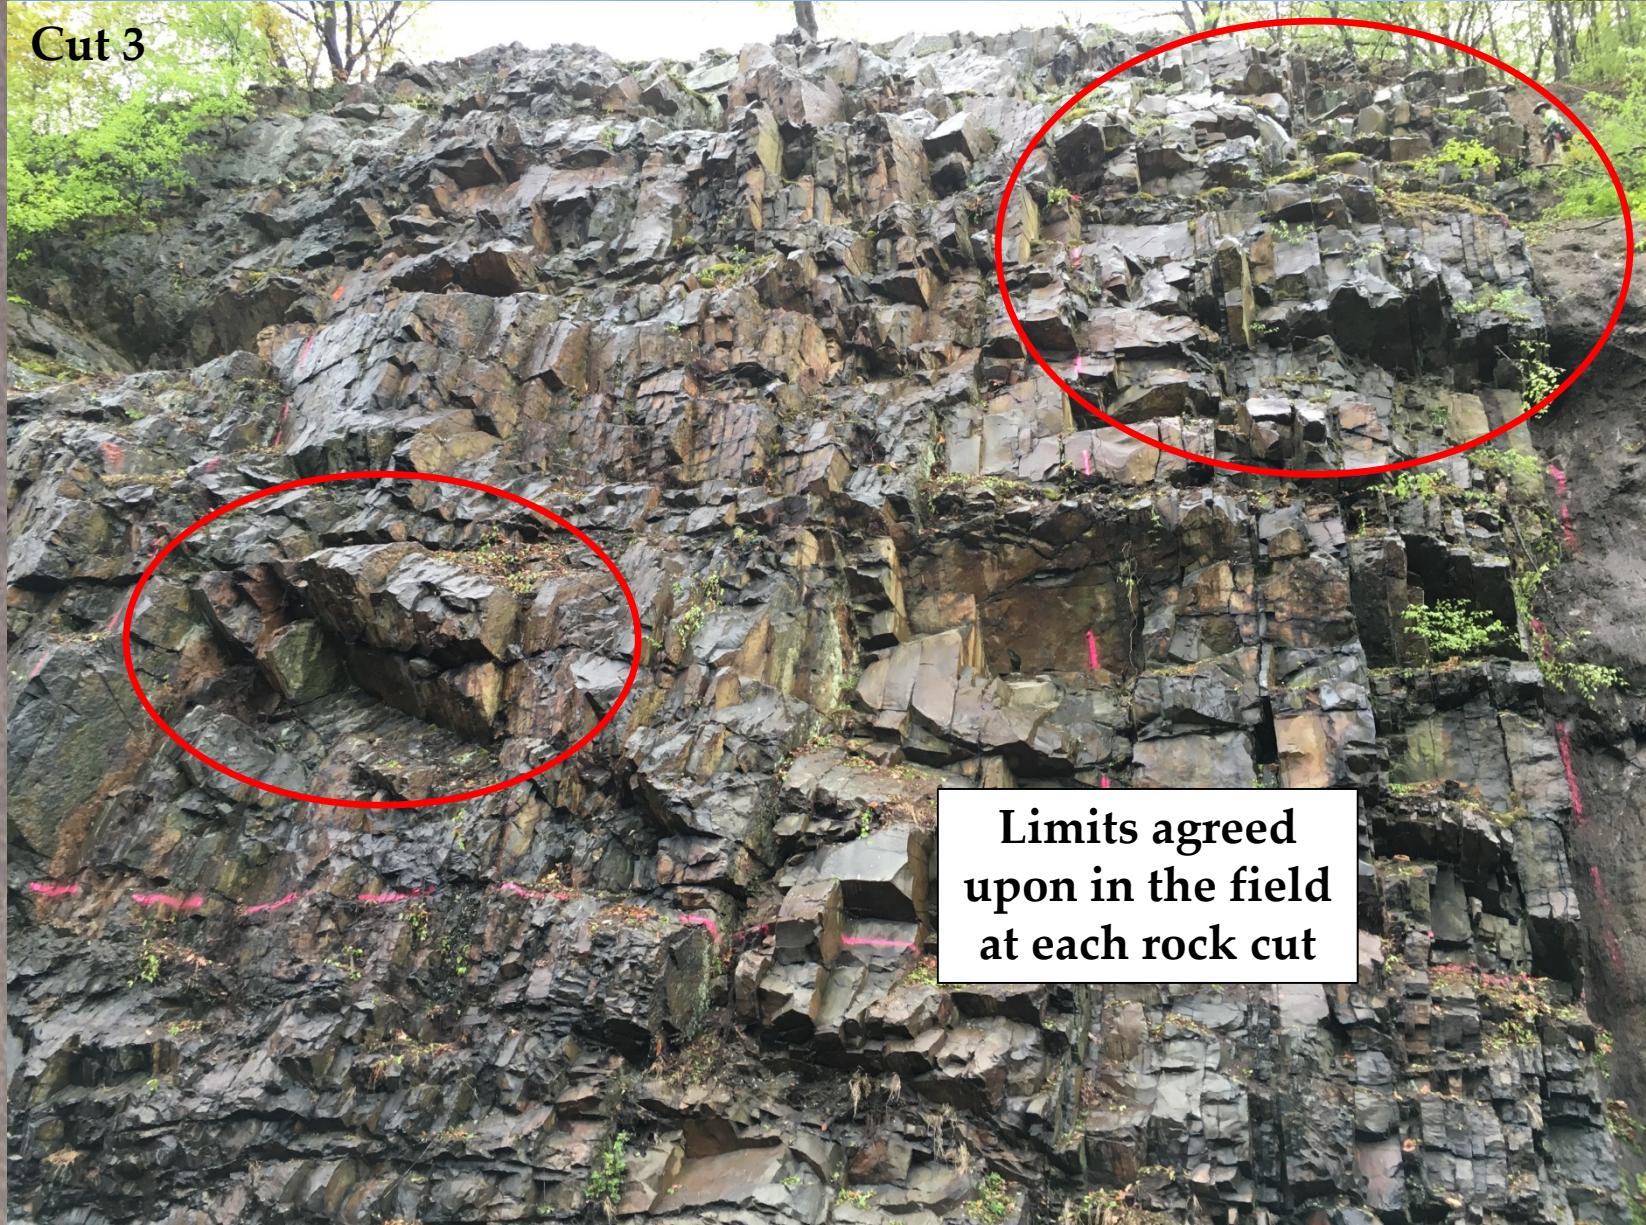
Cut 3

Determination of Spider® mesh locations after rock scaling.

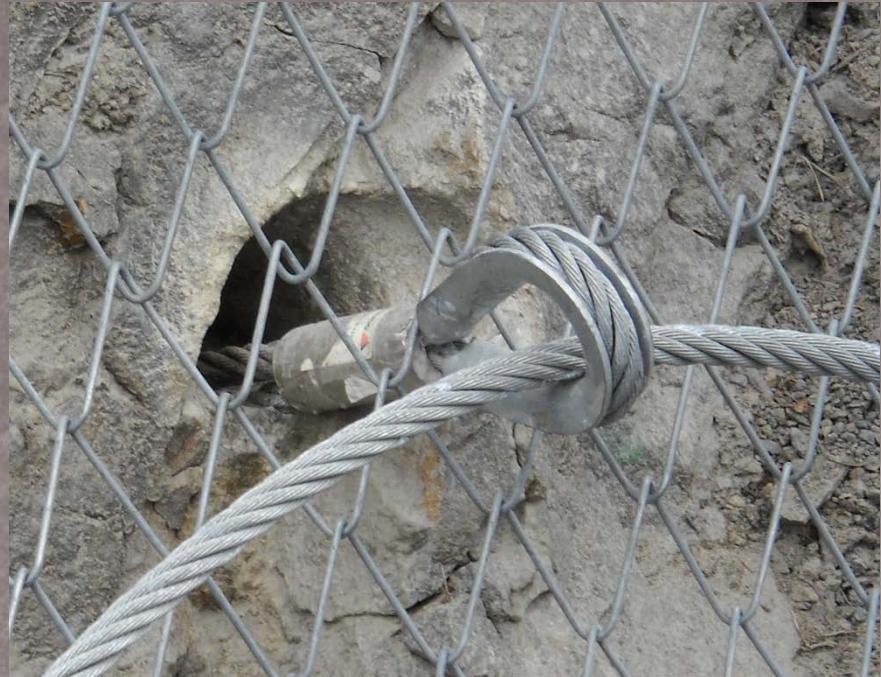
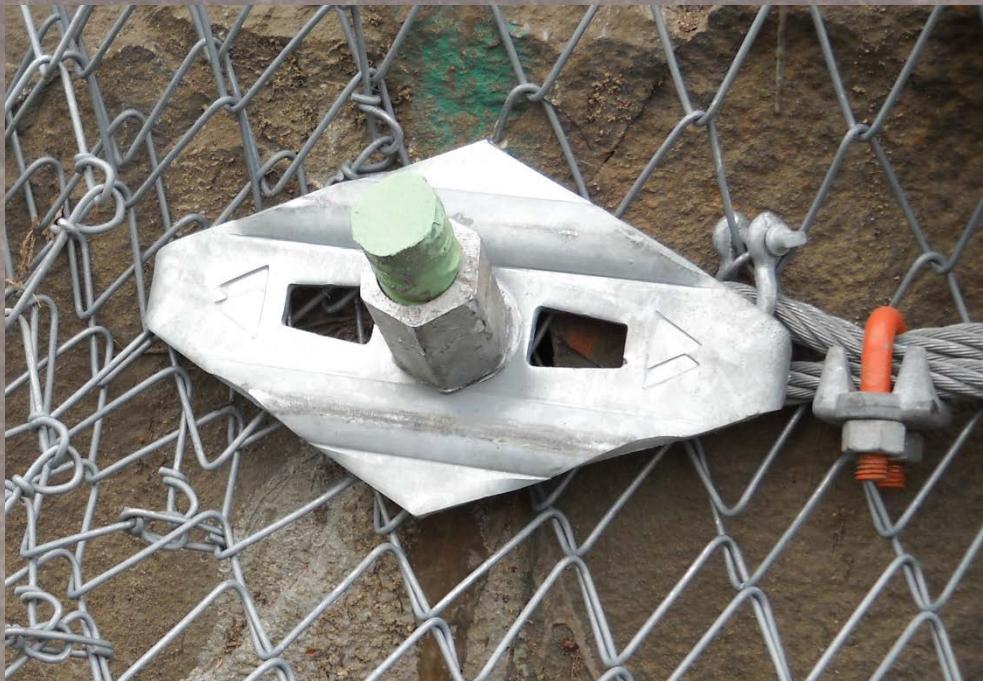
**Wire Rope Anchor
with Support Rope**

**Rock Anchor Bolt
with Spike Plate**

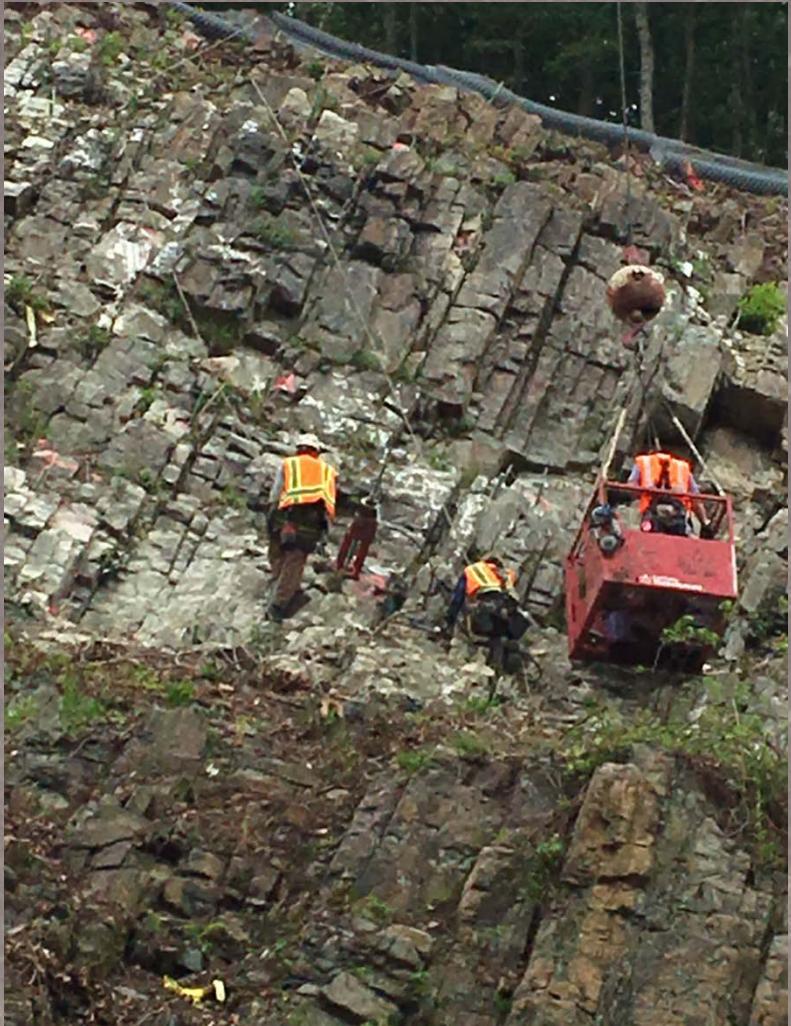
The specifications indicated that a certain number of each type of anchor must be tested to ensure that the bond strength was being attained so that the systems could support the anticipated loads.

Hydraulic
Jacking
System

Pressure
Gauge

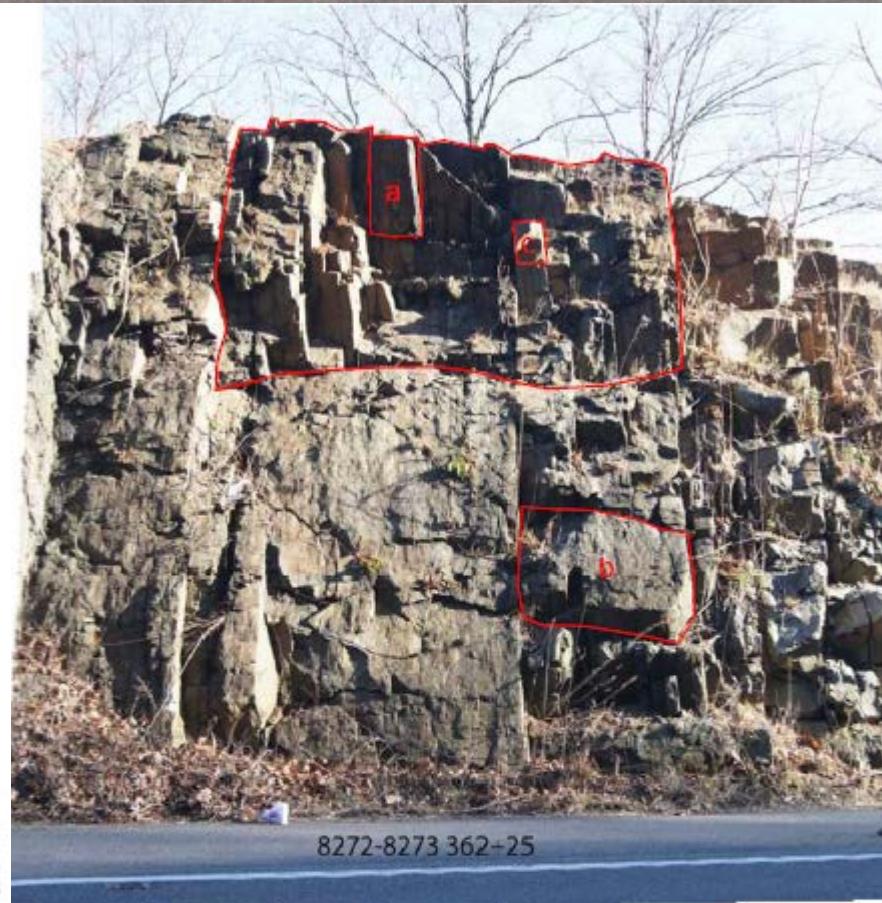
Rock Size Determination

Overall: 10'H x 5.5'W x 30"D
Note: Four primary beds
within, 1.5', 1', 1', and 2'.
Depth based on exposure
near base.

Overall: 8'H x 18"W x 2'-3'D?
a. 2.5'H x 18"W x 2'D?
b. 3.5'H x 4"W x 2'D?
c. 1'H x 8"W x 1'D?
Note: Depth uncertainty

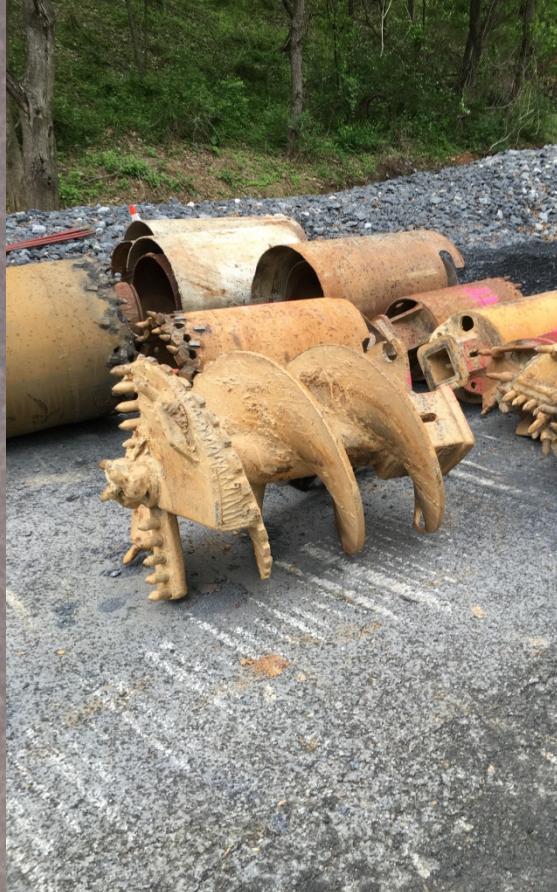
Drilled Caisson
diameter = 18" to 30"

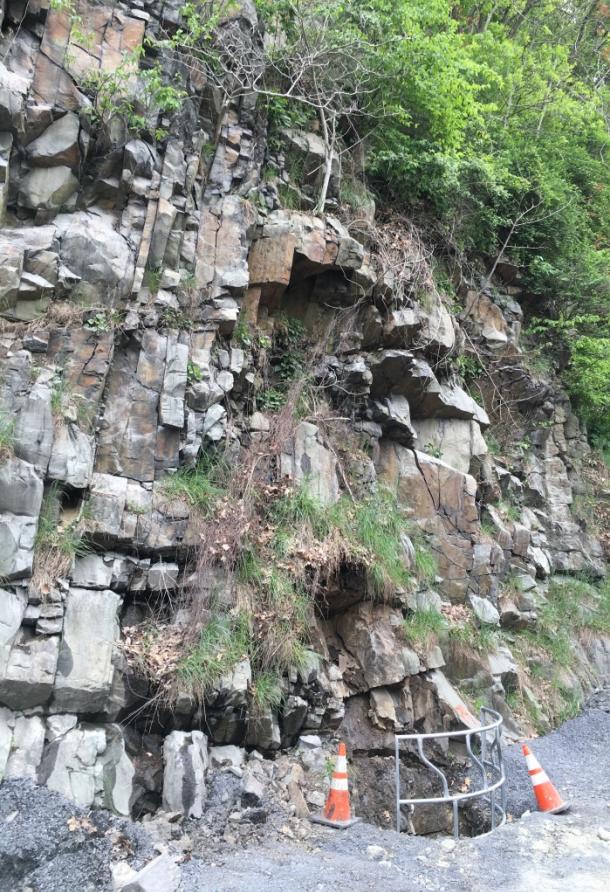
Rock Socket
length = 5' to 15'

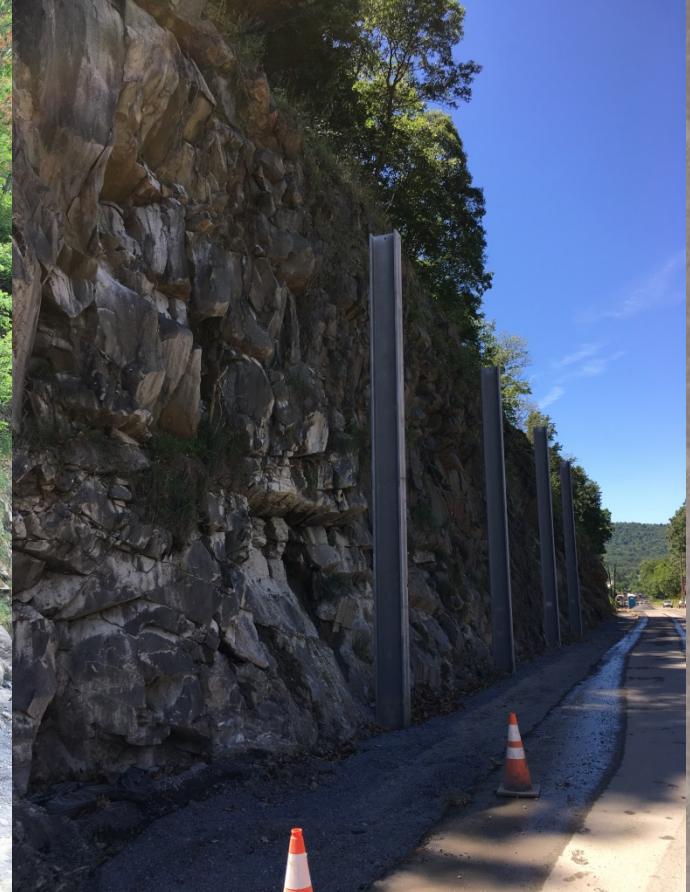
Post length = 27' to 47'
