Geohazard and Transportation Aspects of Sulfidic Rock (Acid Rock) in North Carolina

Tommy Douglas North Carolina Geological Survey

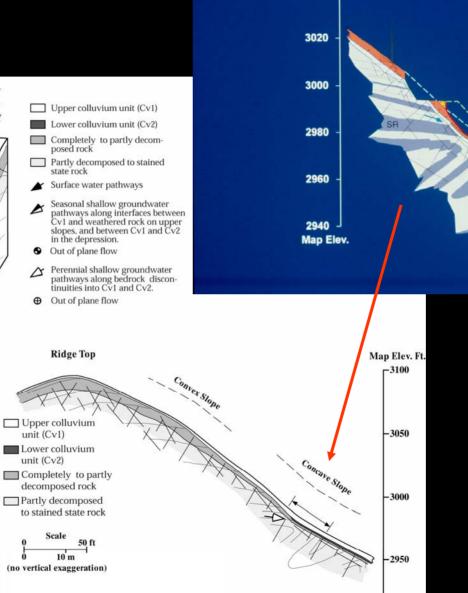
Geologic Cross Section Through Debris Flow Initiation Zone

Road Fill

Colluvial

Soil Units

Rock (Zwe) RE
