Foundation Problems and Pyrite Oxidation in the Chattanooga (Ohio) Shale Estill County, Kentucky

**John Kiefer, Kiefer@uky.edu
Warren H. Anderson, Wanderson@uky.edu
Kentucky Geological Survey
University of Kentucky**

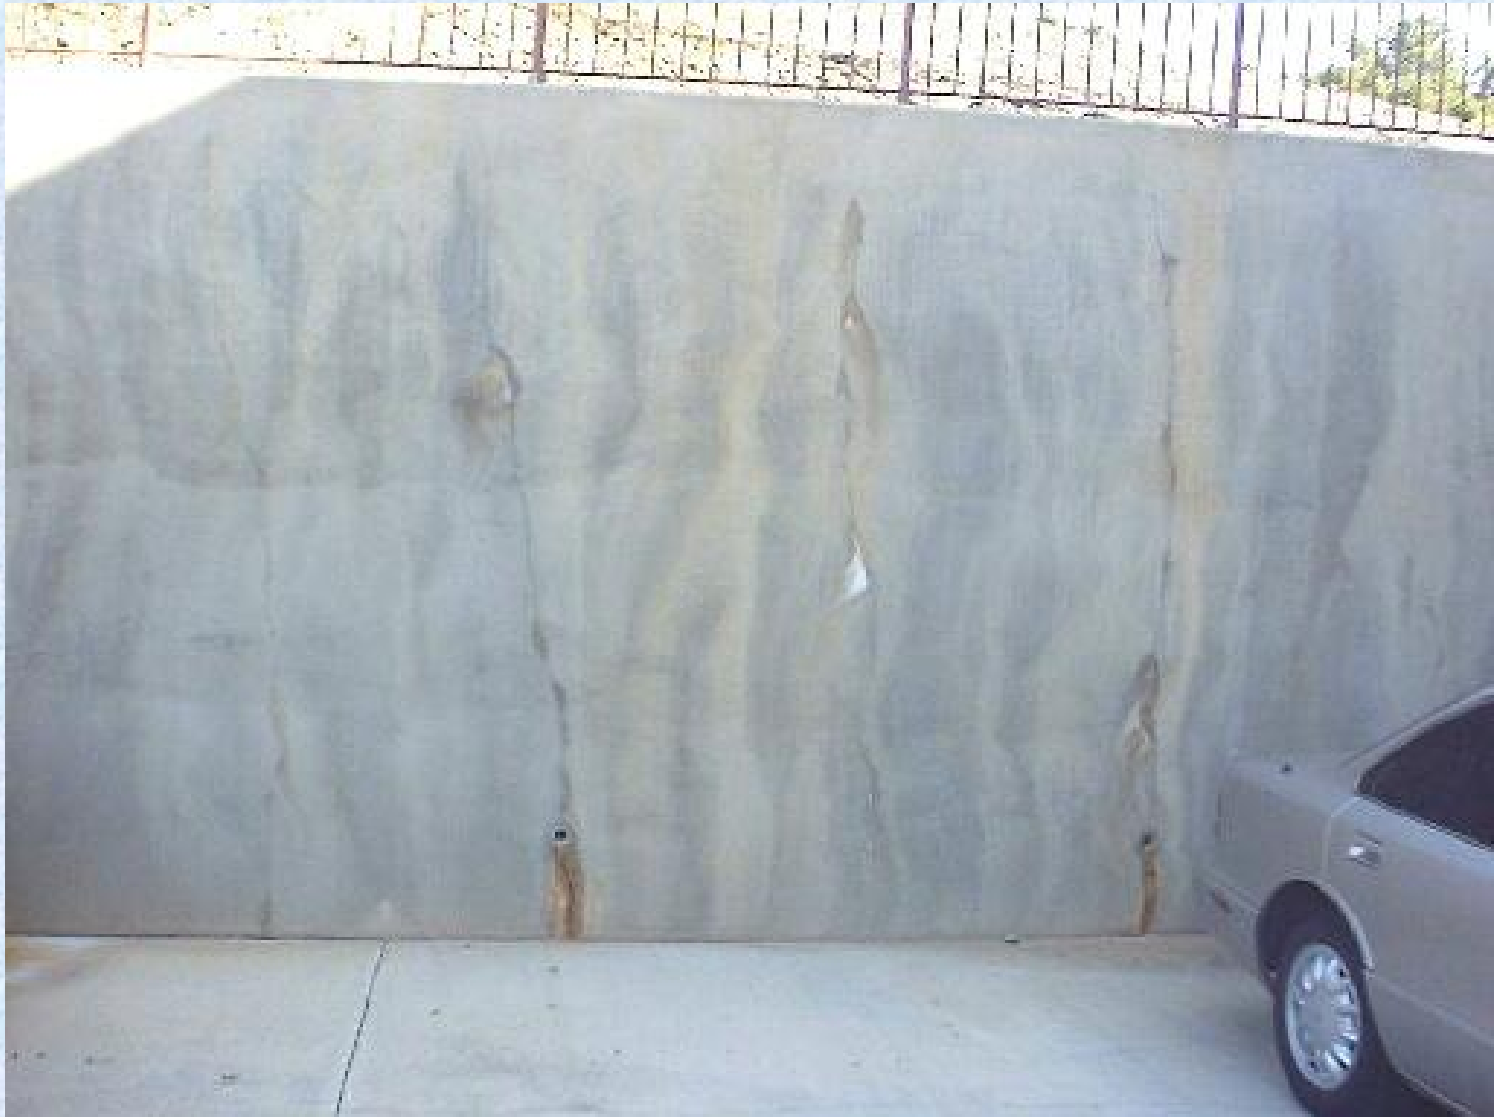
Tension fractures in retaining wall

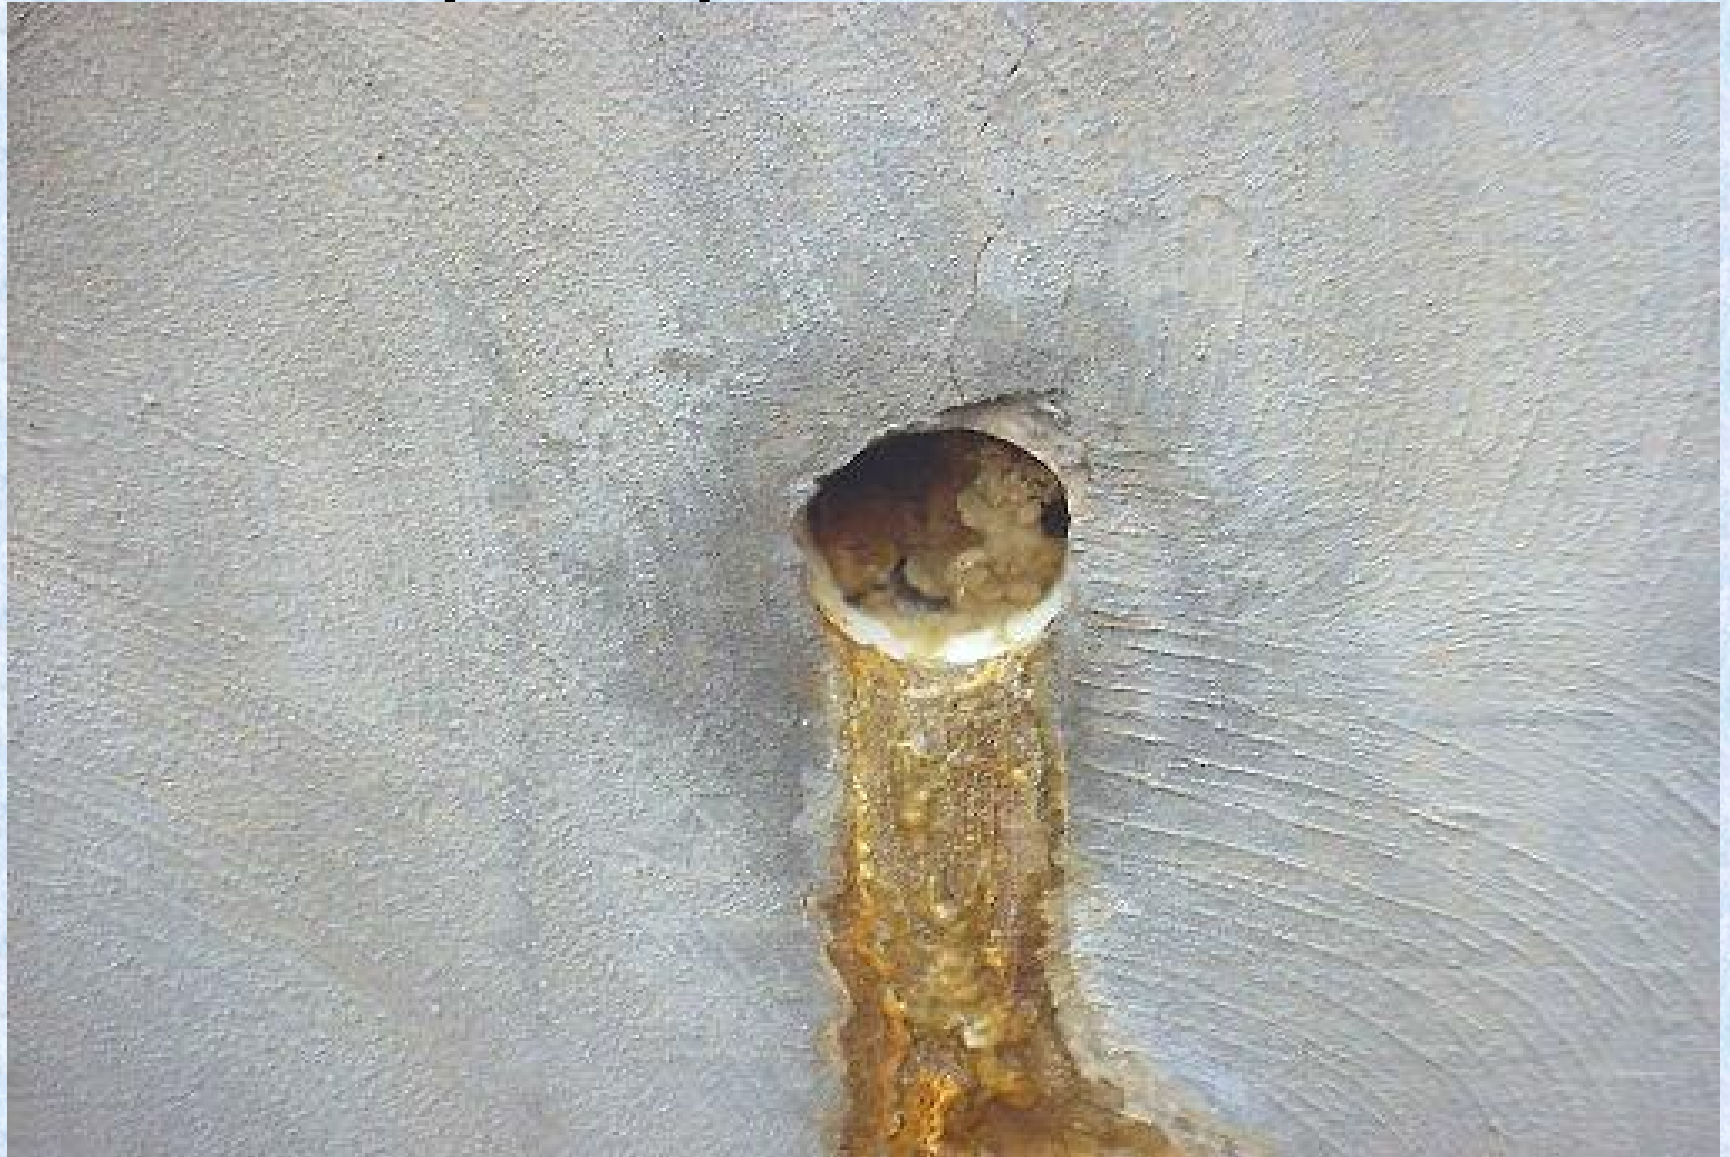
Sulfate precipitates in drain tile

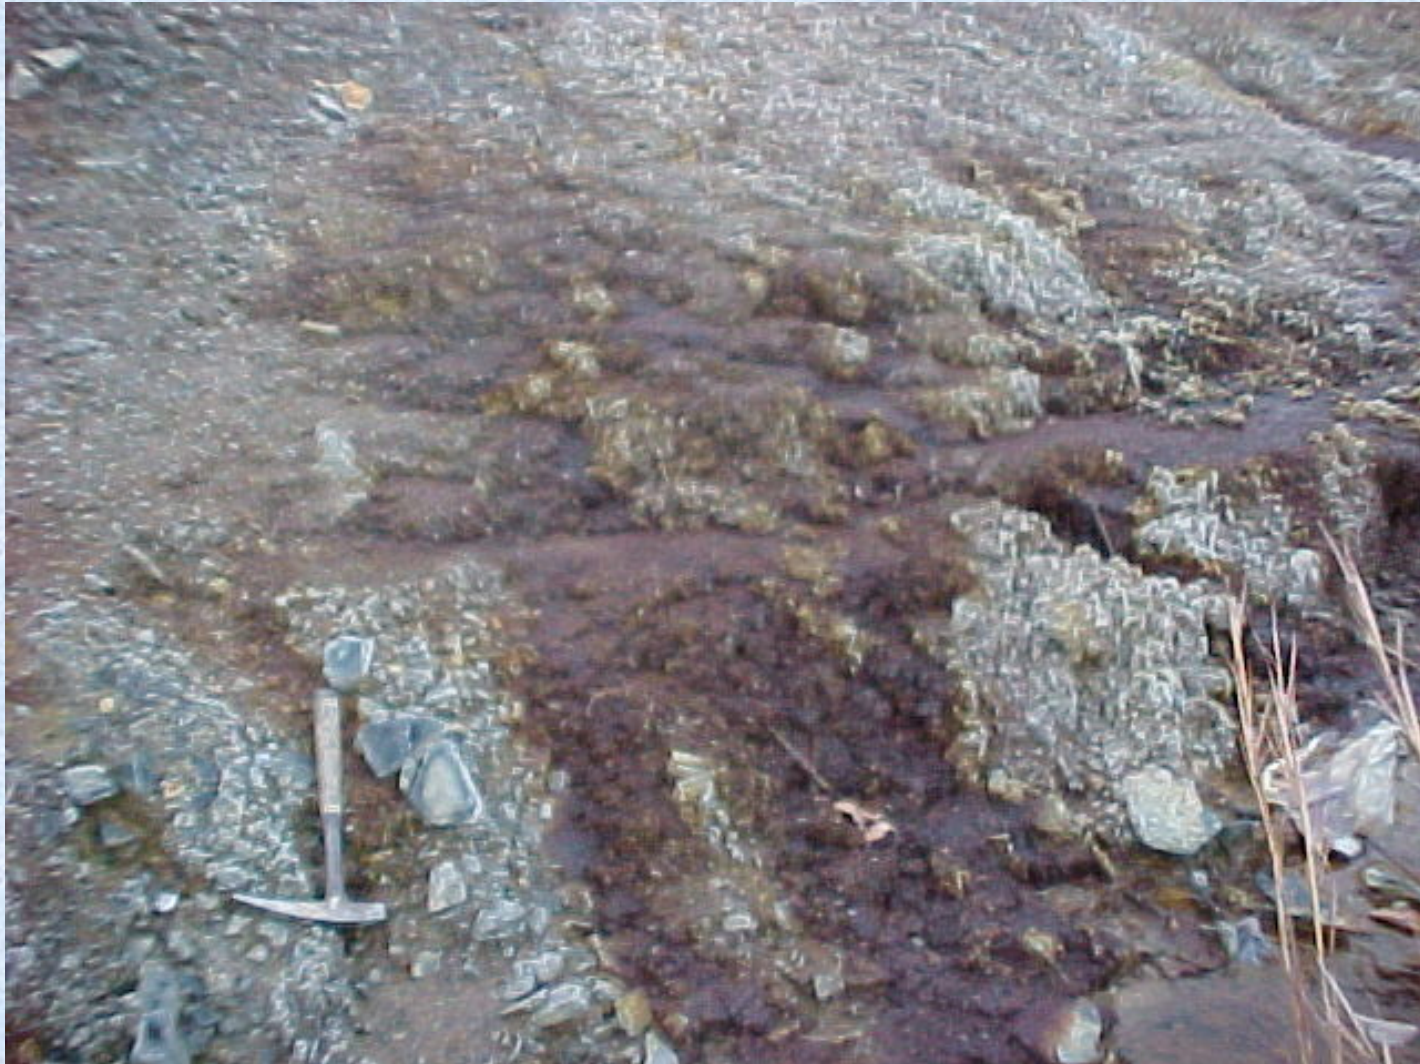
Iron Stain on Black Shale

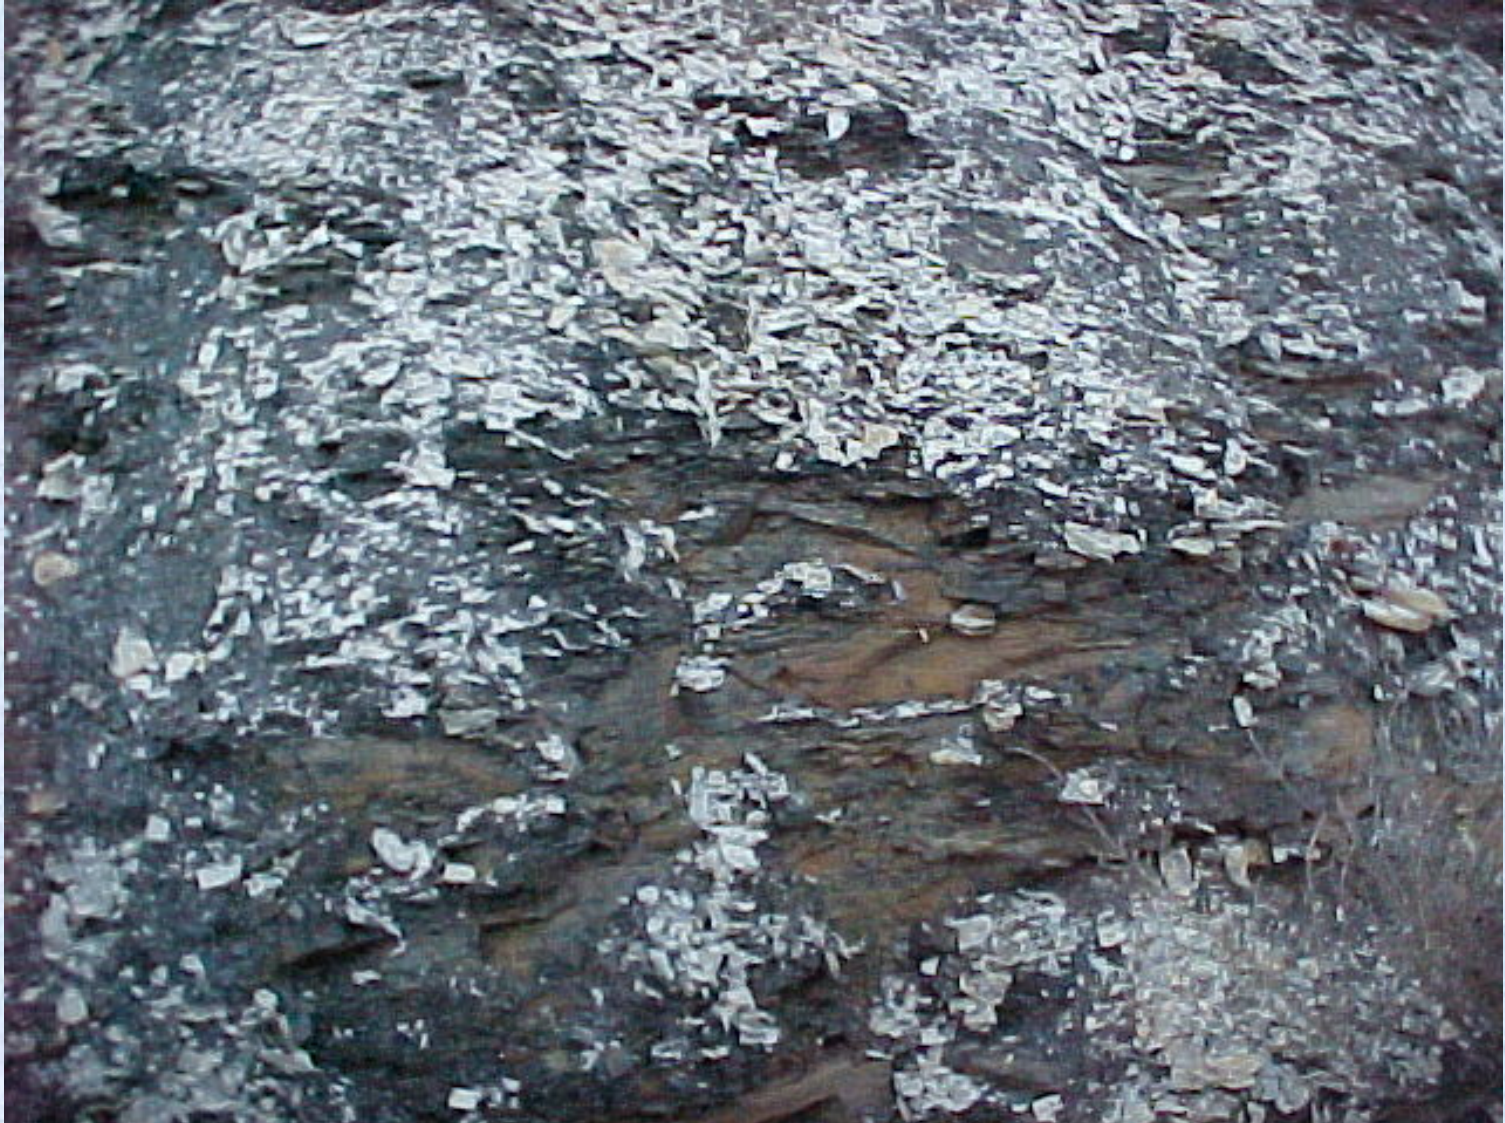
Sulfate efflorescence on Shale

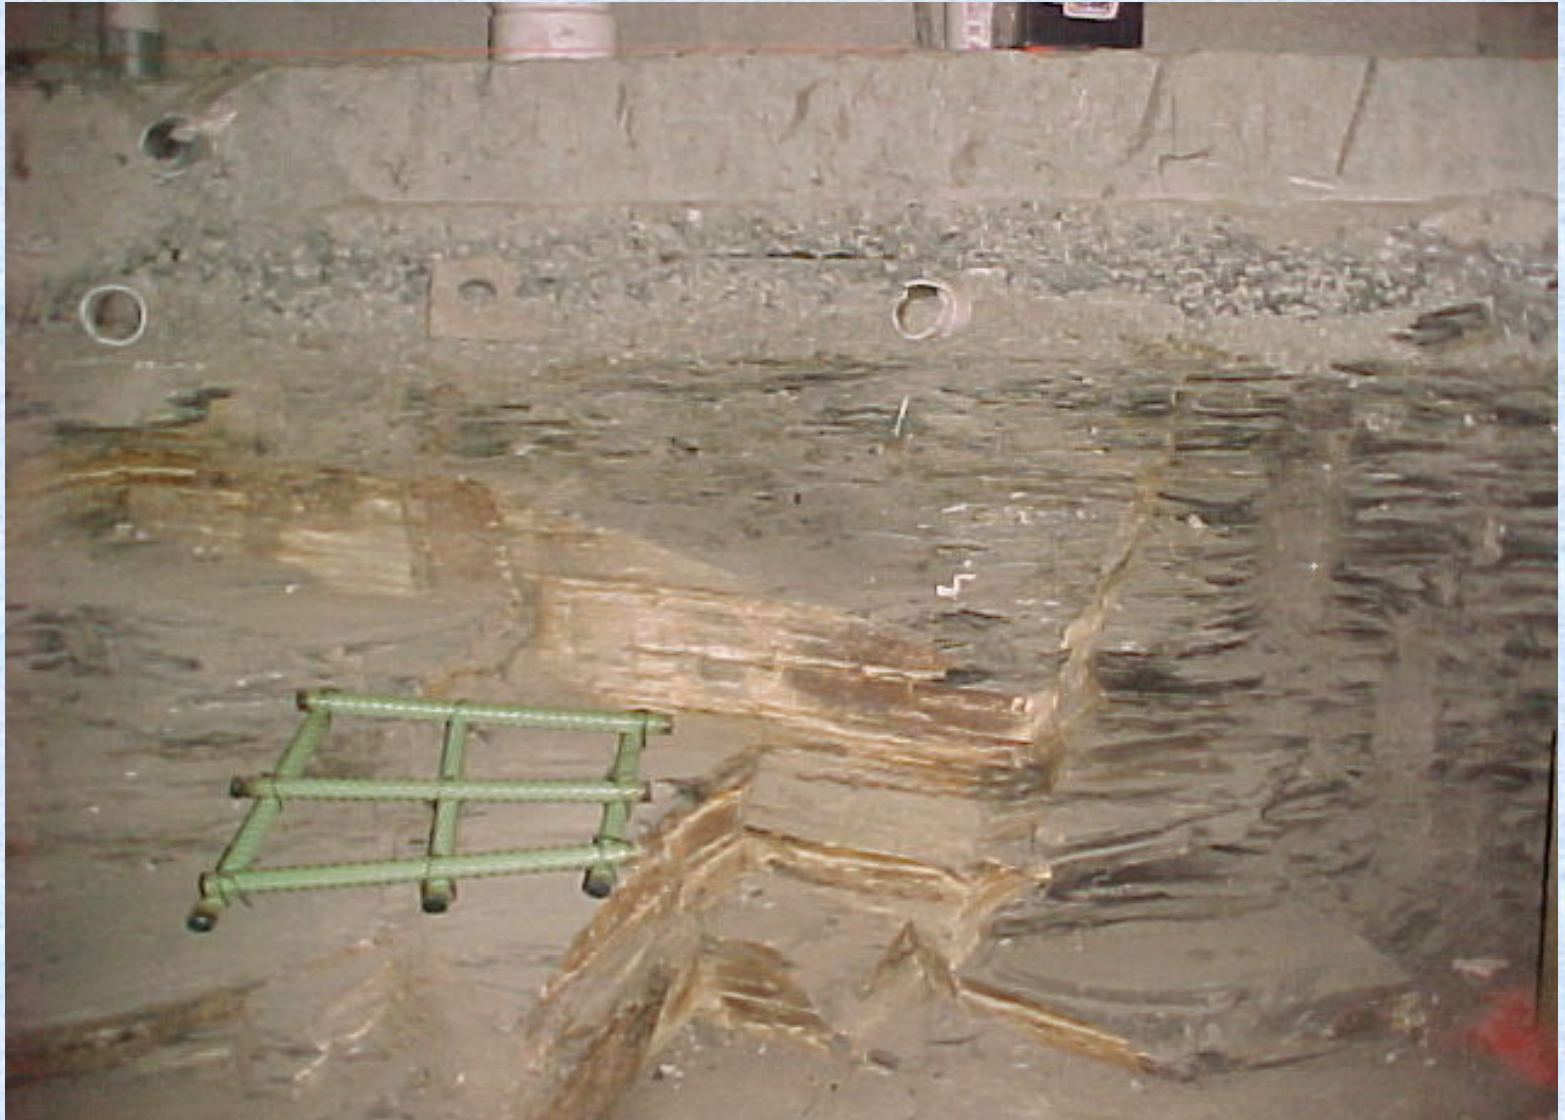
Cleats, fractures in subcrop

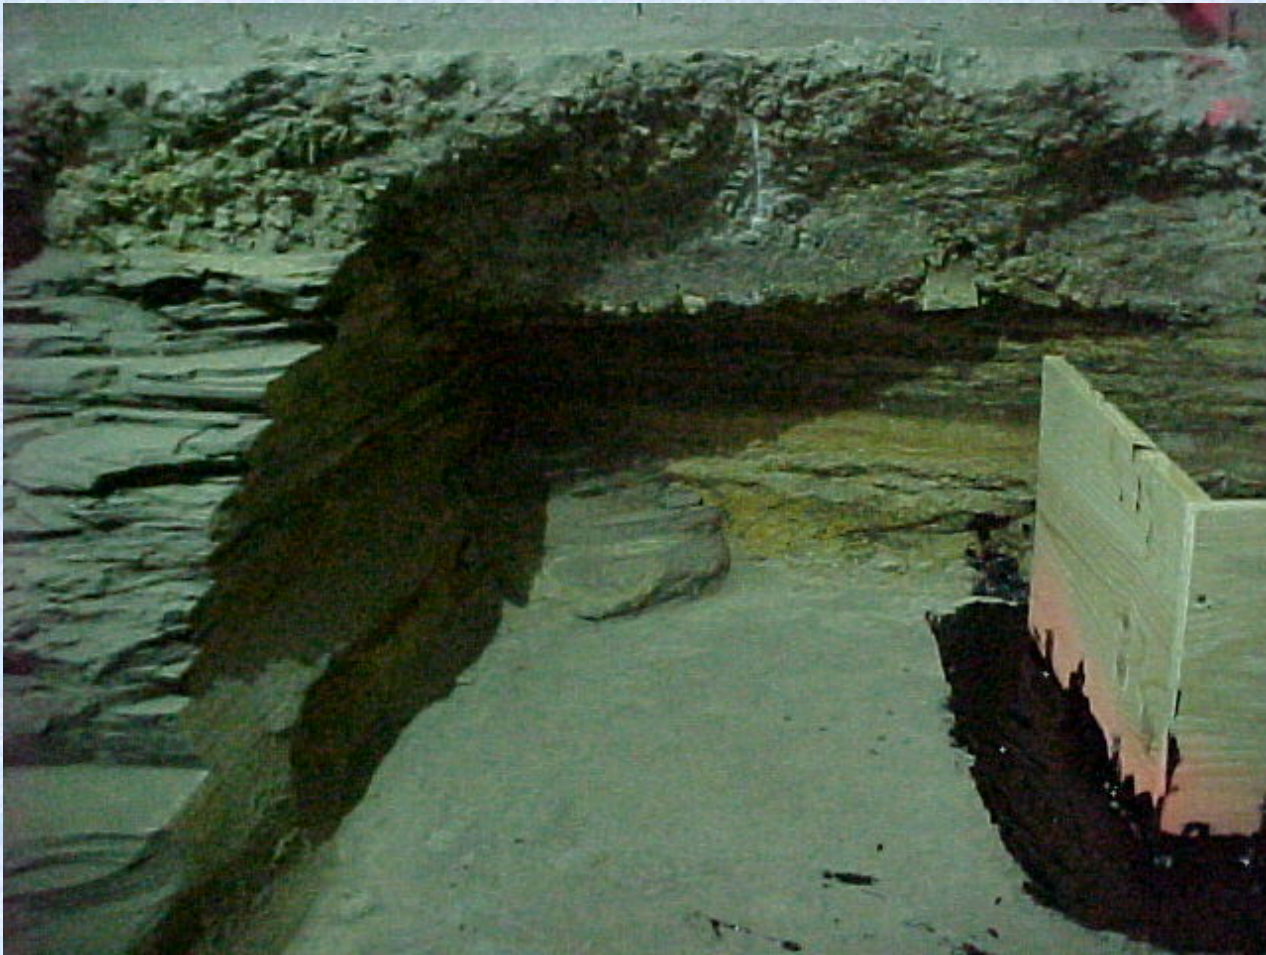
Copiapite along cleat

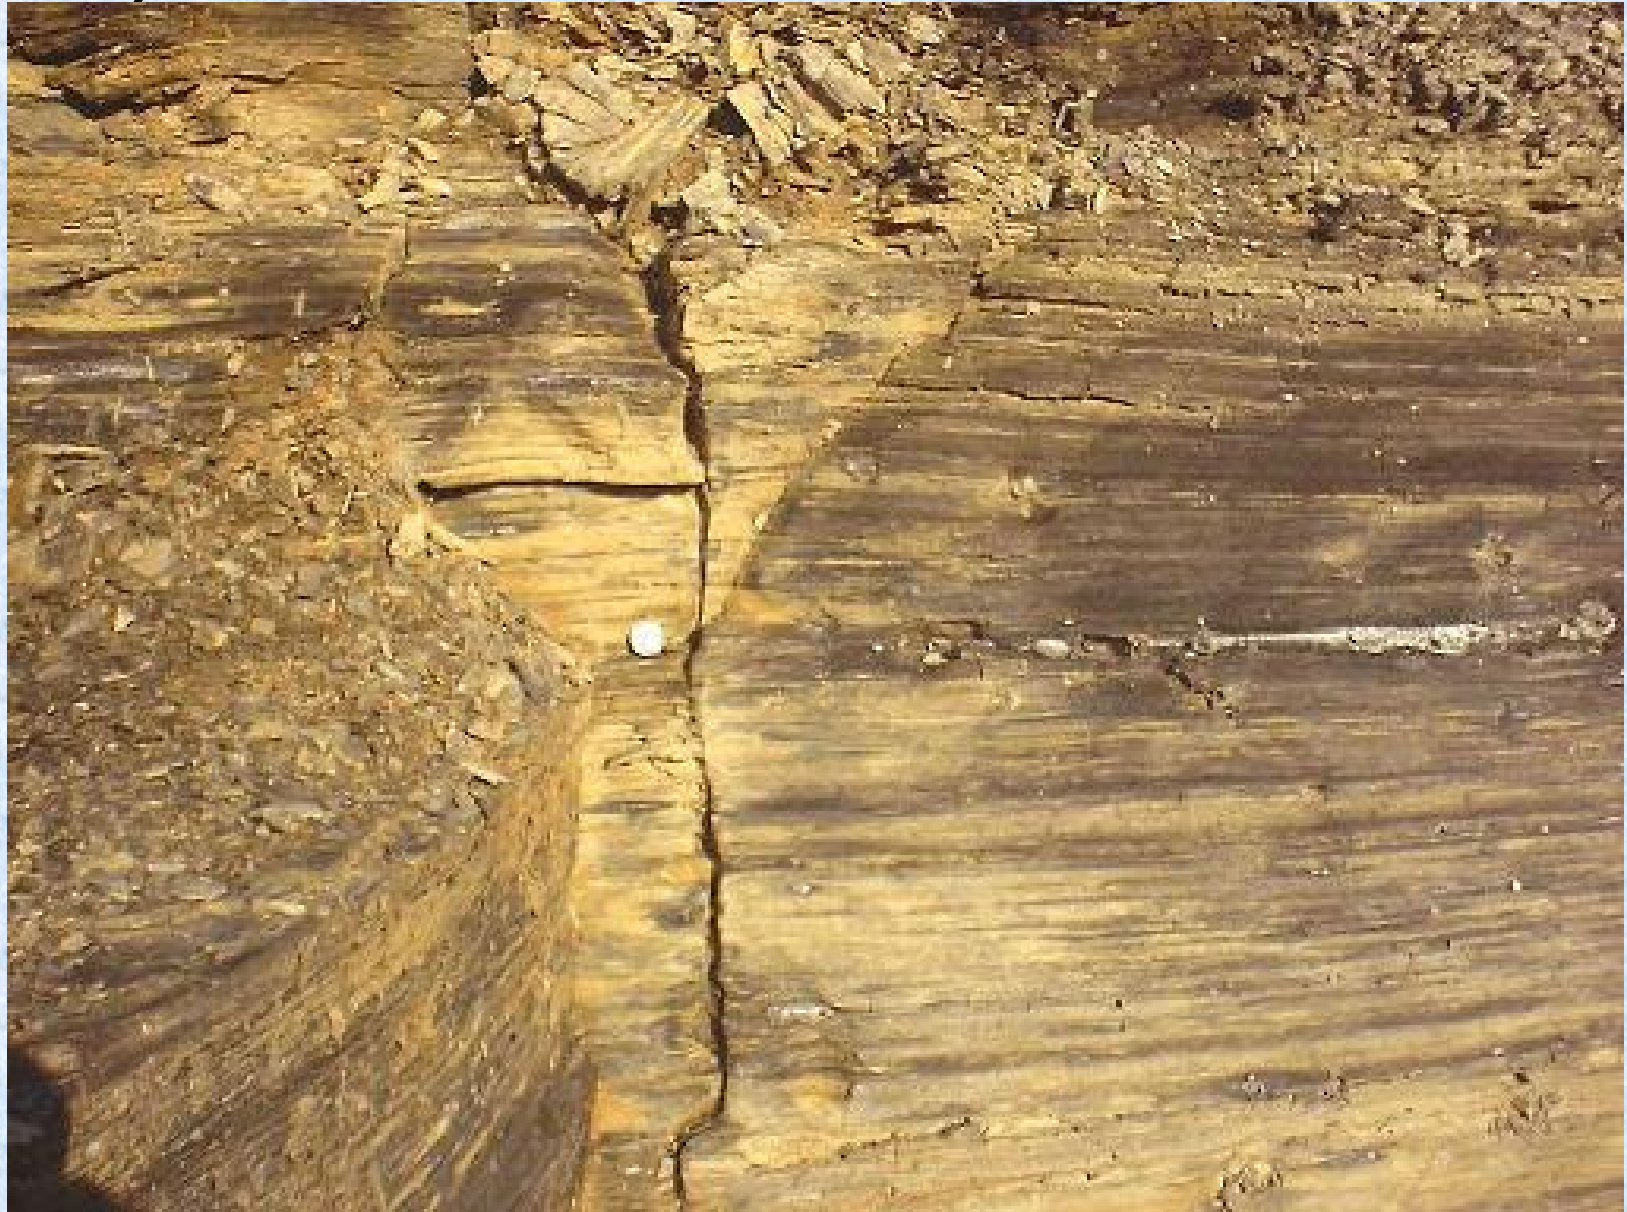
Pyrite nodule zone in Black Shale

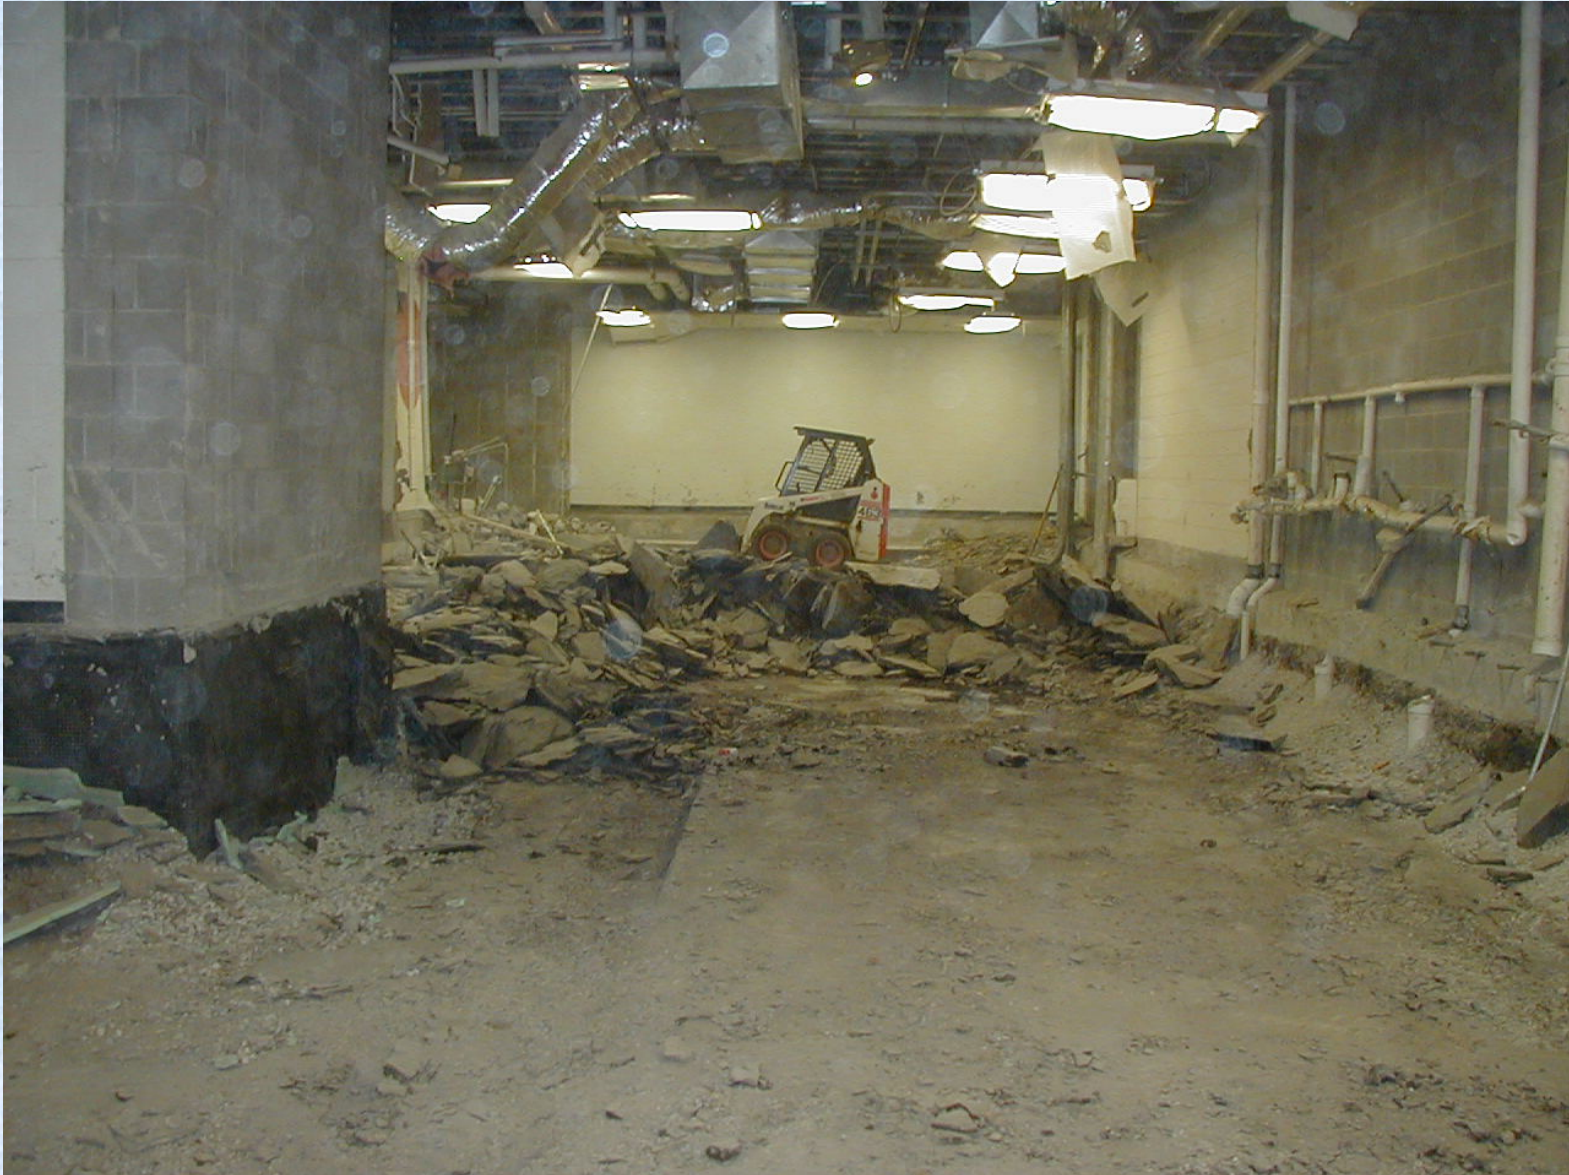
Gymnasium Repair

- **Pre-construction prevention**
- **Remediation solutions**
 - **Remove foundation material and fill, and replace with impermeable water/moisture barrier. Create new sub-floor bearing walls or piers, and refill with non-shale aggregate**

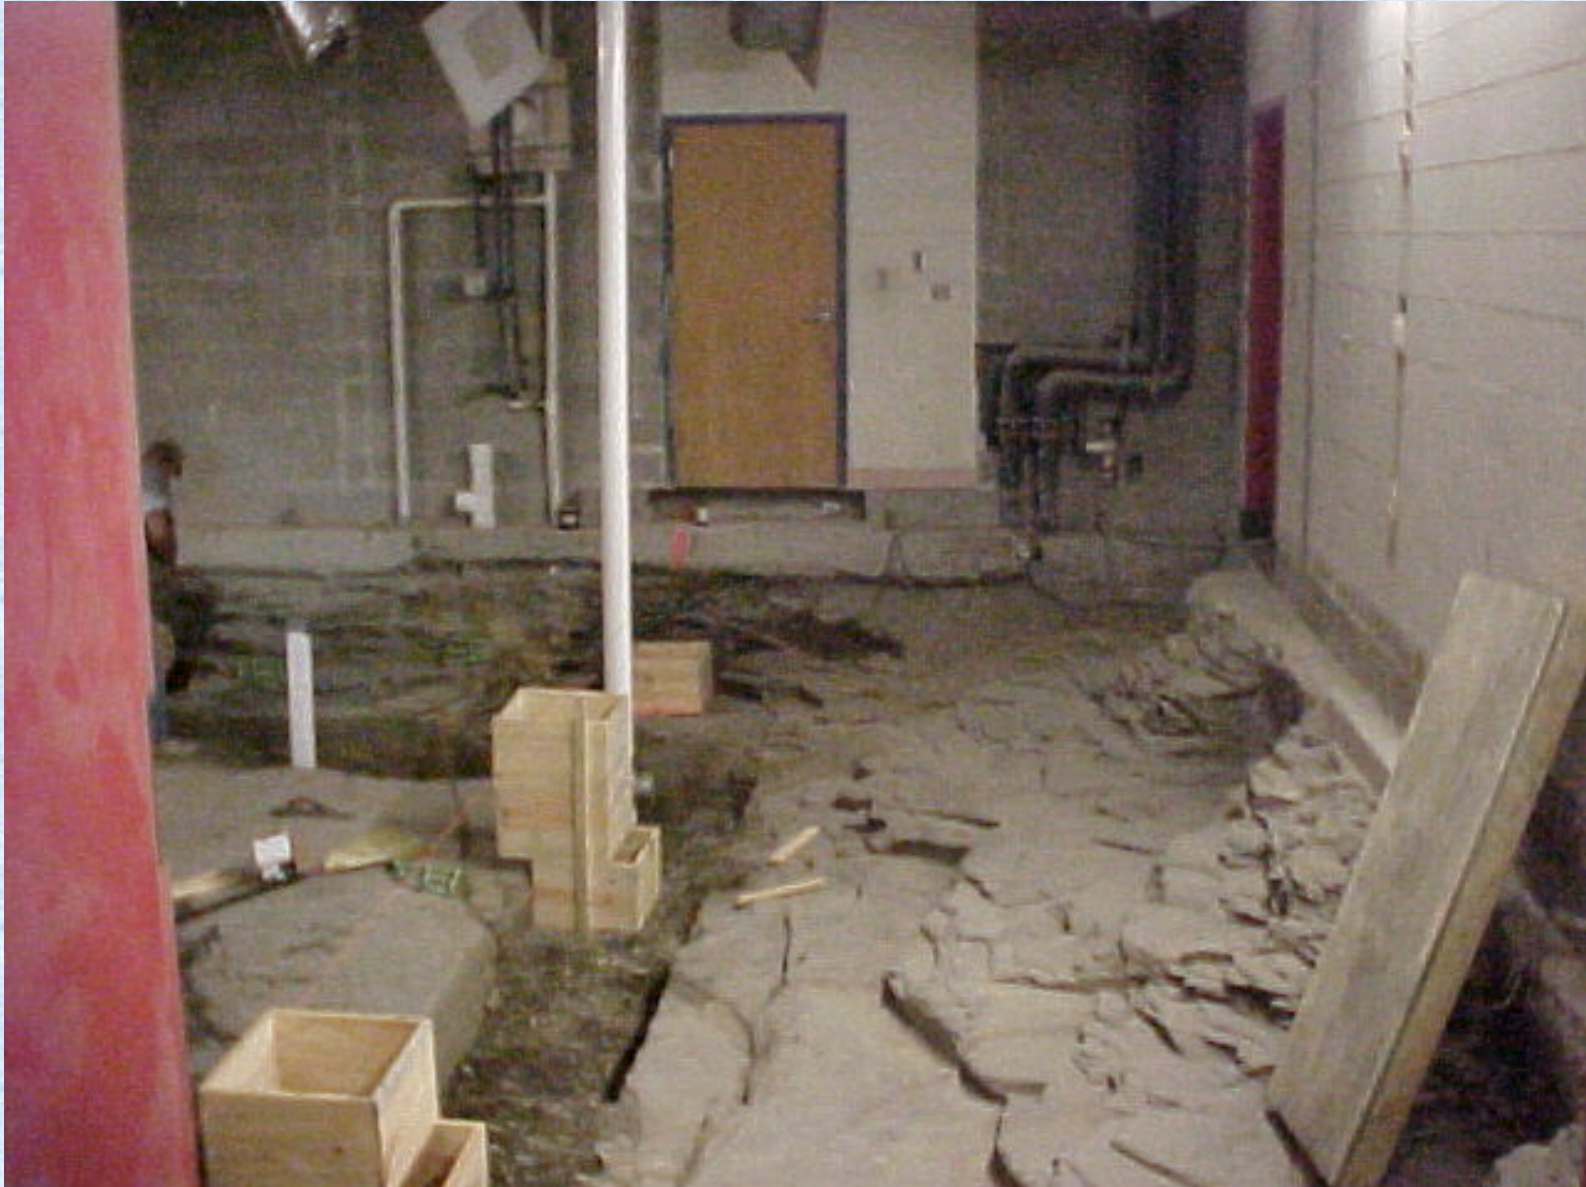
Black Shale subcrop in School

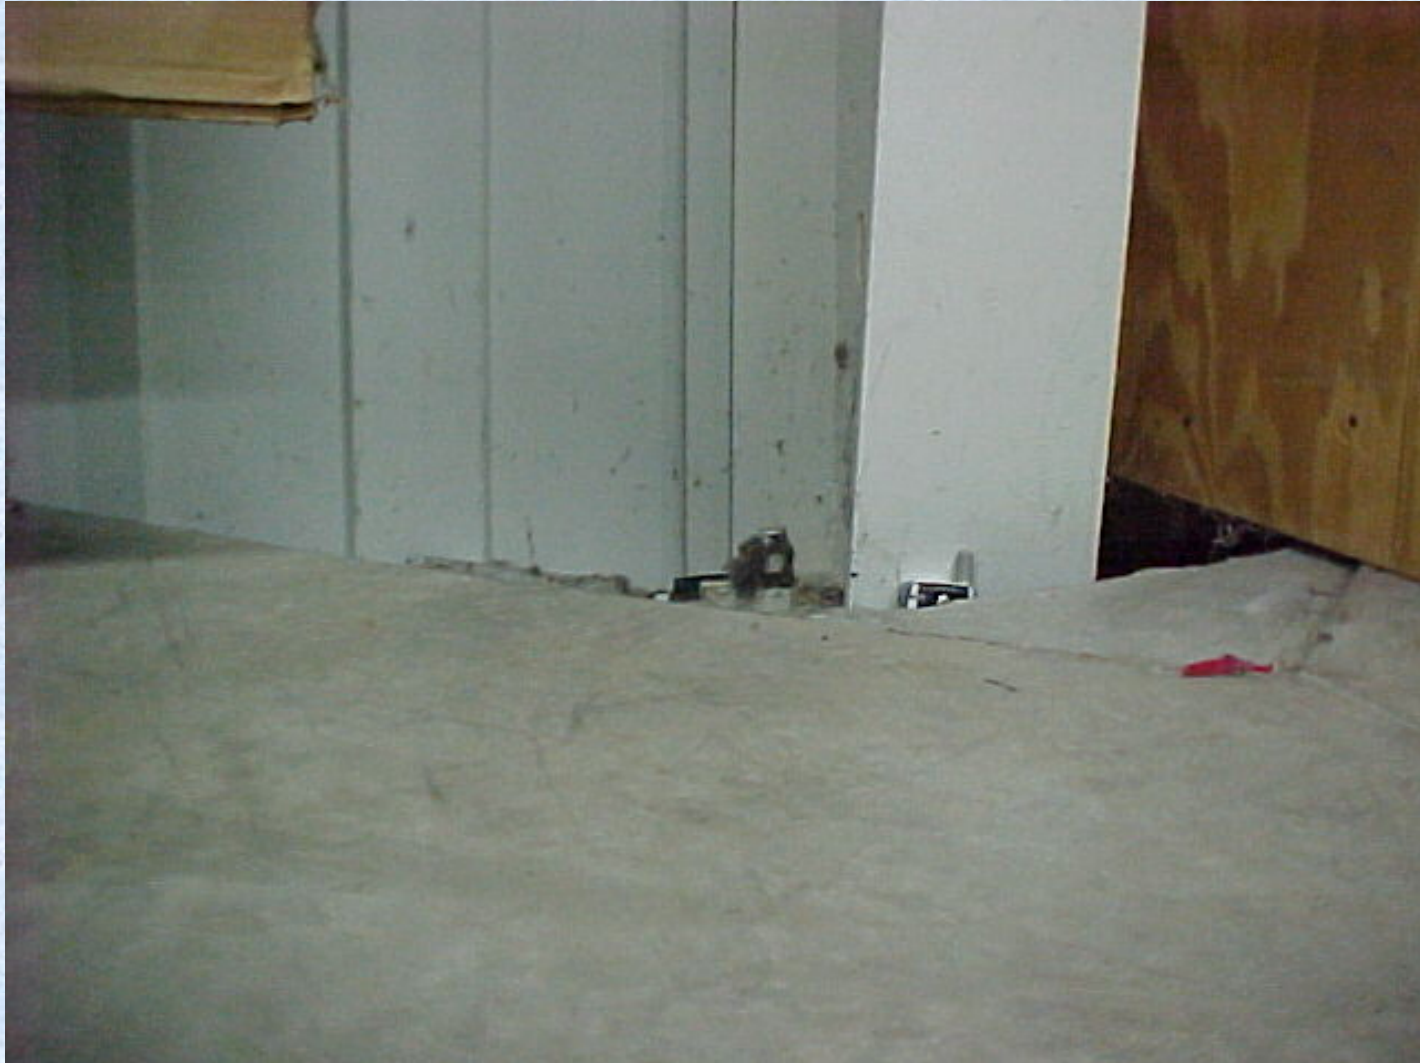
Heaved flooring adjacent to load bearing wall

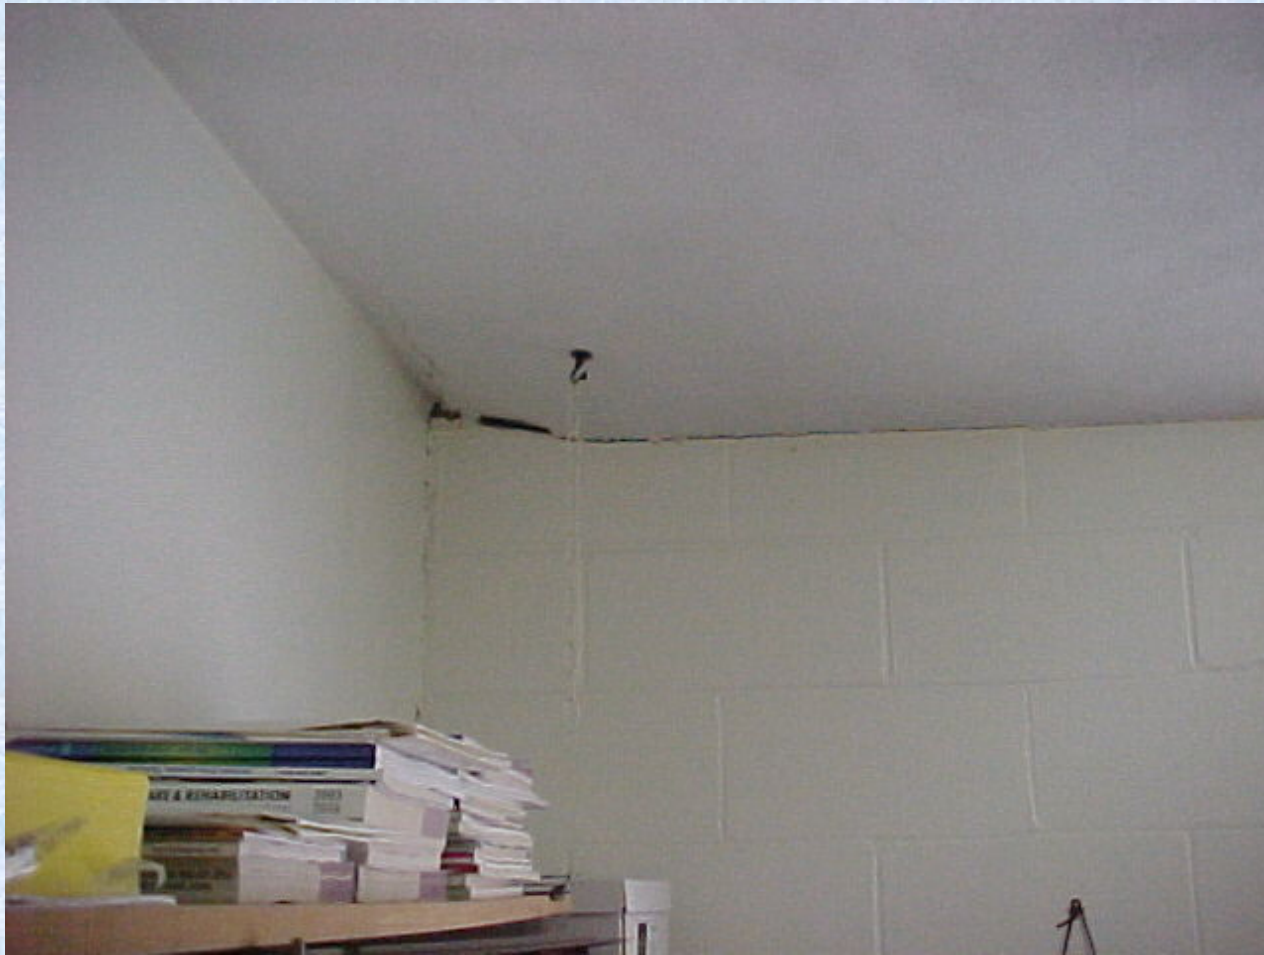
Non-load bearing wall heaving

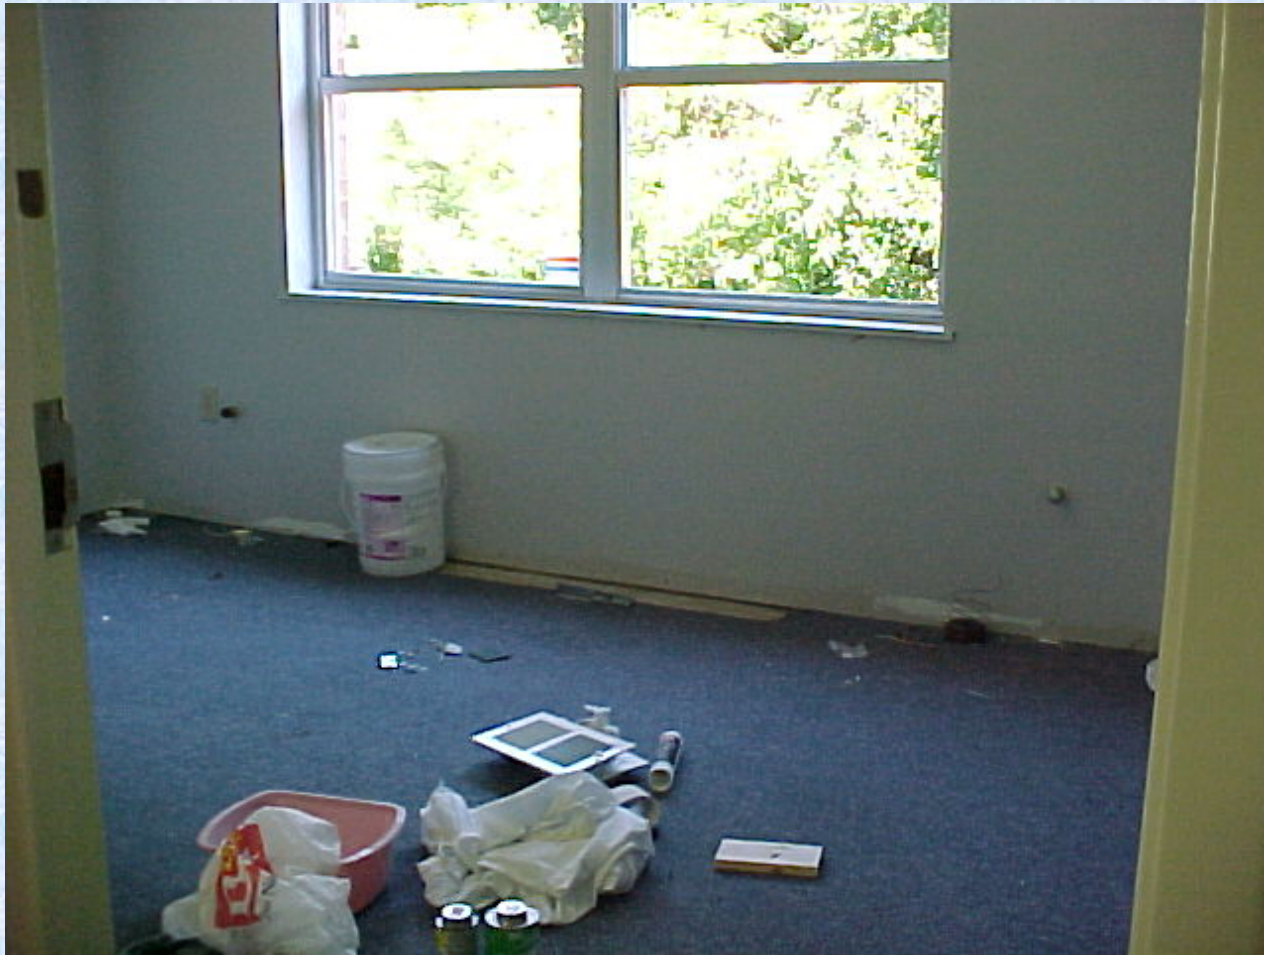
Repaired room adjacent to load bearing wall

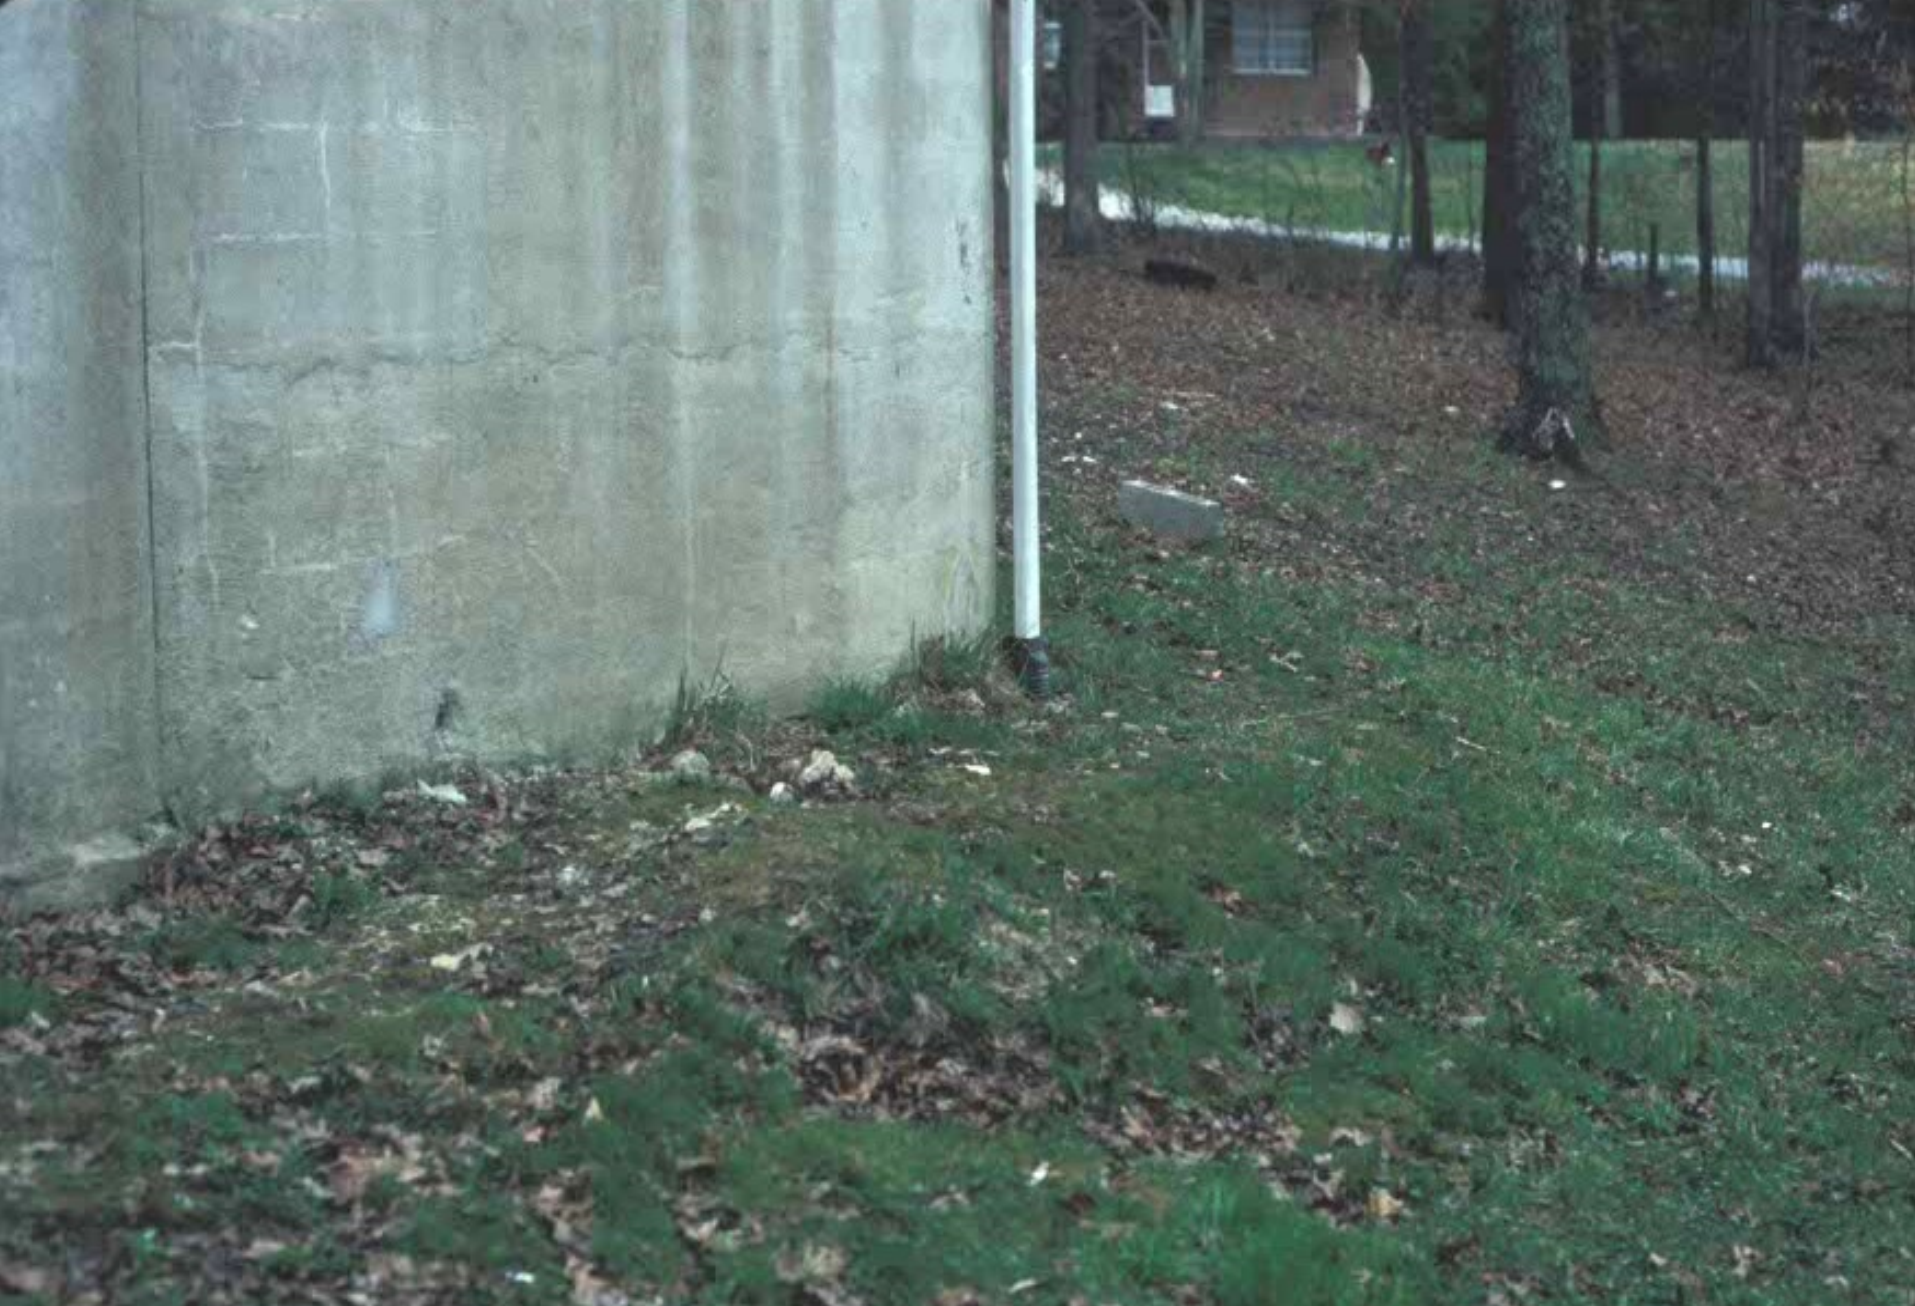
POWELL COUNTY – REAR CORNER OF HOUSE WAS PATCHED BECAUSE THE CISTERN BLEW UP. NATURAL GAS FROM THE SHALE WAS SEEPING IN
