Foundation Problems and Pyrite Oxidation in the Chattanooga (Ohio) Shale Estill County, Kentucky

**John Kiefer, Kiefer@uky.edu
Warren H. Anderson, Wanderson@uky.edu
Kentucky Geological Survey
University of Kentucky**

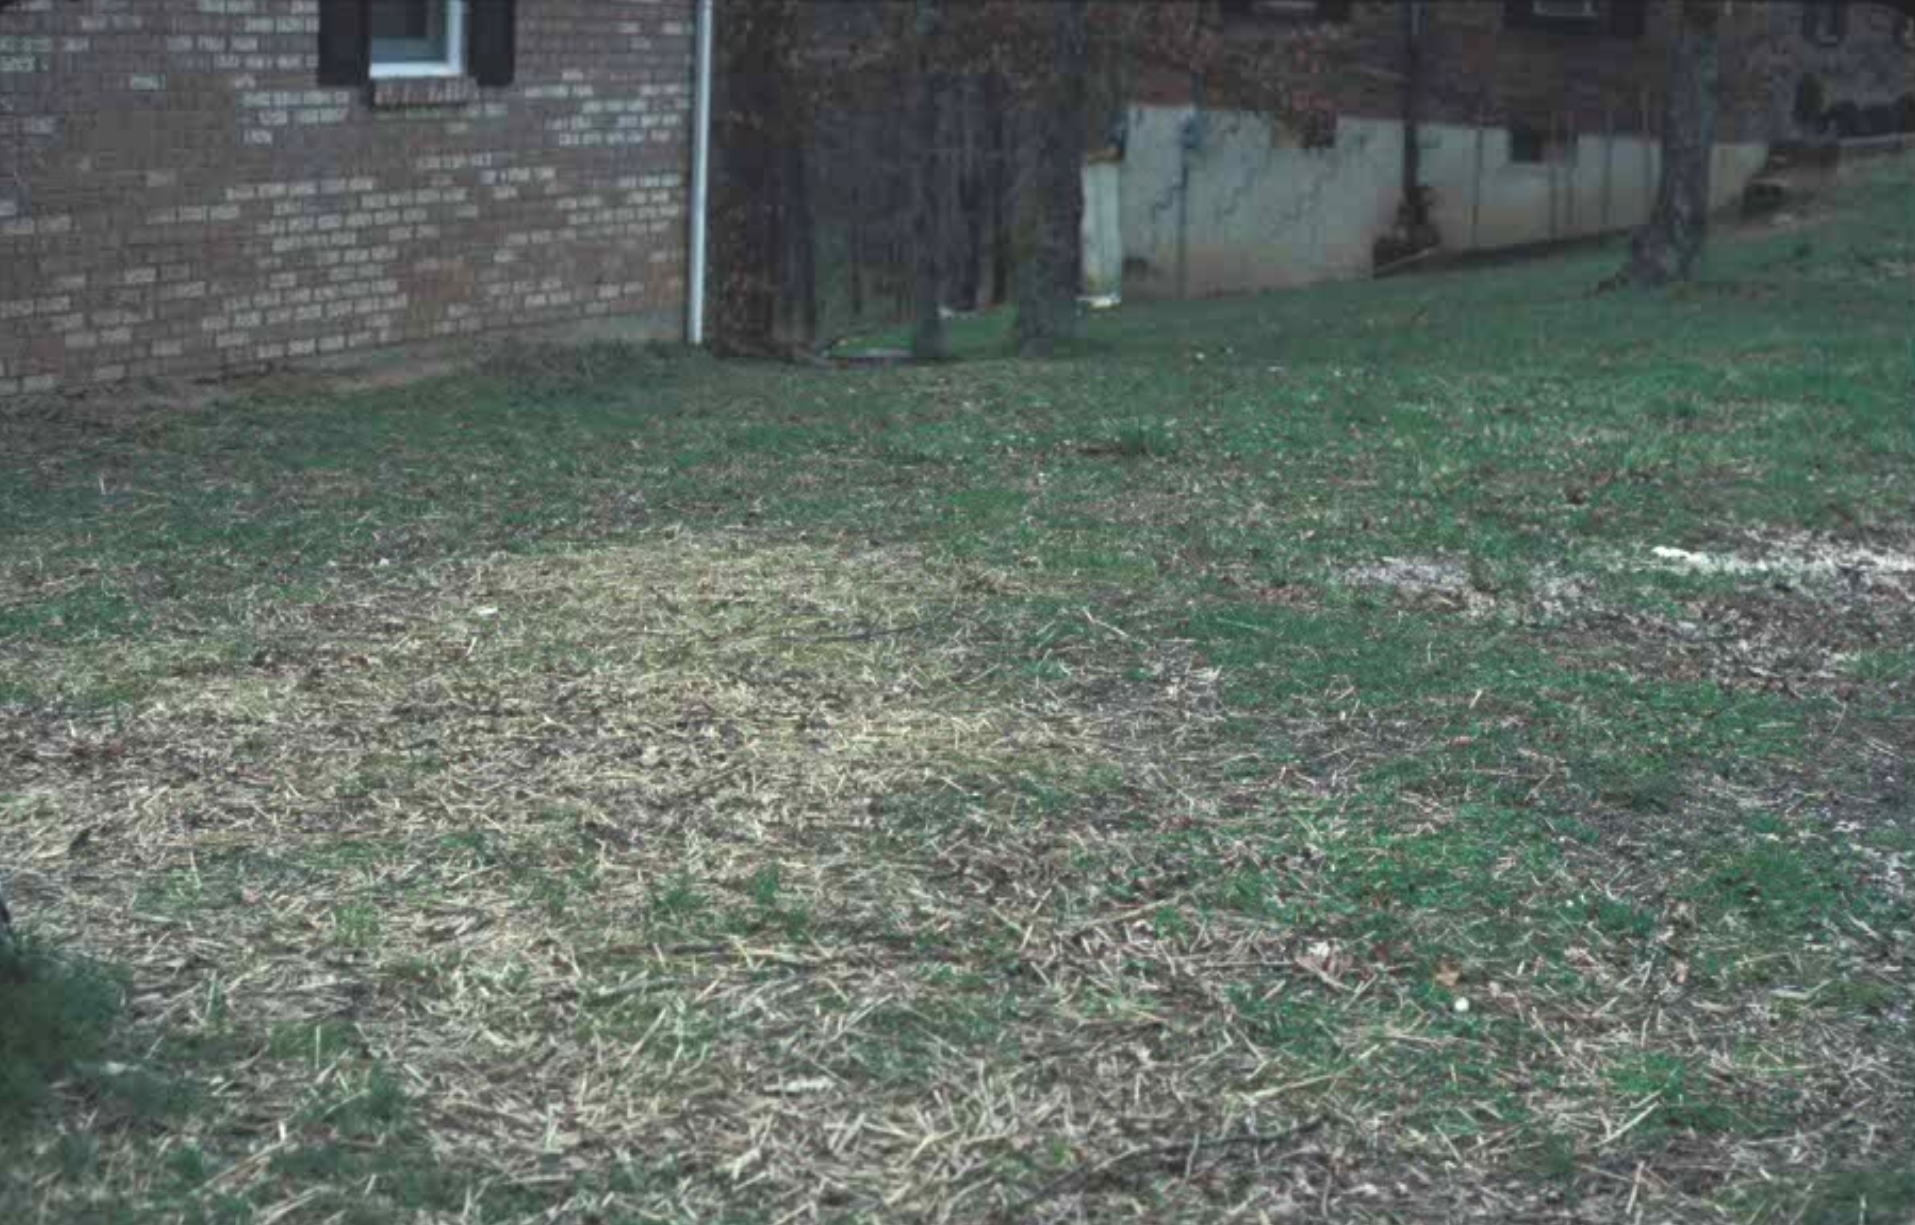
POWELL COUNTY – YARD SLOPED DOWNWARD FROM ROAD ALLOWING WATER TO BUILD UP AGAINST HOUSE AND SEEP UNDERNEATH. NOTE CRACKS IN NEIGHBORS HOUSE.
