Value of Instrumentation Systems and Real-Time Monitoring: An Owner's Perspective

FHWA NATIONAL GEOTECHNICAL PROGRAM

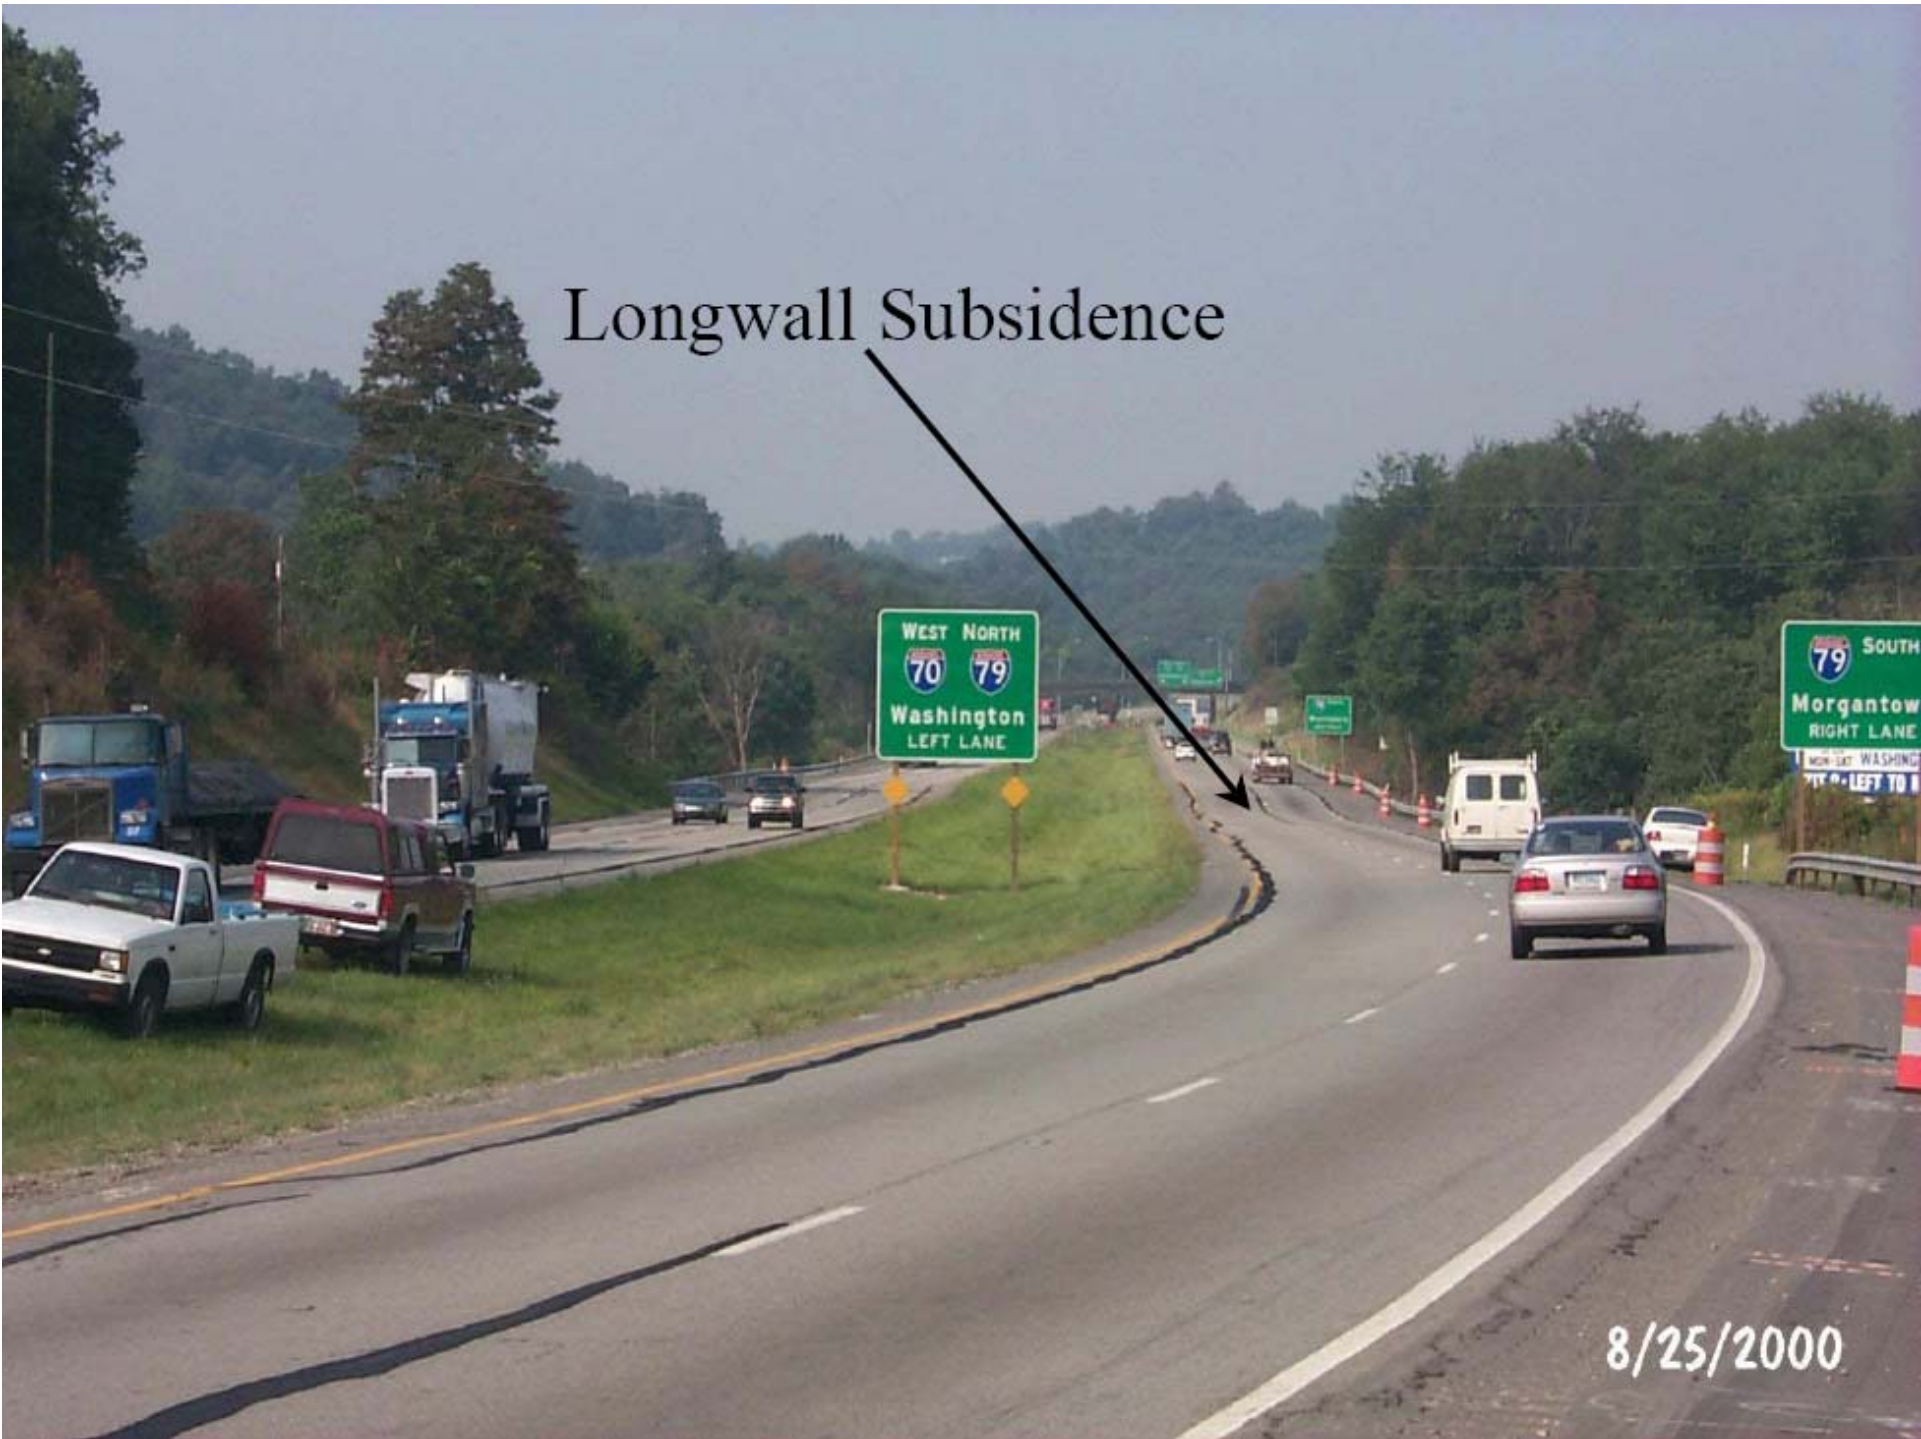
Longwall Subsidence

Significant surface subsidence affecting roads and structures

- Pavement subsidence and cracking
- Underpinning or abandonment of bridges
- Removal of overhead sign structures
- Monitor performance of box culverts

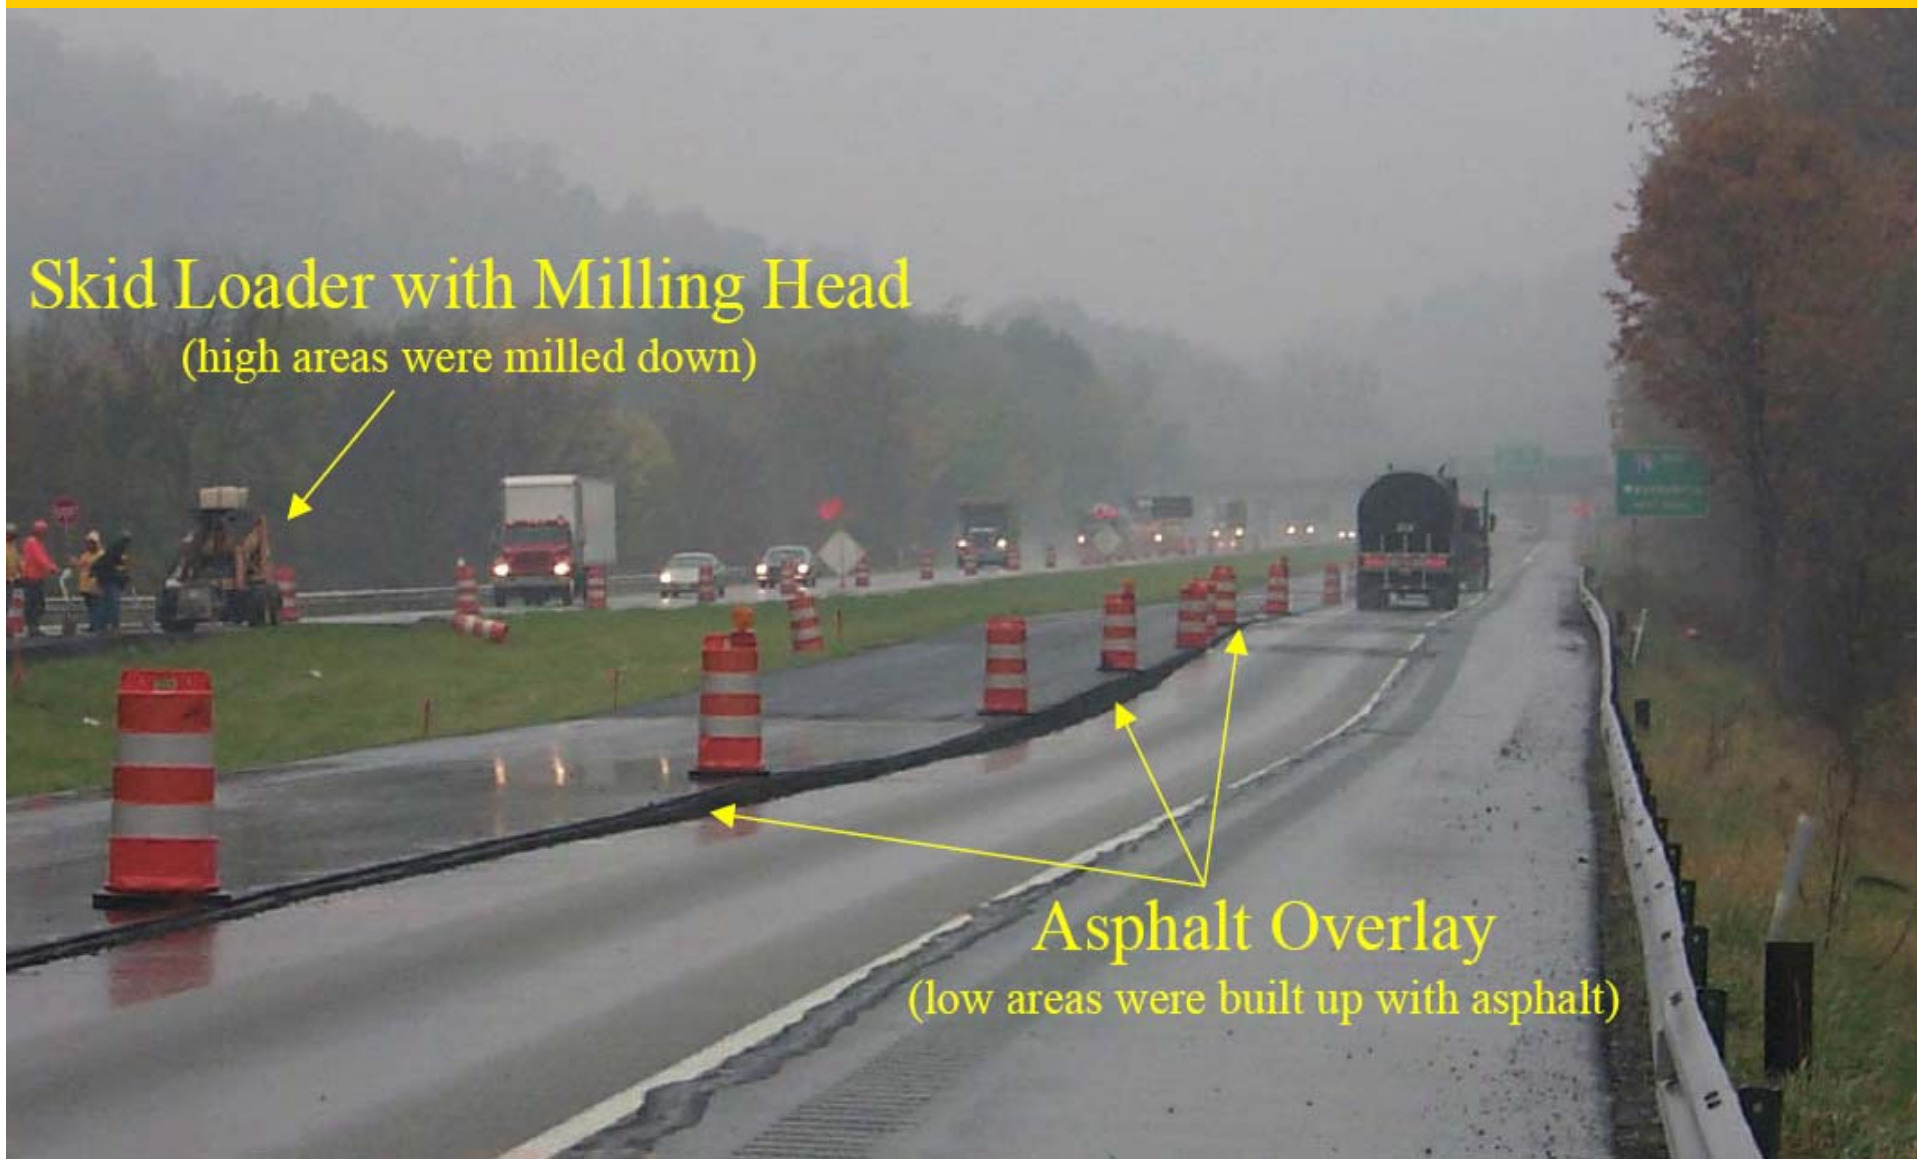
Skid Loader with Milling Head
(high areas were milled down)

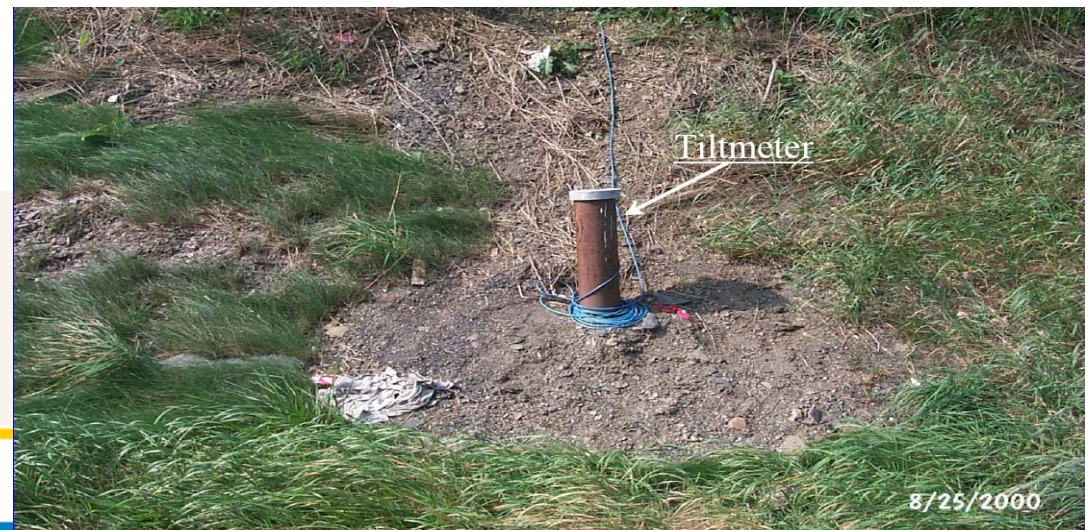
I-70 Instrumentation Plan

3 SOUTH LW PANEL

Monitoring of deformations and changes in highway conditions allowed PennDOT to make rational decisions on speed limits and temporary maintenance on I-70 and I-79

Alarms were triggered at when anticipated movements were exceeded

Alarms automatically notified PennDOT personnel to the problem

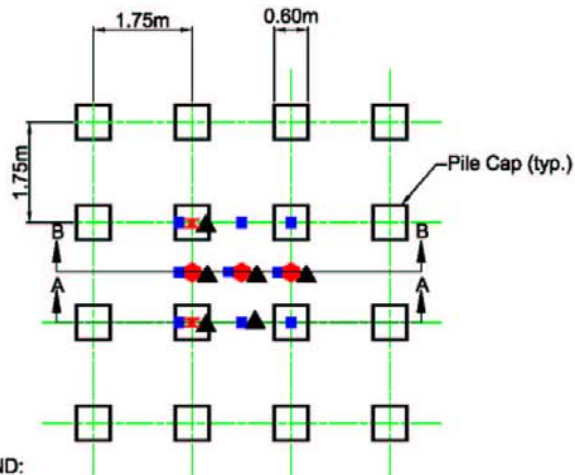
PLAN VIEW
N.T.S.

- Pressure Cell
- ▲ Settlement Cell
- Strain Gauge On Geogrid
- ⊠ Four (4) Strain Gauges On (See Detail This Sheet)

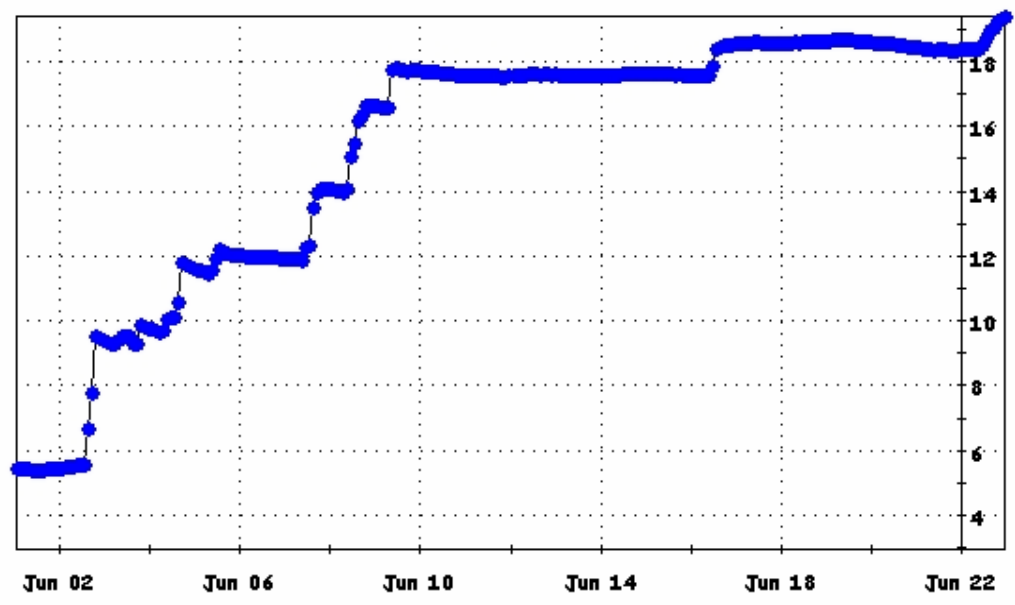
PCB-1R VW Pressure Cell (s/n 04-1376) - June 2004

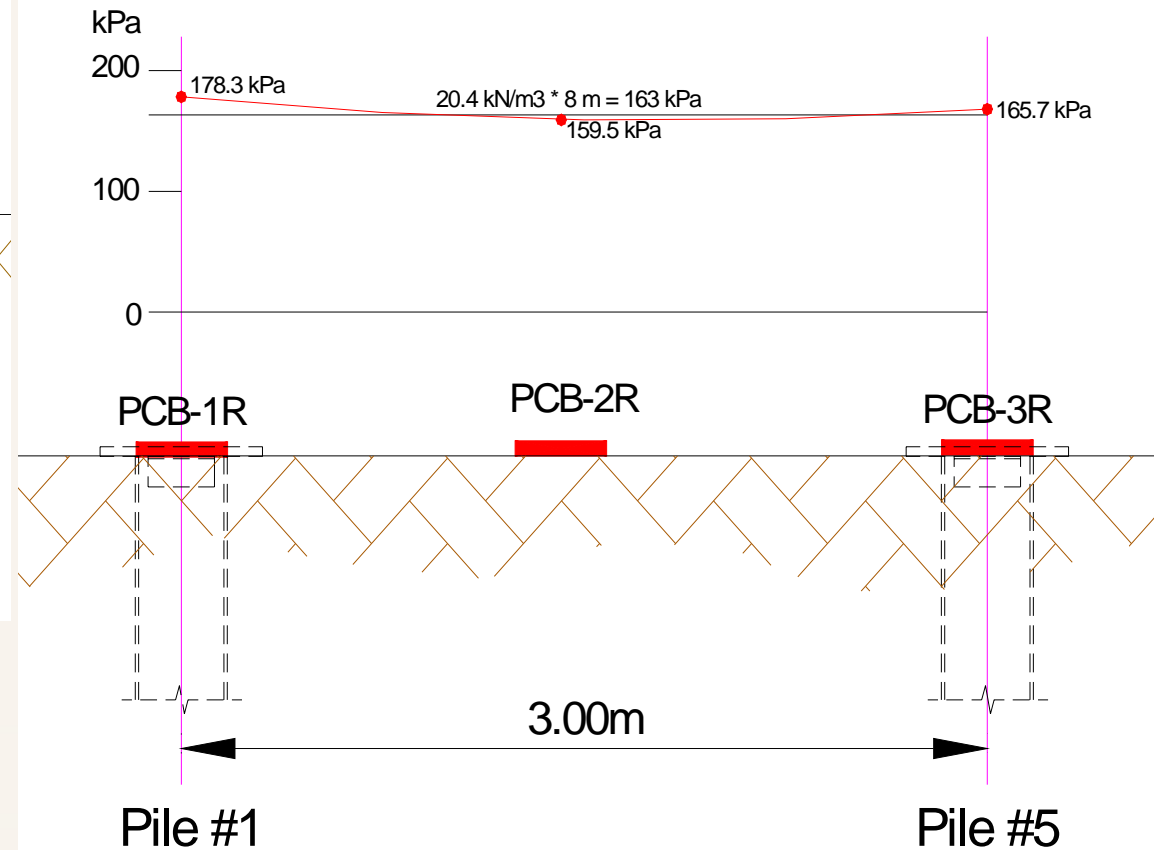
Pressure Cell Results Production Section

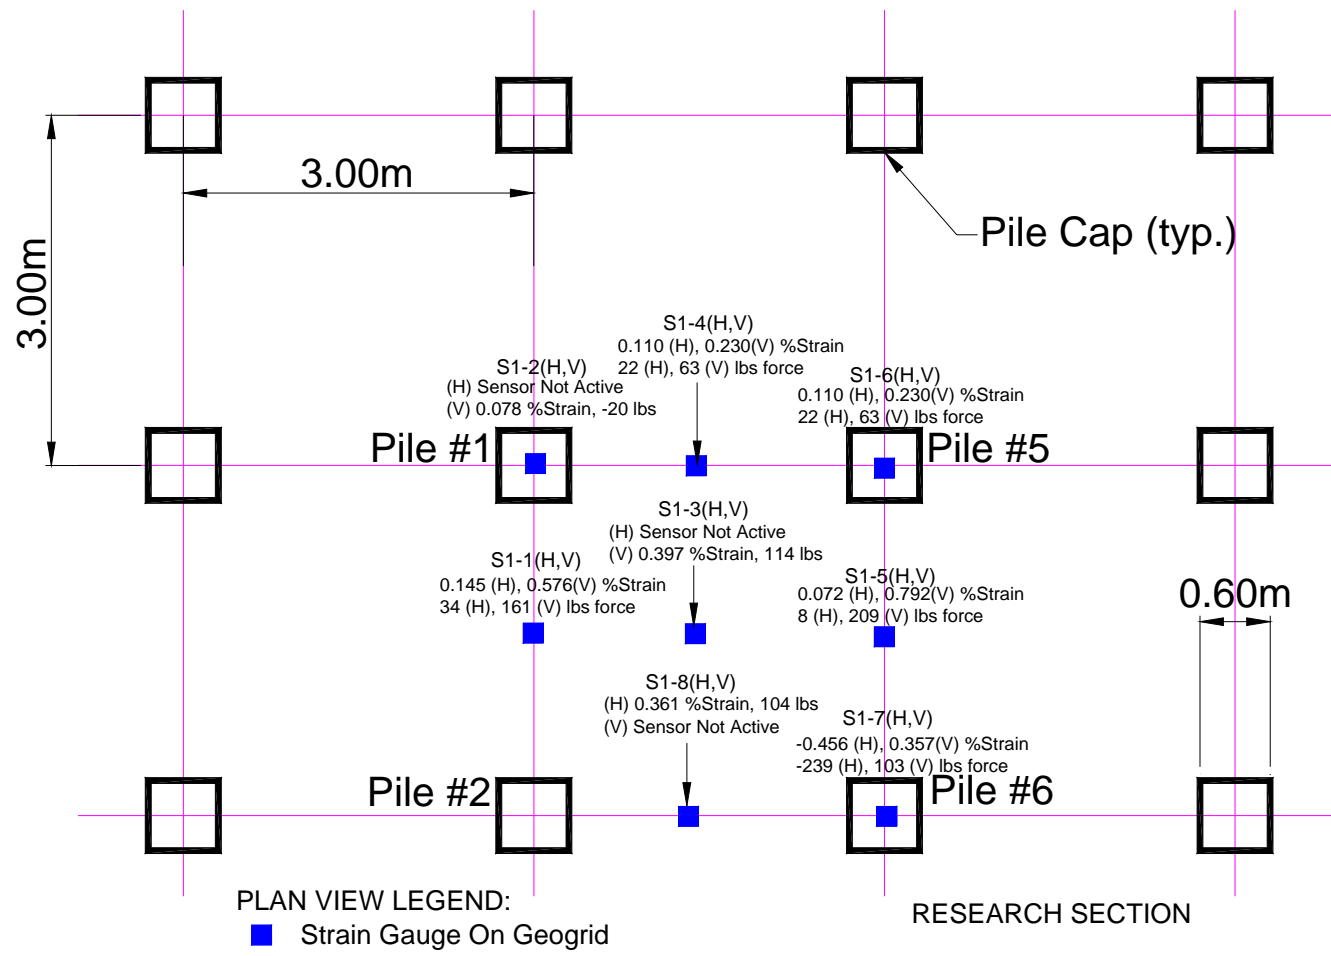
Strain Gage Layout

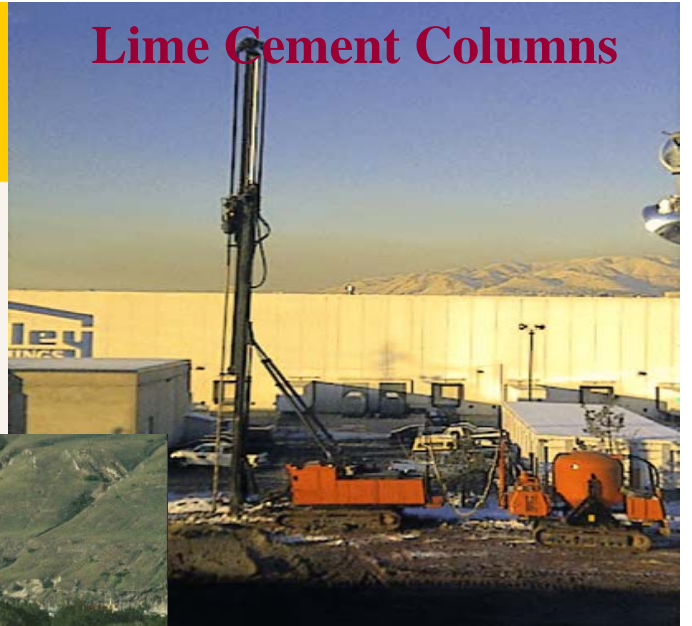
Lime Cement Columns

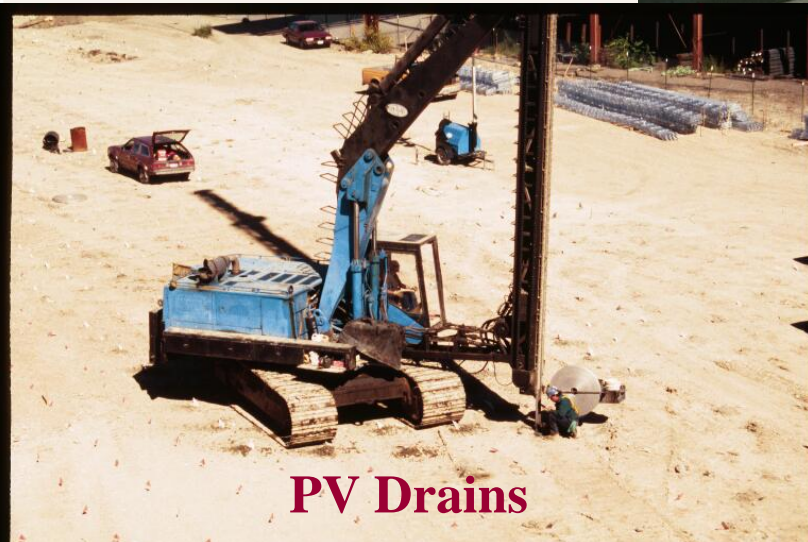
PV Drains

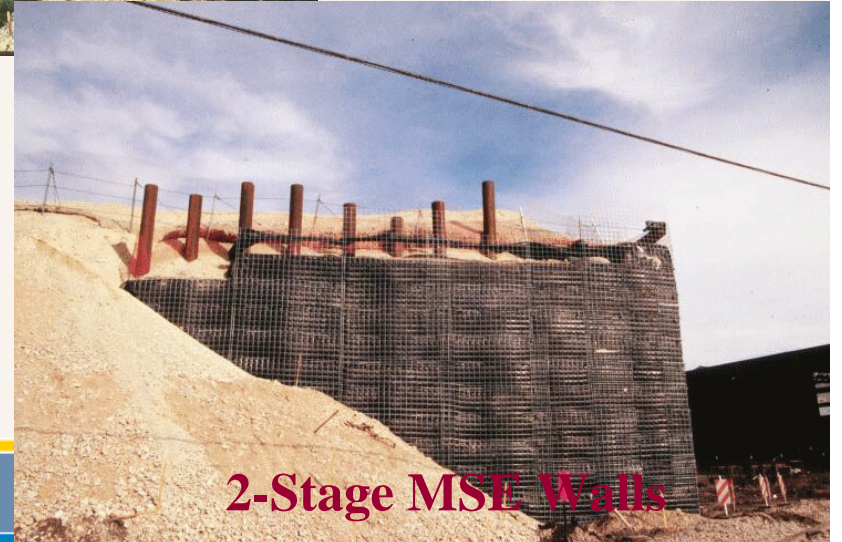
2-Stage MSE Walls

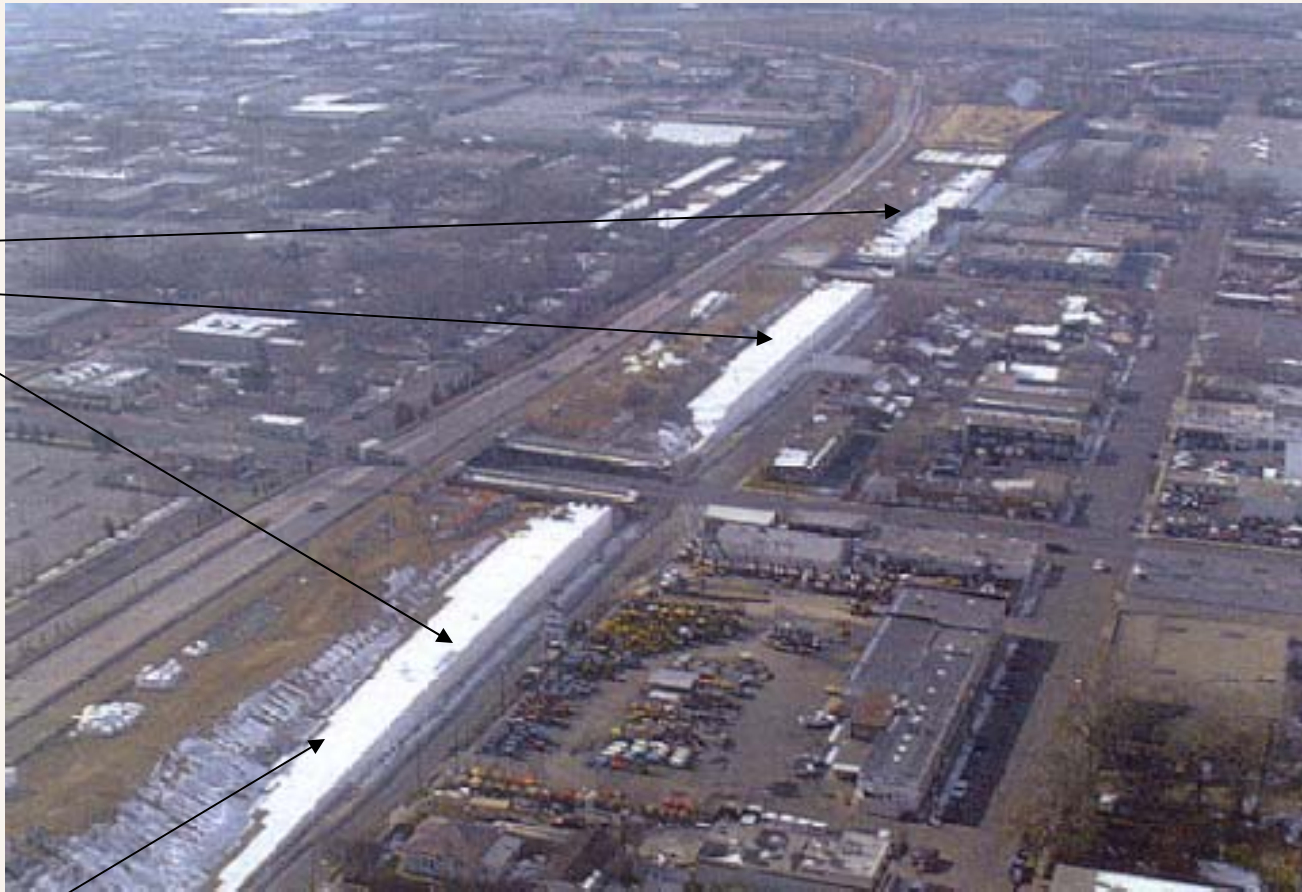
Geofoam Embankment

**Buried
Utilities**

**Geofoam Embankment from State St. to 200 W. Along
Interstate I-80, Salt Lake City, Utah**

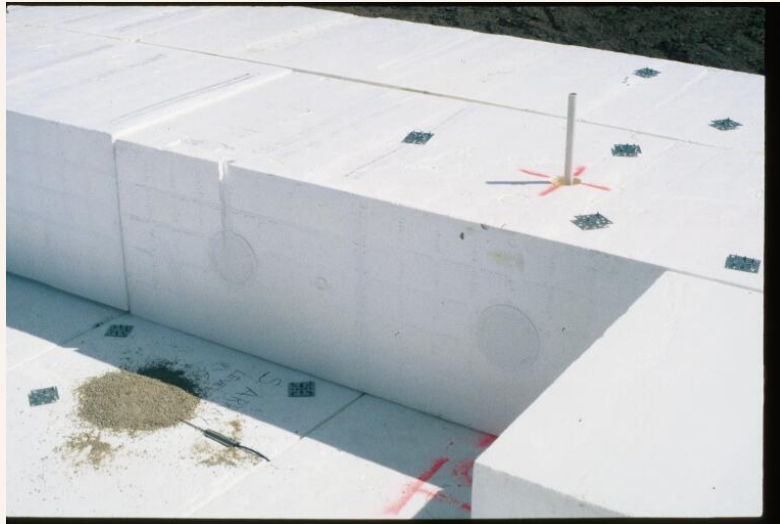
Geofoam Array Installation

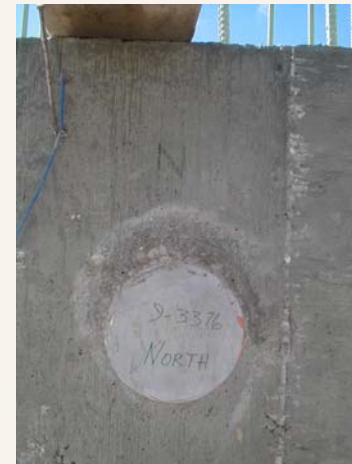
Pressure Cell Cast in Bridge Abutment

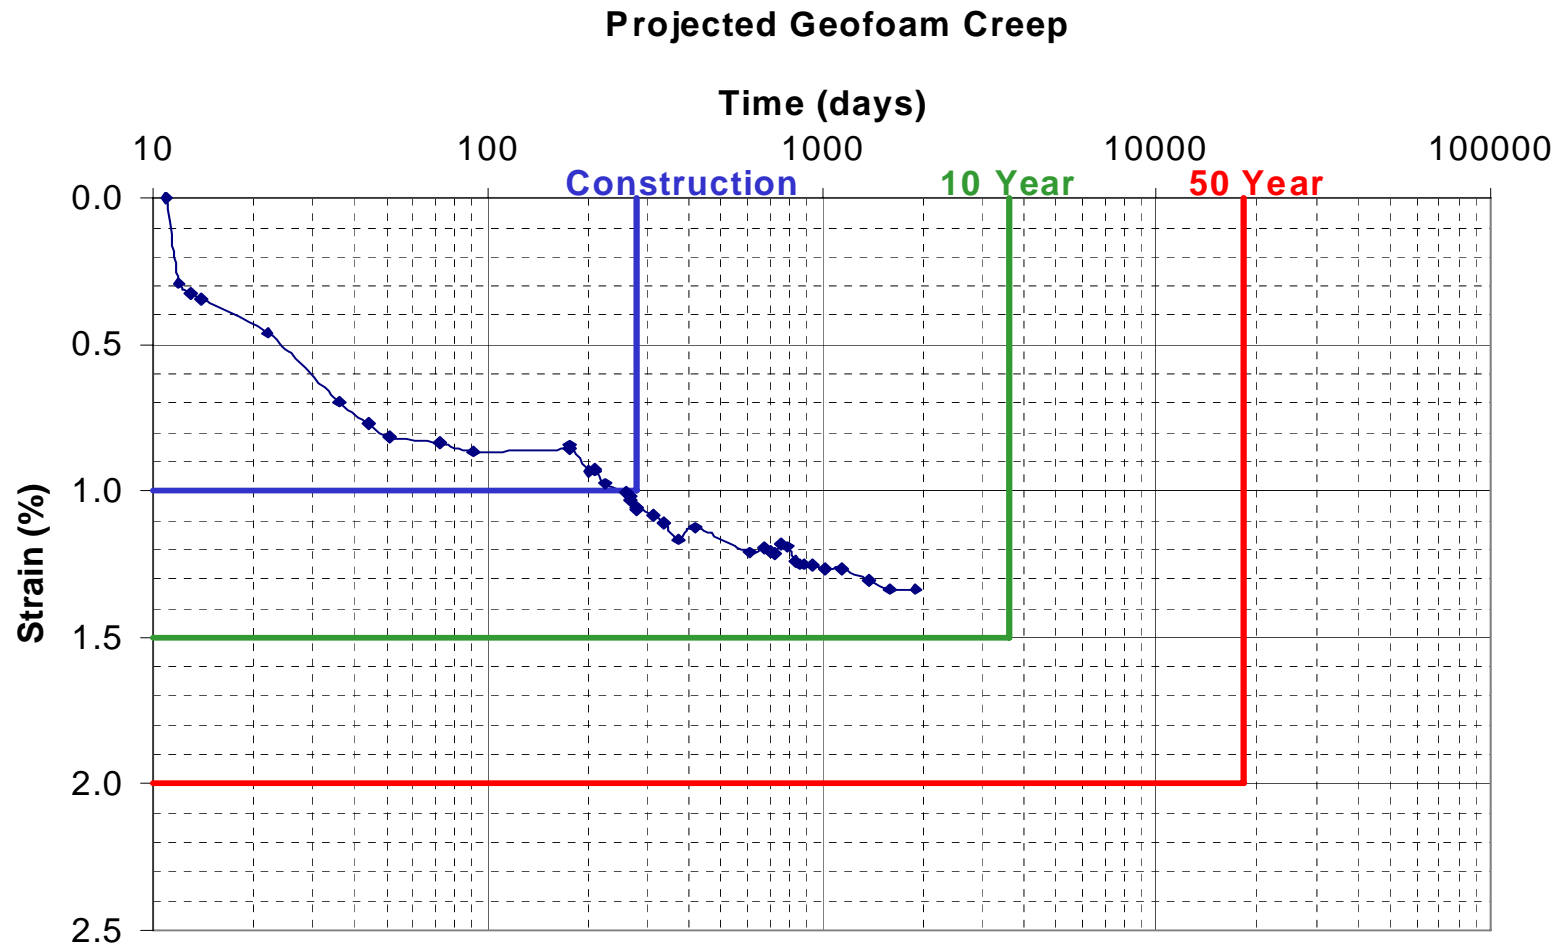
Geofoam Magnet Extensometer Data

- Approximately 1 percent vertical strain occurred during construction
- Approximately 0.3 percent creep strain (1.3 inches) has occurred in a 4-year post construction period
- Creep strain in a 10 year post-construction period is expected to be about .4 percent (about 1.7 inches)
