# **GEOTECHNICAL CHALLENGES OF THE LEWISTOWN NARROWS RECONSTRUCTION**

**GTS TECHNOLOGIES, INC.  
BRENT J. BASOM, P.E. AND  
DANIEL S. RAMER, P.E.**

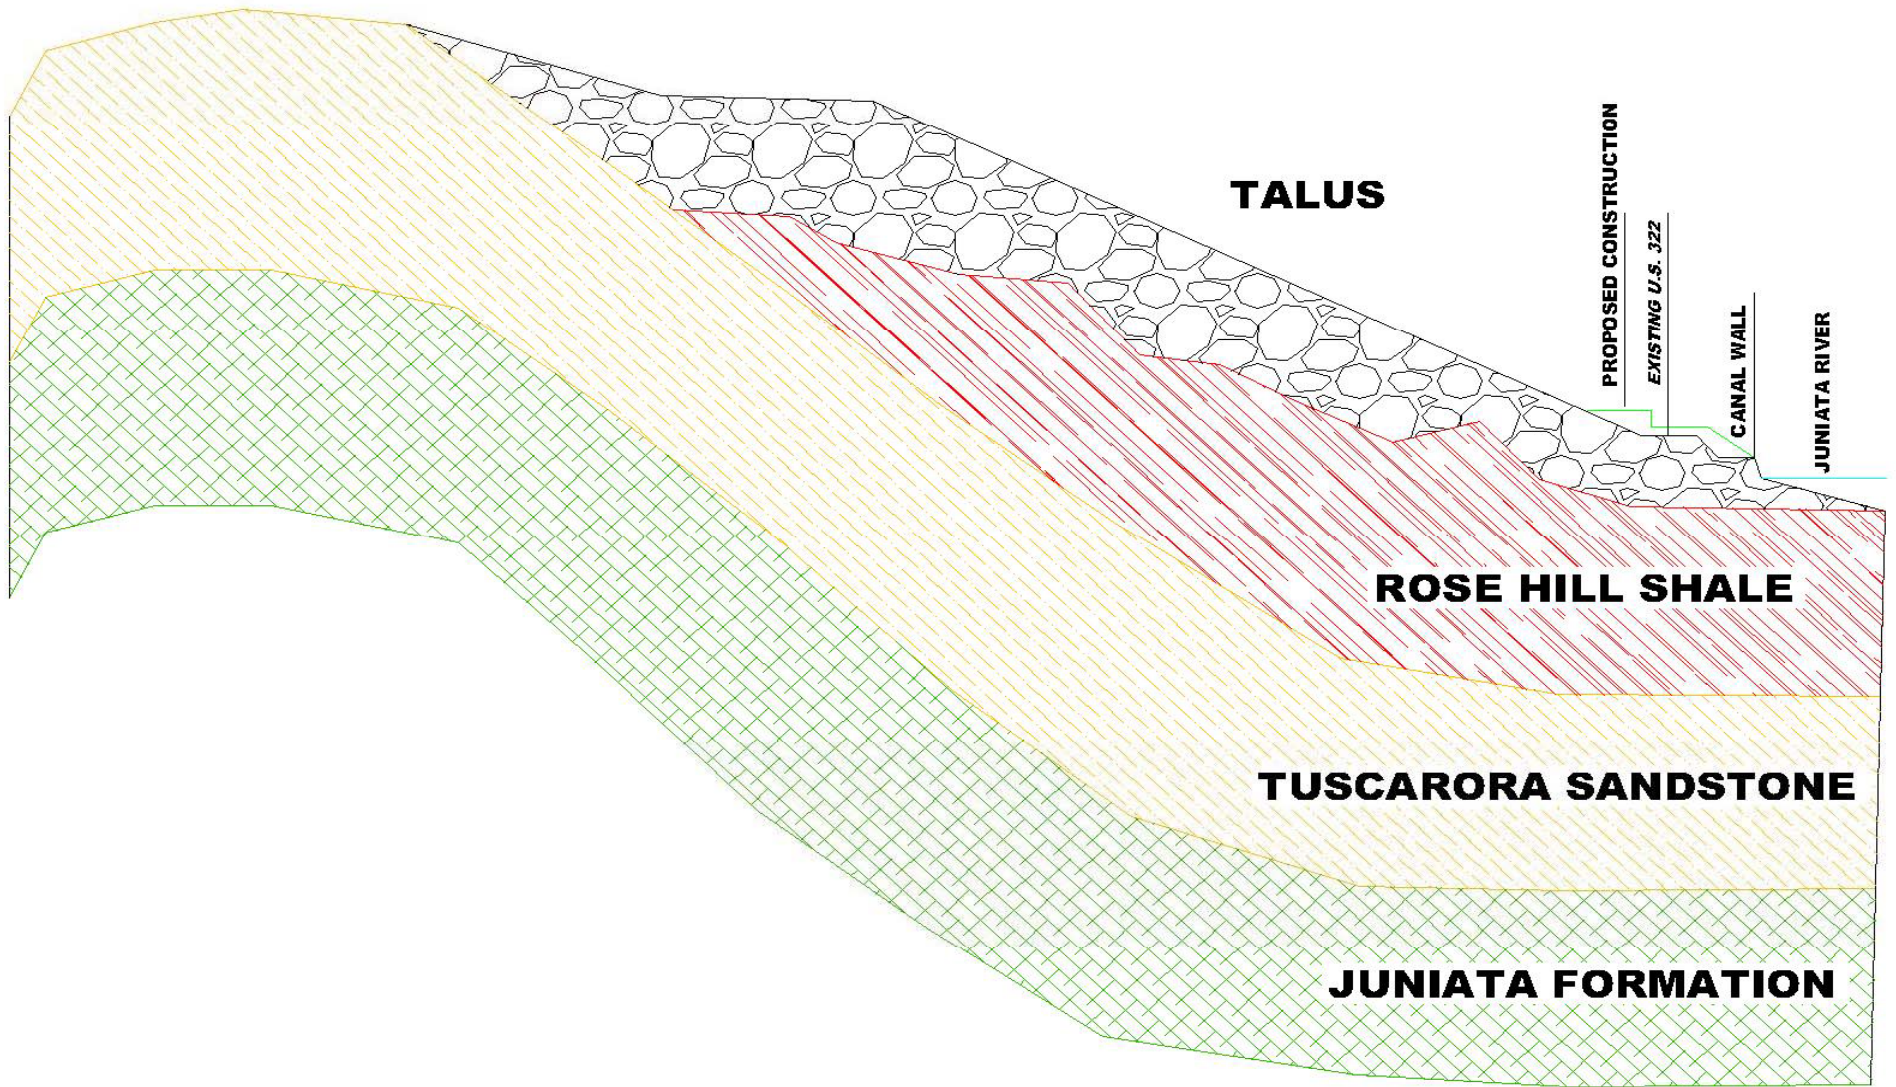
**TALUS**

**PROPOSED CONSTRUCTION**

**EXISTING U.S. 322**

**CANAL WALL**

**JUNIATA RIVER**

**ROSE HILL SHALE**

**TUSCARORA SANDSTONE**

**JUNIATA FORMATION**

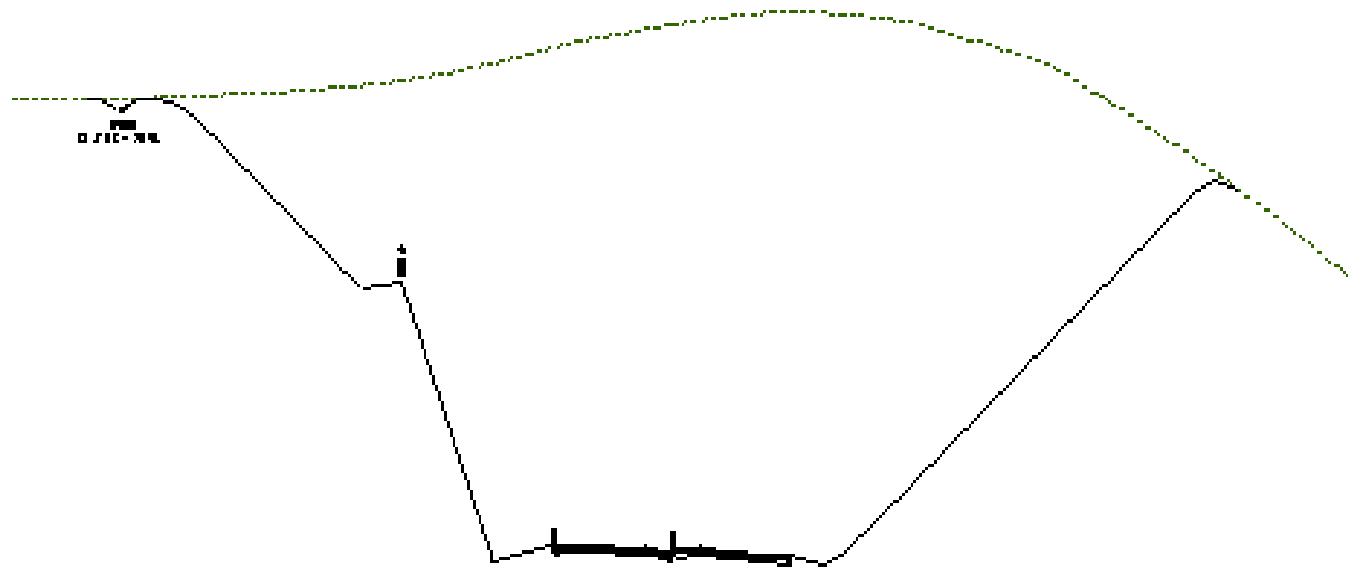
# TYPICAL ROCK CUT XS

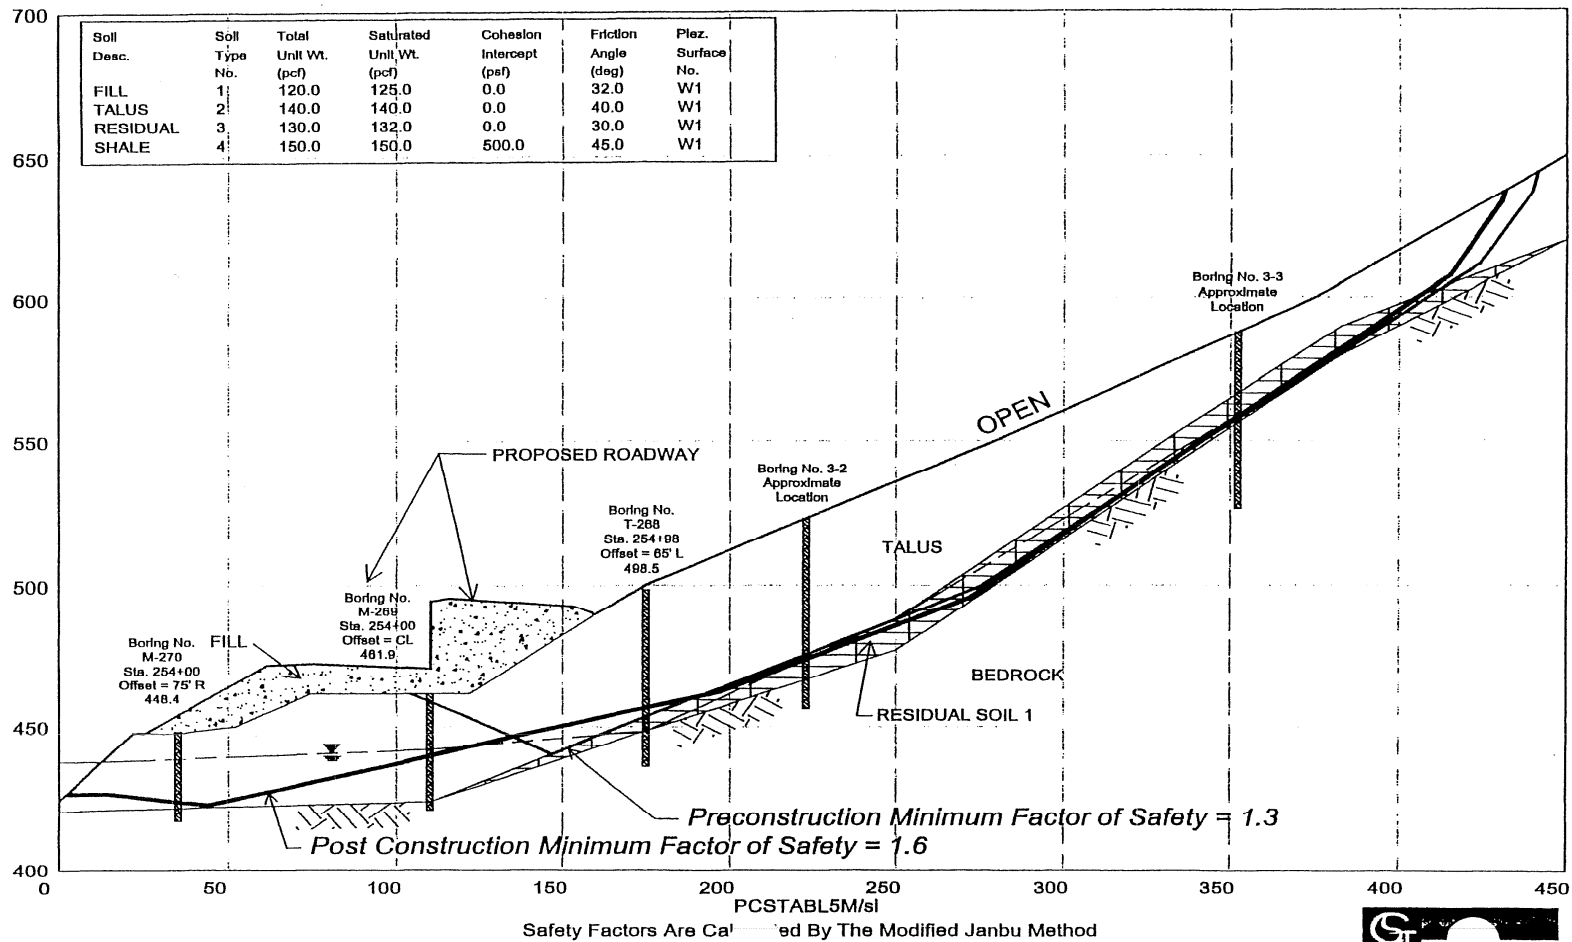
# TALUS STABILITY

S.R. 0022, SECTION A09, STATION 254+00 PROPOSED CONDITIONS, WL#1, BLOCK SRCH B

Station	SF <sub>existing</sub>	SF <sub>proposed</sub>
188+00	1.2	1.4
192+00	1.1	1.7
196+00	1.3	1.6
212+00	1.8	1.9
238+00	1.2	1.3
254+00	1.3	1.6
274+00	1.3	1.7

- Proposed construction increases SF, with overall  $SF > 1.3$ .
- No recorded slides or slope movement, through flood events and excavations into talus.
- Based on recent history the talus is in a state of equilibrium.
- No economically feasible methods exist to stabilize the mountain slopes. Therefore  $SF = 1.3$  is acceptable.
- Do not allow excavations into talus slopes.

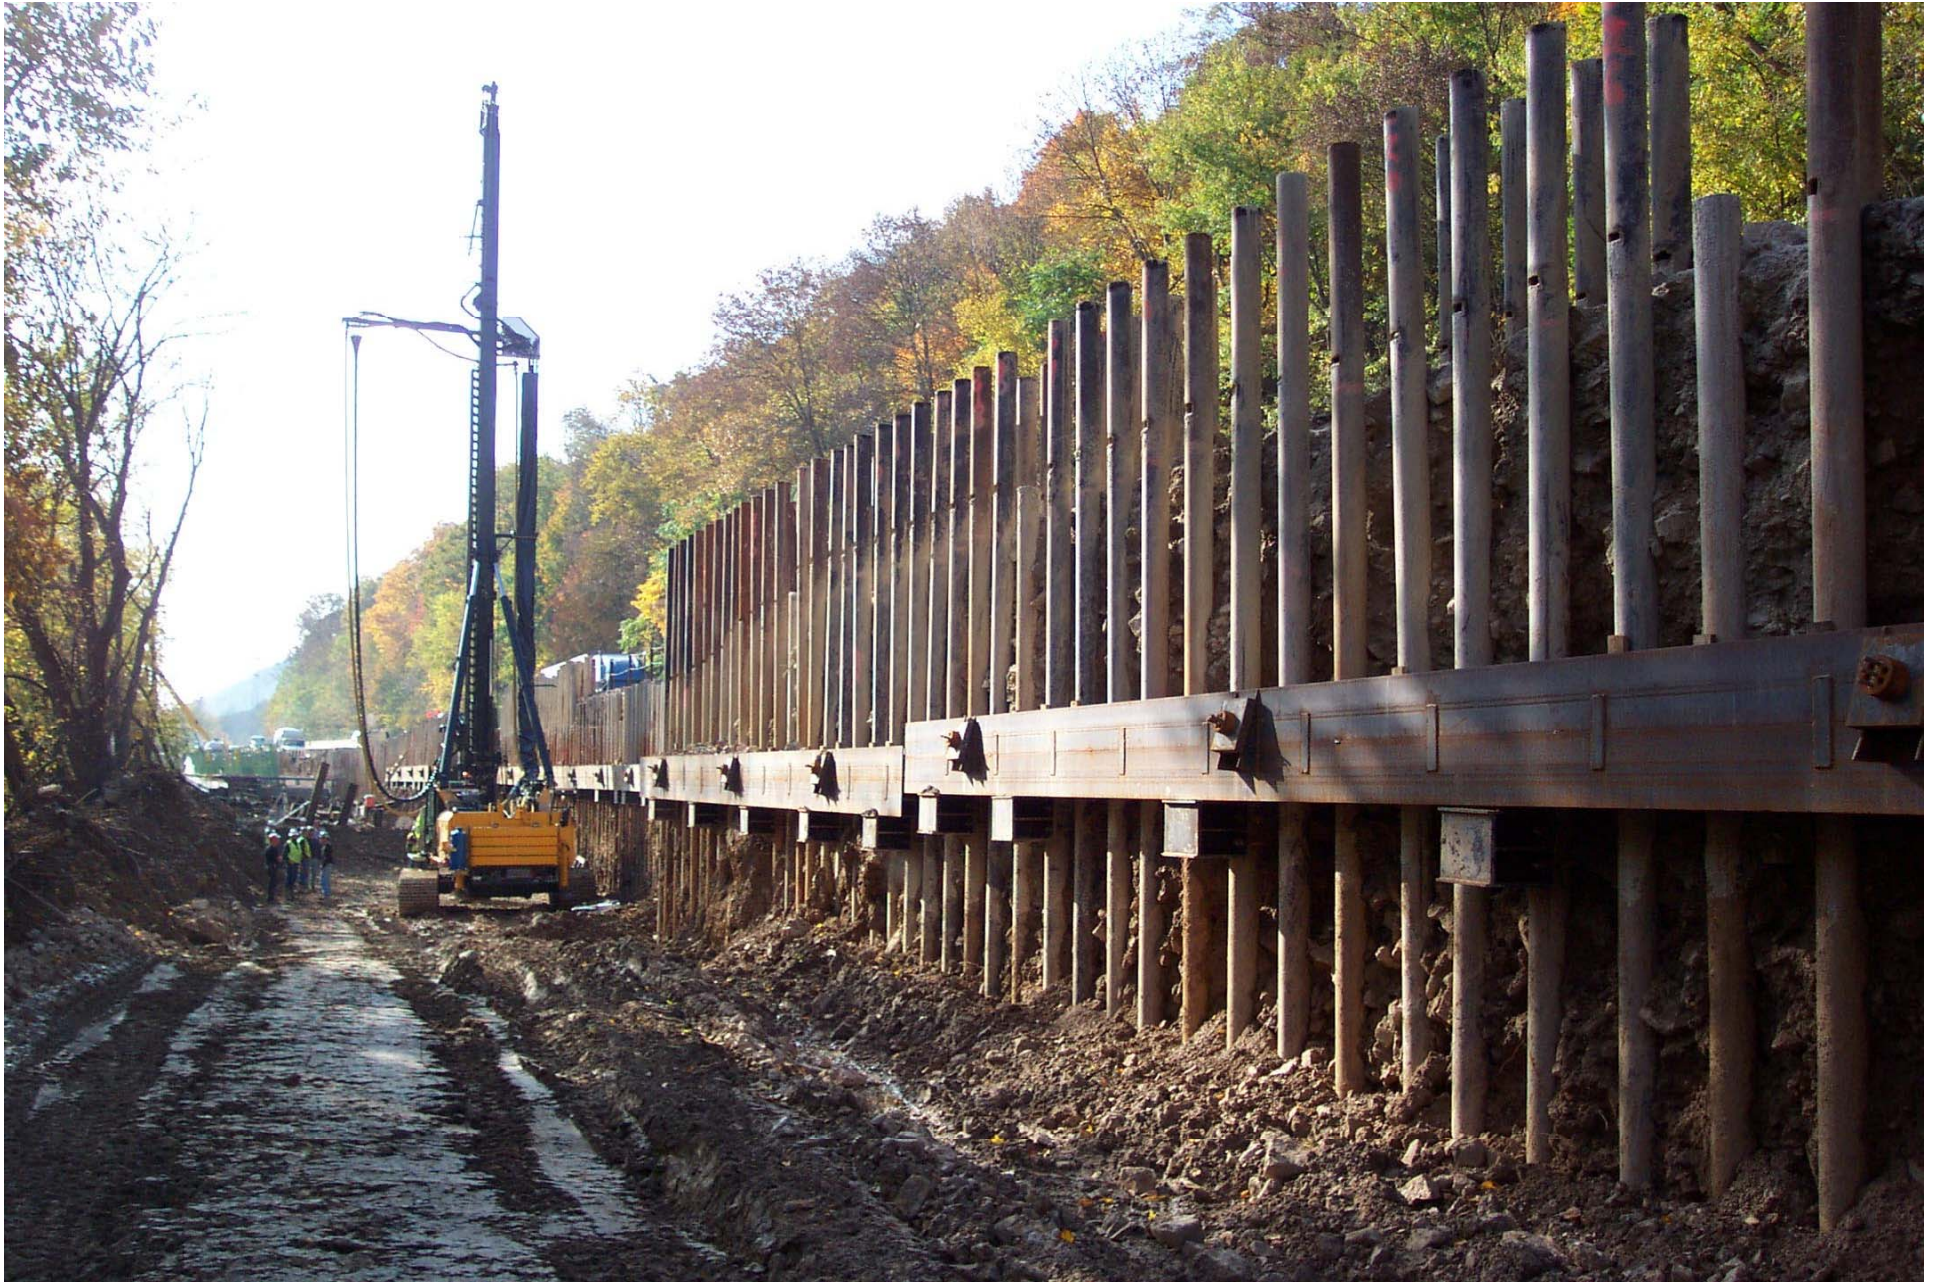
- System of discrete vertical elements designed to resist the driving forces through bending and shear of the element.
  - Steel H-piles socketed into bedrock
  - Micro-piles drilled into bedrock
  - Drilled Shafts socketed into bedrock
- Piles located 5 feet behind the heel of the retaining wall. Will not allow loads to transfer to wall.

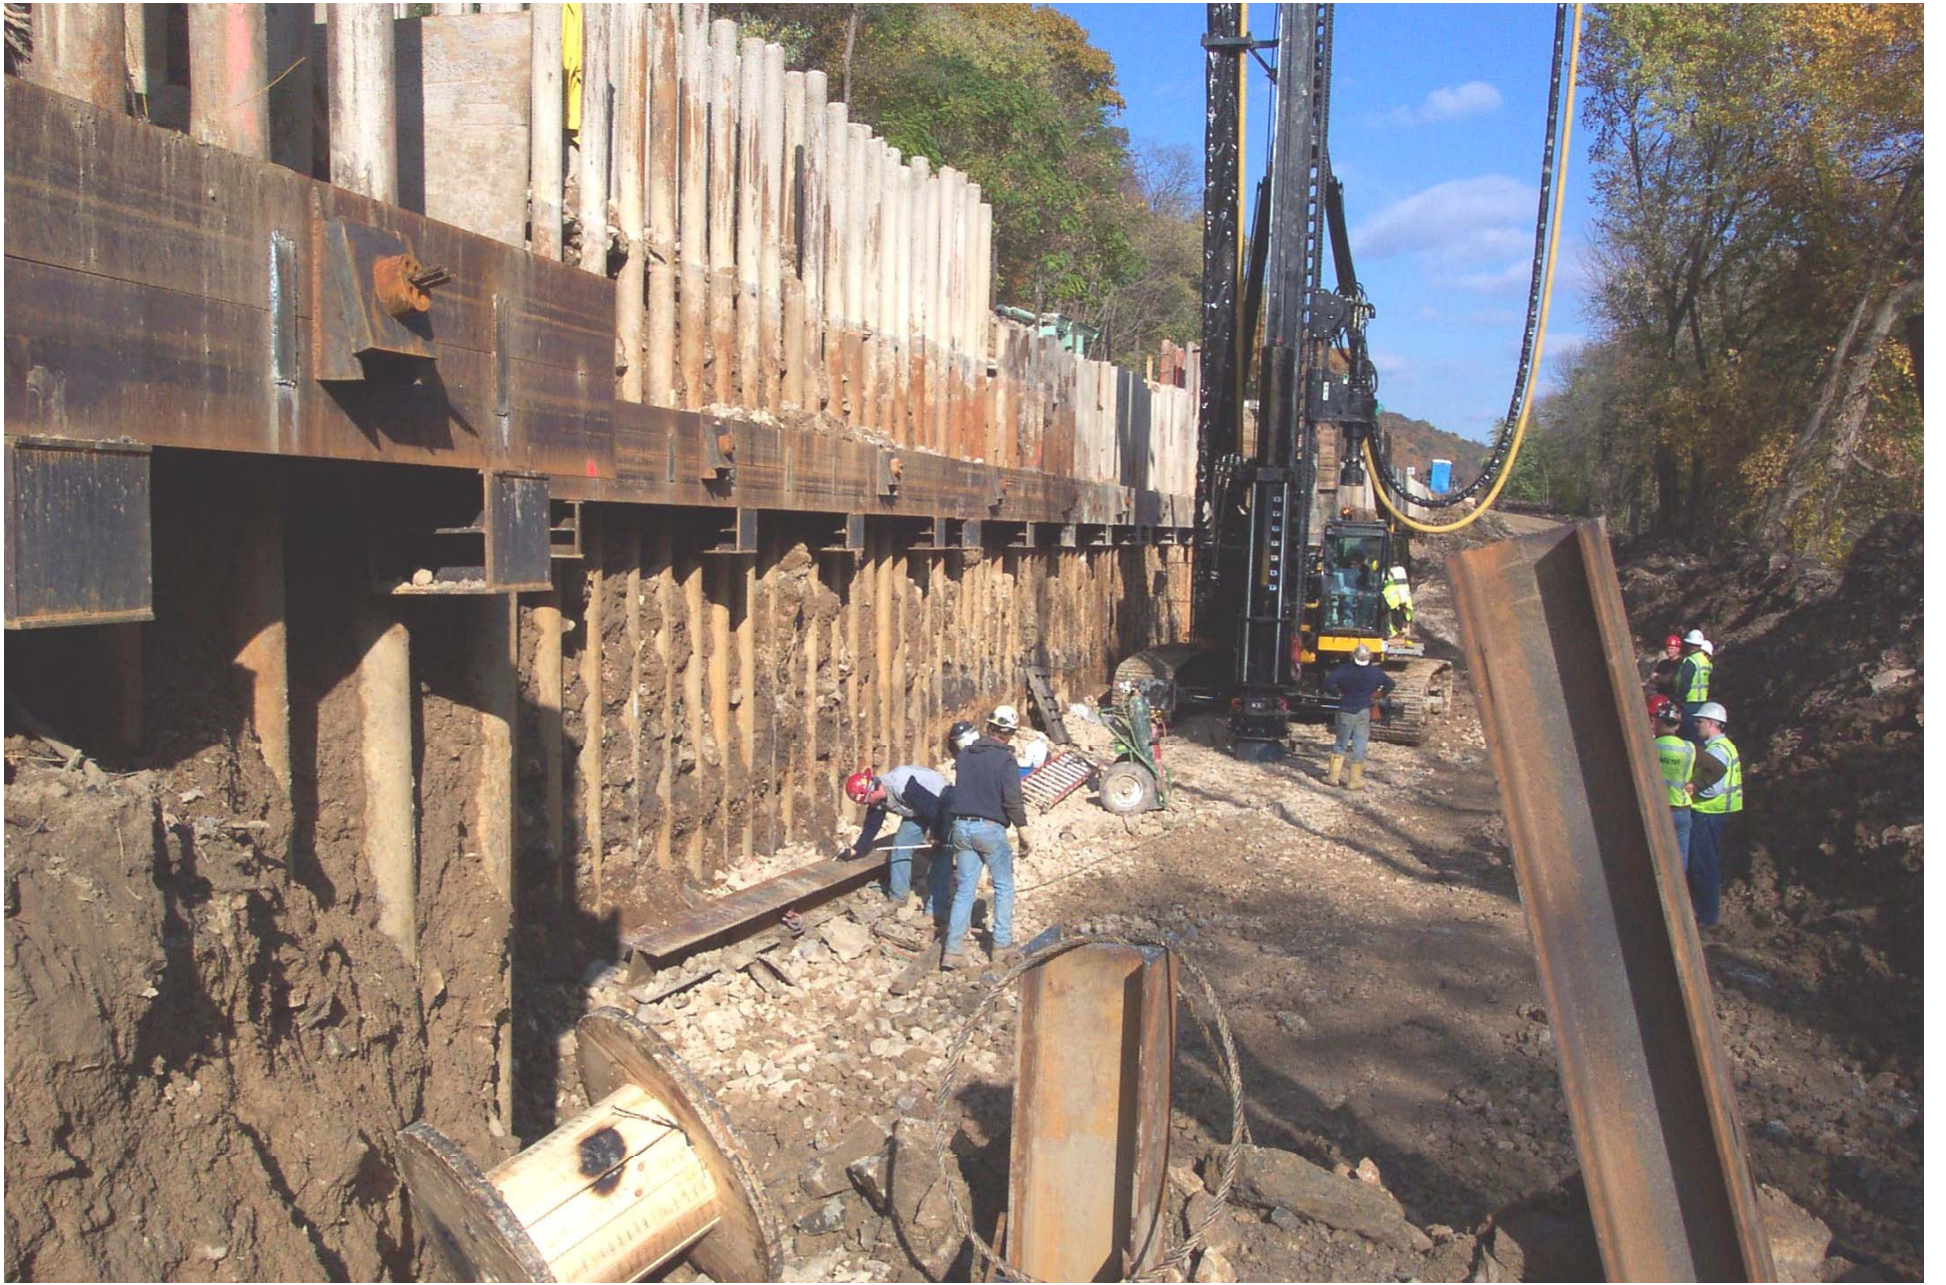
# SELECTED REMEDIATION OPTION

Option	Structural Resistance (k/lf)	Total Cost	Production Rate
14" H-piles	200	\$20 m	2/day
7" Micro-piles	100	\$14 m	8/day

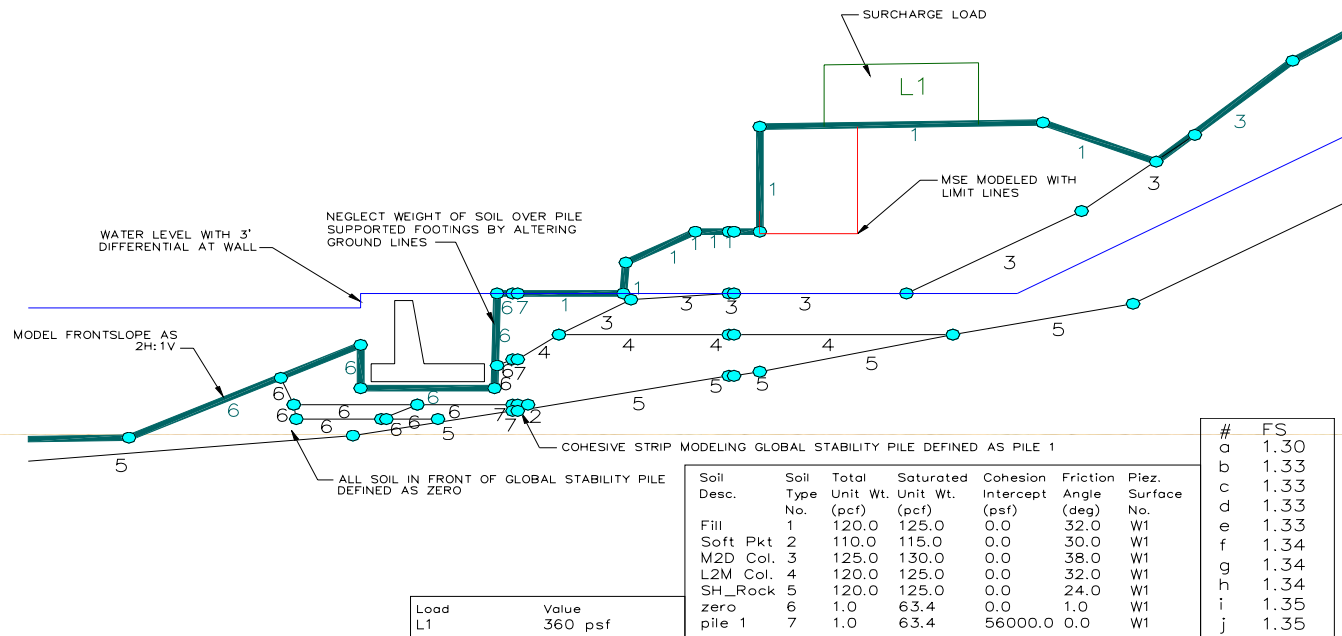
# ANALYSIS METHODOLOGY

- Retaining wall does not contribute to the stability of the slope (i.e. neglect all soil in front of the wall).
- Model the necessary resisting force as a 1 foot wide cohesive strip extending through bedrock.
- Adjust the cohesion of the strip to obtain the target safety factor.

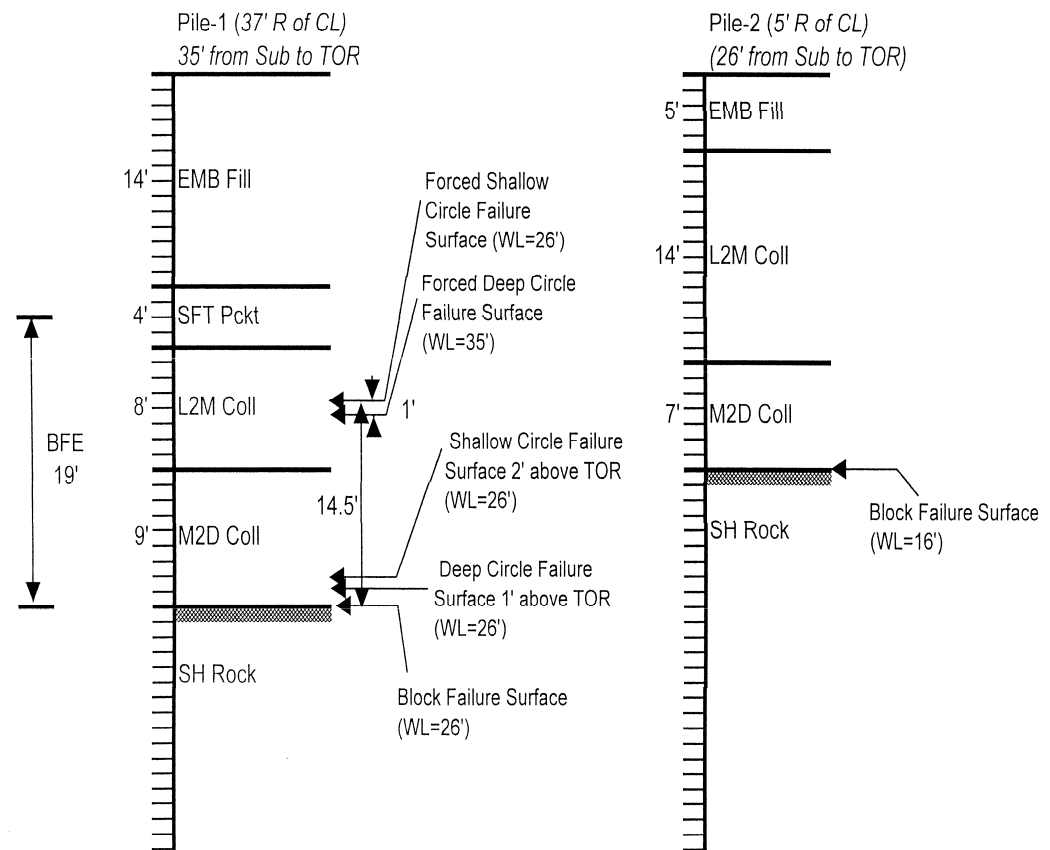
Soil Properties	Unit Weights (pcf)		Friction Angle	Subgrade Modulus (pci)	
	Dry	Sat.		Dry	Sat.
EMB FILL	120	125	32	130	90
SFT PCKT	110	115	26	60	40
L2M COLL	120	125	30	120	80
M2D COLL	125	130	38	275	175
SH ROCK	140	145	45	600	500

Phase No.: 3

- Eastbound and Full Block failures typically resulted in a load of 60 to 100 k/lf.
- Shallow circles and full circles typically resulted in a load of 20 to 40 k/lf.
- MSE circles and MSE Blocks occurred in isolated areas (10 to 20 k/lf) requiring an occasional second row of piles at the median.

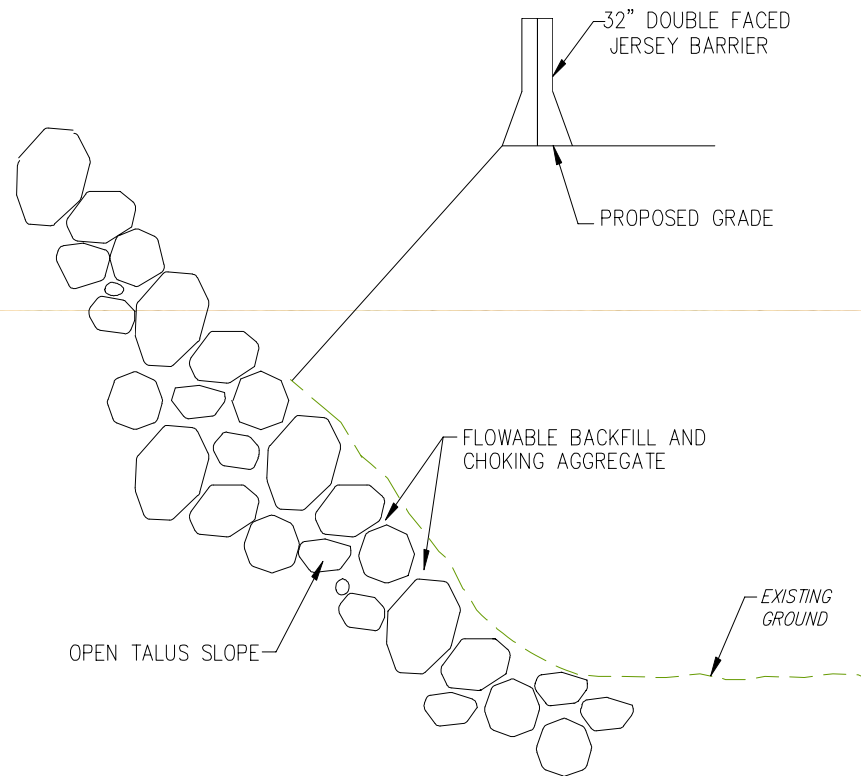
# EMBANKMENT OVER TALUS

TALUS CHOKING

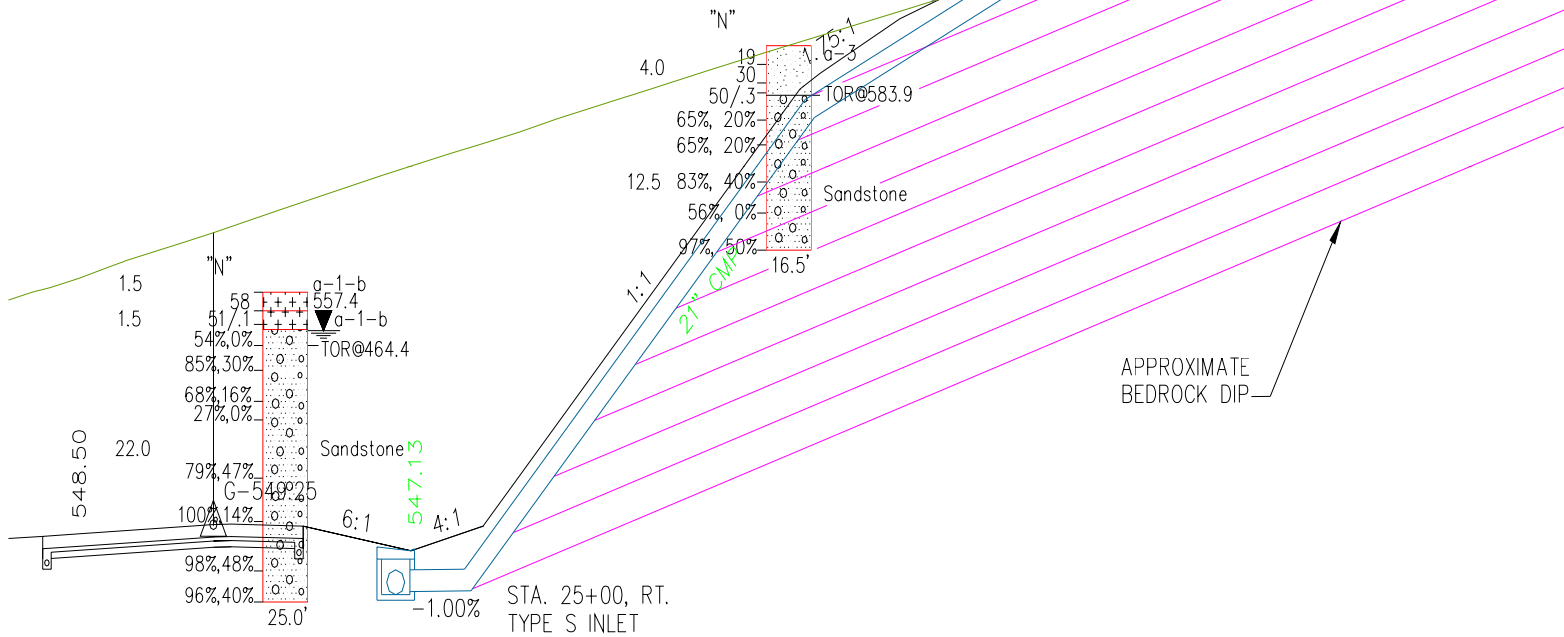
# ROCK ANCHORS

BEGIN 6" PAVT. BASE DRAIN, RT.  
AT STA. 25+11.00 RT., OUTLET TO INLET  
DRAIN OUTLET 16 L.F.

BOR. NO. M-52  
Sta. 25+06 (RAMP B)  
Offset=64' R  
587.9

STA. 25+00, RT.  
TYPE D ENDWALL  
INV. ELEV.=607.5

BOR. NO. M-53  
Sta. 25+83 (RAMP B)  
Offset=8' R  
568.7

STA. 25+00, RT.  
TYPE S INLET  
T.G.=547.13  
INV. IN=543.84  
INV. OUT=543.59

- Design cut slopes up to 1H:1V
- Design loading = 240 k
- 360 anchors
  - 10' c/c grid pattern
  - 2 to 4 rows of anchors
- Temporary excavations in rock for abutment and temporary roadway

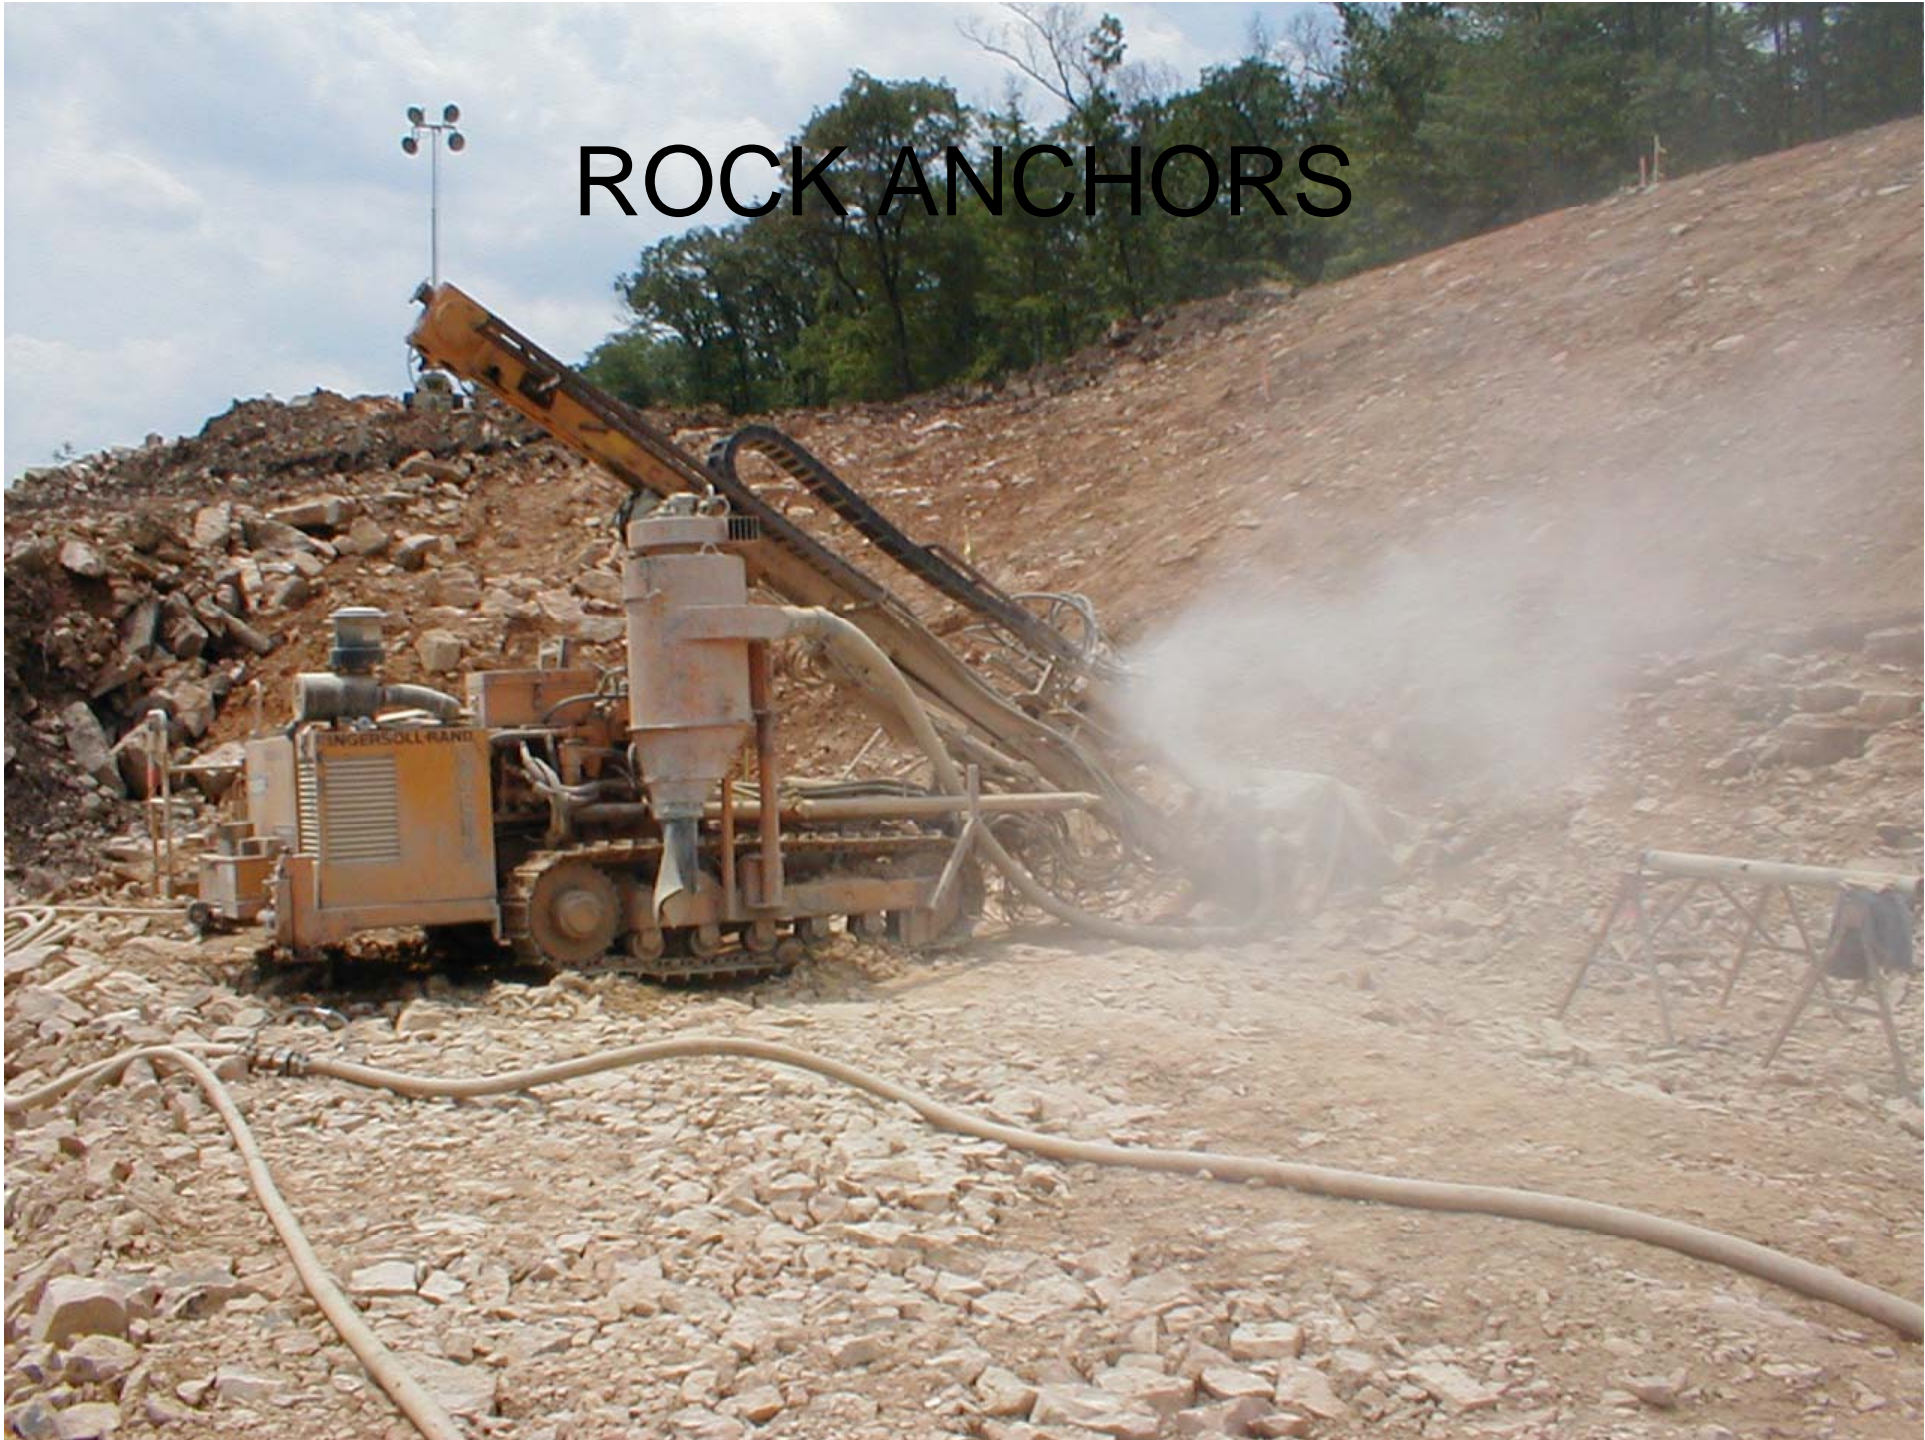
# ROCK ANCHORS
