SR 115/US 129 “The Dragon” Slide

David Barker, PE, TDOT
Geotechnical Engineering Section

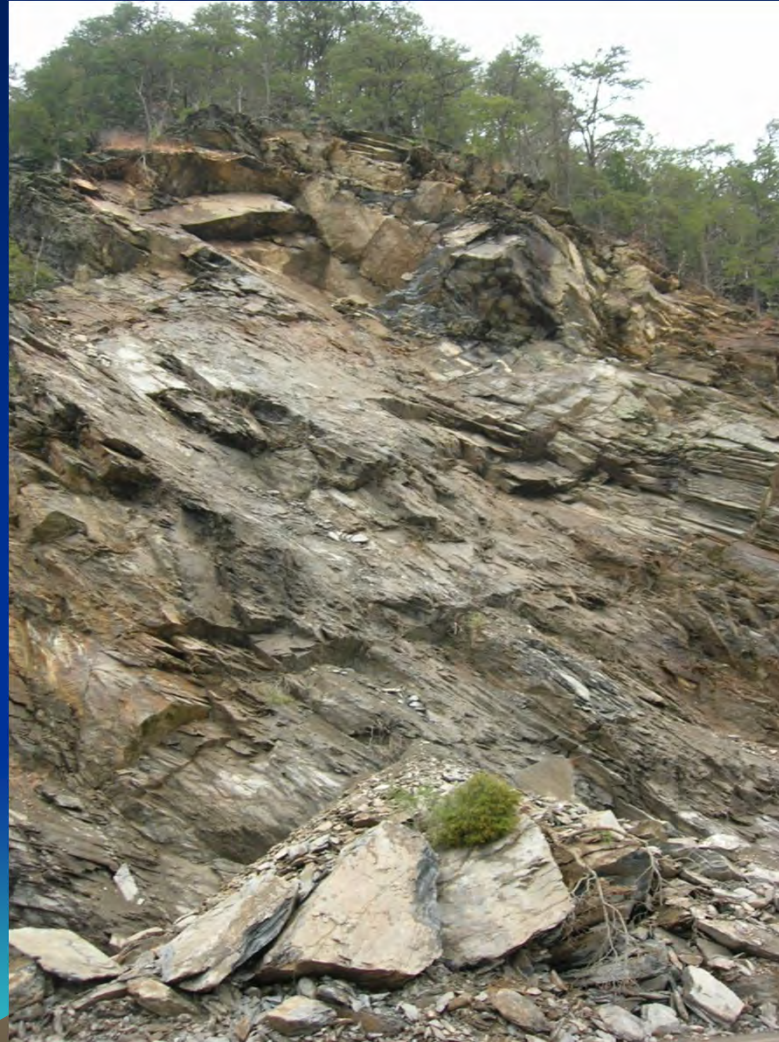
Slope deemed unsafe for traffic after inspection

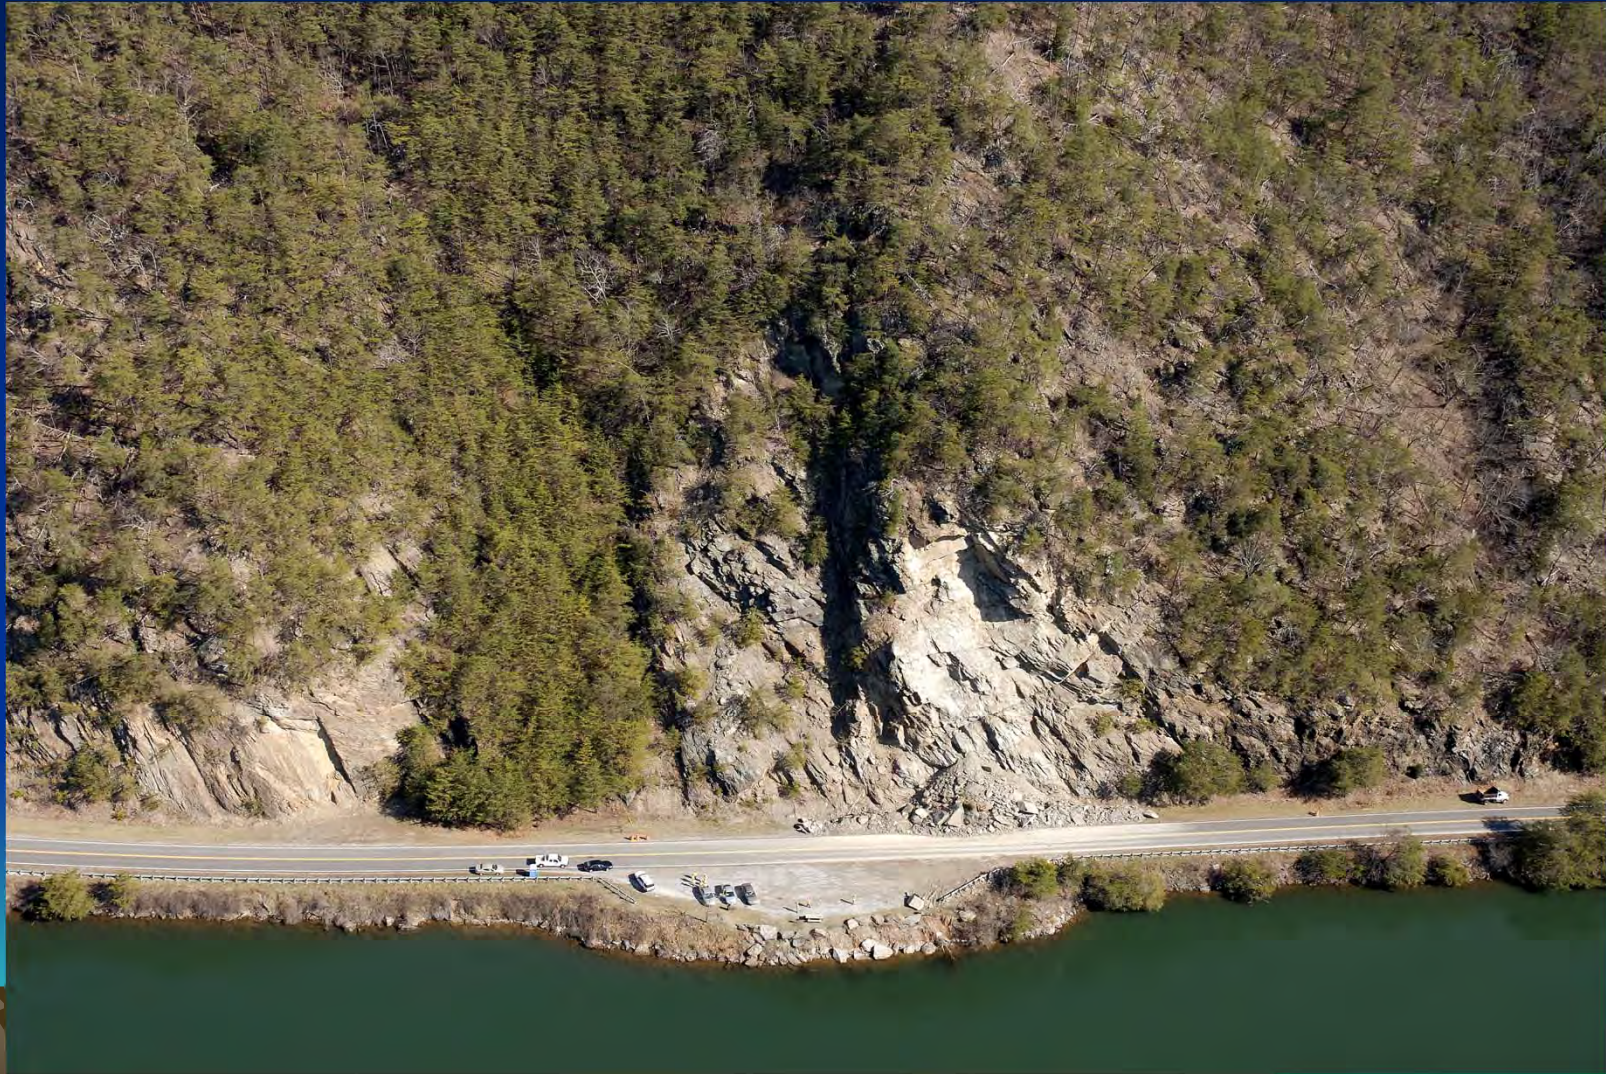
Aerial view on March 19, 2010

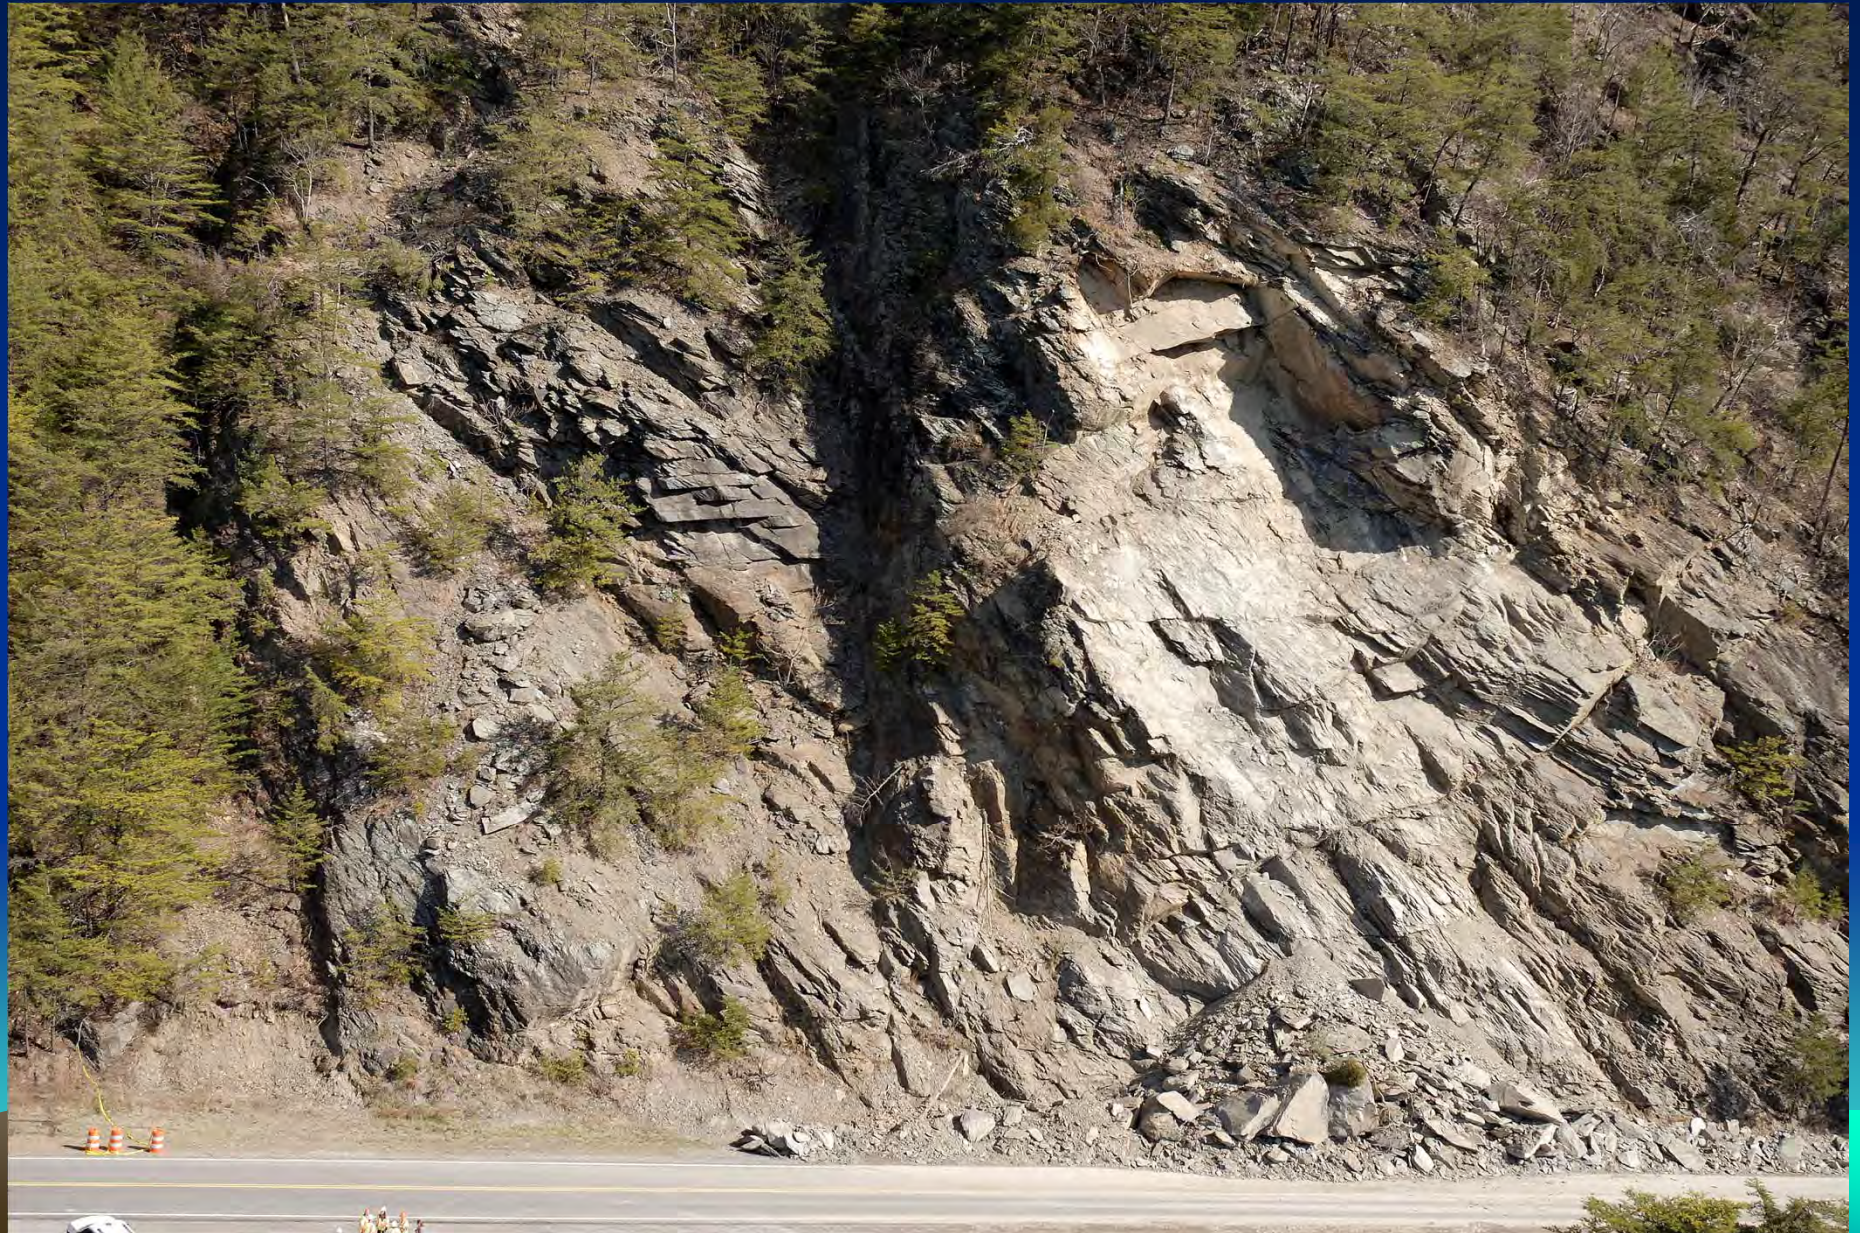
Aerial view on March 19, 2010

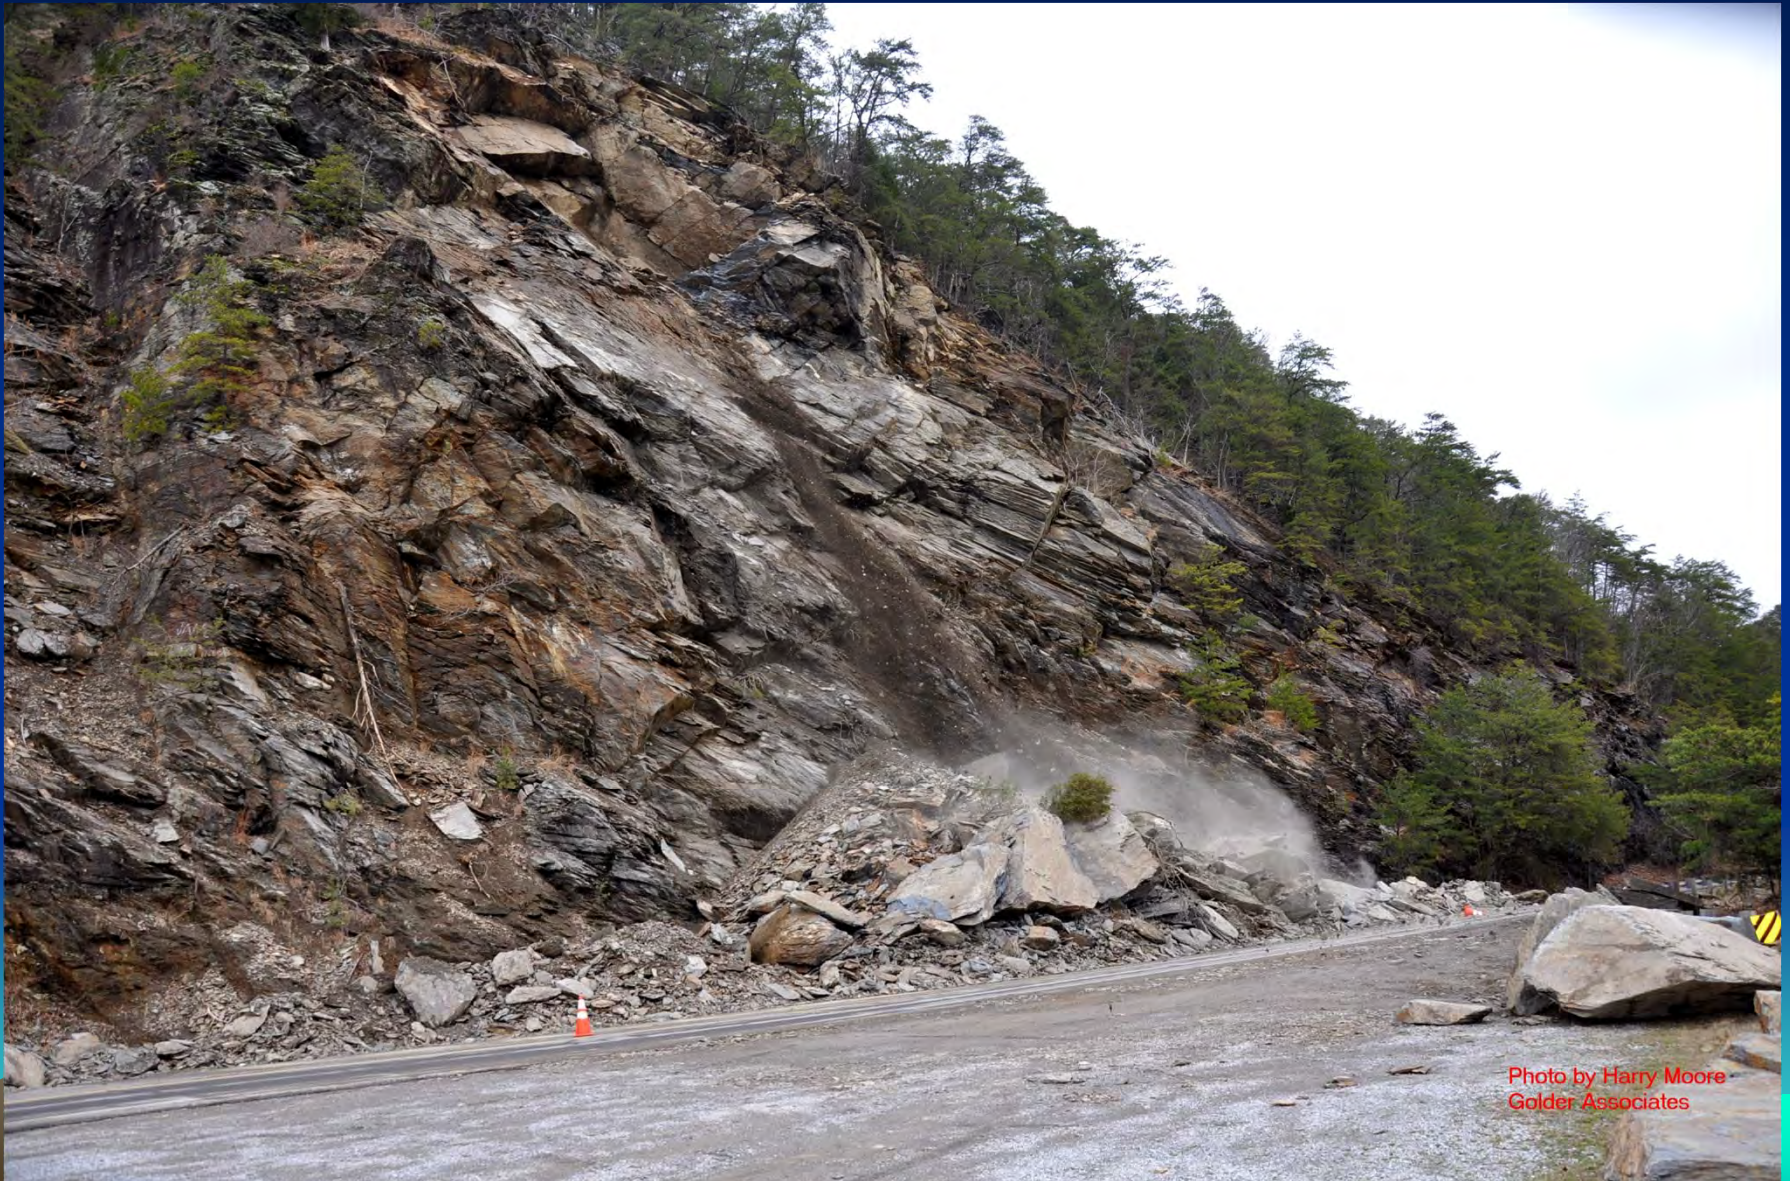
The small stuff can also be disconcerting

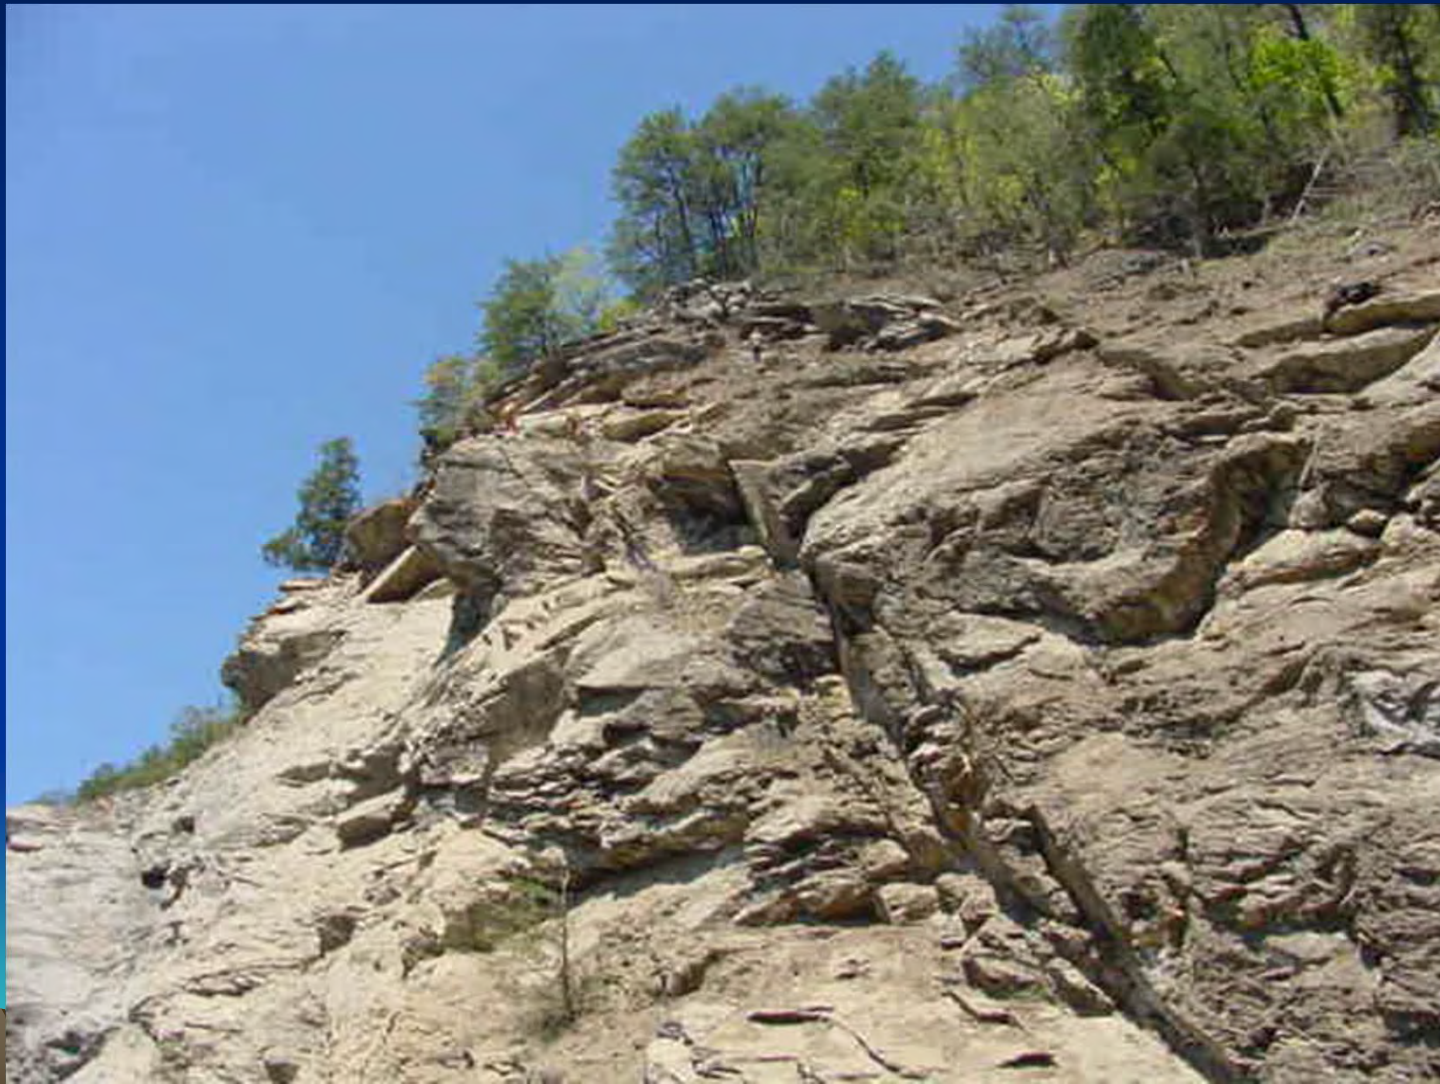
Trimming and Scaling underway, shown on April 11, 2010

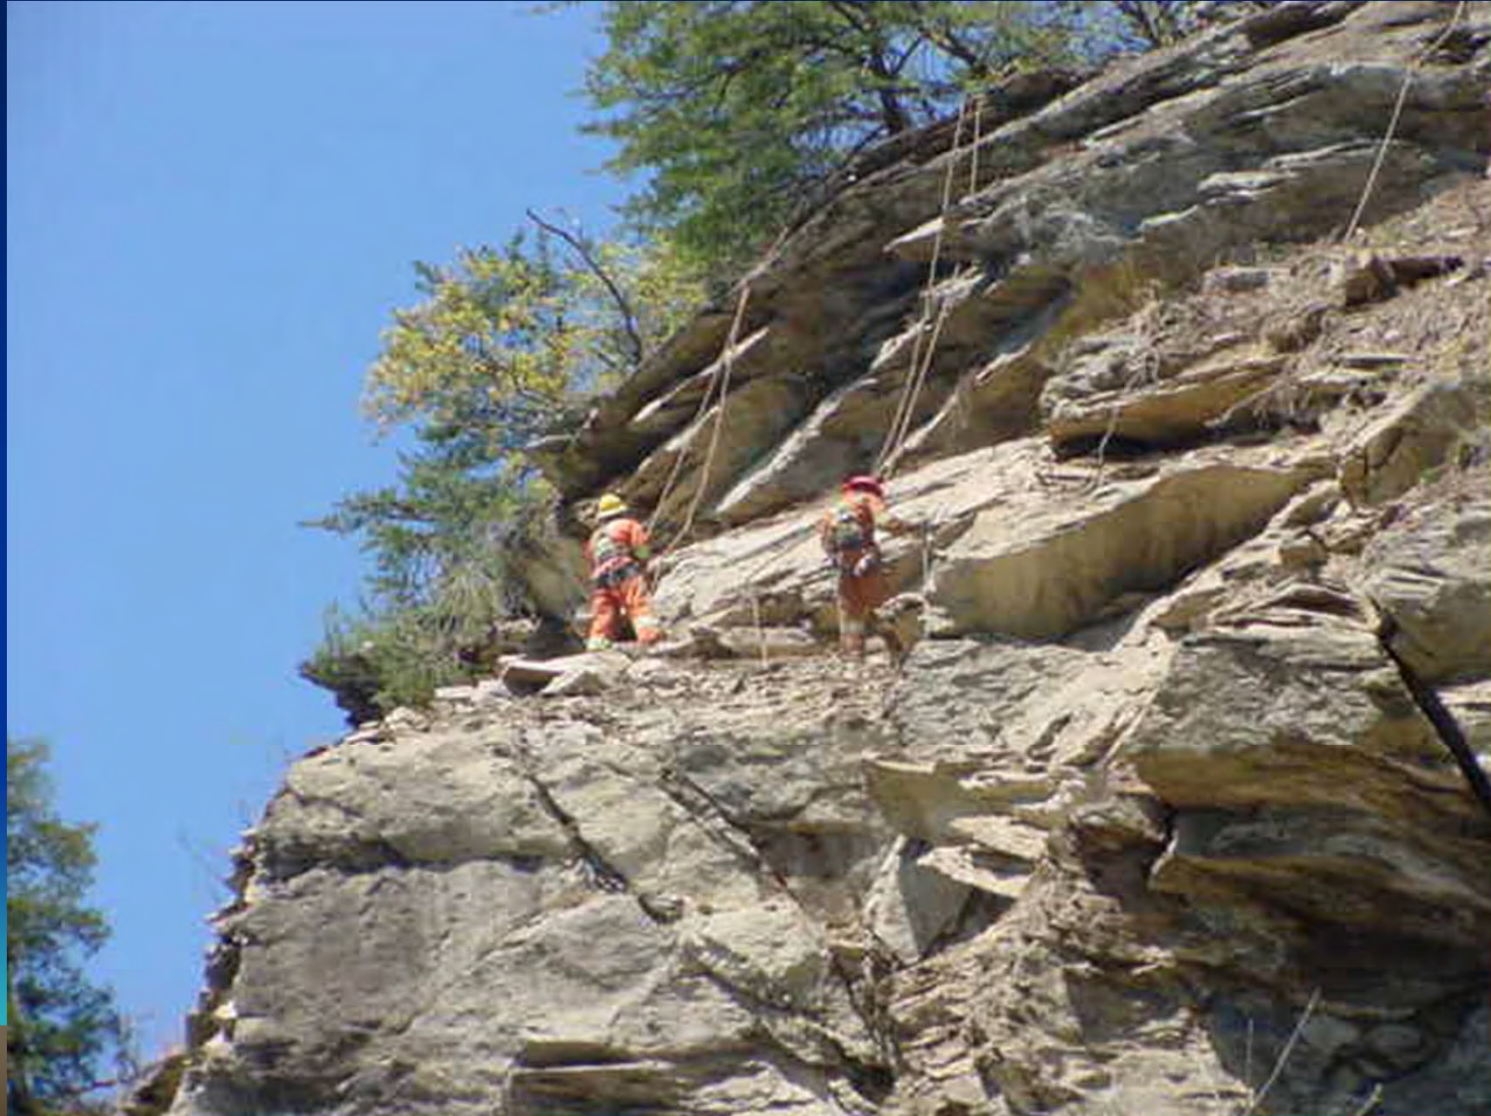
More trimming and scaling

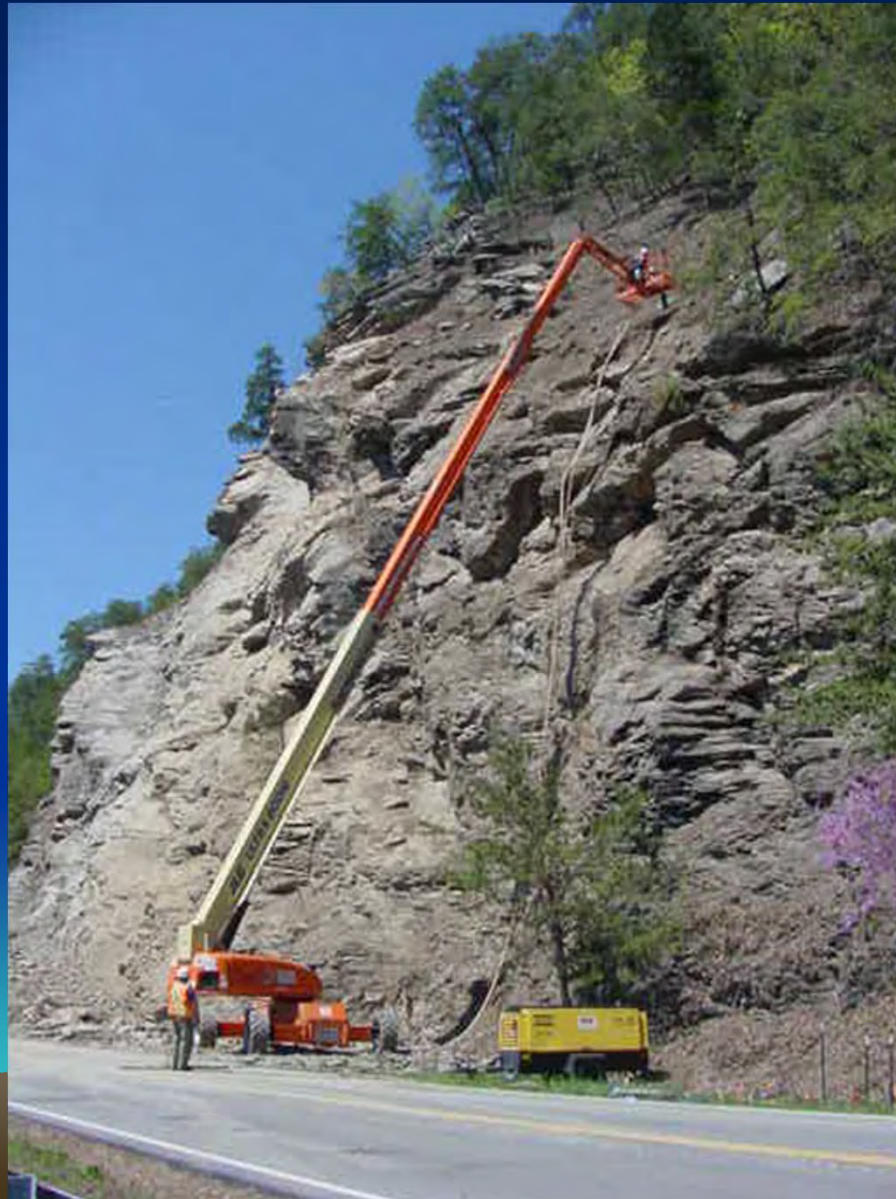
Cleaning portions of the slope with compressed air

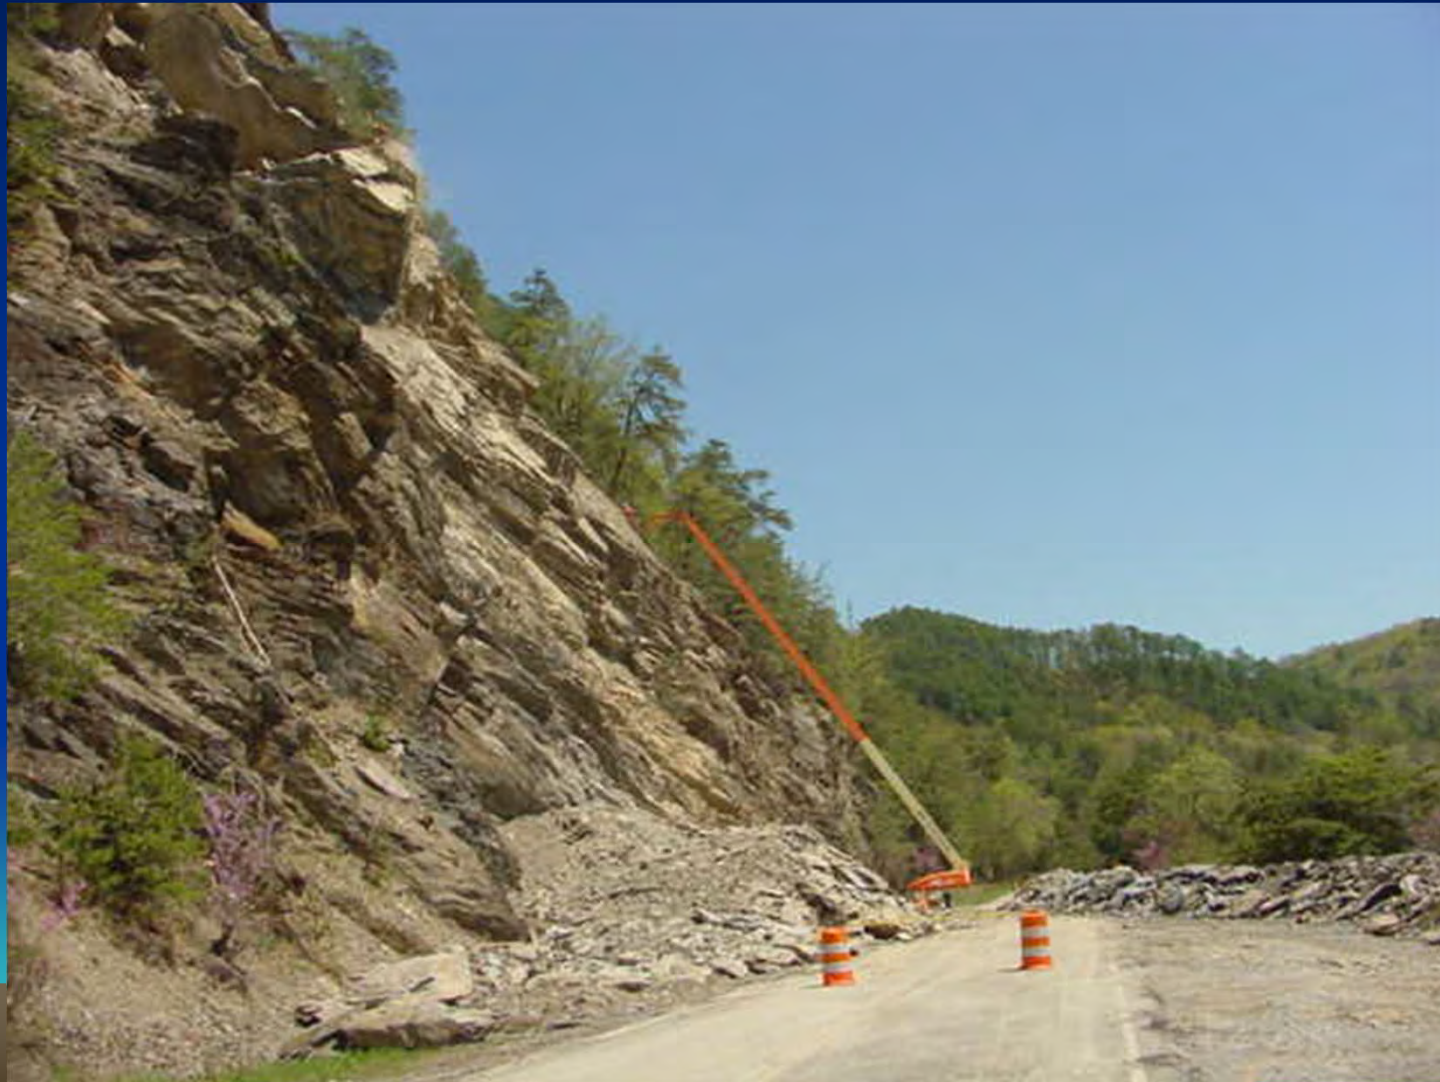
View of slope showing debris used as berm along lake

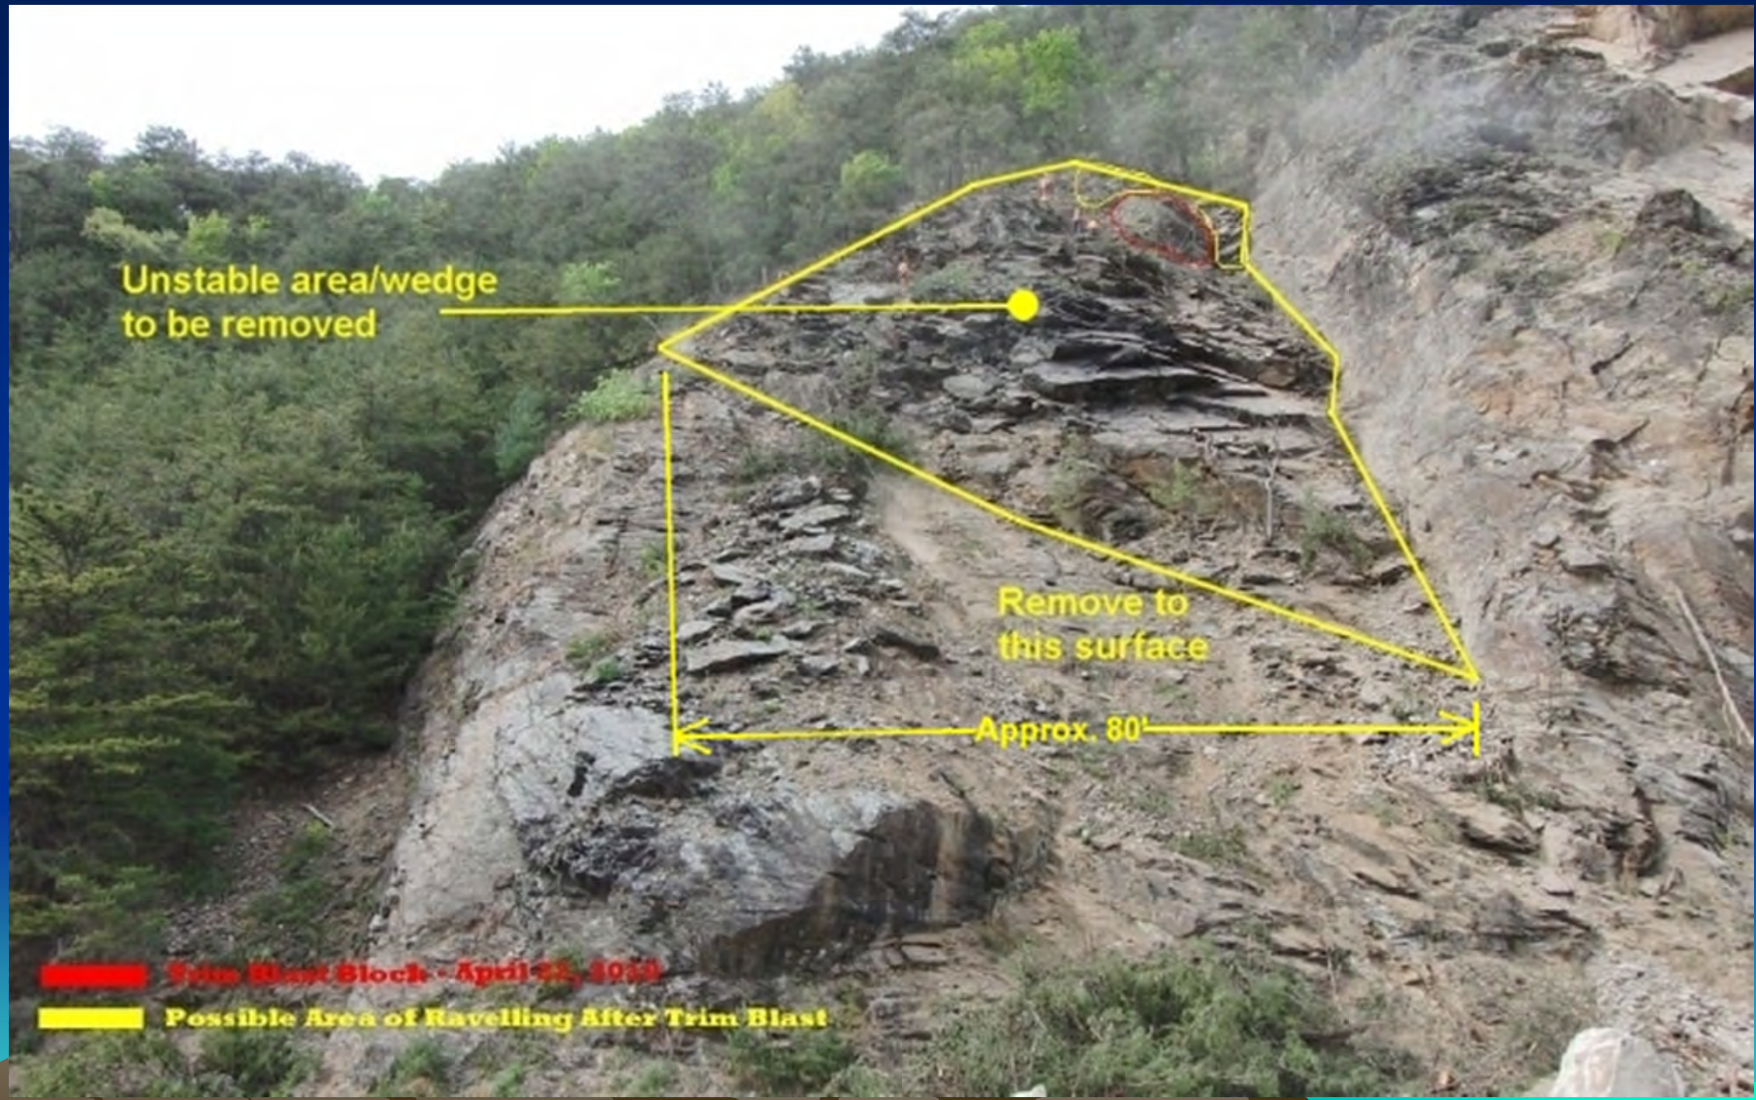
House of cards, originally to be trimmed and scaled, to be removed

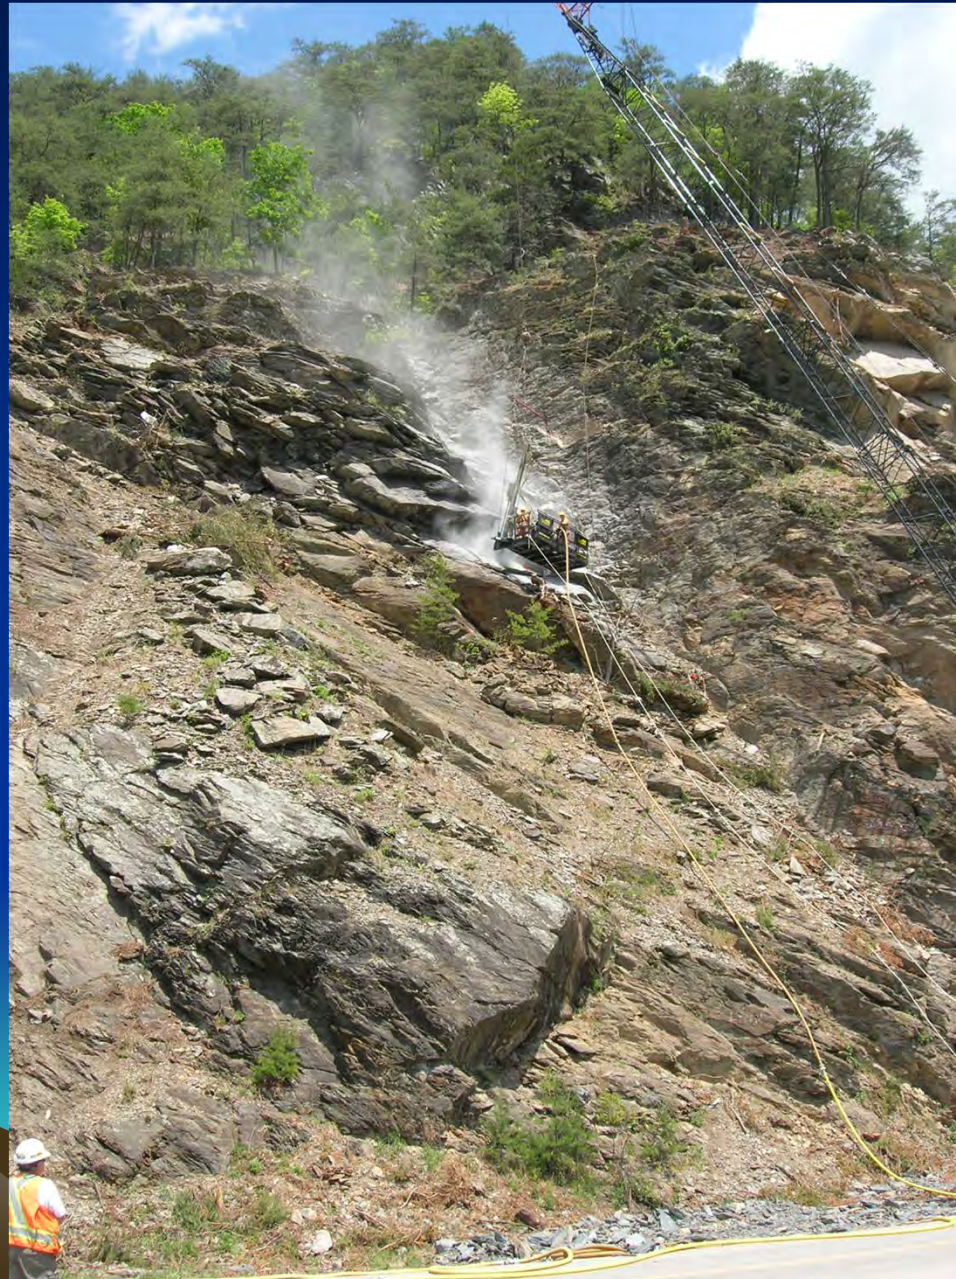
Drilling for blasting

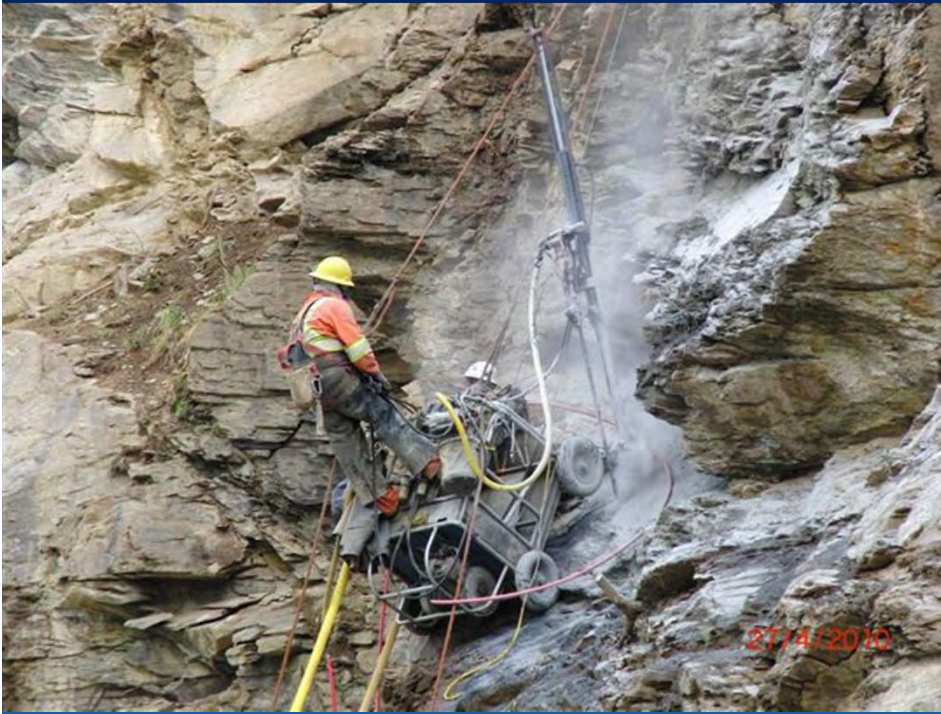
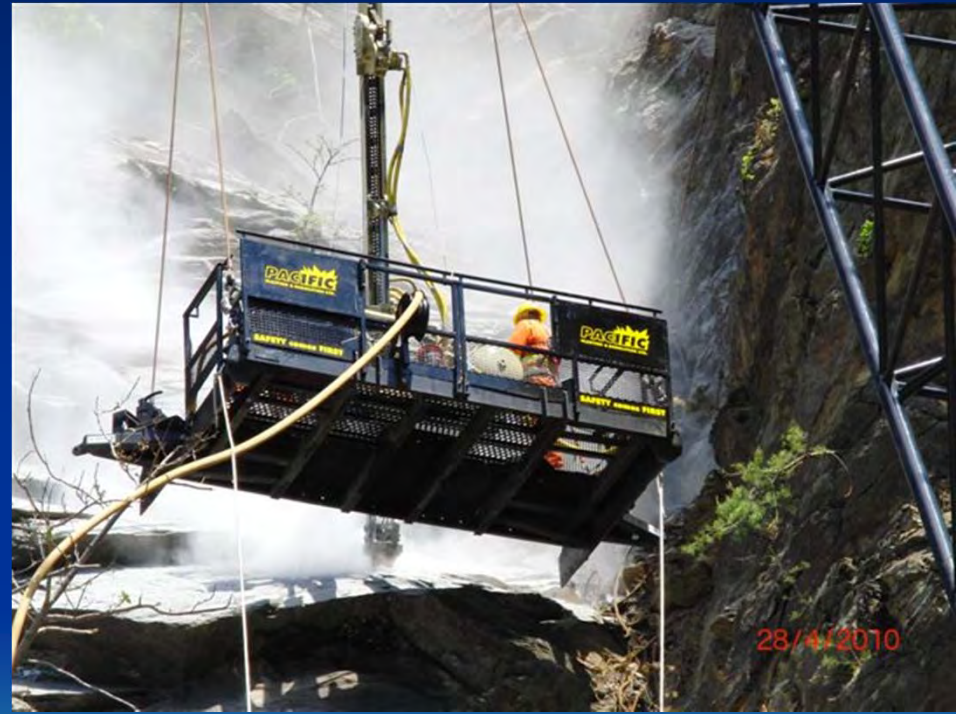
More drilling

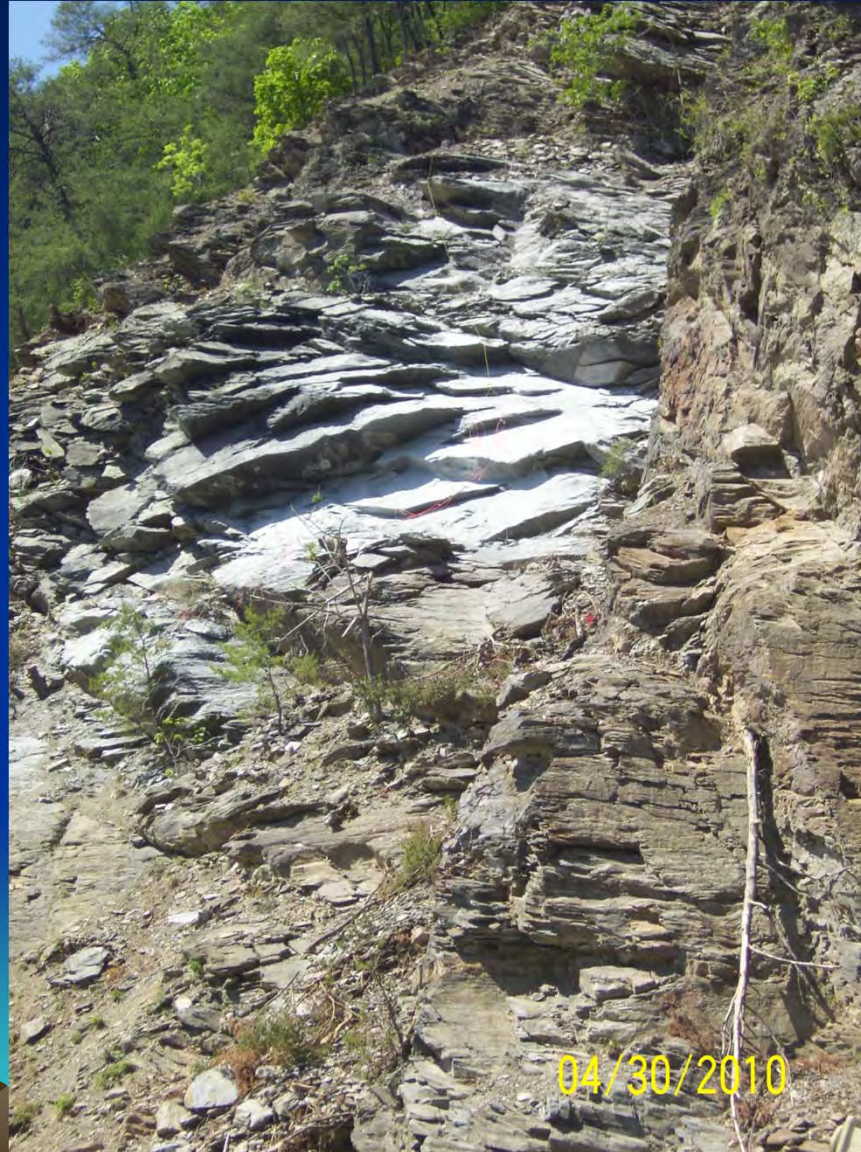
House of cards before 1st shot

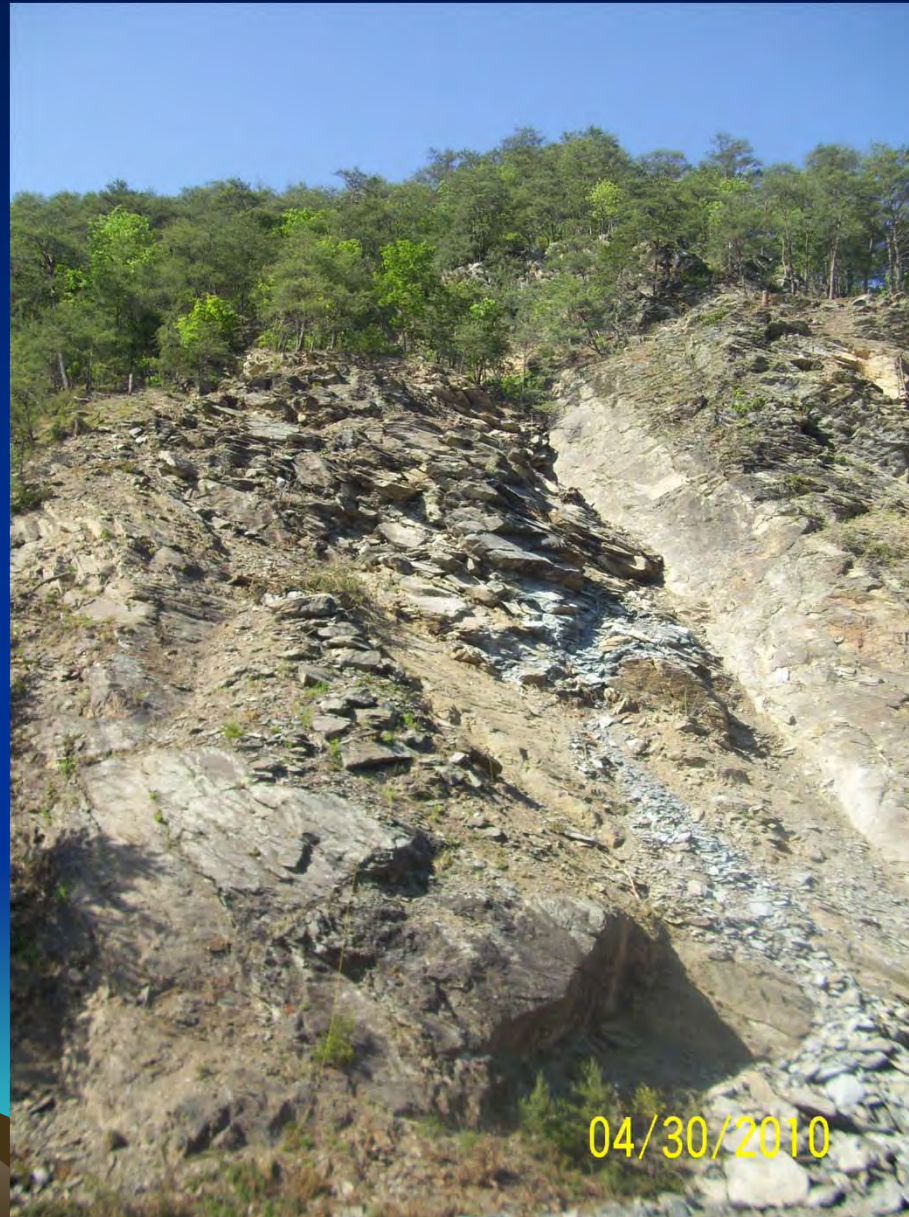
House of cards after 1st shot

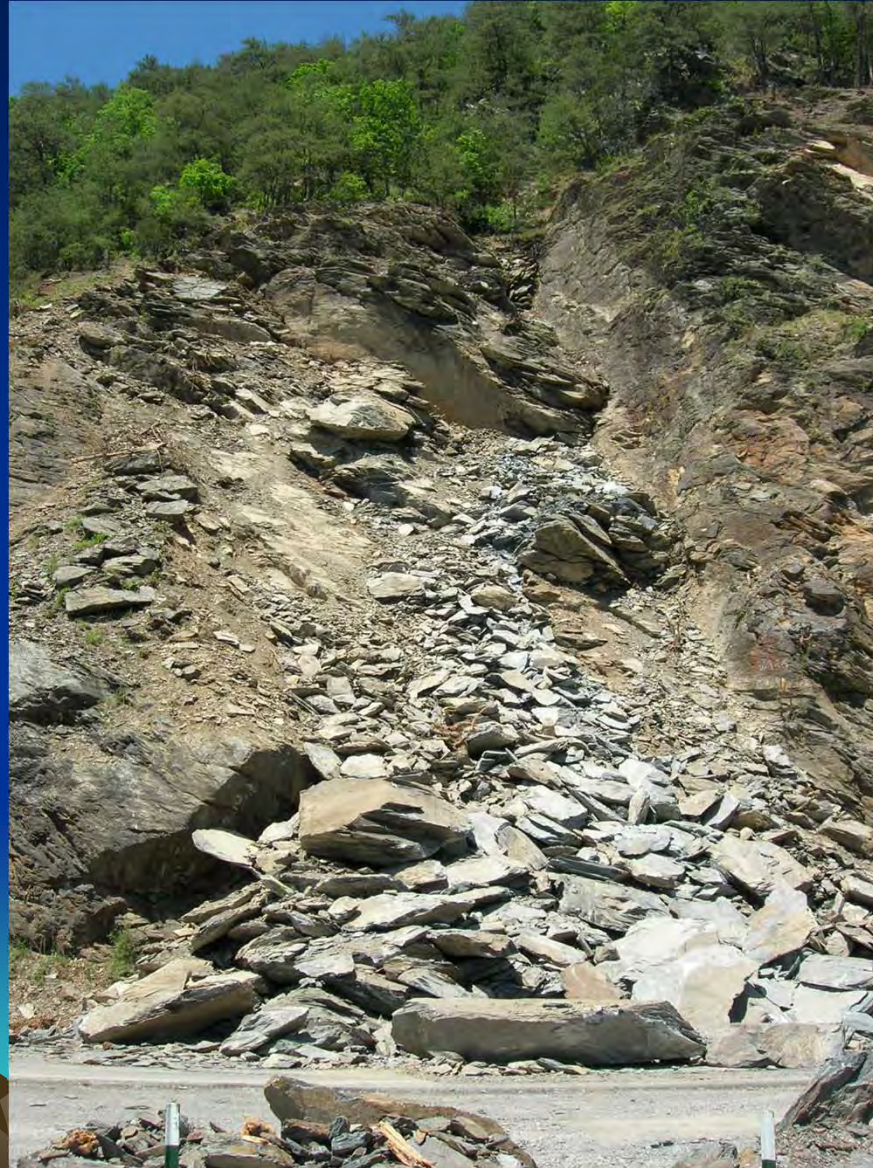
House of cards after 2nd shot

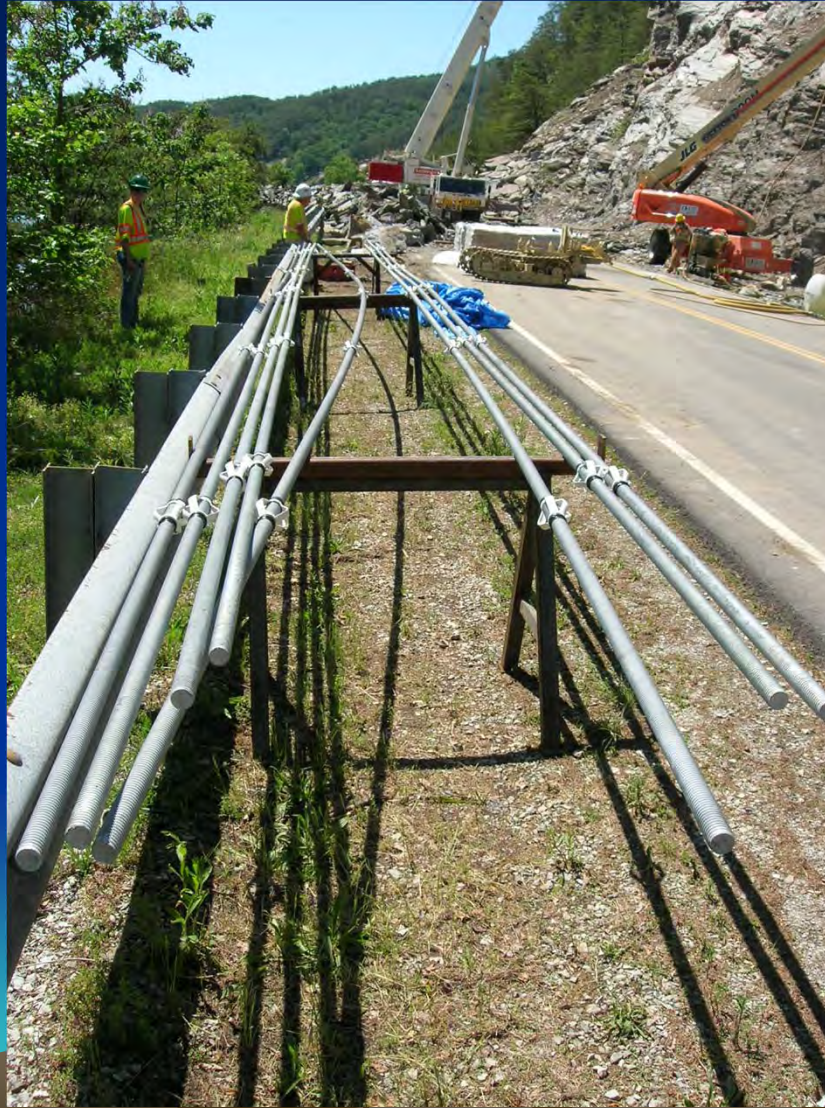
Anchors prepared for installation

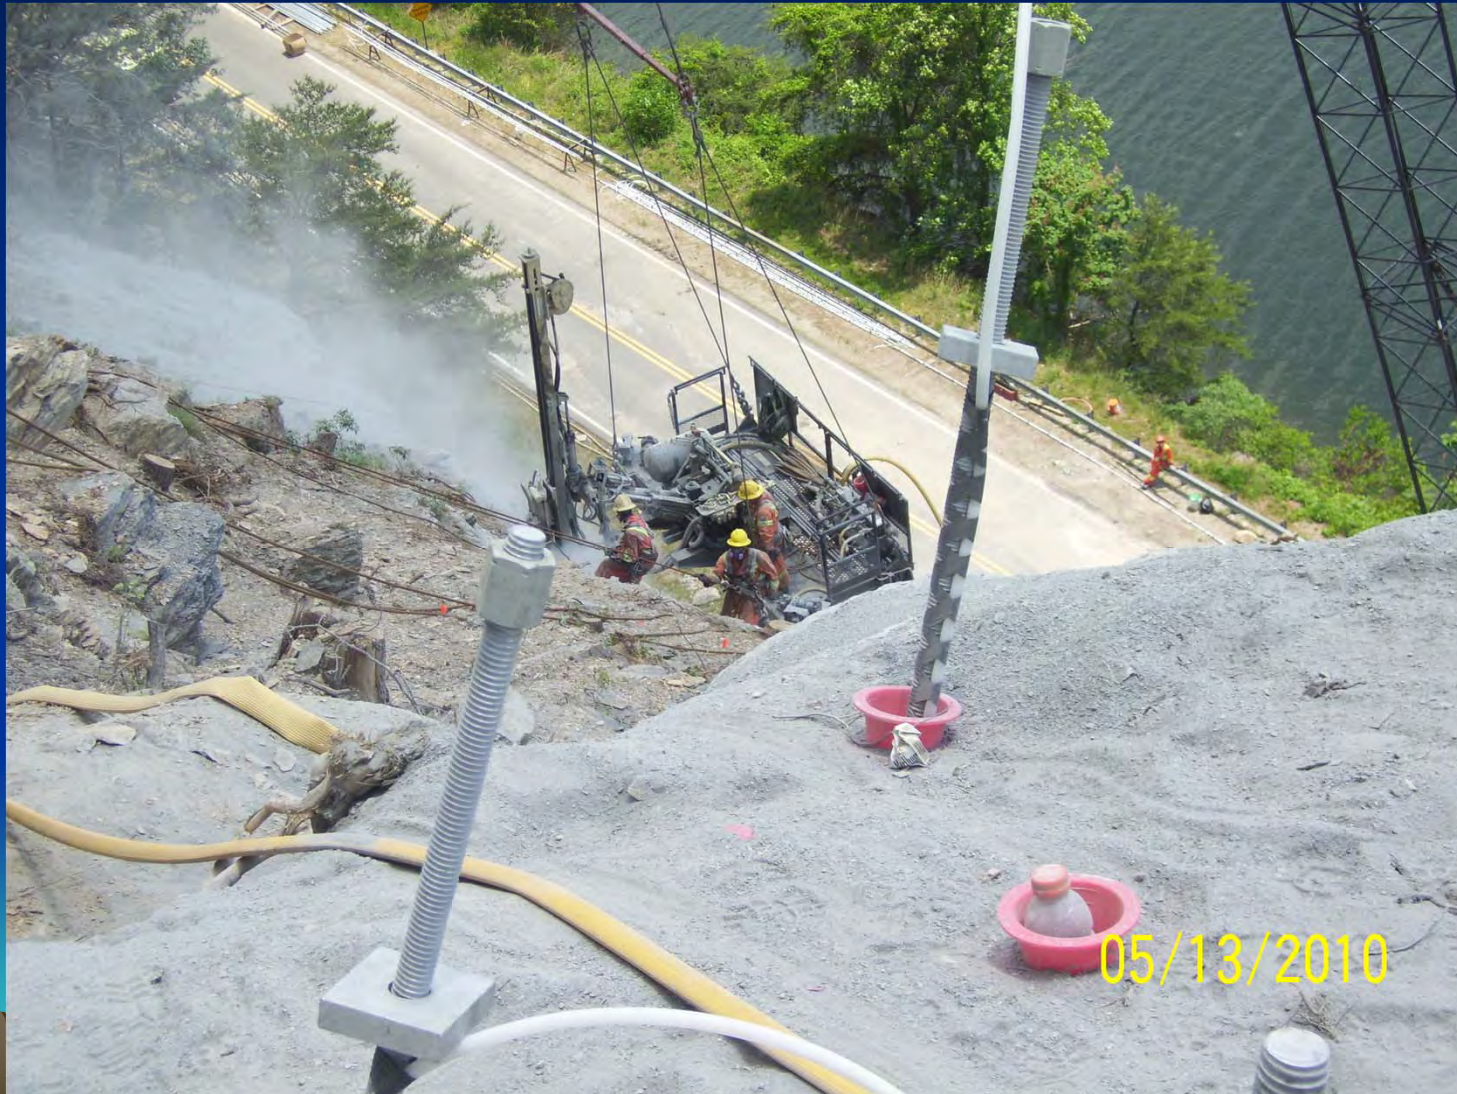
Anchors/dowels prior to grouting
