SR 115/US 129 “The Dragon” Slide

David Barker, PE, TDOT
Geotechnical Engineering Section

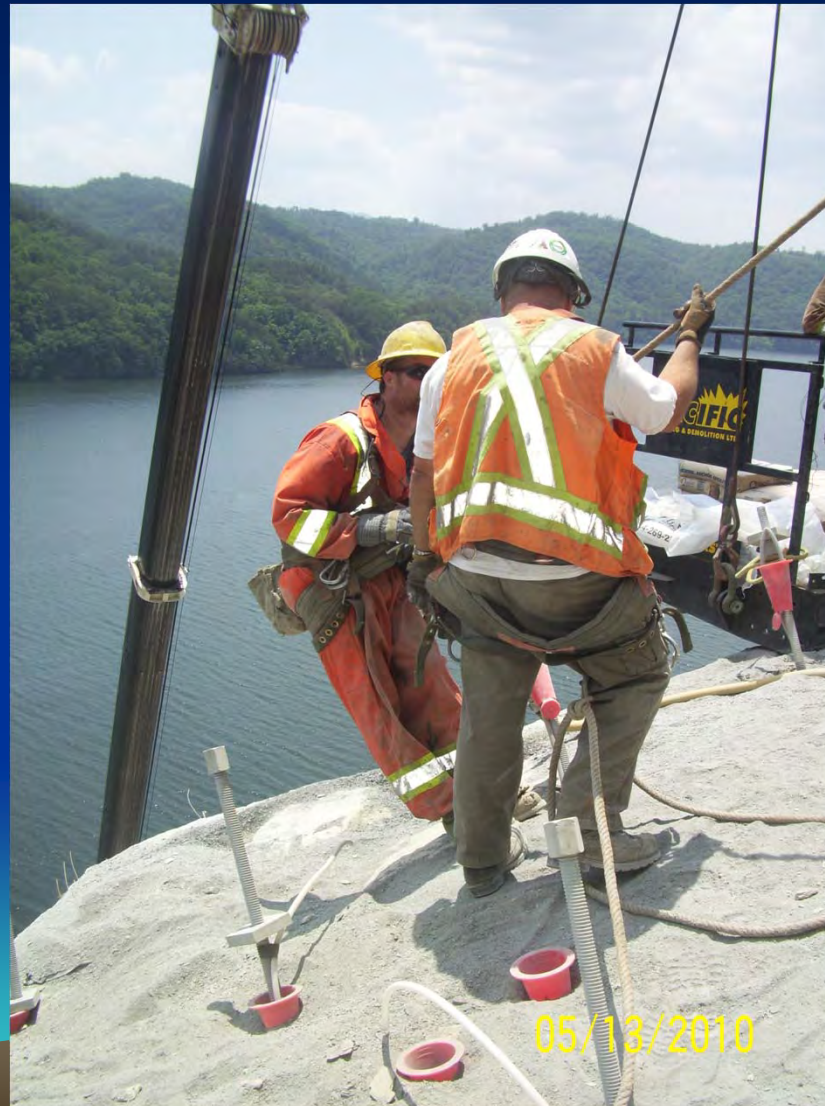
Closely spaced anchors on ledge

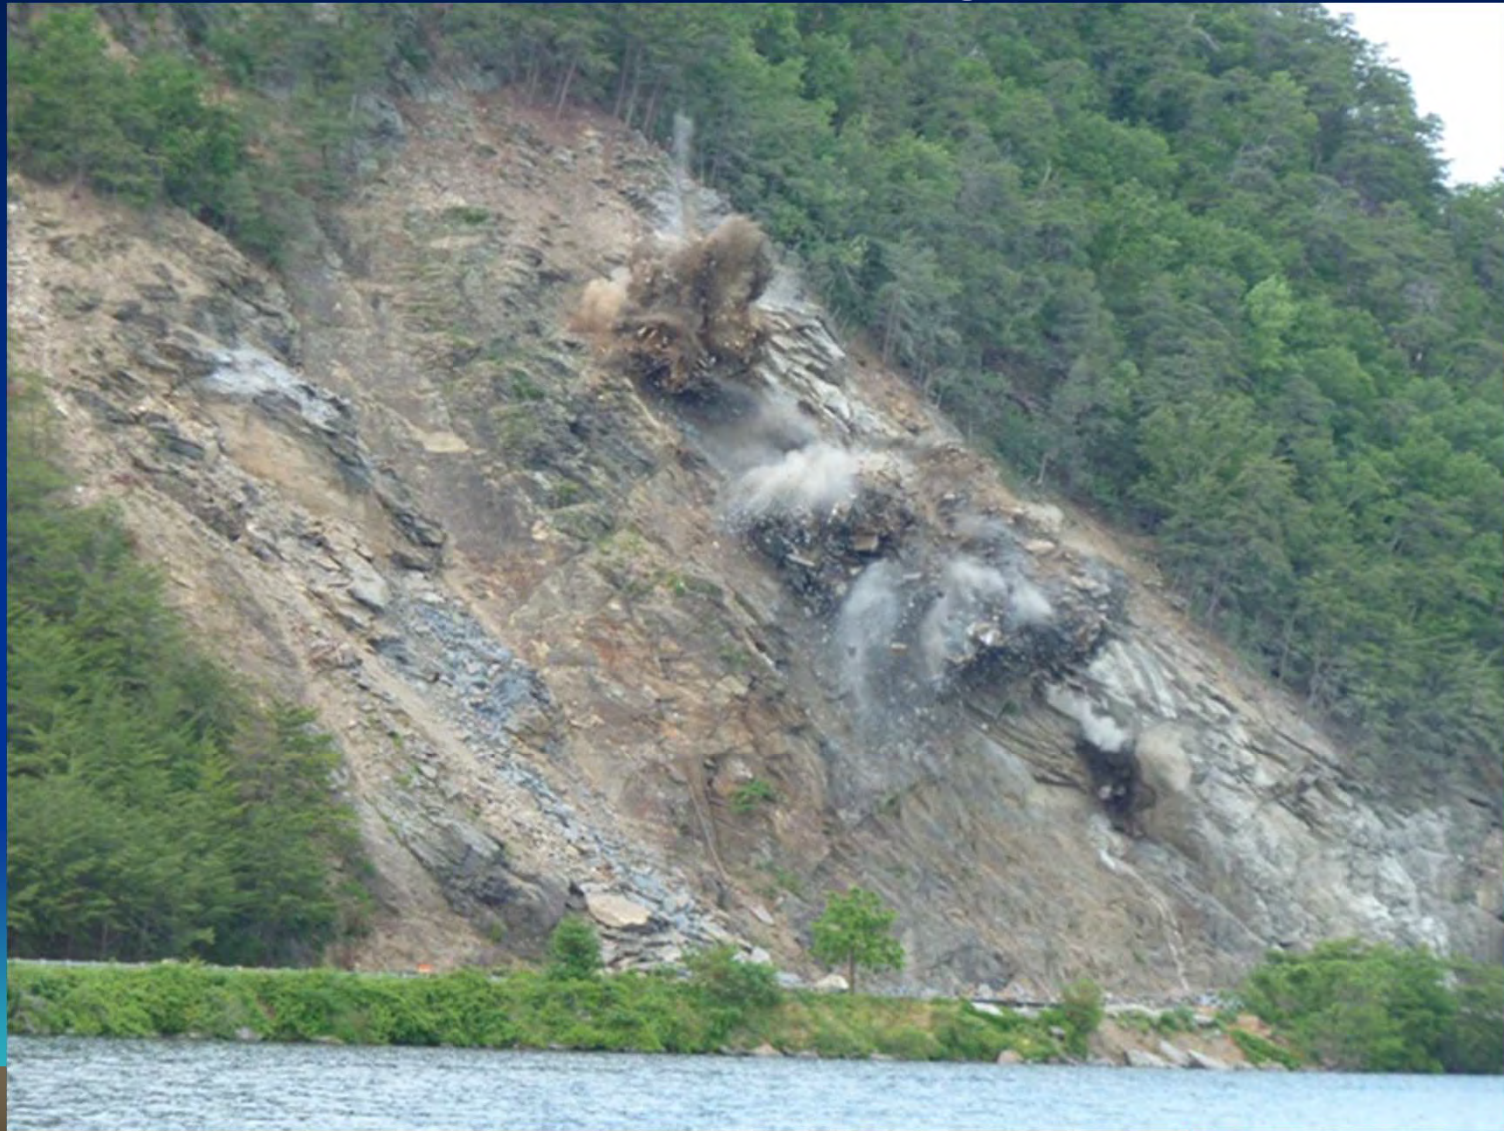
Trim Blasting

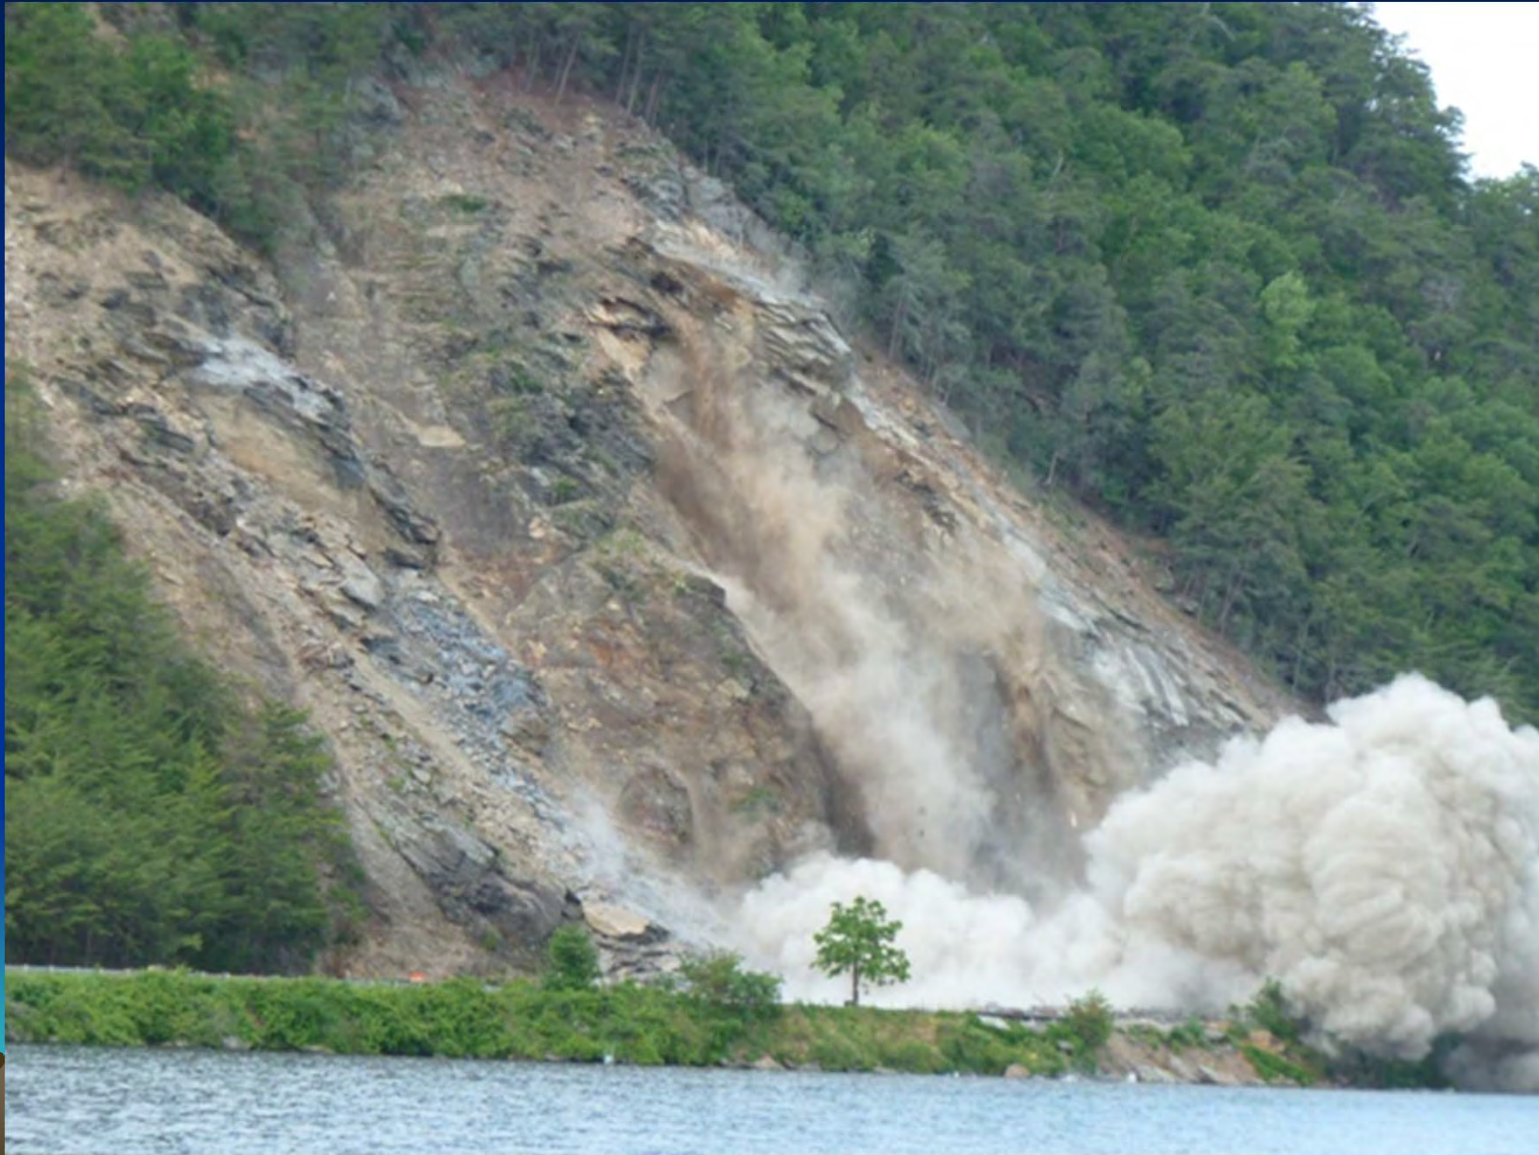
More trim blasting

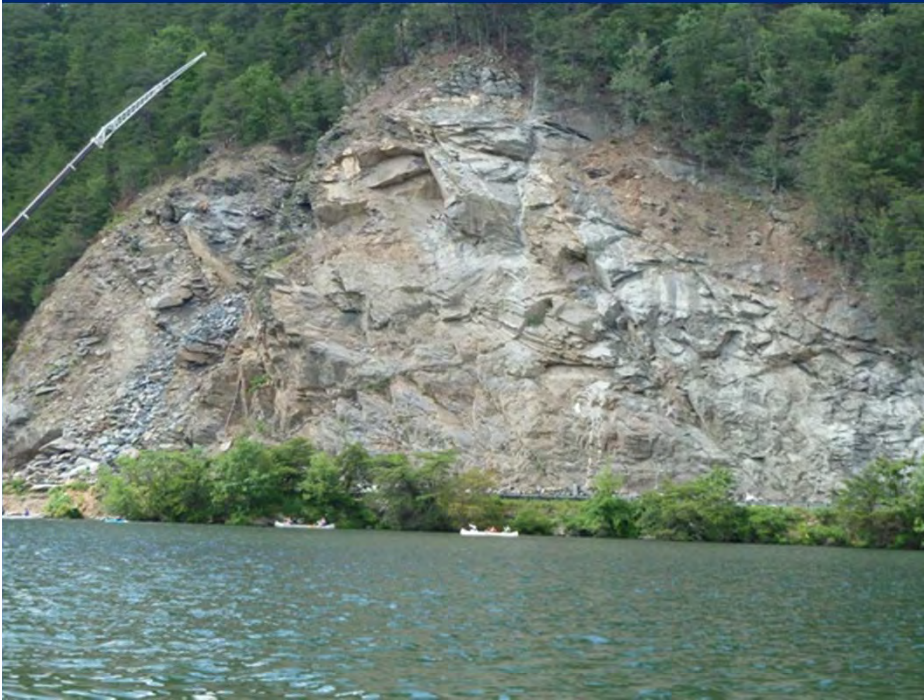
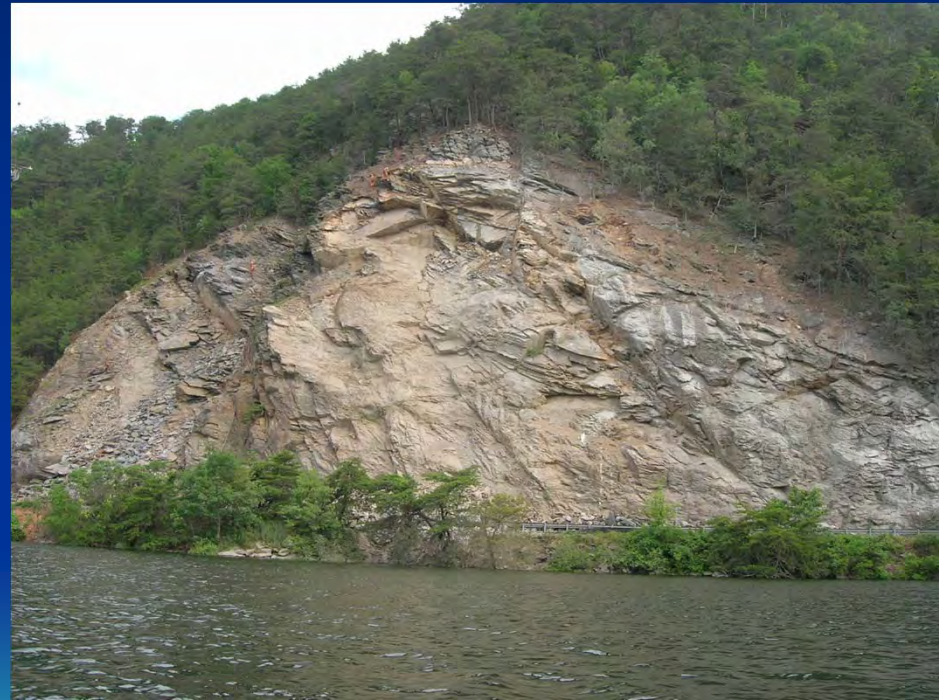
Slope before and after trim shot on May 18th

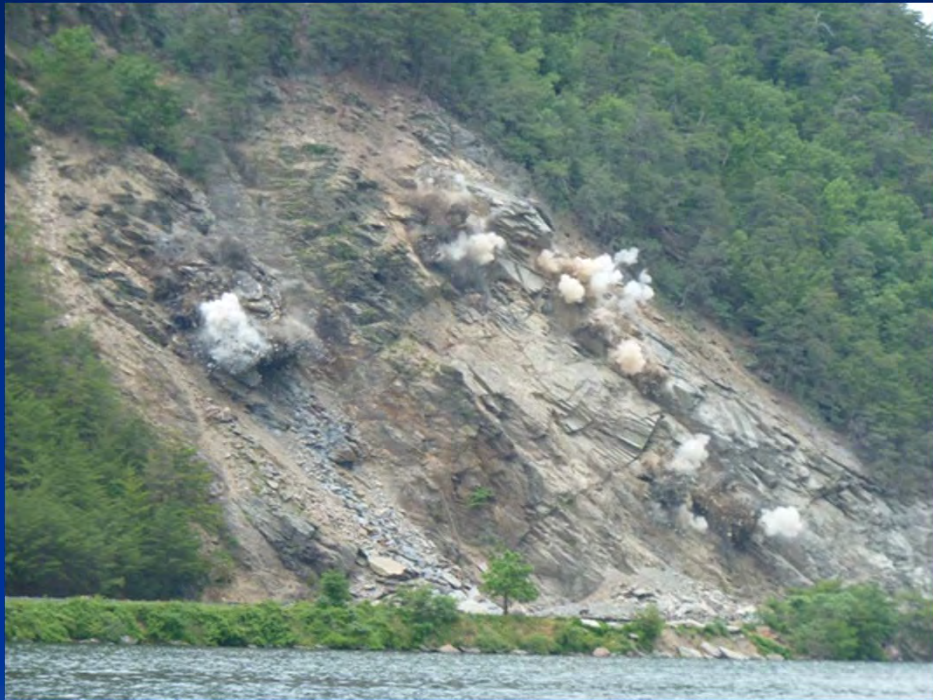
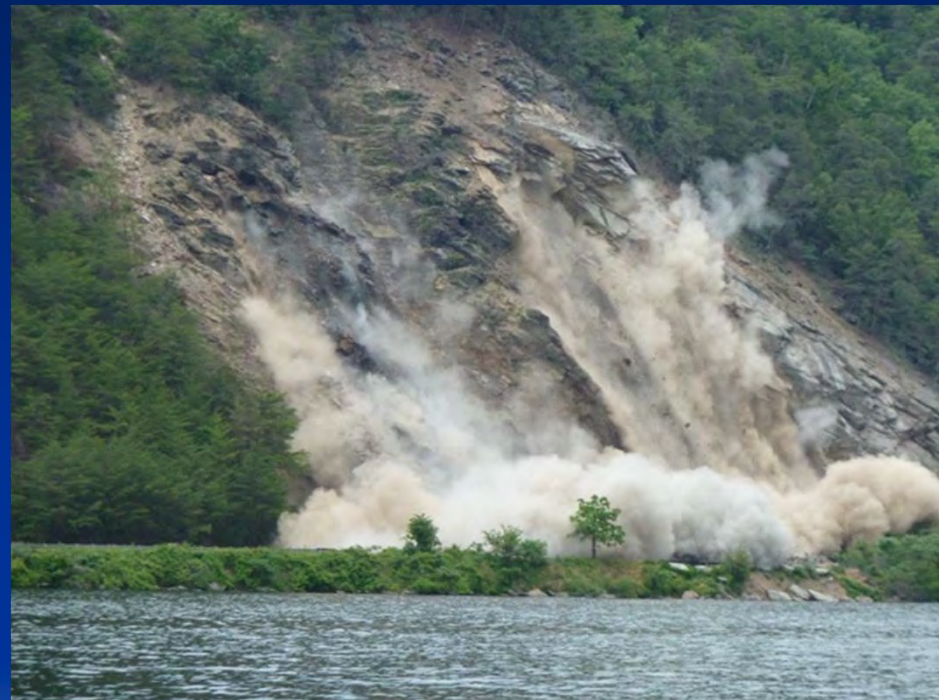
Trim shot on May 21st

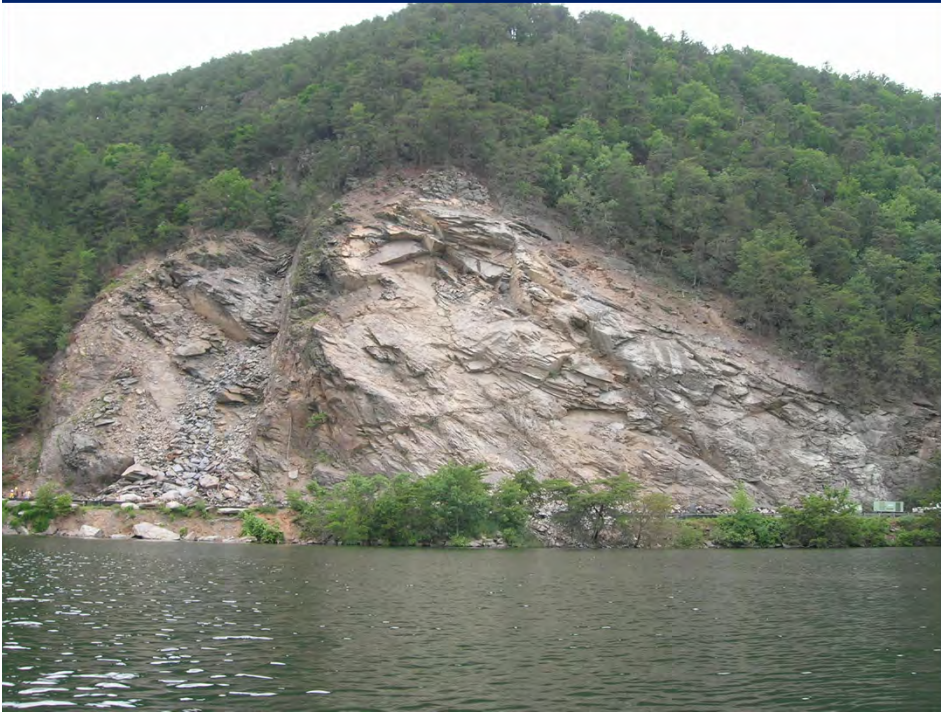
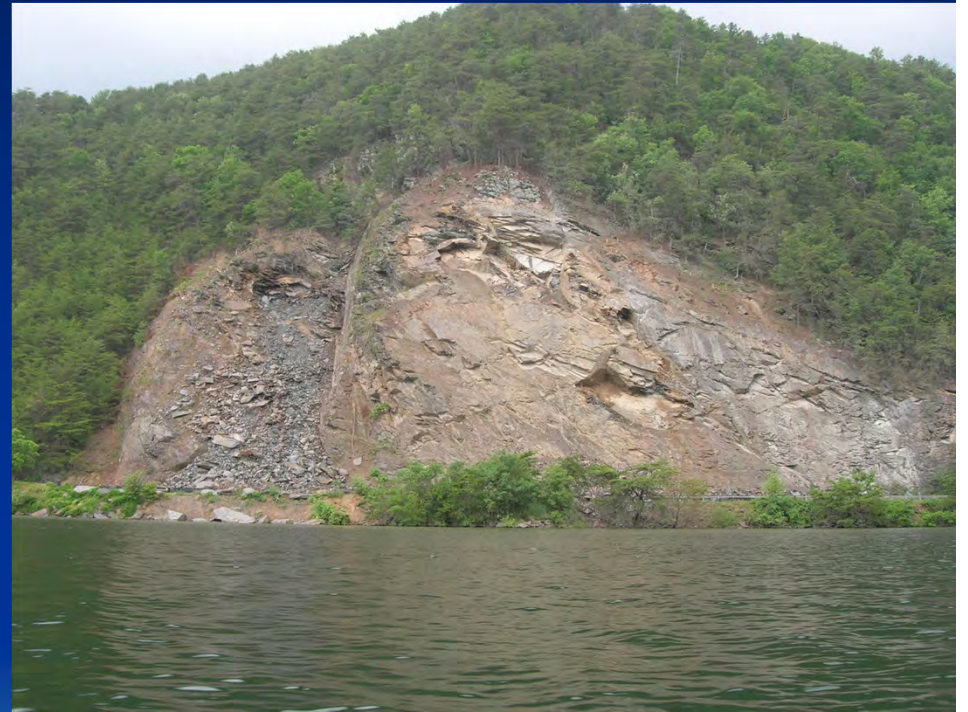
Before and after trim shot on May 21st

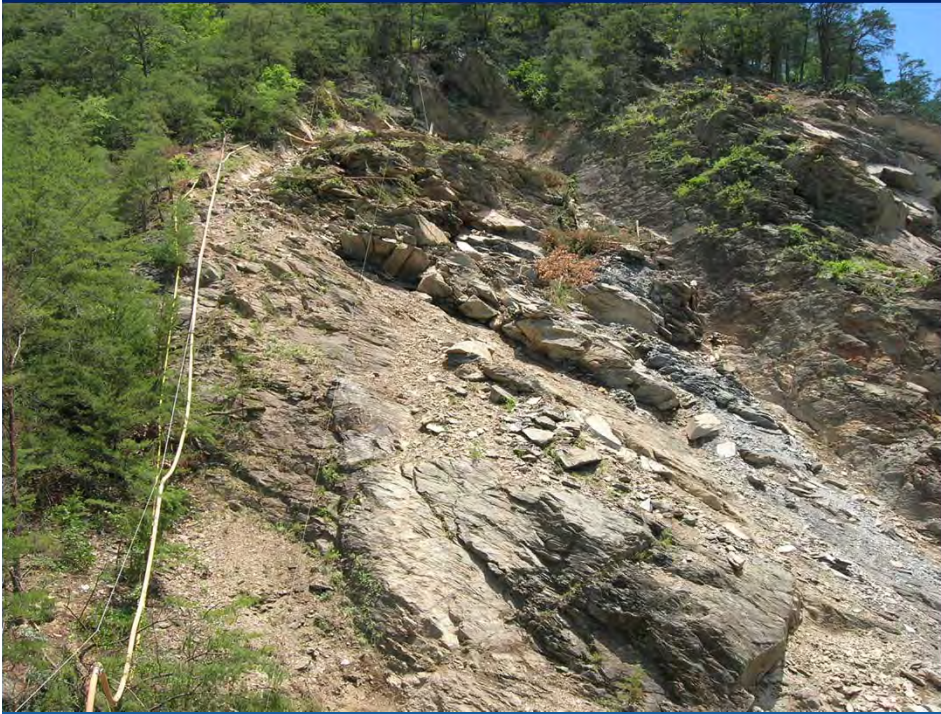
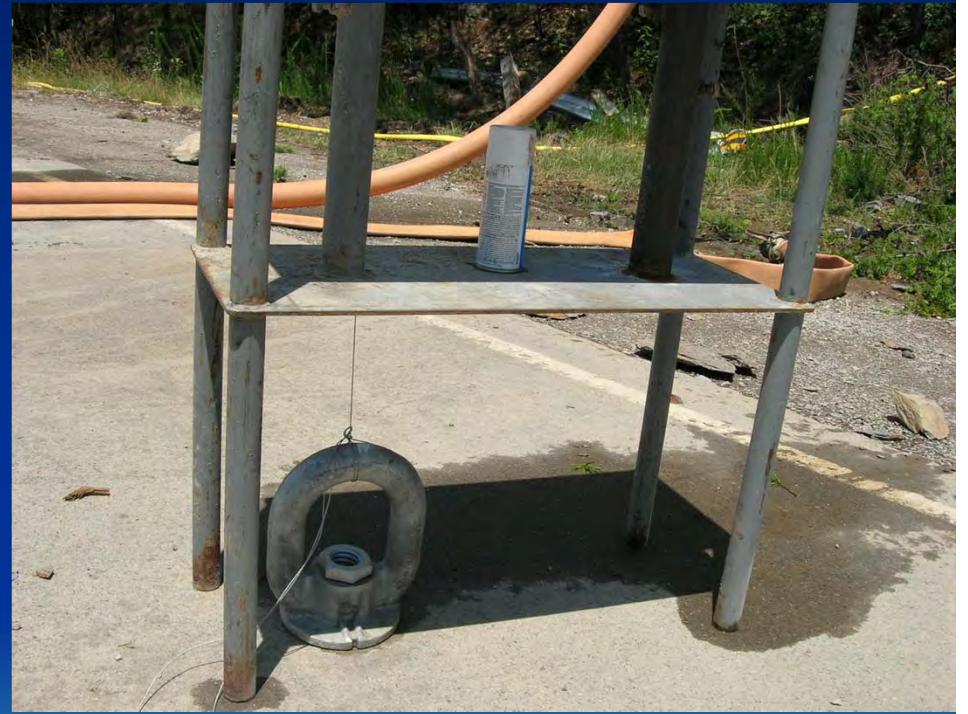
Tracking movement of House of Cards on June 7th

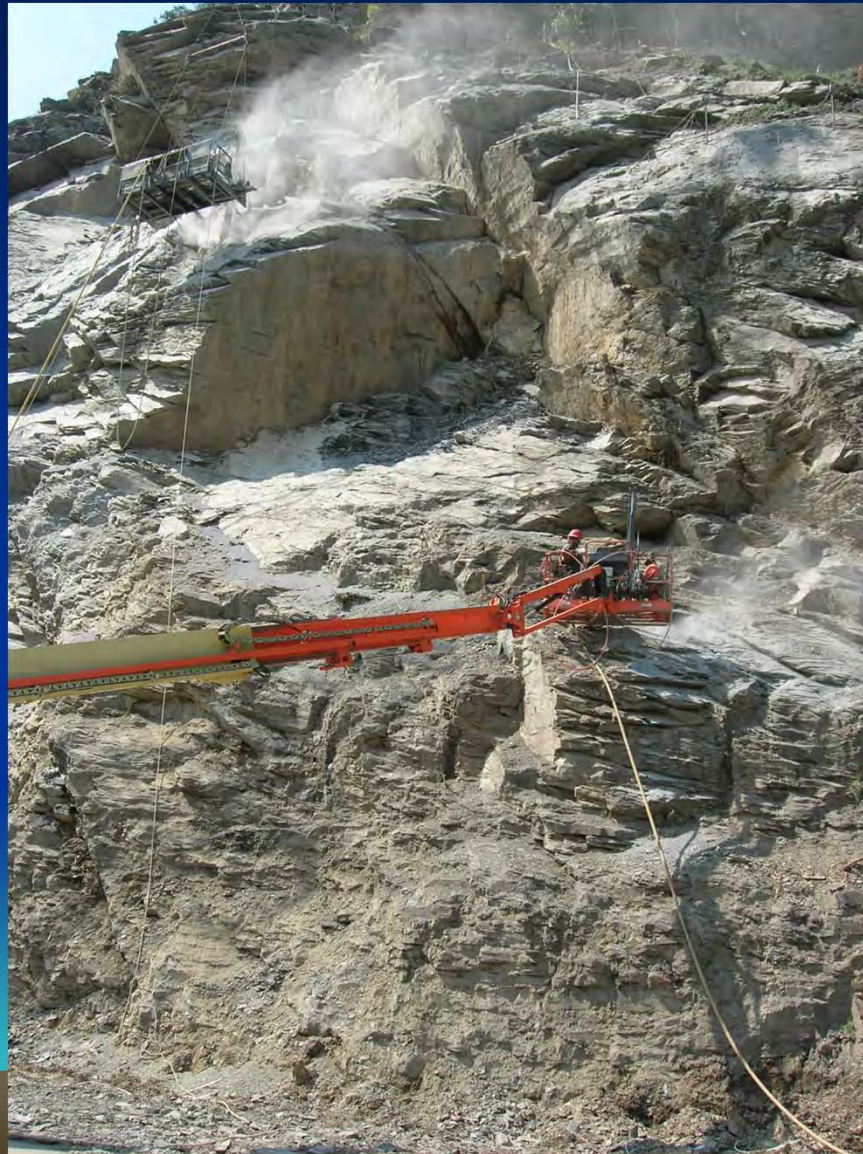
Drilling for anchors on slope face

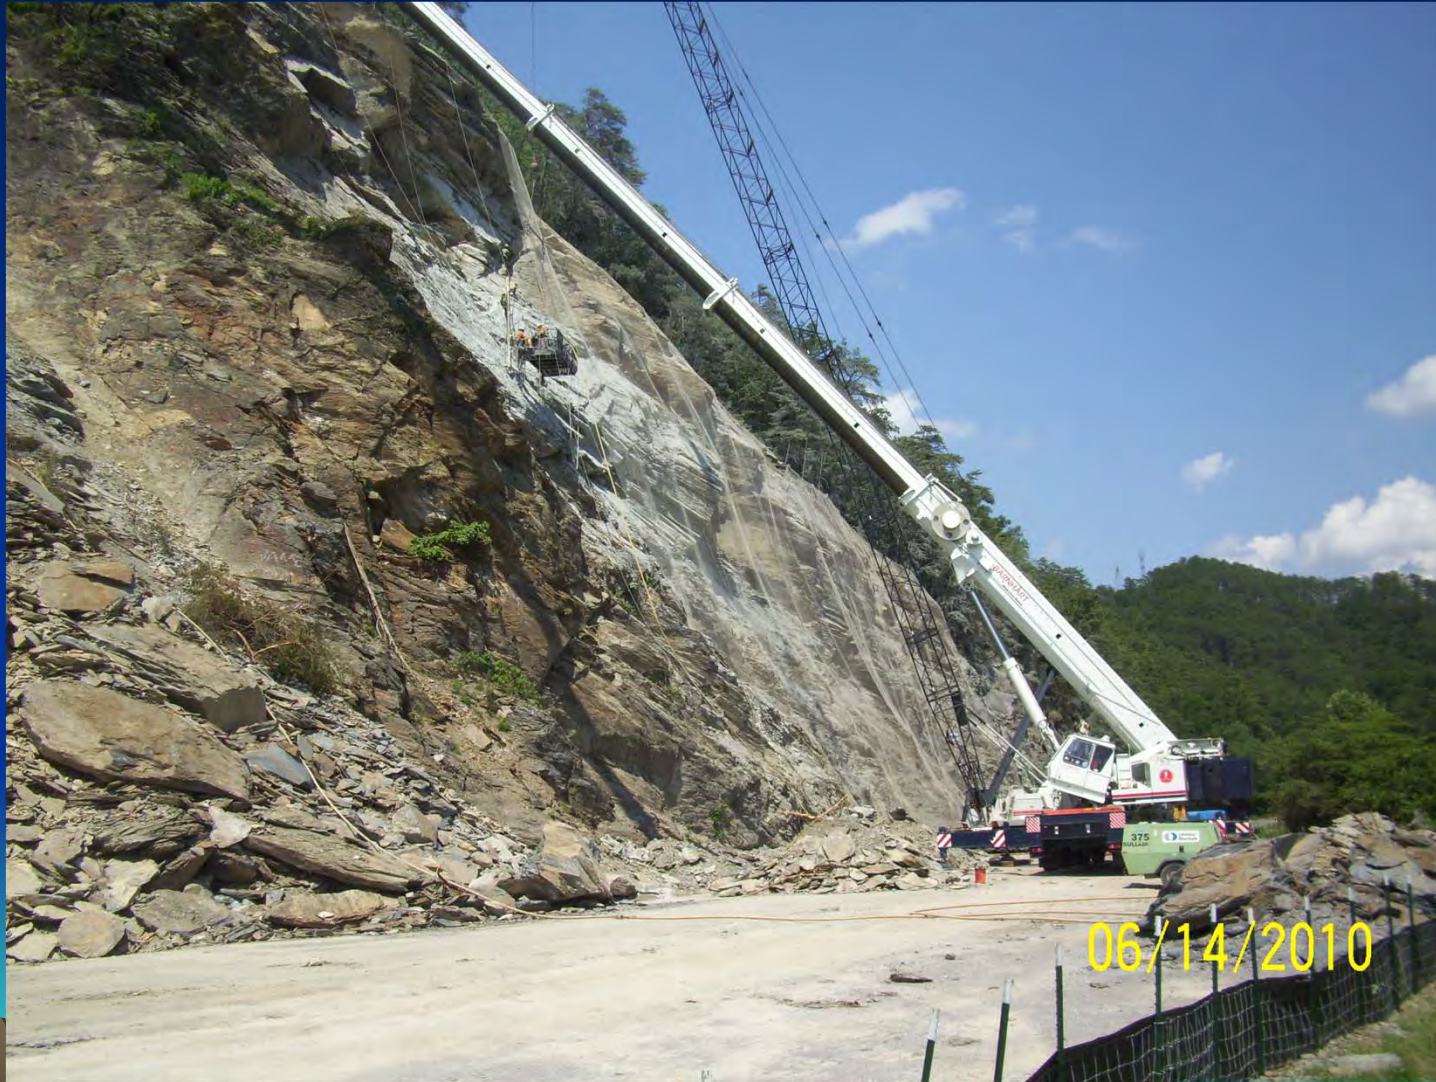
Installing wire mesh and drilling for anchors

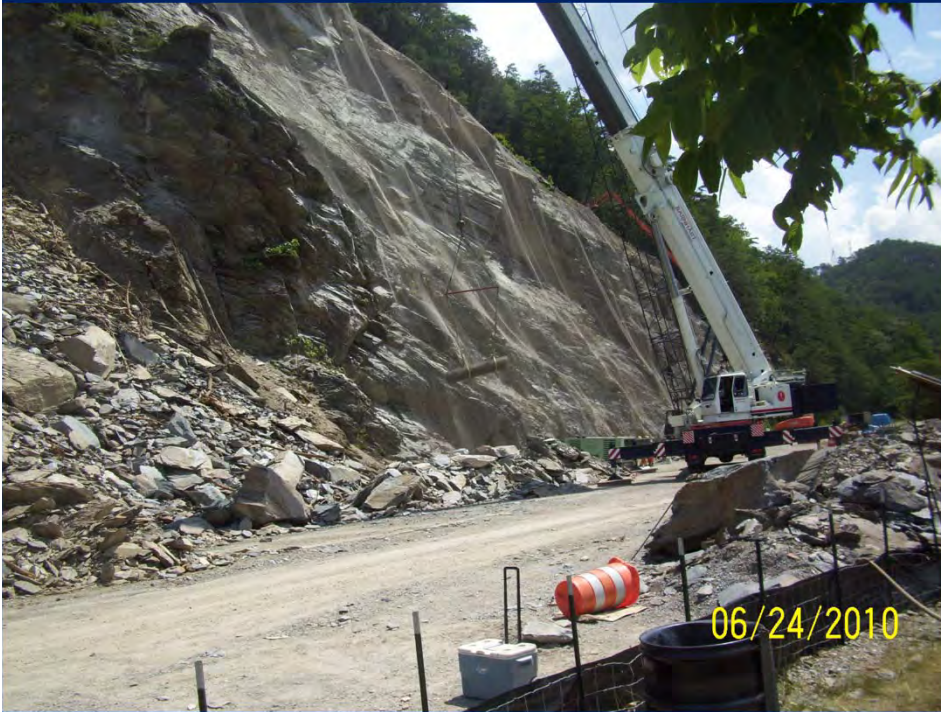
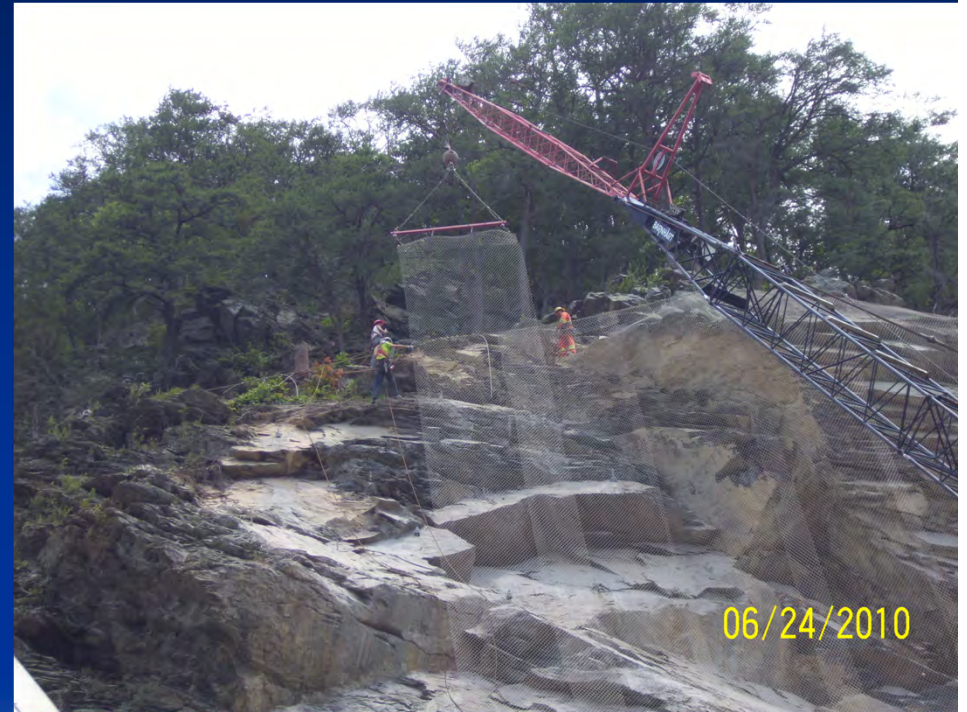
Hanging wire mesh

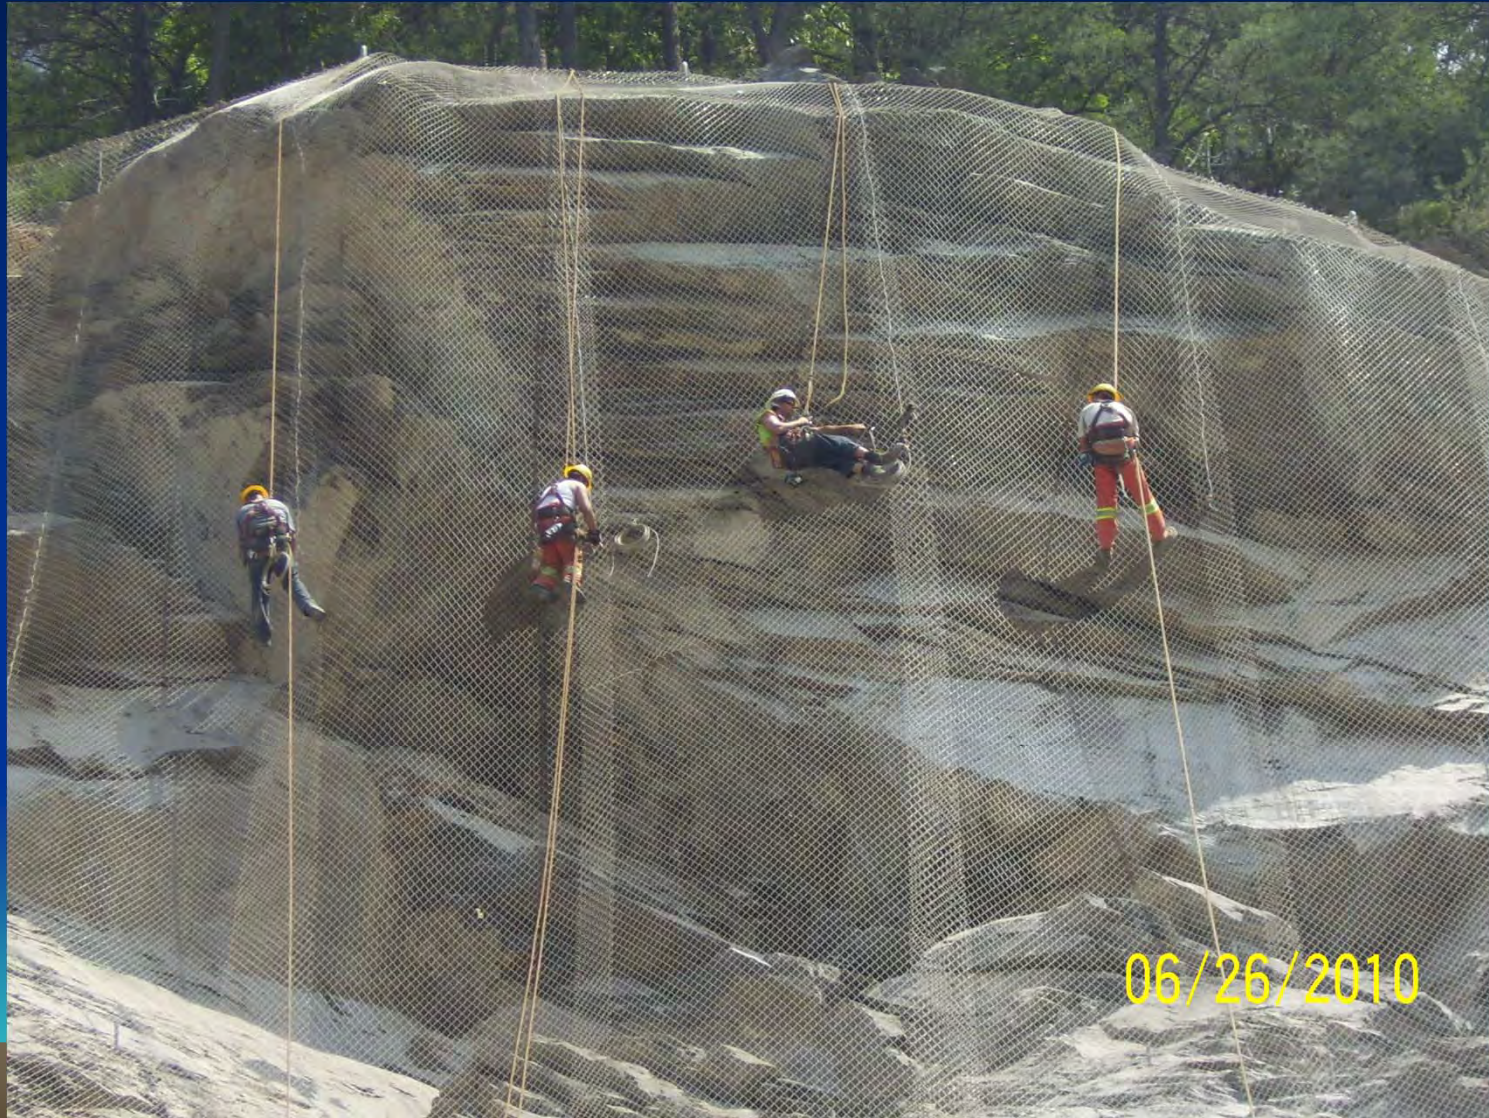
Weaving mesh together

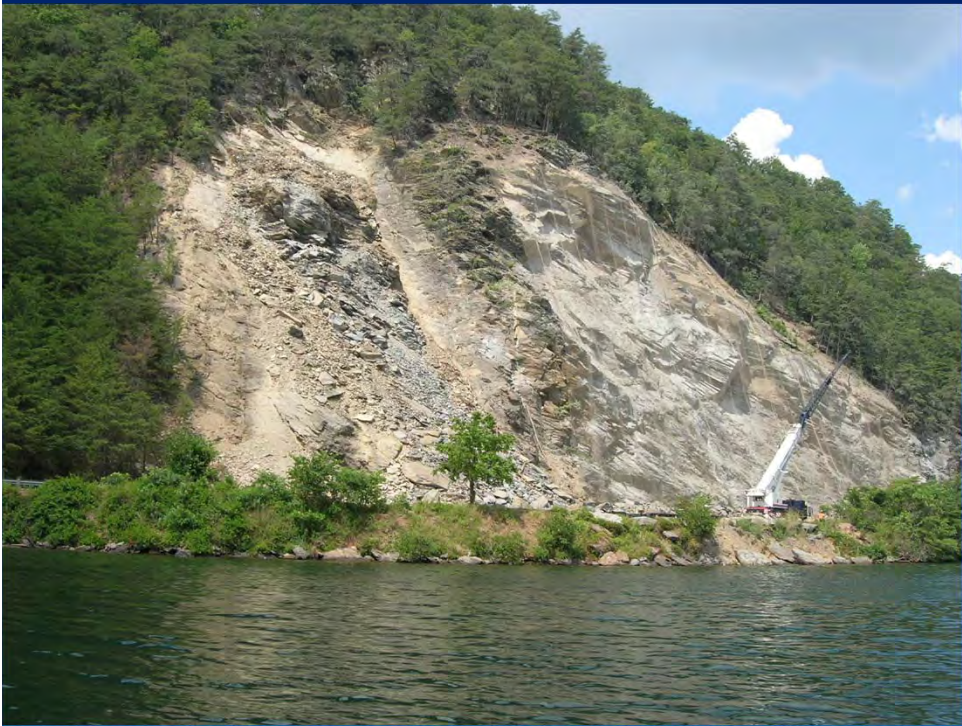
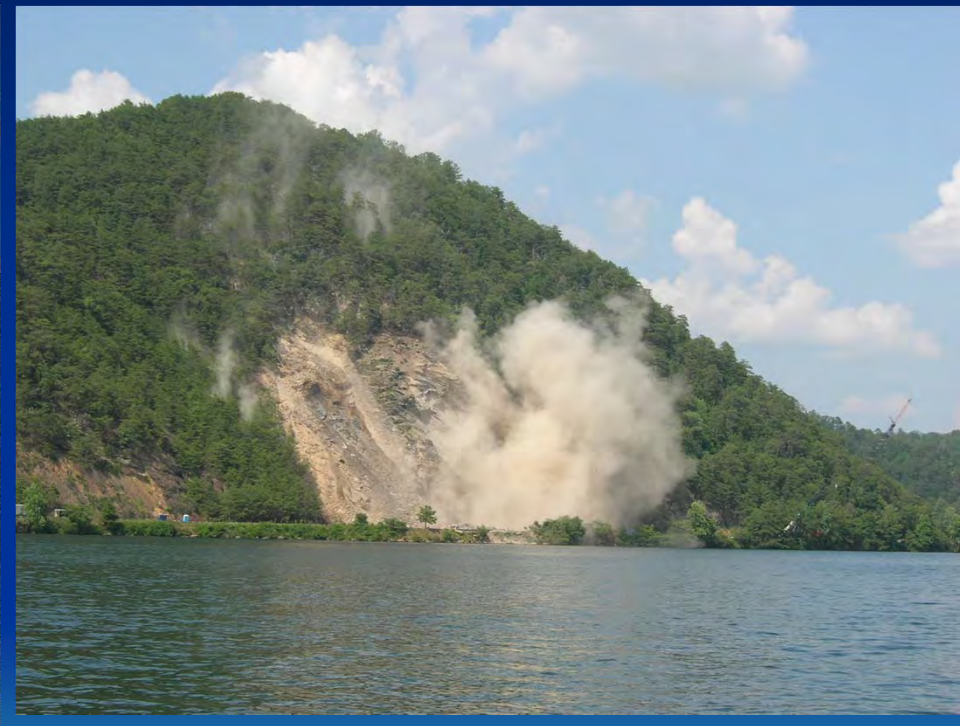
One last shot on June 26th

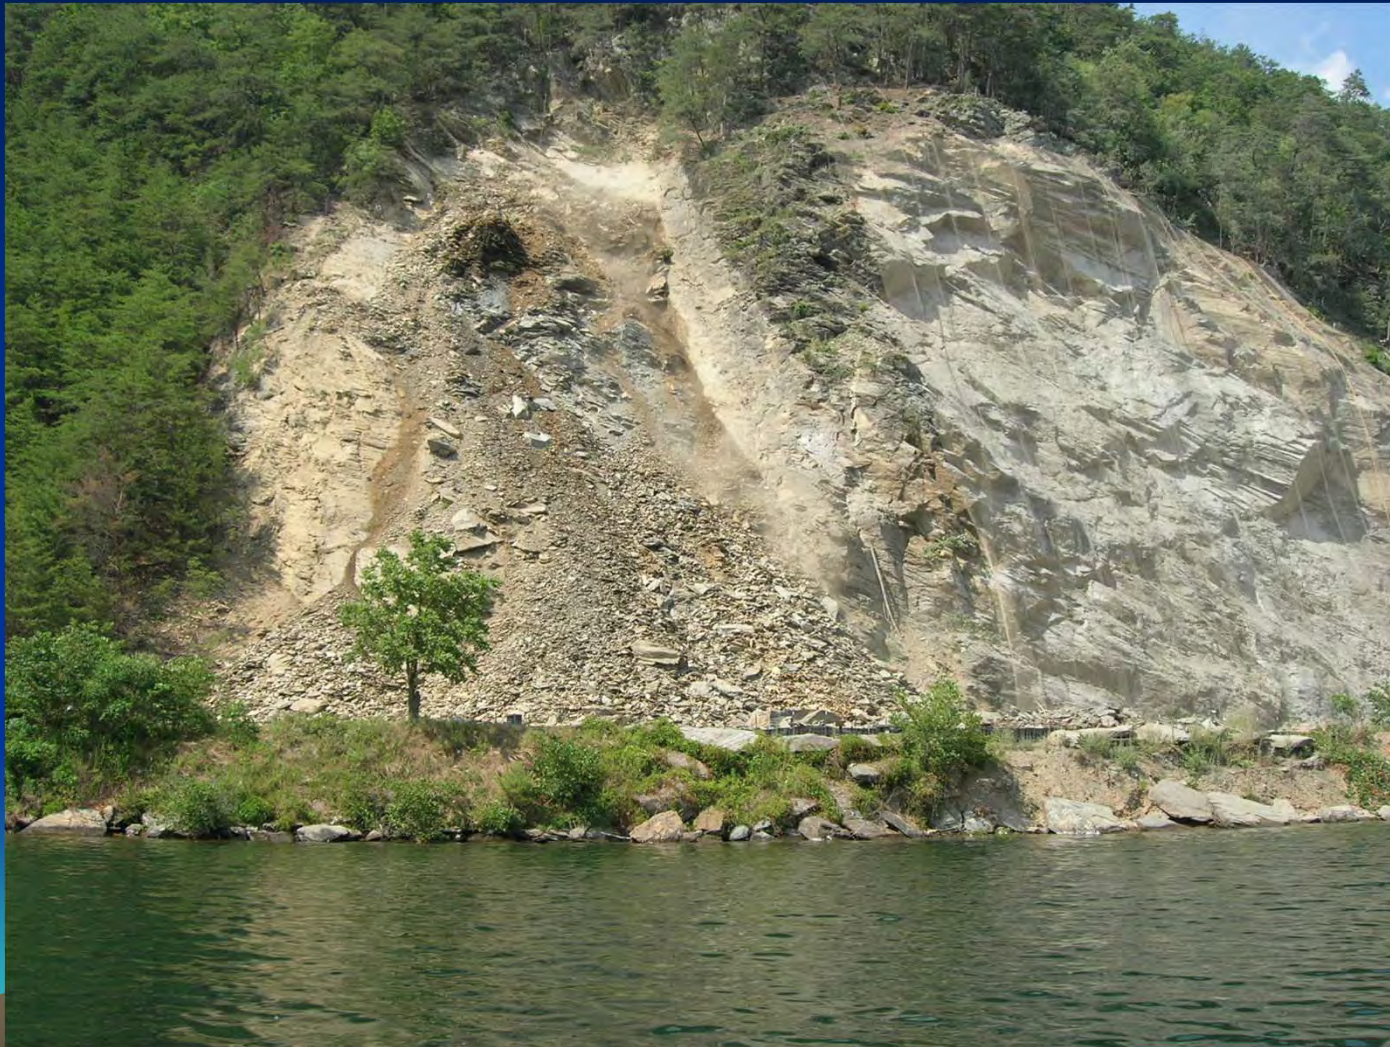
A lot of rubble, but rock remains

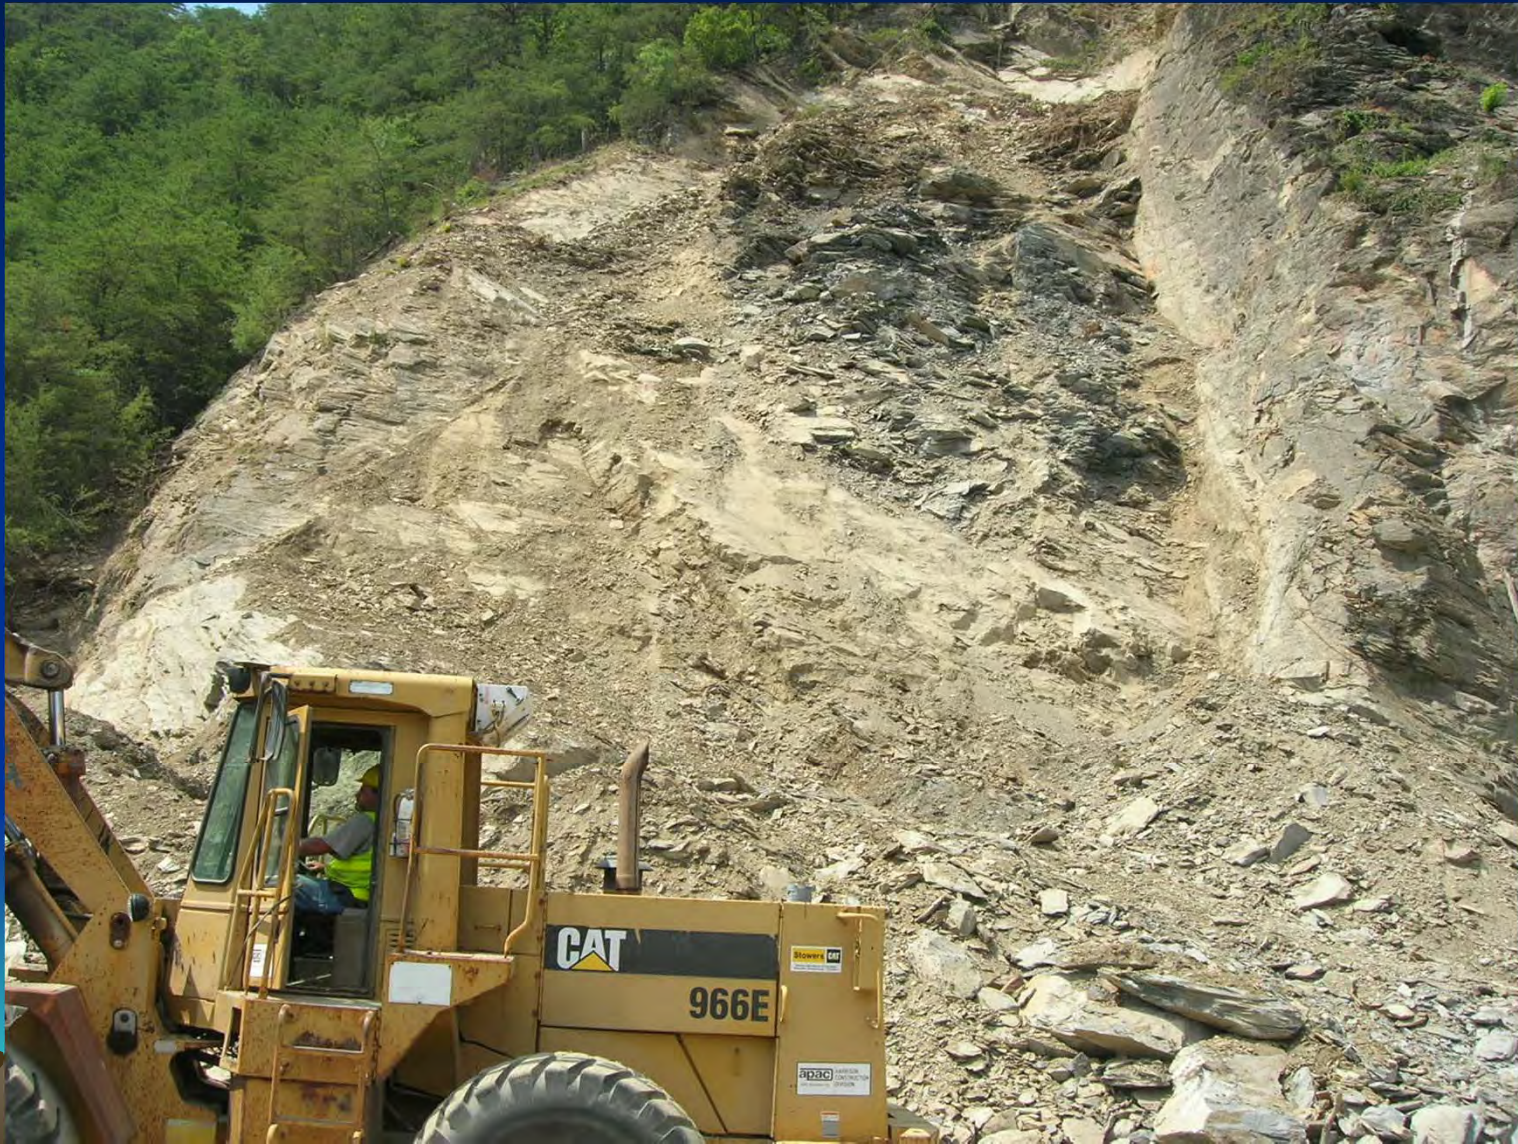
Excavating rubble

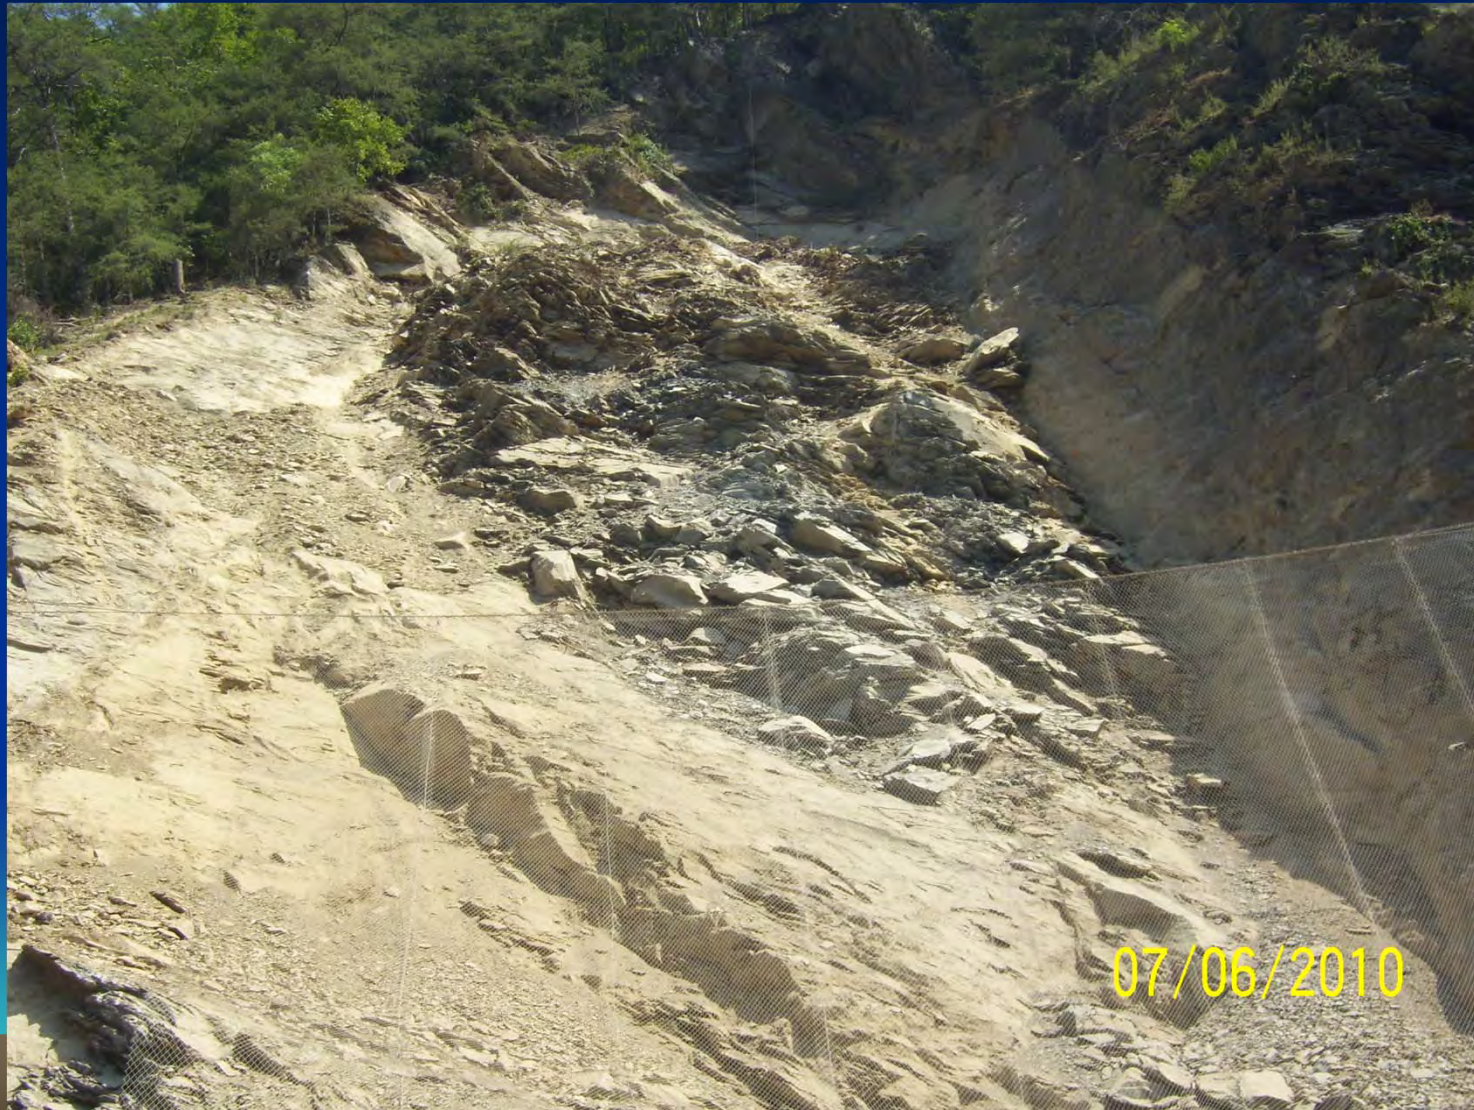
Wire mesh drape curtain in place

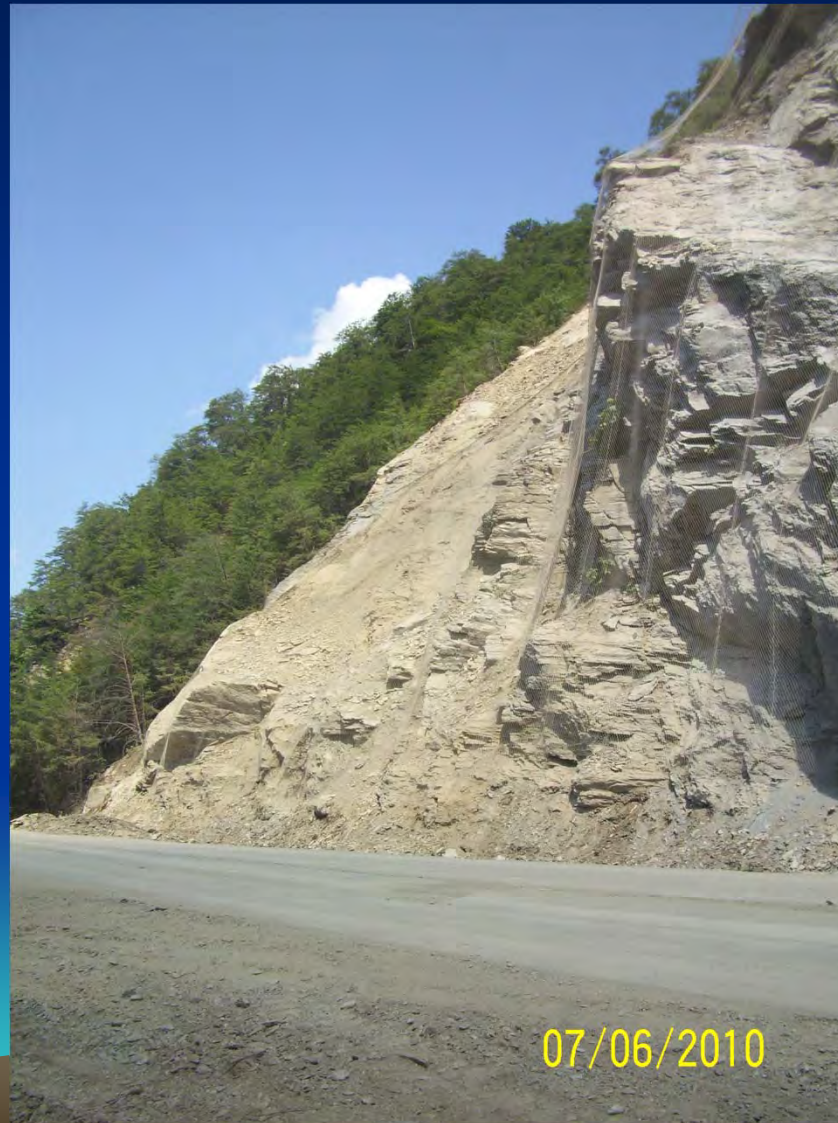
Road and ditch below wire mesh curtain
