SR 115/US 129 “The Dragon” Slide

David Barker, PE, TDOT
Geotechnical Engineering Section

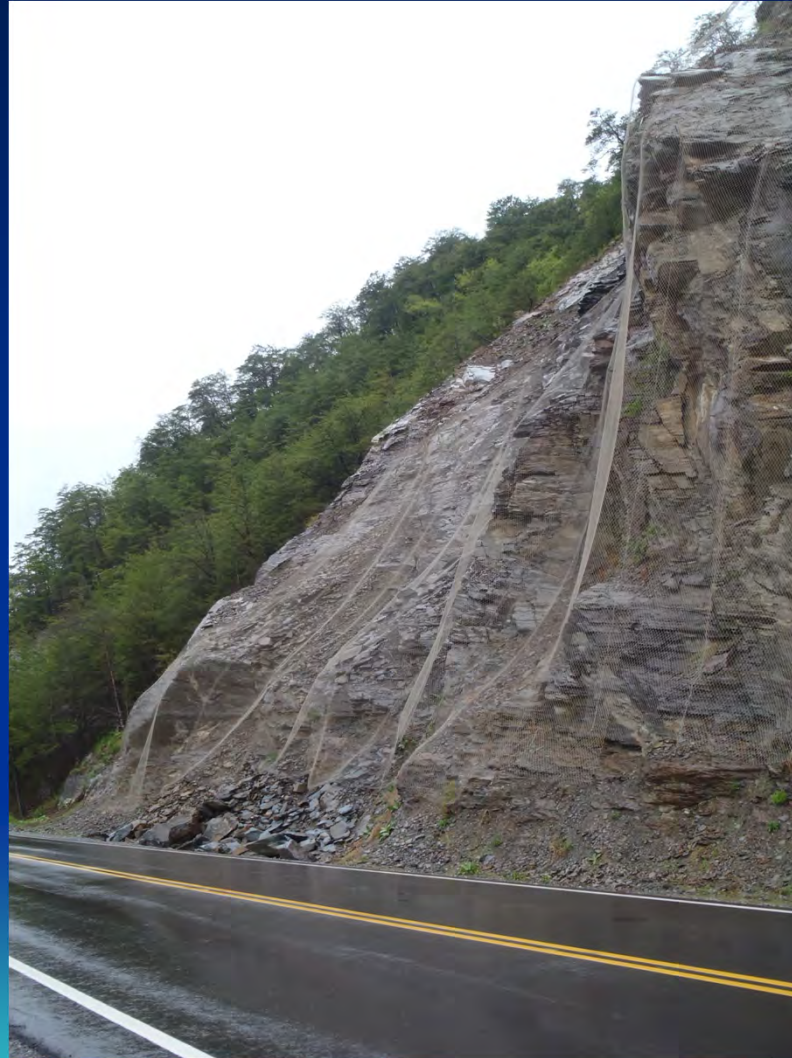
April of 2011, time for some debris removal
