# 11<sup>th</sup> Annual Technical Forum GEOHAZARDS IMPACTING TRANSPORTATION IN THE APPALACHIAN REGION

### GEO-DESIGN APPLICATIONS IN KARST ENVIRONMENTS

William D. Spencer, P.G., Jaye Richardson, and Chris Ramsey, P.E. AMEC, Nashville TN August 3, 2011

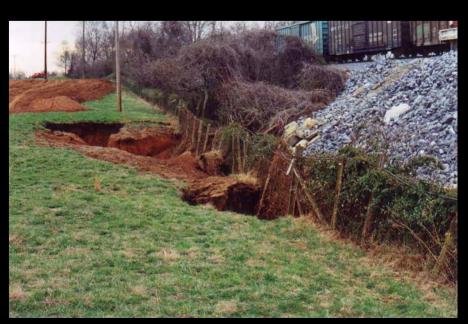
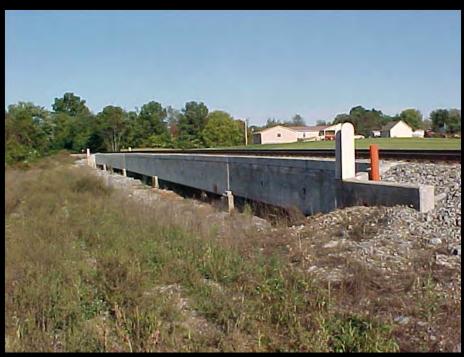
BEFORE
Karst engulfing the soil and ballast

AFTER
Micro pile and structural land bridge
REMOVES the karst from play and
provides for surface drainage
under the track.

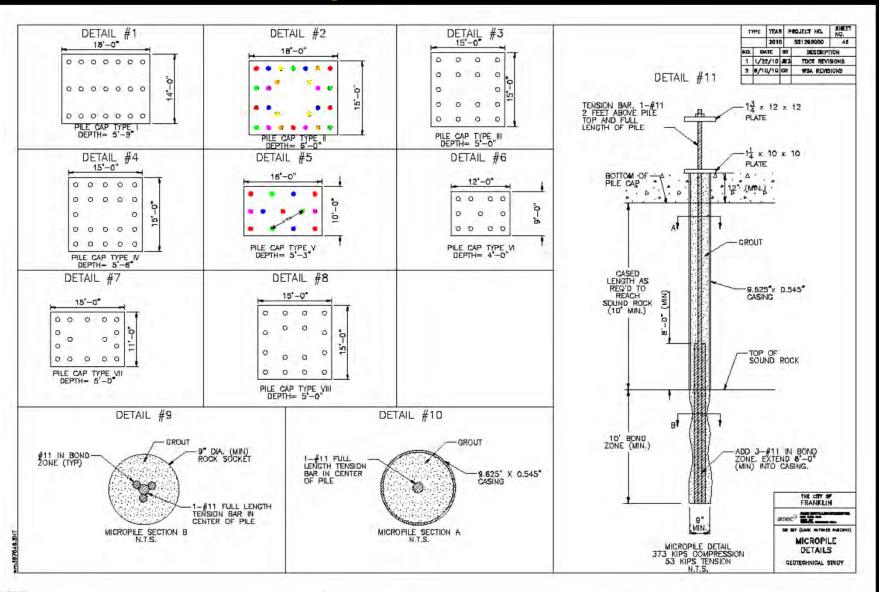
### Micro-piles as a SOLUTION

# RECENT LOAD TESTING ON INSTALLED MICRO-PILES

DESIGN LOADS WERE 300 KIPS COMPRESSION AND 180 KIPS TENSION

COMPRESSION LOADING EXCEEDED 200% OR 600 KIPS

TENSION LOADING FAILED AT 200% OR 360 KIPS DUE TO FOLIATION OF WEATHERED ROCK

FOLLOW-UP LOAD TESTING EXCEEDED 200% OF DESIGN FOR TENSION AND COMPRESSION
