I-40 Fill Slide, Roane Co. Tennessee

BY: Lori McDowell, PE
TDOT, Geotechnical Engineering

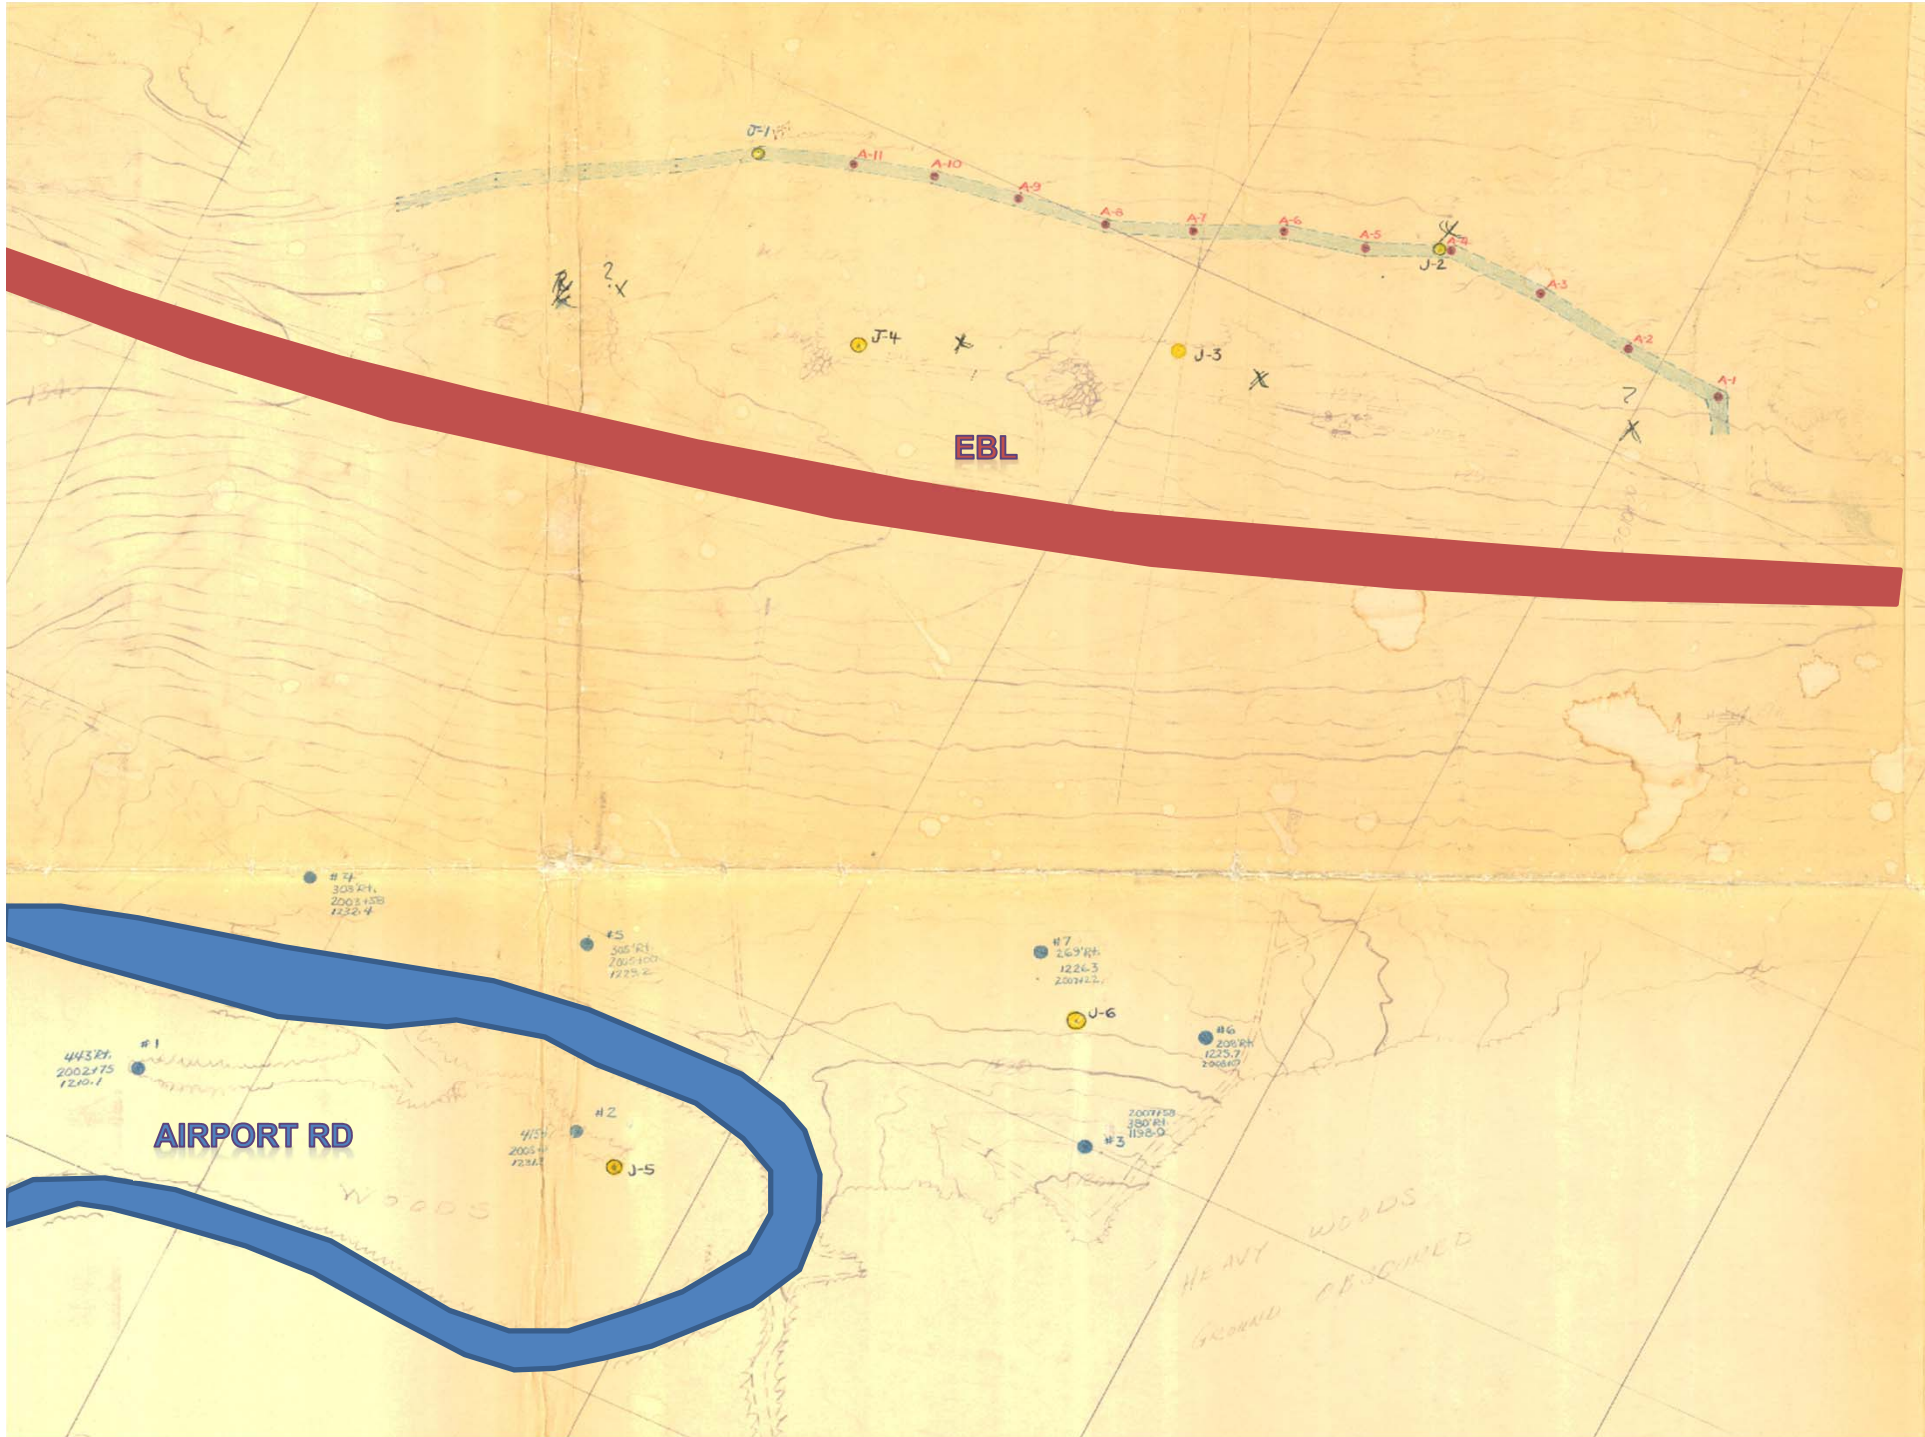
- Between March-April 1974, there was an installation of 7 Slope inclinometers at the toe of the embankment and an observation well in the median and about 4 more located along the slope.
- On August 19, 1974, the last portion of the East Bound Lane of I-40 through the state of Tennessee is open to public.

- Movement noted through the slope inclinometer readings for the year of 1974 had a max movement of 3" horizontally and 6"-8" vertically

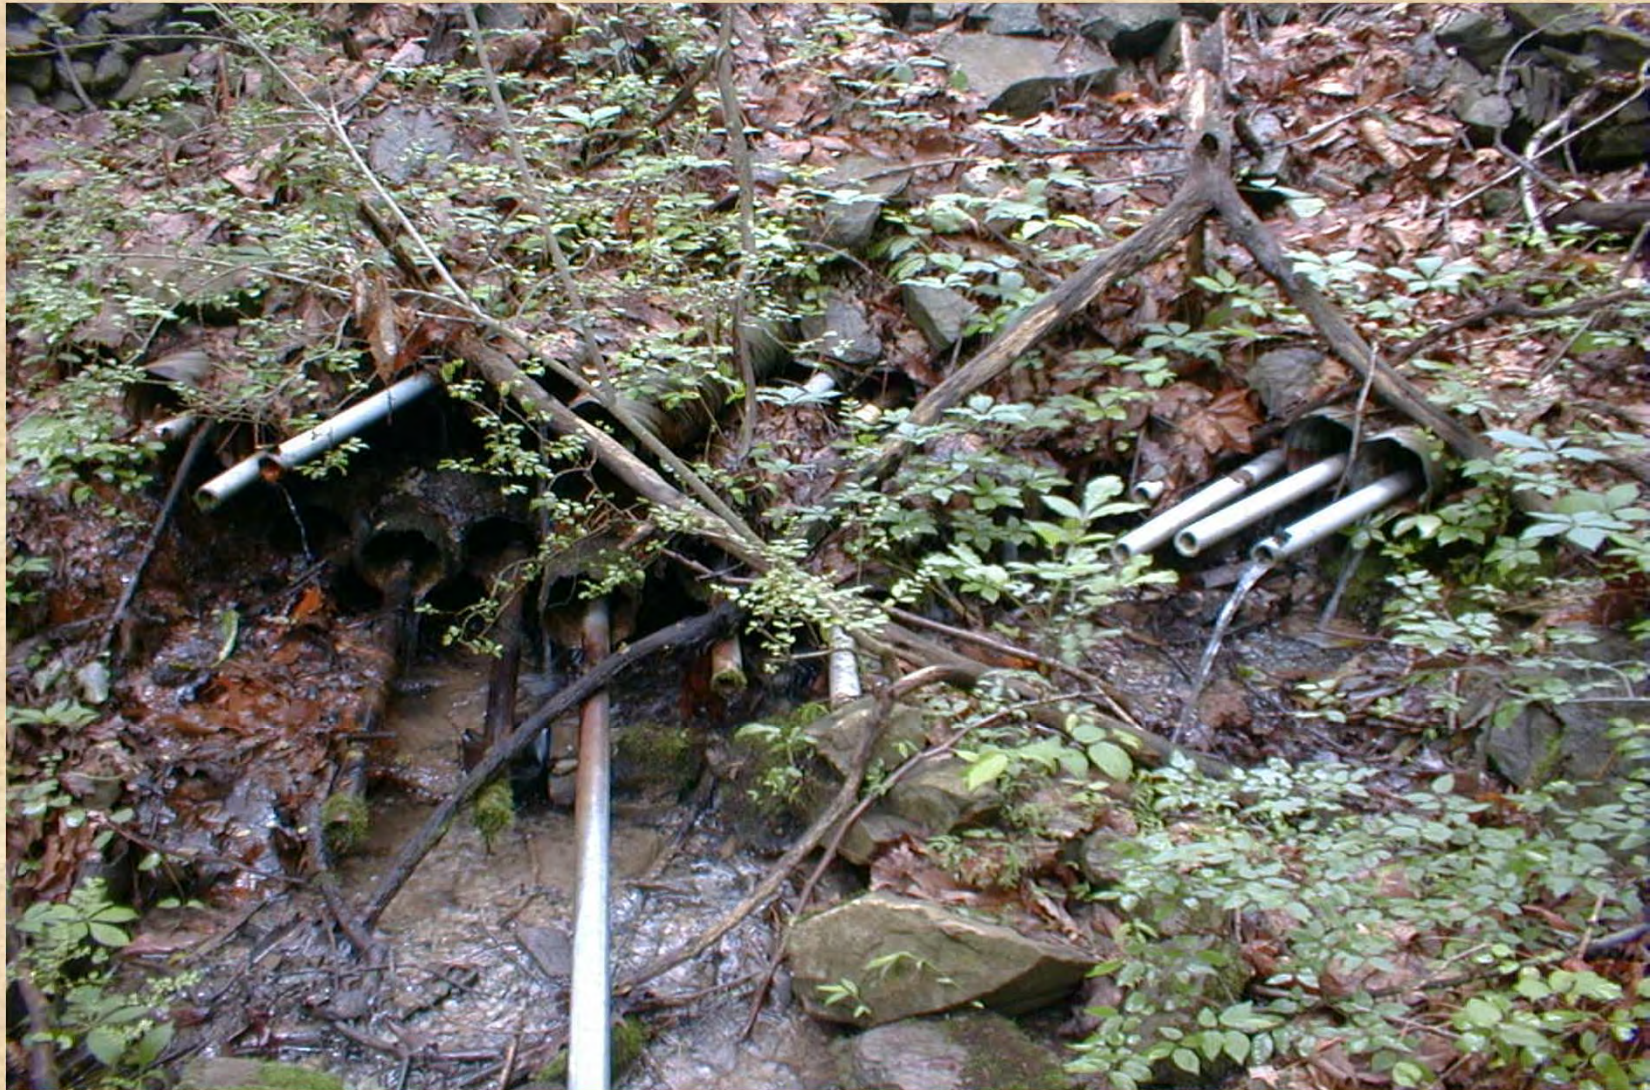
Horizontal Drain Outlet as of 5-19-2003

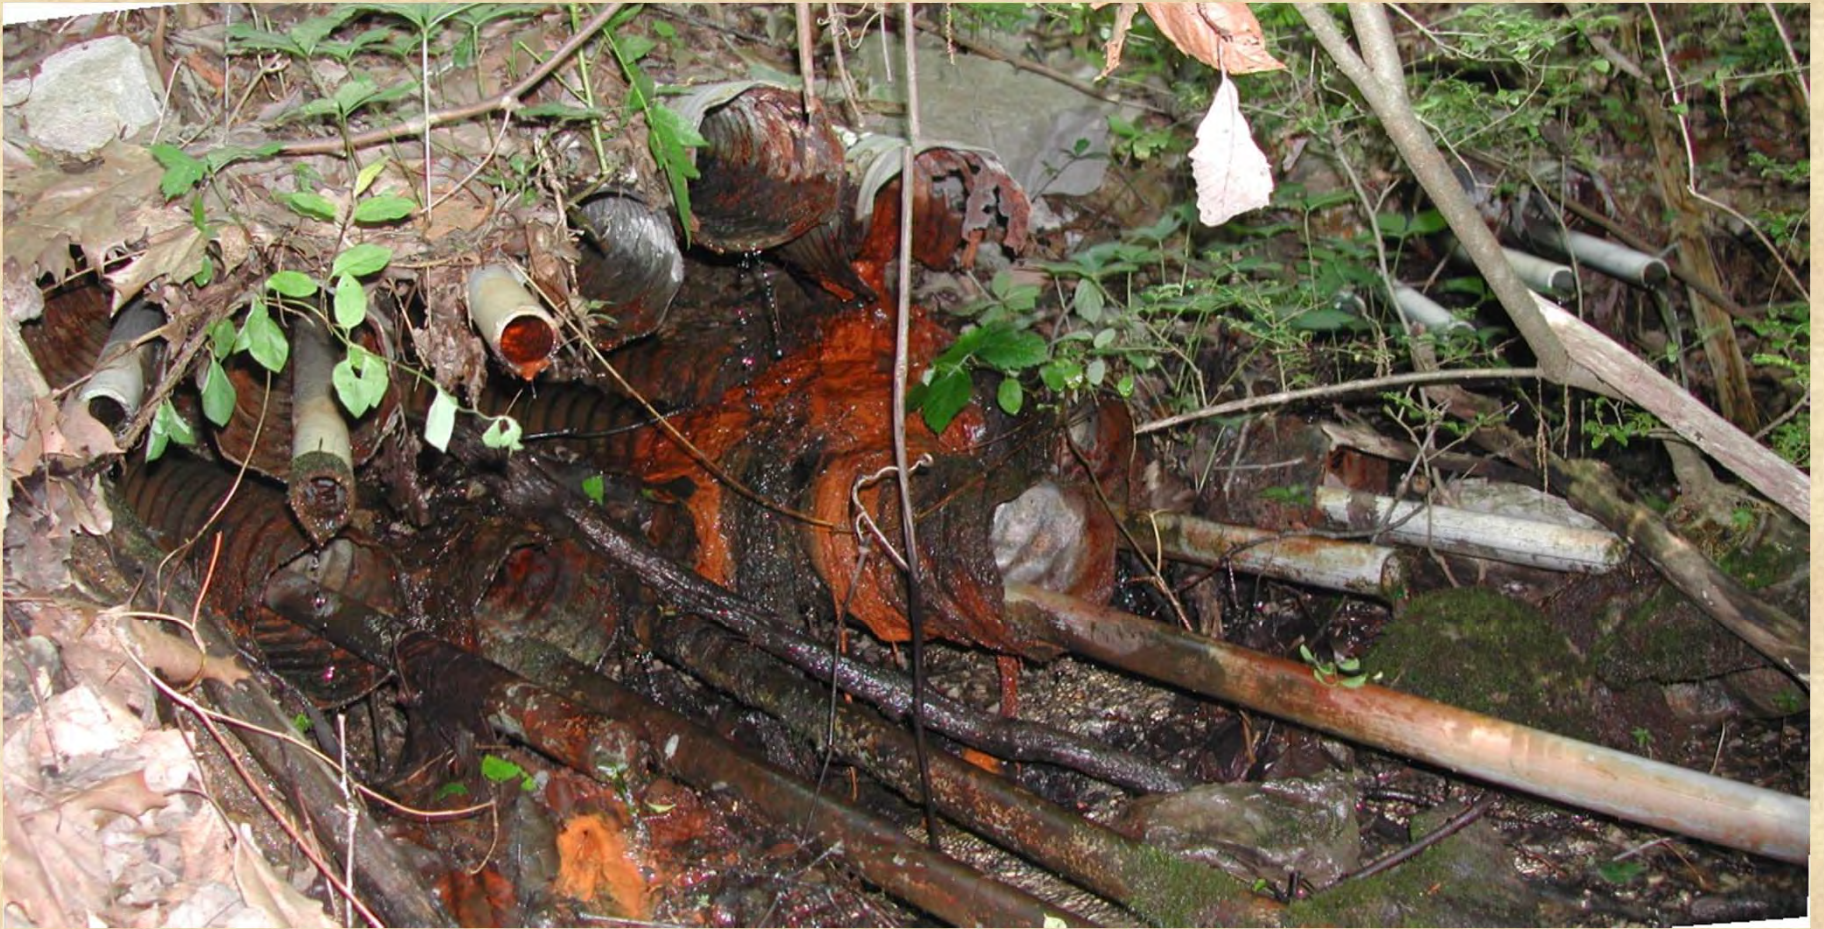
Horizontal Drain Outlet as of 6-9-09

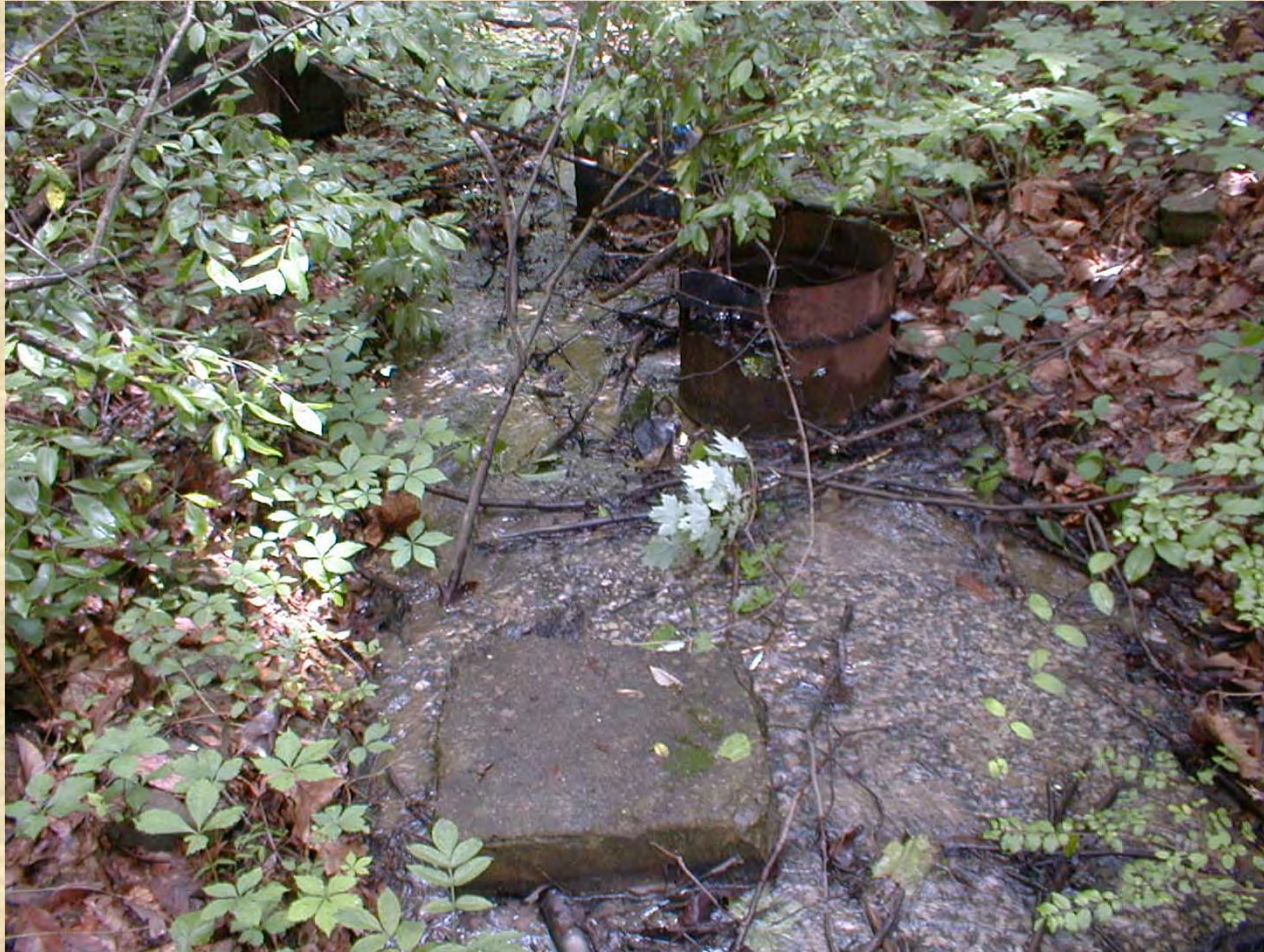
Stream created by horizontal drains
