CSXT Emergency Response for May 2010 Flood Repairs

11th Annual Geohazards Forum
Chattanooga, Tennessee

Christopher Ramsey, PE
AMEC

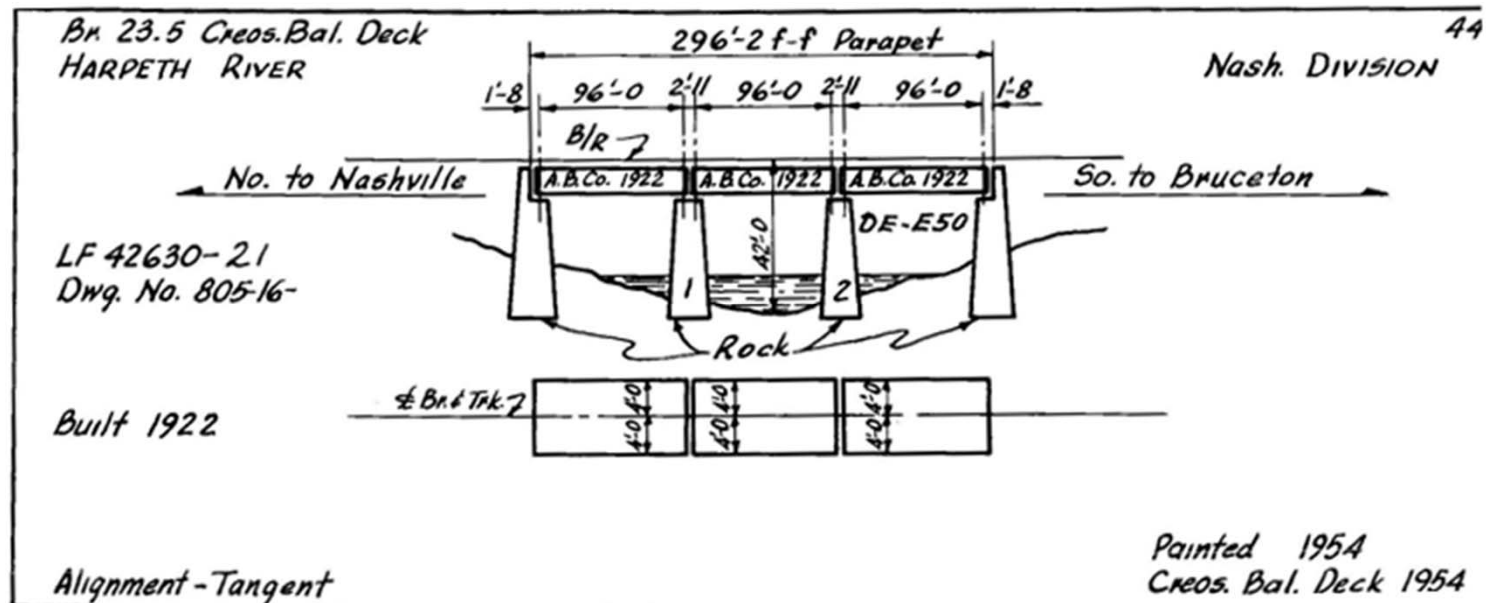
Milepost 23.5 assessment

- MP 23.5 is a three span bridge totaling approximately 296 feet, with eastern most span washed out
- Both approach embankments damaged with severe roadbed damage mainly to the east
- Constructed in 1922, consisting of stone masonry piers and abutments bearing on bedrock

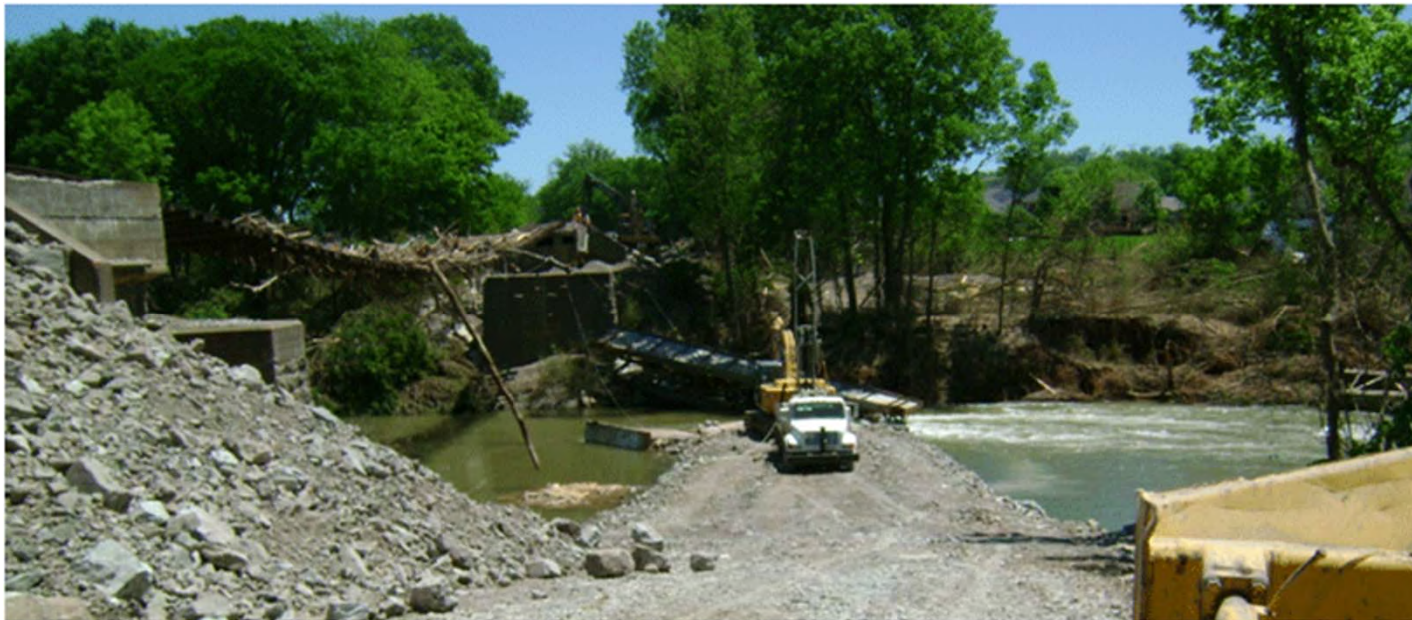
Site Investigation

- Preliminary plan is to install two new piers at MP17.4 and one new pier at MP23.5
- Drill one boring, including rock core, at each bridge site
- Boring at MP17.4 site drilled just downstream at approximately center of total span. Boring at MP23.5 site drilled on location of proposed replacement pier
