# INFLUENCE OF WEAK PENNSYLVANIAN SYSTEM SHALES IN OHIO AND KENTUCKY ON TRANSPORTATION PROJECTS

11<sup>TH</sup> ANNUAL TECHNICAL FORUM – GEOHAZARDS IMPACTING TRANSPORTATION IN THE APPALACHIAN REGION, CHATTANOOGA, TN AUGUST, 2011

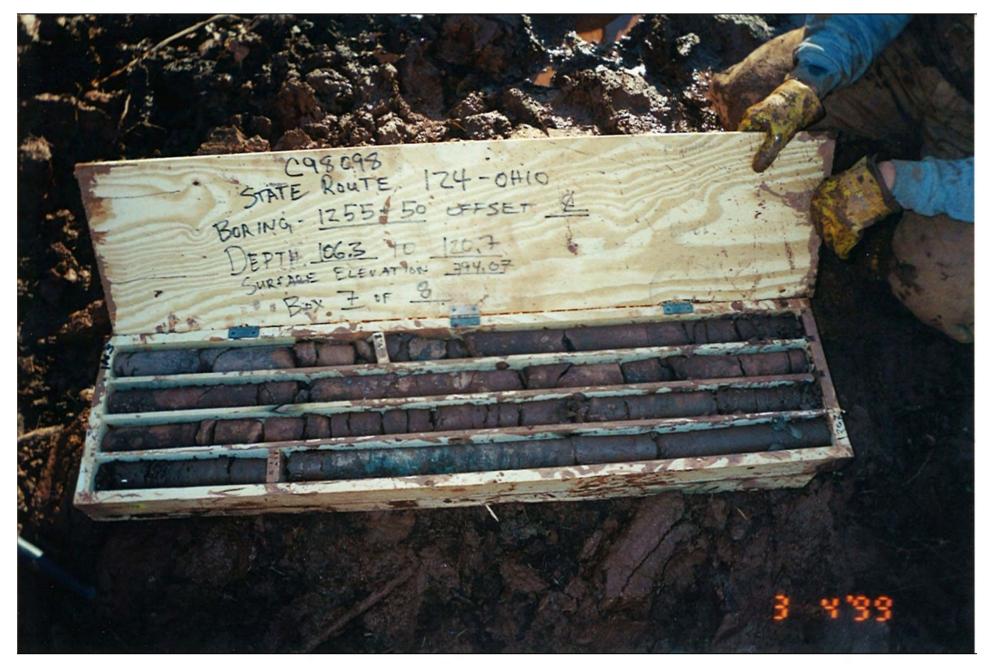
**Core Box Containing Redbed Shale Sample**

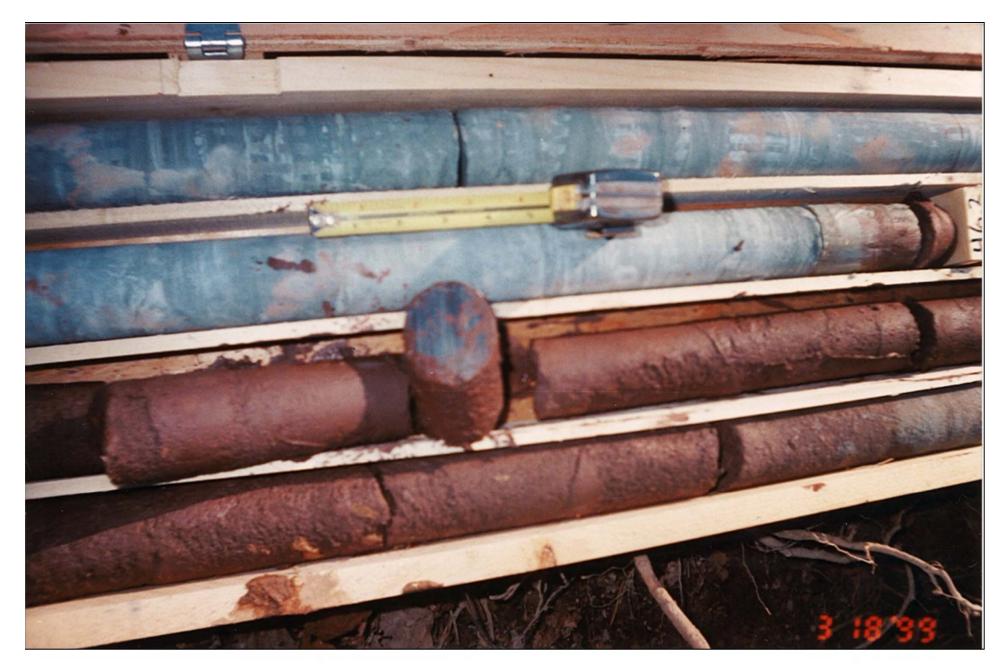
Example of Slickensided Bedrock Surface

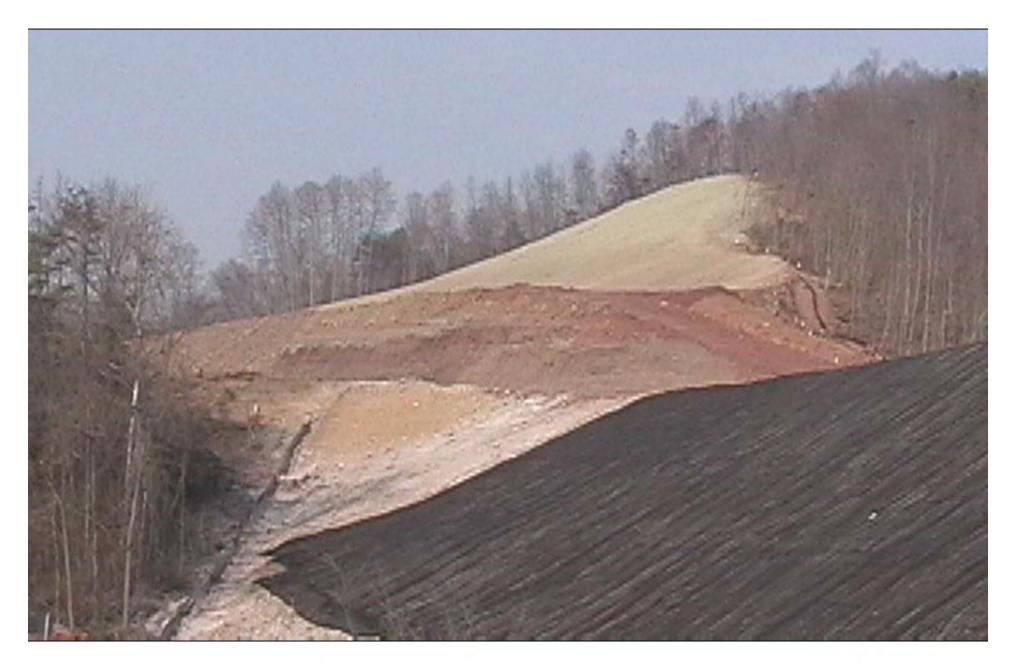
Constructed Reinforced Soil Slope

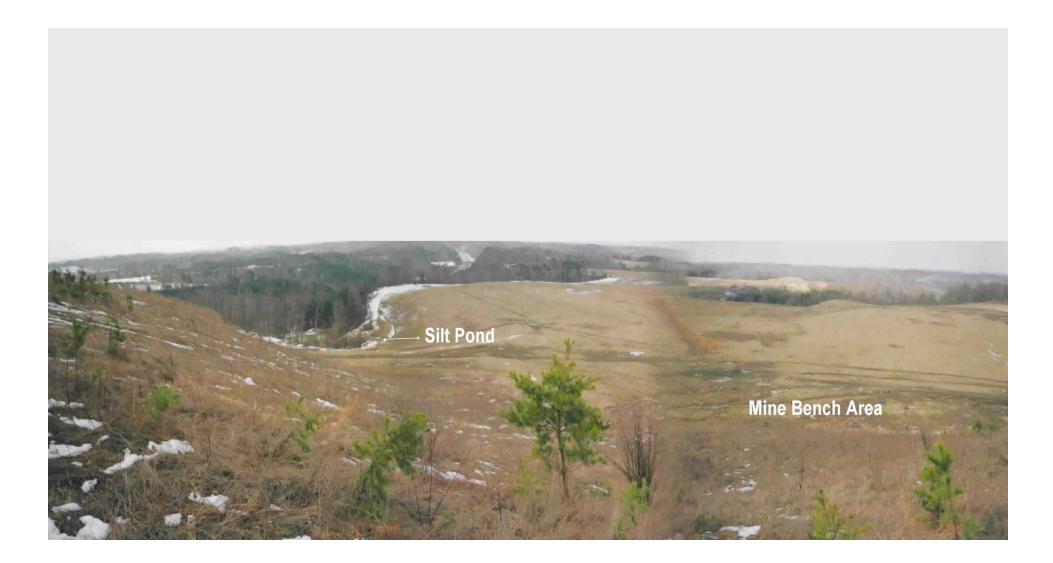
#### Silt Pond and Mine Bench Area Encountered at Project Site

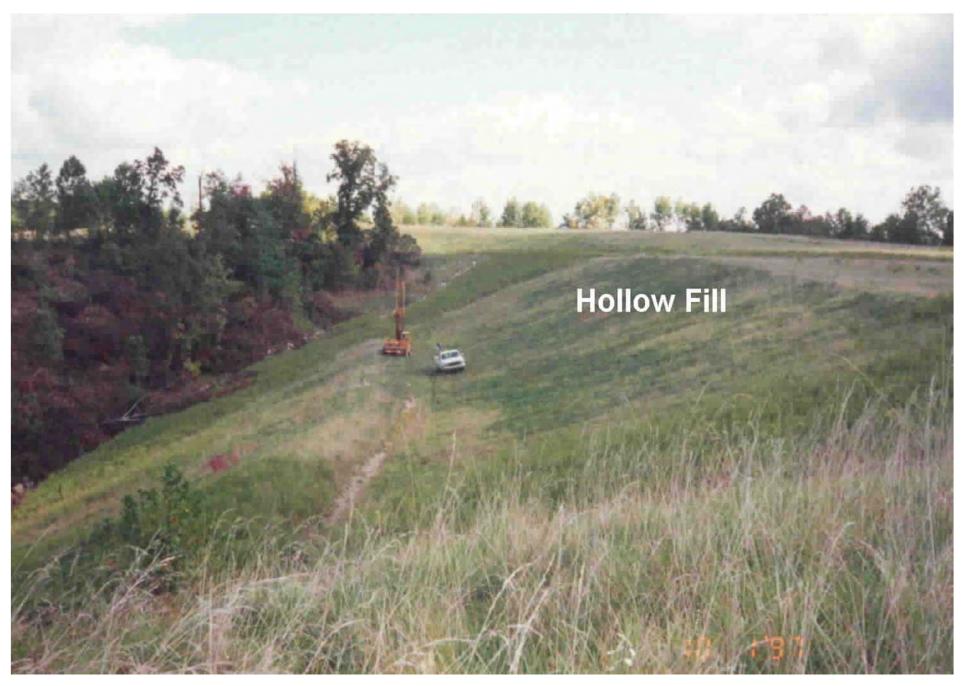
**Typical Hollow Fill Encountered Along the Project**

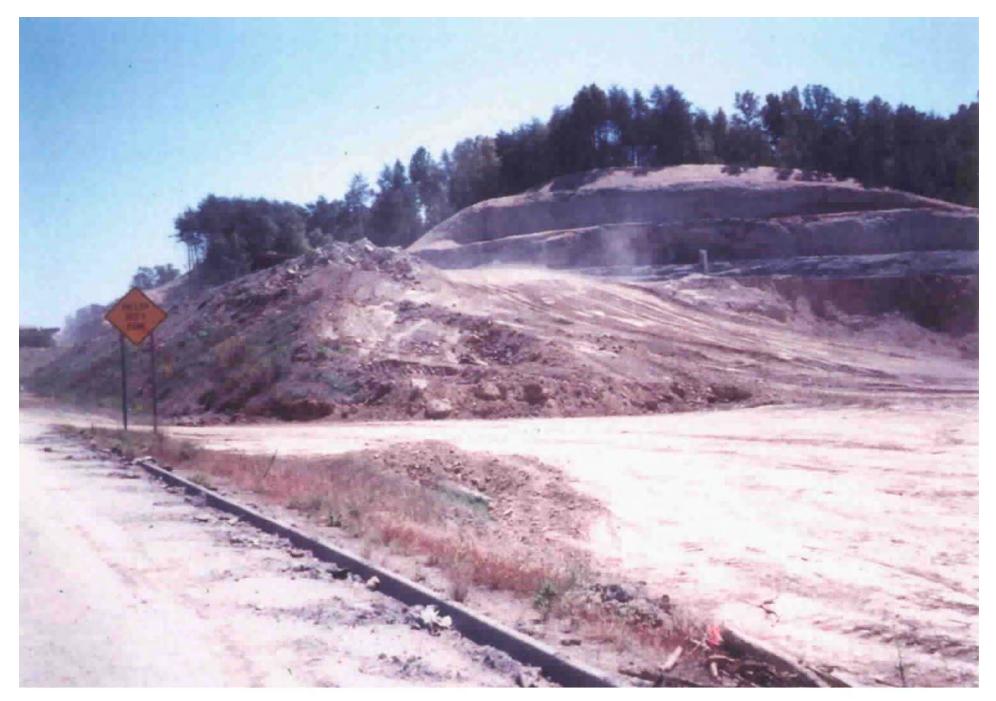
Roadway Cut being Constructed within Non-Durable Shales

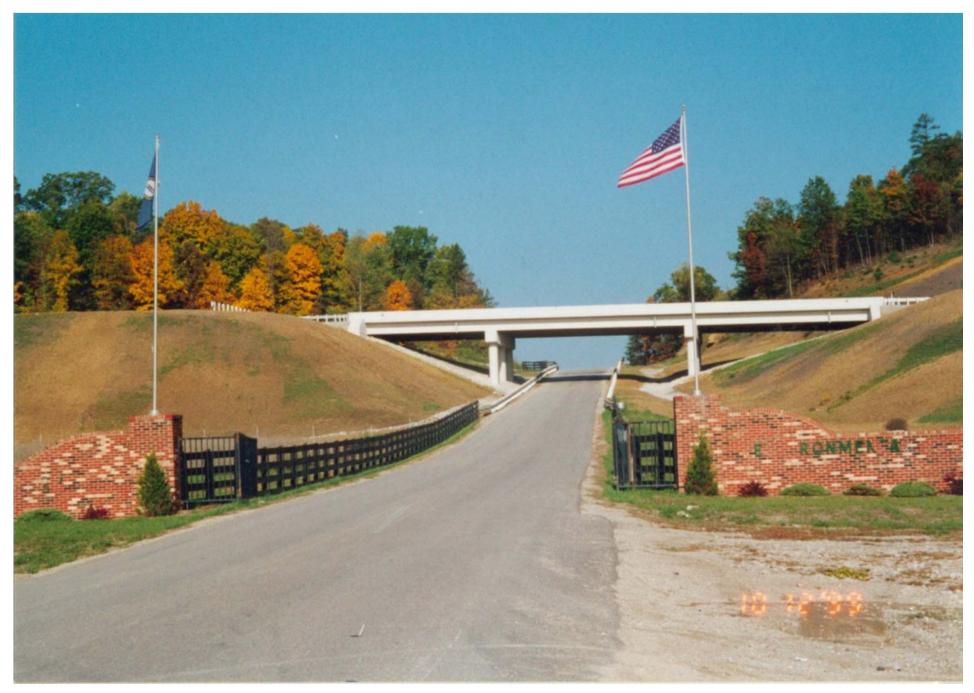
View of Approach Embankment after Construction
