Rockfall in Ohio – An Update of the Rockfall Database Population

Eric Kistner – Stantec August 1, 2012 Geohazards Conference

Presentation Outline Rockfall in Ohio – An Update of the Rockfall Database Population

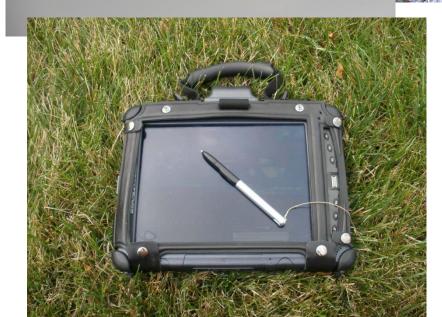
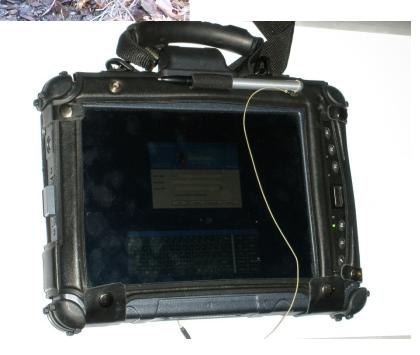
IV. Data Collection Field Equipment

(Performed by PSI – Columbus, Ohio) Criteria Required for All Sites

- Beginning/Ending Mileage Point
- Orientation/Position of Rock Slope
- Lat/Long/Elevation

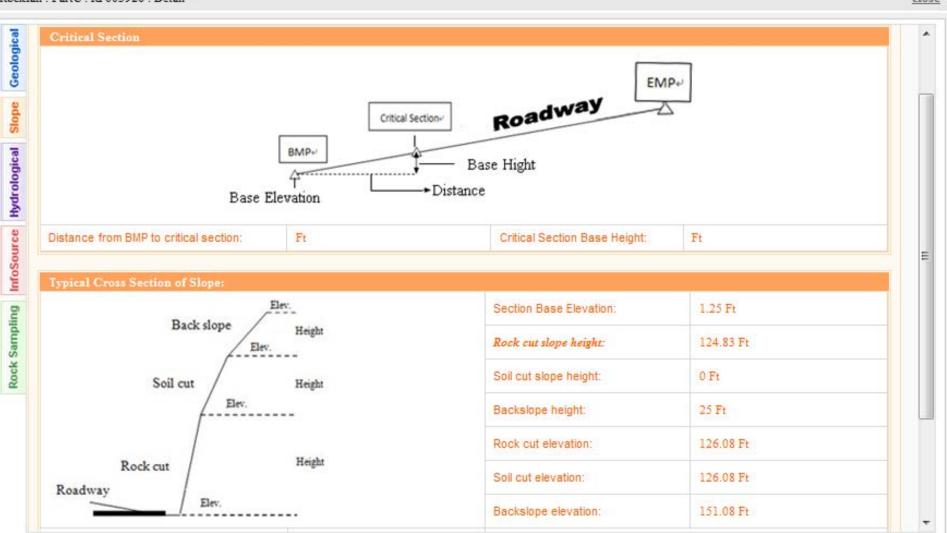
V. Database Population Slope Information

Rockfall : PartC : RF003926 : Detail

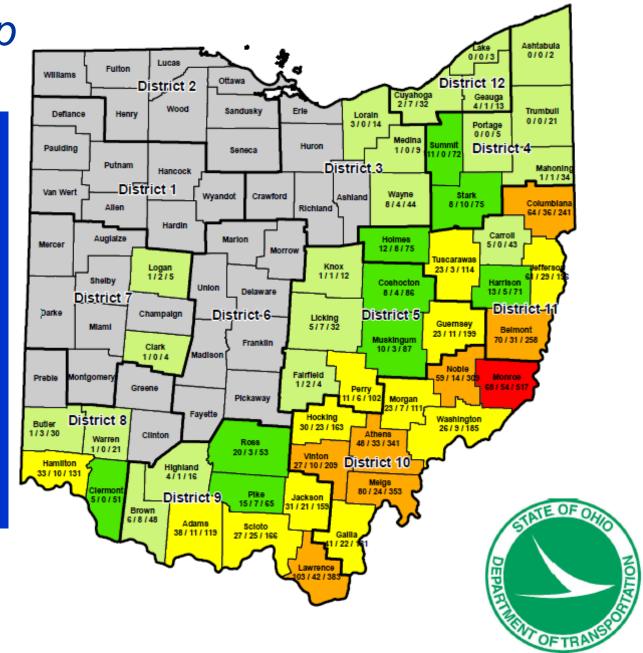
VI. Results Statewide Map

RED Rockfall Sites > 400

ORANGE Rockfall Sites > 200

YELLOW Rockfall Sites > 100

GREEN Rockfall Sites > 50

LIGHT GREEN Rockfall Sites > 0

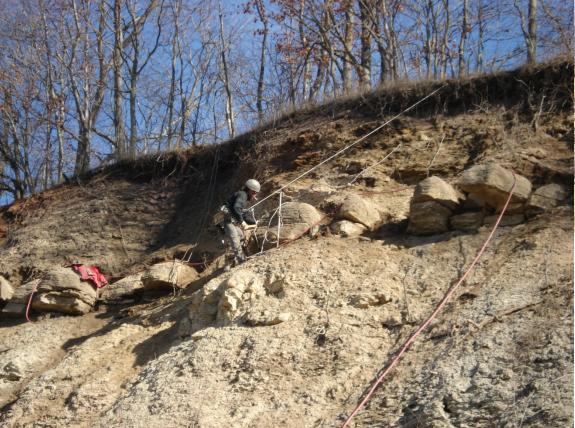
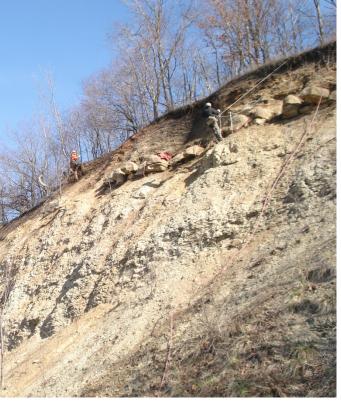
COS-36

VII. Remediation Cost Estimating Scaling

Remediation Scenario	Cost (\$) / Foot Site Length
New Jersey Barrier	87
Modified D50 Concrete Barrier	101
Scaling	164
Trim Blasting	240
Flatten Slope	1,885
Flatten Slope with Added Catchment	2,392

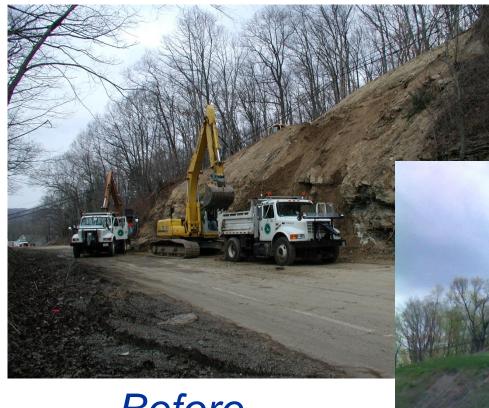
GUE-22 North Slope

VII. Remediation Cost Estimating Trim Blasting

After

Before

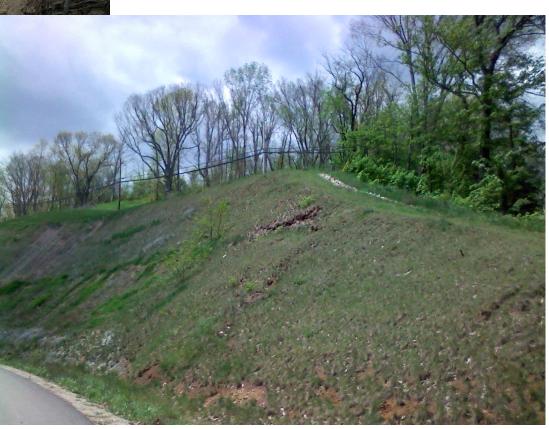
GUE-22 South Slope

VII. Remediation Cost Estimating Trim Blasting/Draping

After

Before
