Use of Grout Technology for Stabilization of Soft Ground and Sinkholes

Matthew Hammett, PE
Area Manager (TN, KY)

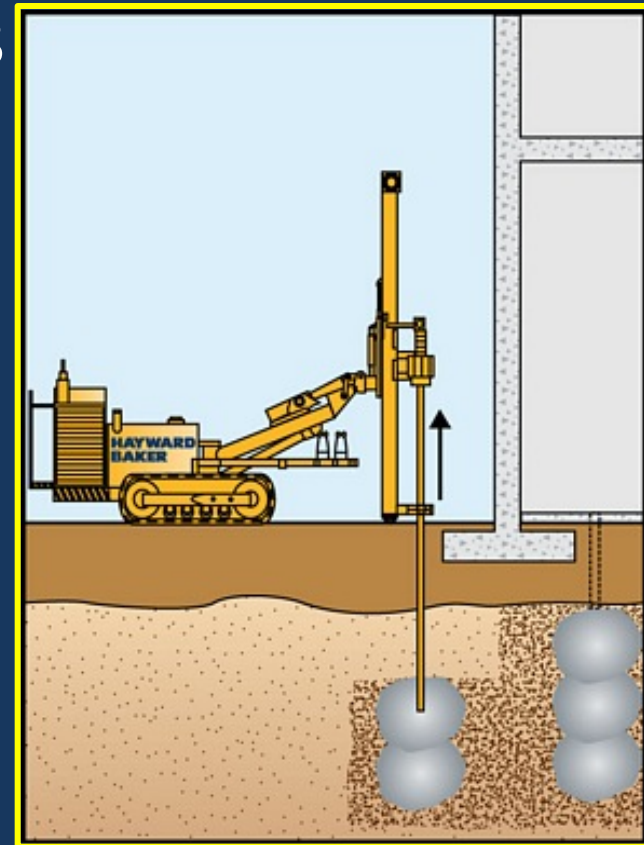
Low Mobility Grouting

- Grouting technique that displaces and densifies loose granular soils, reinforces fine grained soils and stabilizes subsurface voids or sinkholes, by the staged injection of low-slump, low mobility aggregate grout.

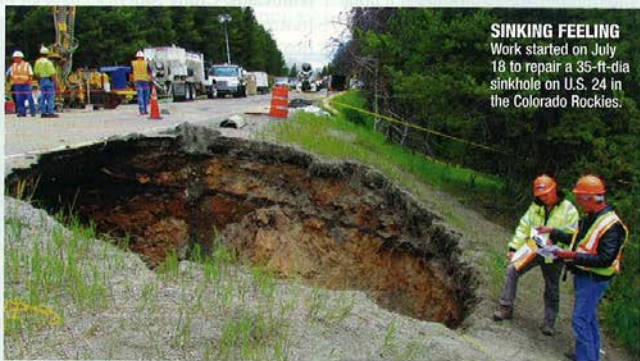
SINKING FEELING
Work started on July 18 to repair a 35-ft-dia sinkhole on U.S. 24 in the Colorado Rockies.

To repair the sinkhole, Hayward Baker crews

are drilling nearly 200 holes in a grid pattern across the site and injecting 5,000 cu ft of low-mobility compaction grout into the edges of the void on the north and south sides of the highway. Then, crews will add 1,200 cu yd of back-fill and another 1,200 cu yd of flow-fill and pressurized grout to fill any remaining voids and compress the materials underneath the highway.

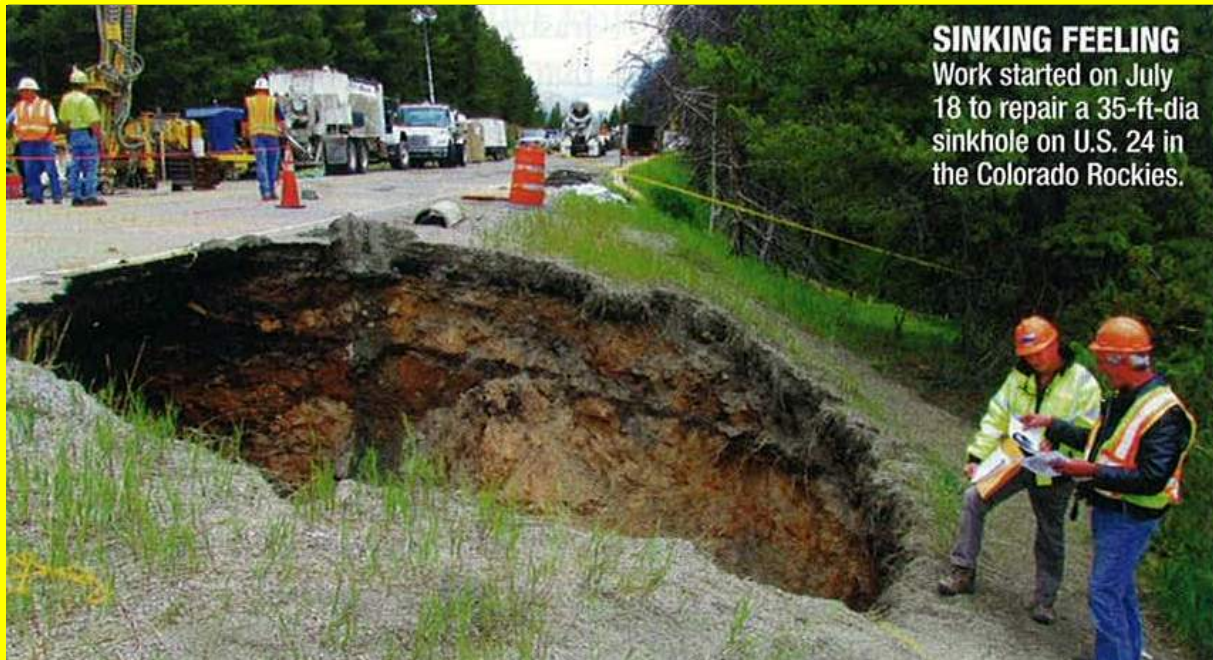
Colorado Rail Tunnel

SINKING FEELING
Work started on July 18 to repair a 35-ft-dia sinkhole on U.S. 24 in the Colorado Rockies.
