William F. Kane, PhD, P.G., P.E.
KANE GeoTech, Inc.
Stockton, California

12th Annual Forum
Geohazards Impacting Transportation in
the Appalachian Region
Beckley, West Virginia
July 31-August 2, 2012

- U.S. Highway 19 connects Weston, West Virginia primarily as commuter route to neighboring counties
- Site parallels the New Fork River
 - Also known as “The Narrows”
- Along a cut-slope
 - approximately 900-ft long
 - On-going rockfall problem

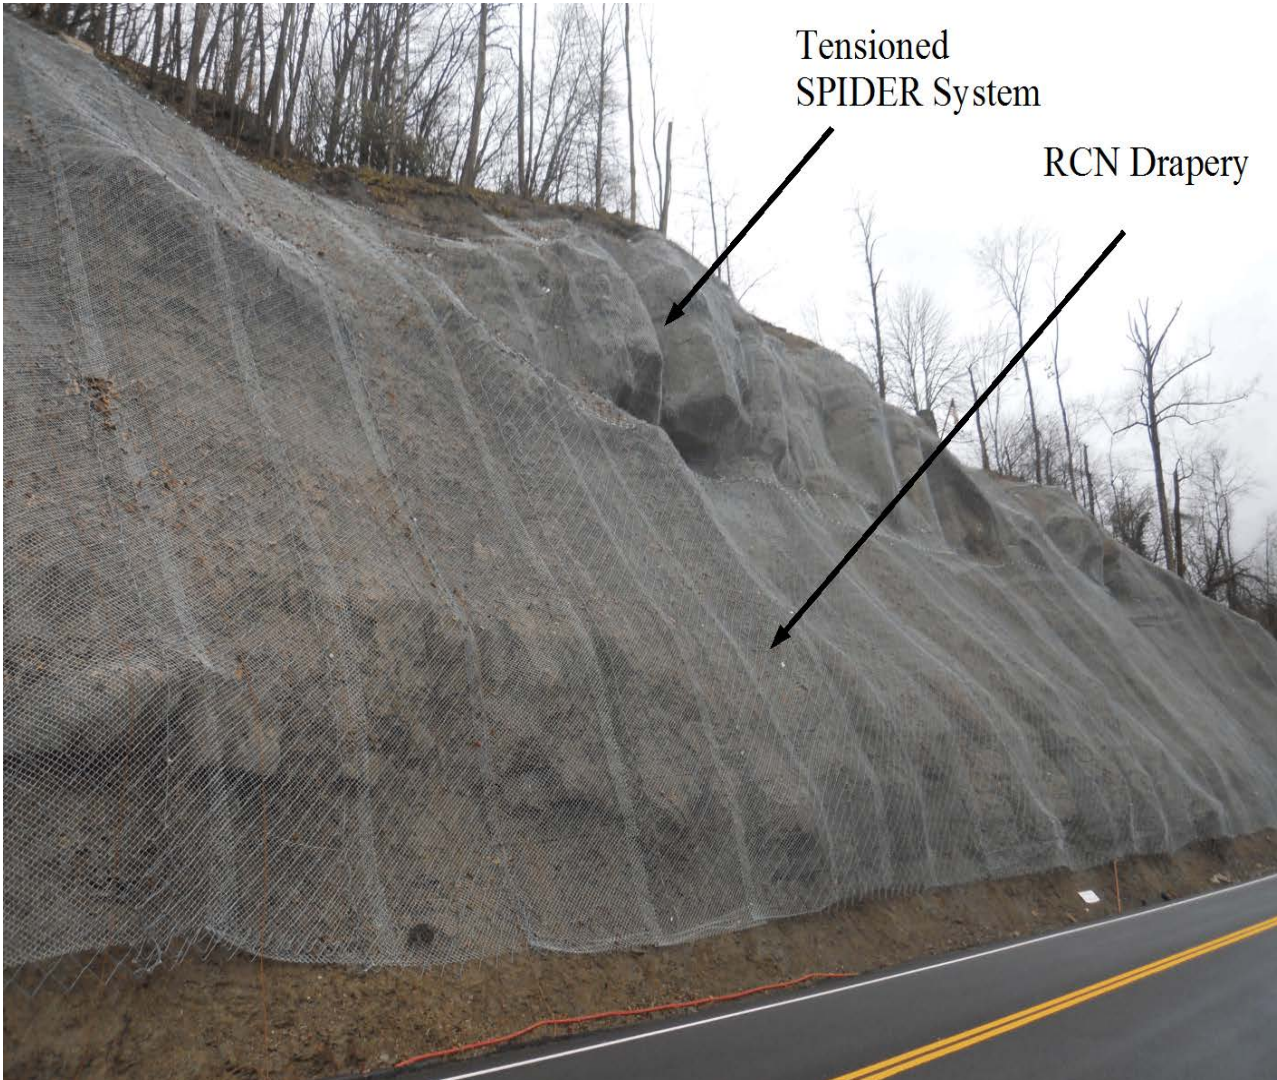
Tensioned
SPIDER System

RCN Drapery

- Detailed calculations and plans from Phase 2
- Finalized change from a rock bolt and draped slope at the top of the middle section to a tensioned SPIDER system
 - Design was more effective for the purpose of full retention of the outcrops in Section 2
