Digital Photogrammetry Component of an Experimental Project to Monitor Rock Slope Activity at Multiple Sites in the Valley and Ridge, Virginia.

William L. Niemann₁, Brian B. Bruckno₂, Brett A. Morris₁, Edward J. Hoppe₃

- **1** Marshall University Geology Dept.
- 2 Virginia Dept. of Transportation (VDOT)
- **3 Virginia Transportation Research Council (VTRC)**

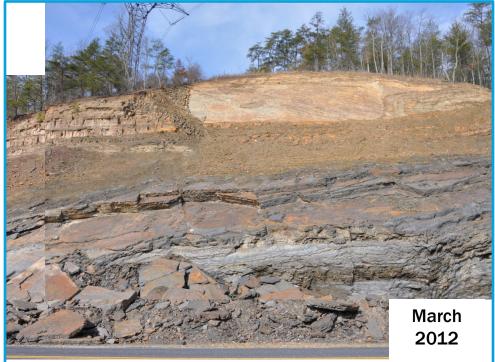
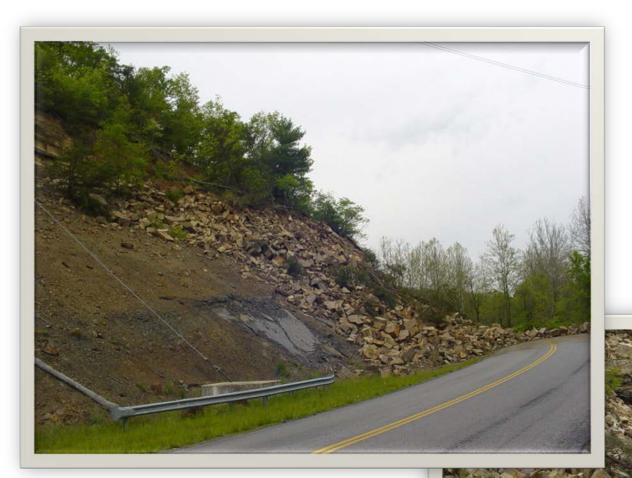
RS-00629-001

- Catastrophic slope failure in 2009 (10K yds³).
- Folded and jointed beds.
- Clastic metasediments of Brallier Formation (Devonian).
- Dip slope (35 deg.) on lower cut.
- Upper and lower

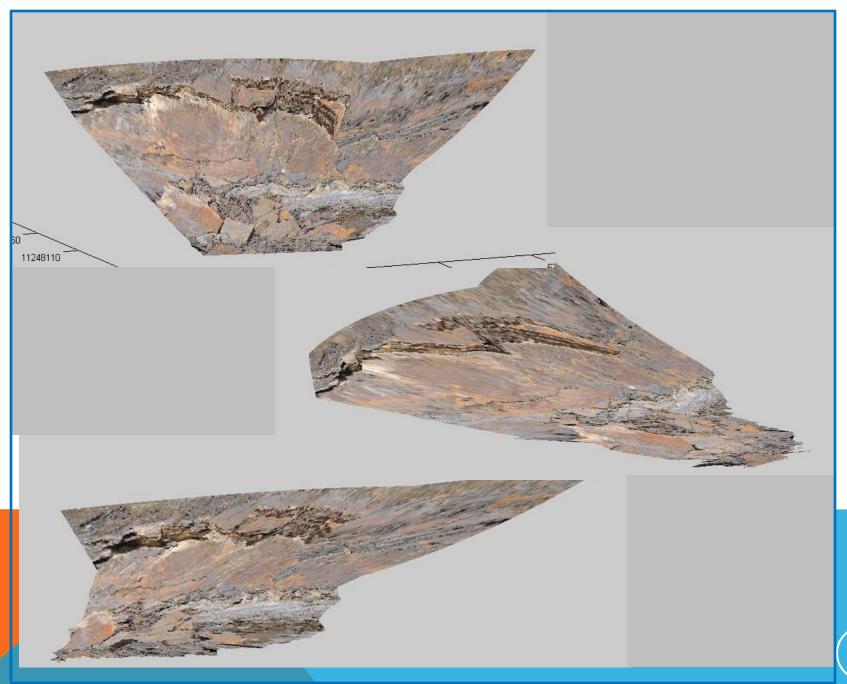
RS 00629-001

Catastrophic slope failure in 2009 (10K yds³)

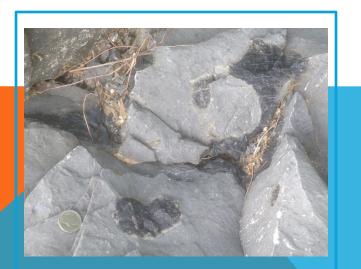
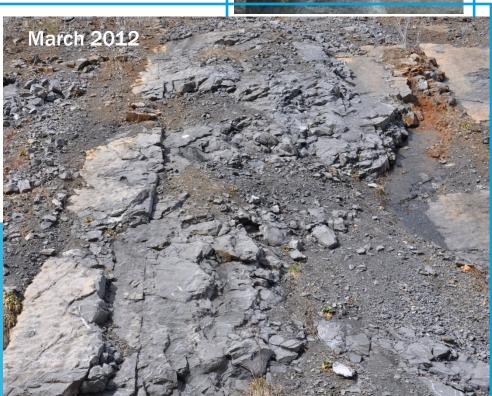
RS-00600-001

- Dip slopes (40 deg.) of cherty, wavy-bedded limestone.
- Helderberg Group (Devonian-Silurian).
- High-angle joints intersect bedding and slope, form blocks.

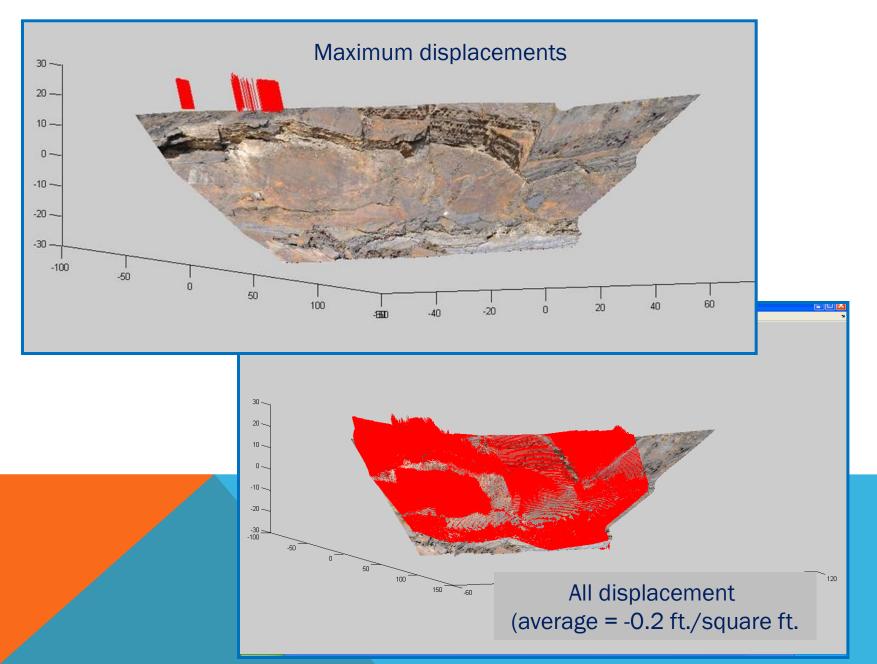
RS-00629-001 displacement vectors, March to June 2012

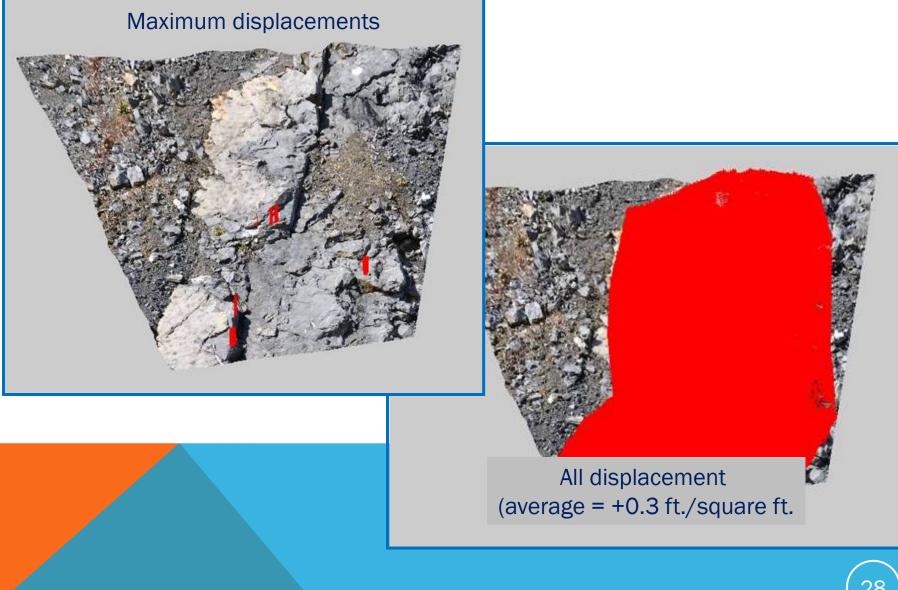
RS-00600-001 displacement vectors, March to June 2012
