Restoration and Rehabilitation of the Big Slackwater Section of the Historic C&O Canal Along the Potomac River

Martin J. Woodard, PhD, P.G. P.E.
mwoodard@haleyaldrich.com

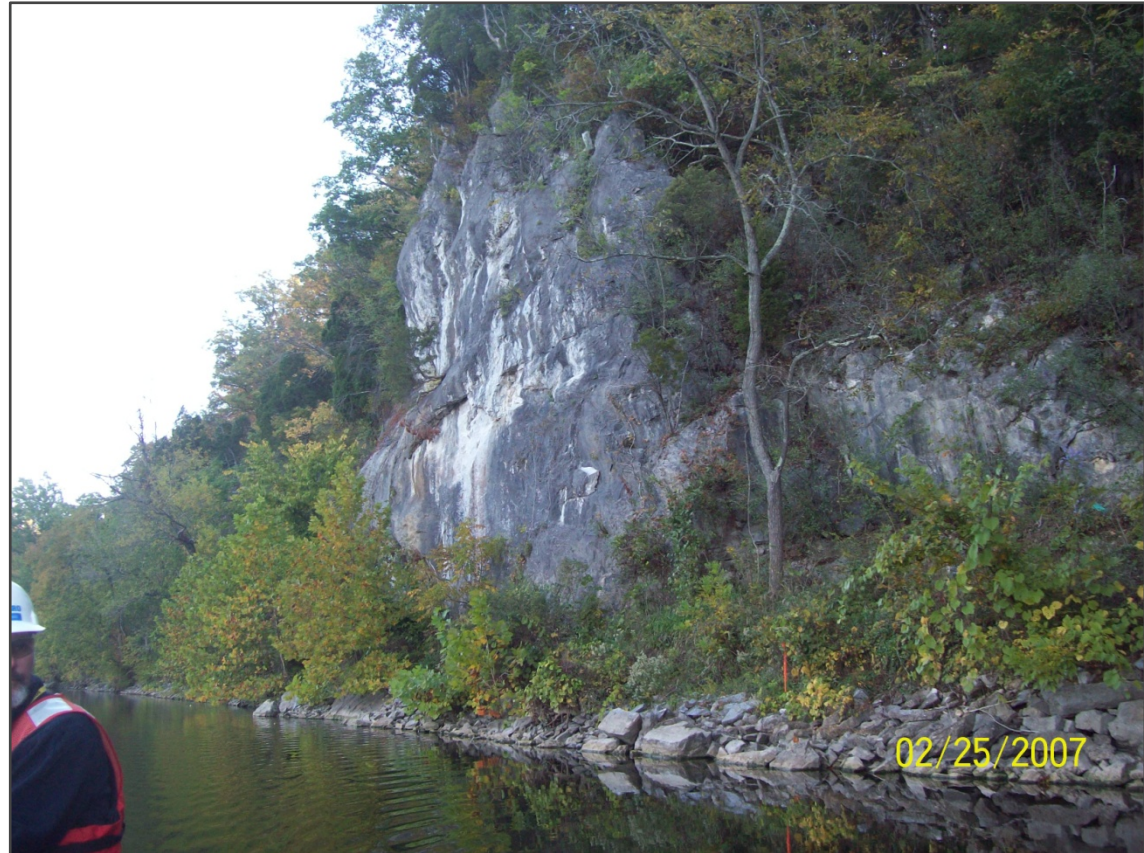
Advanced Karst Topography

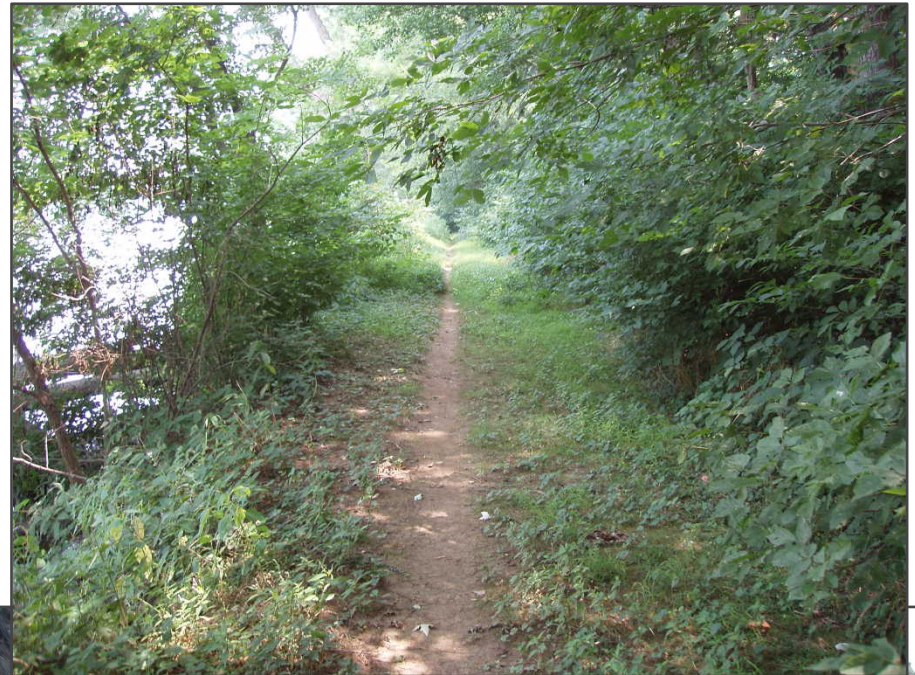
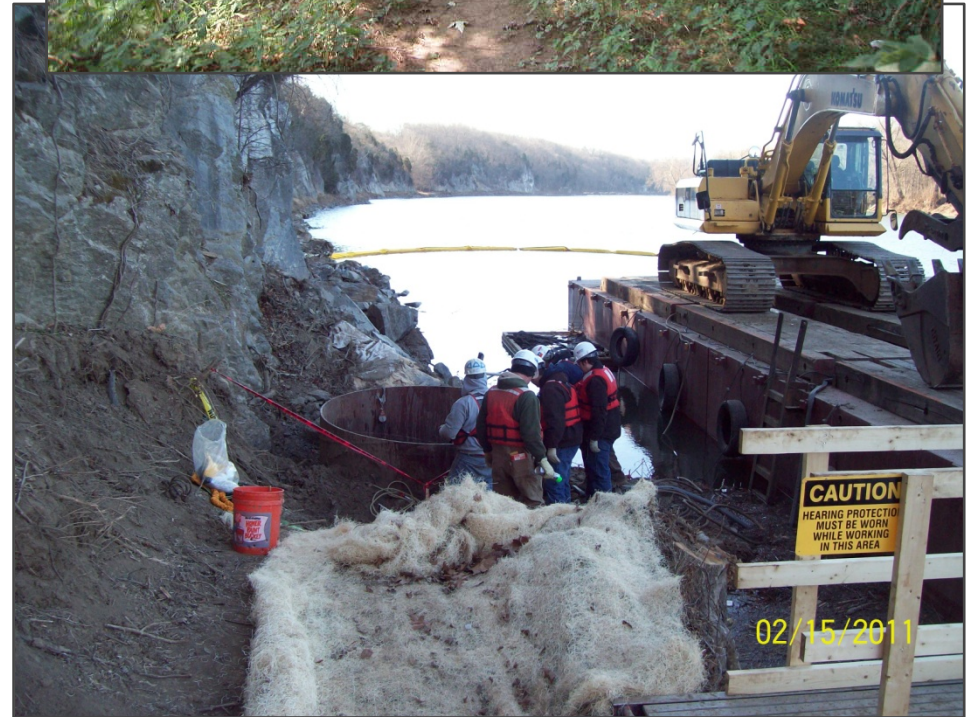
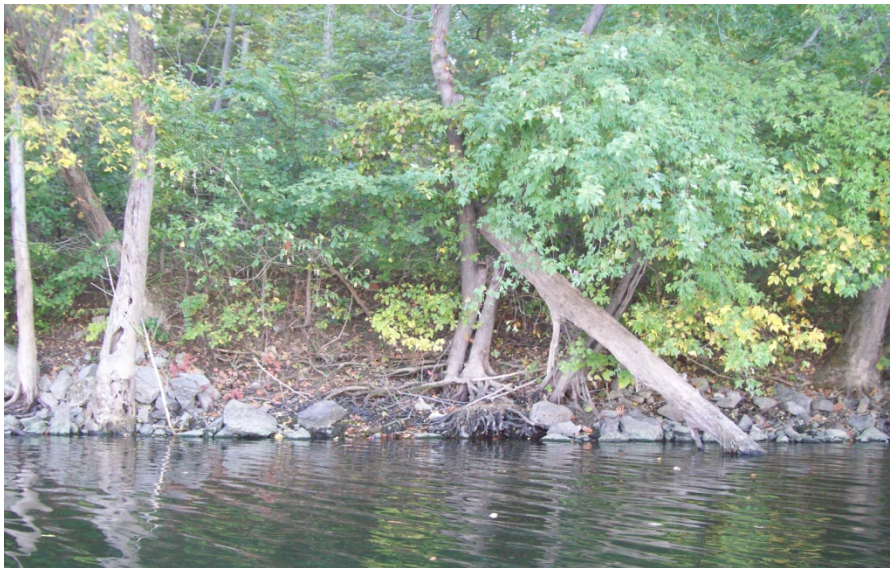
Top of Rock

- Minimal Subsurface investigation.
- 4 borings, 4 test pits
- 2 mile long project
- Gaps in Information

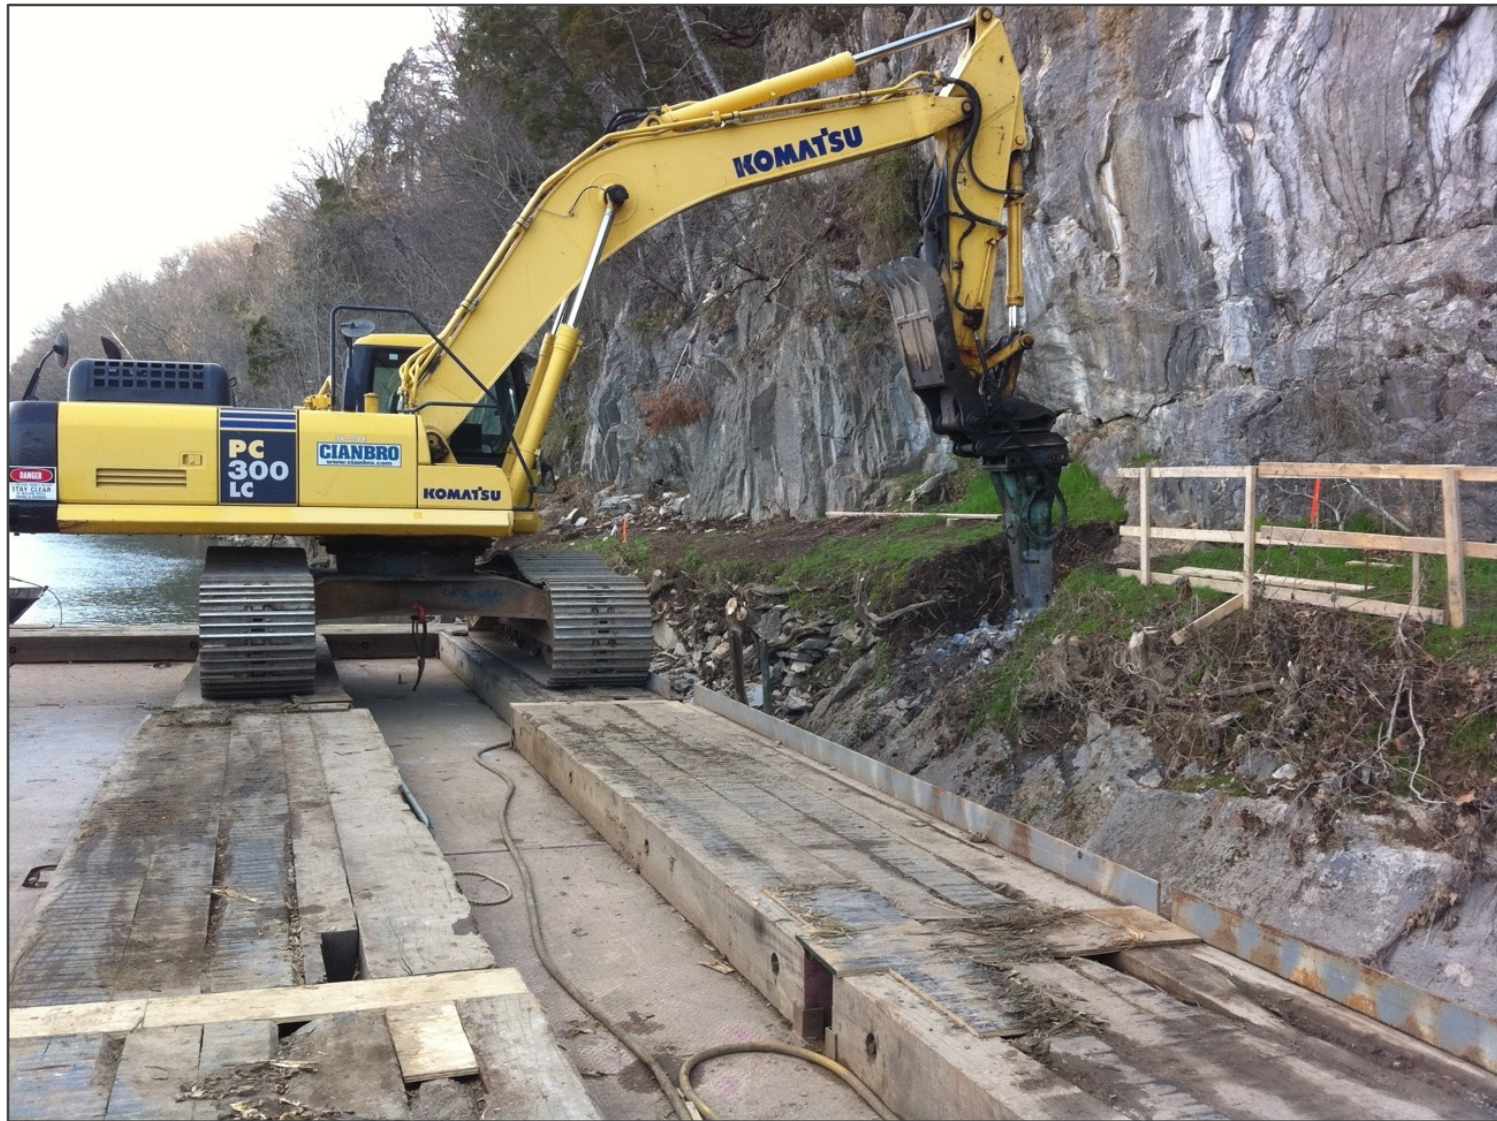
Foundation Excavation

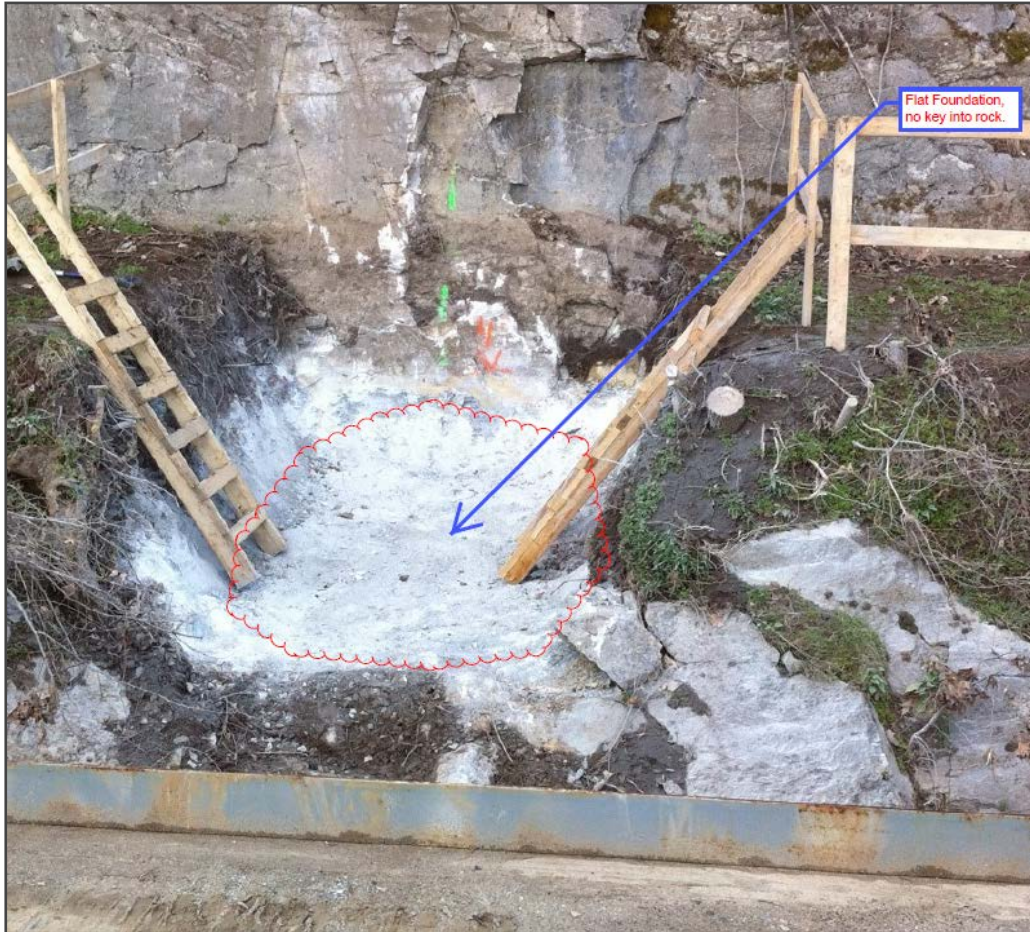
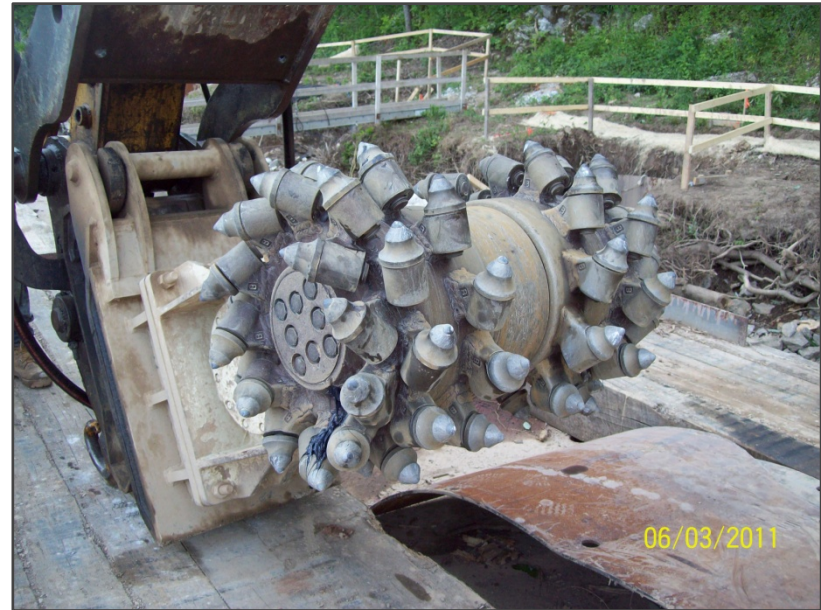
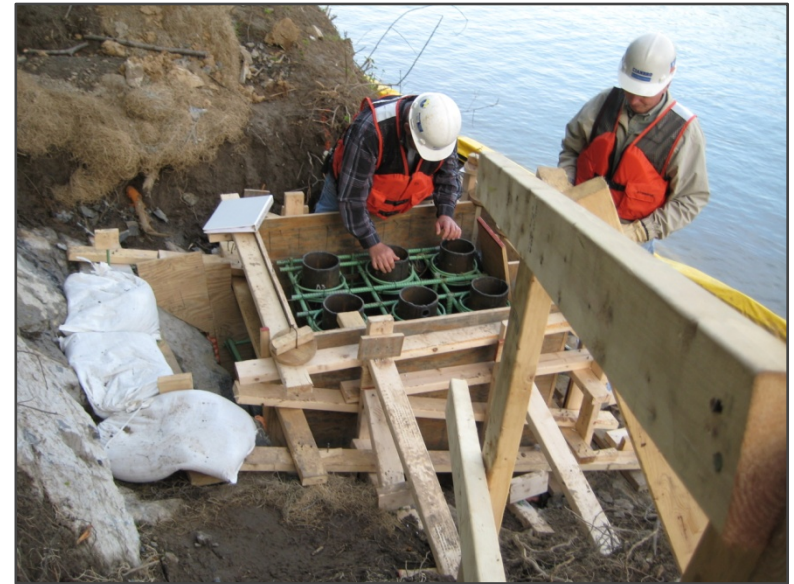
Foundation Preparation

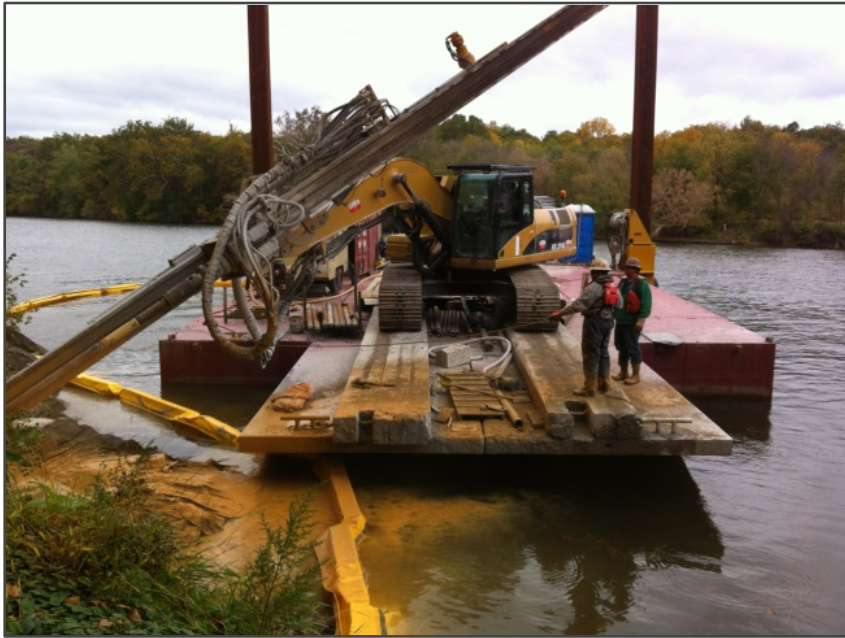
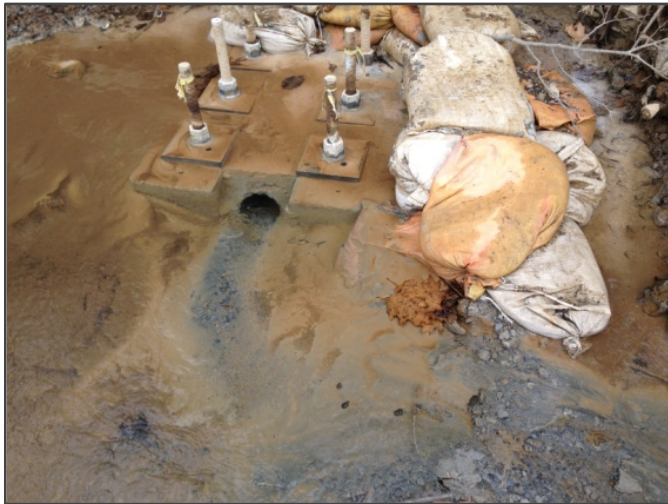
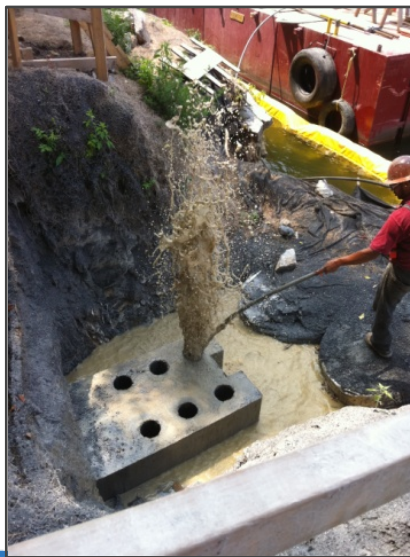
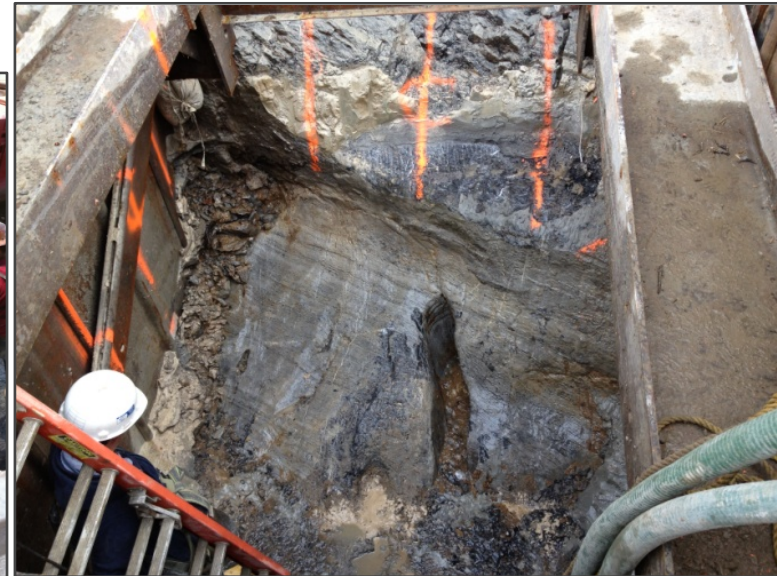
Anchor Installation Issues

- Flooding stopping progress
- Hole collapse after drilling
- Highly eroded rock
- Fractures
- Solution cavities
- Artesian well conditions

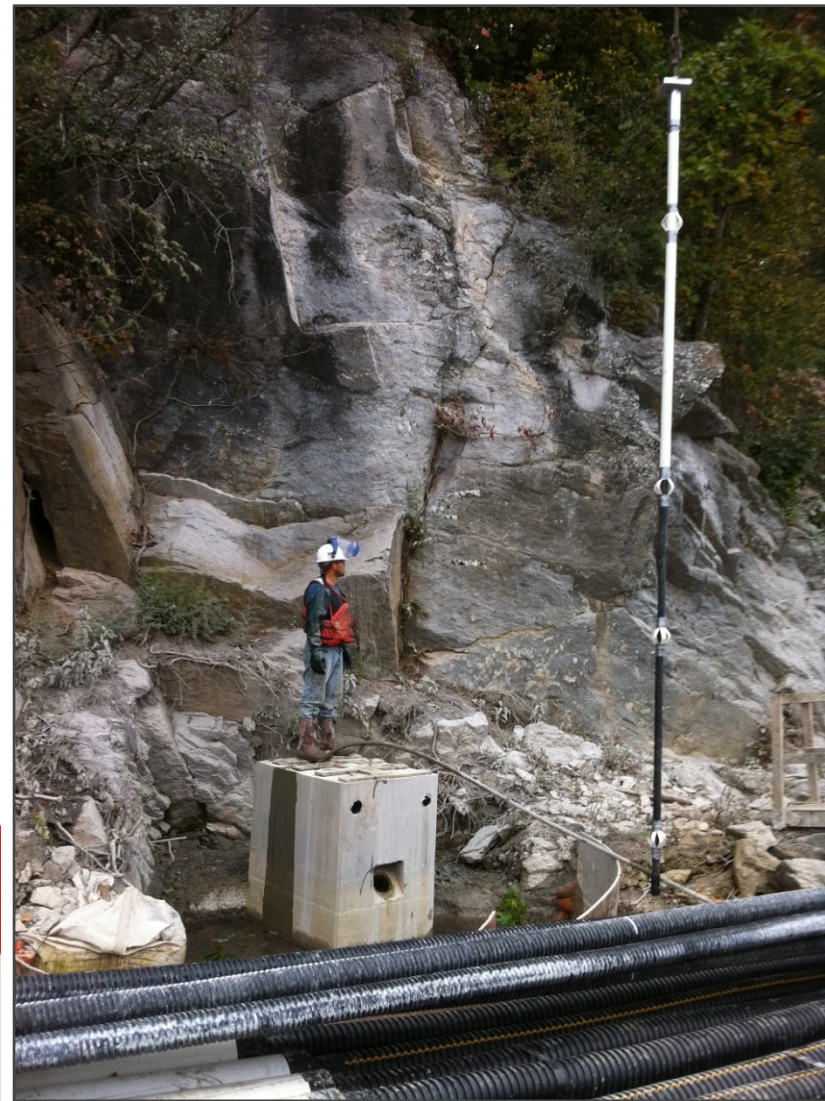
Rock Anchors

- 121 Piers (849 anchors total)
 - 7 Anchors per pier
 - 6 vertical
 - 1 angled down
 - Loads
 - Uplift, river flow, **flood, ice**

Type I

- 1 in.
- 77 kips
- 20' deep

Type II

- 1 3/8 in.
- 142 kips
- 28' deep

Type III

- 1 3/4 in.
- 240 kips
- 40' deep

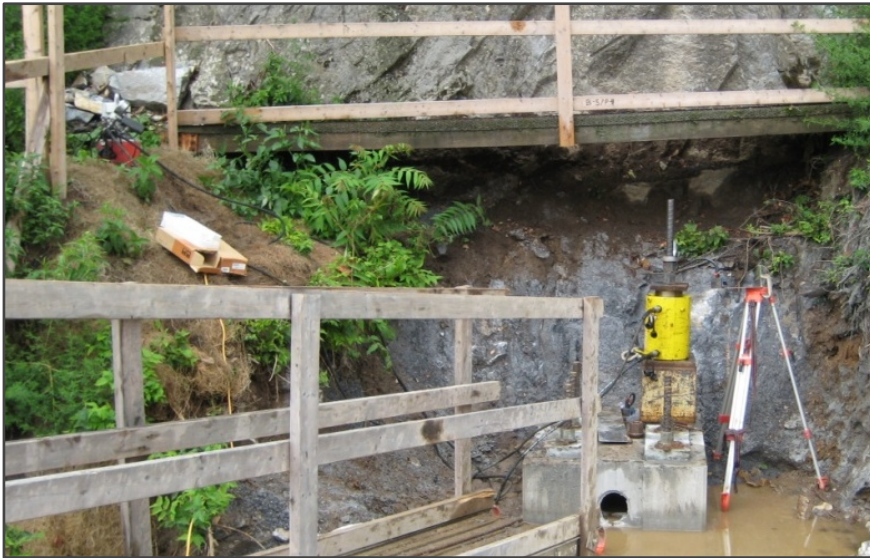
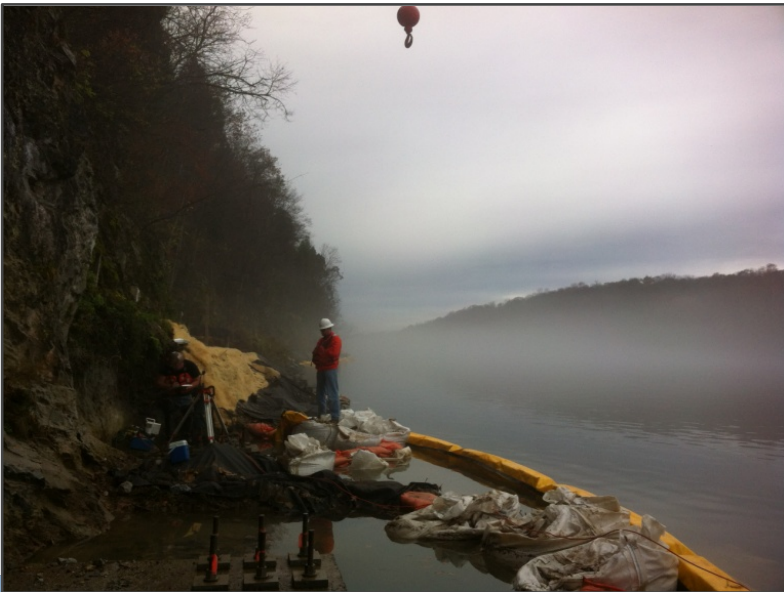
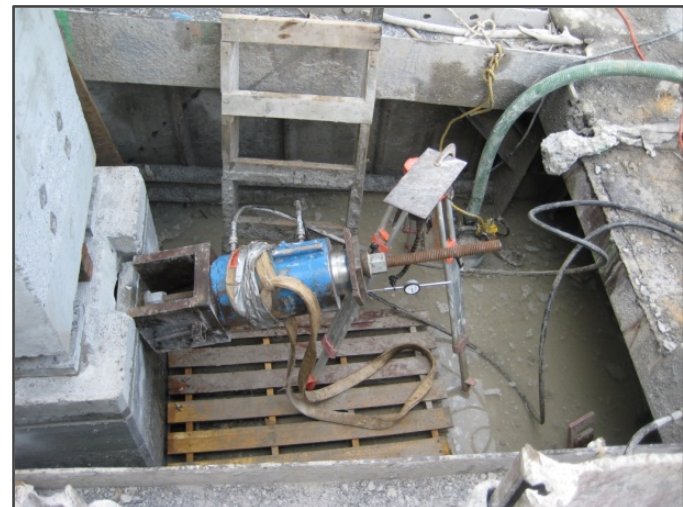
Anchor Testing Issues

- Flooding
- Incorrectly calibrated jack
 - Load Cell Fix
- Two Failures.
 - 1: Manufacturing flaw
 - 2: Initial anchor failure
 - Redesign of Pier.

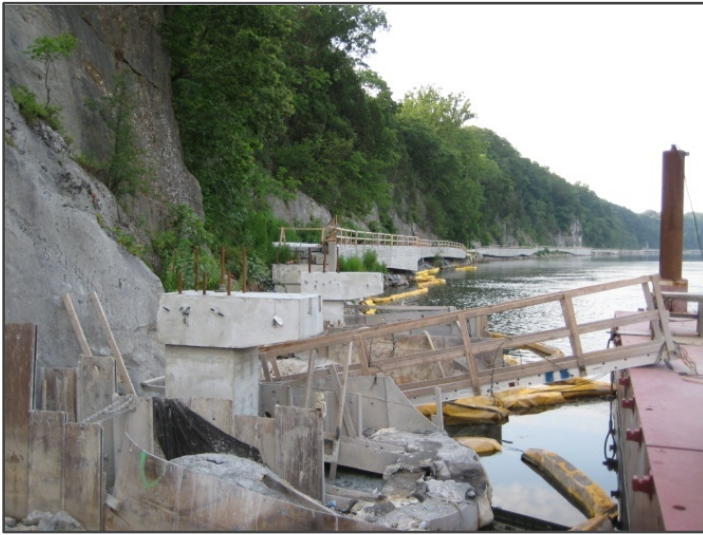
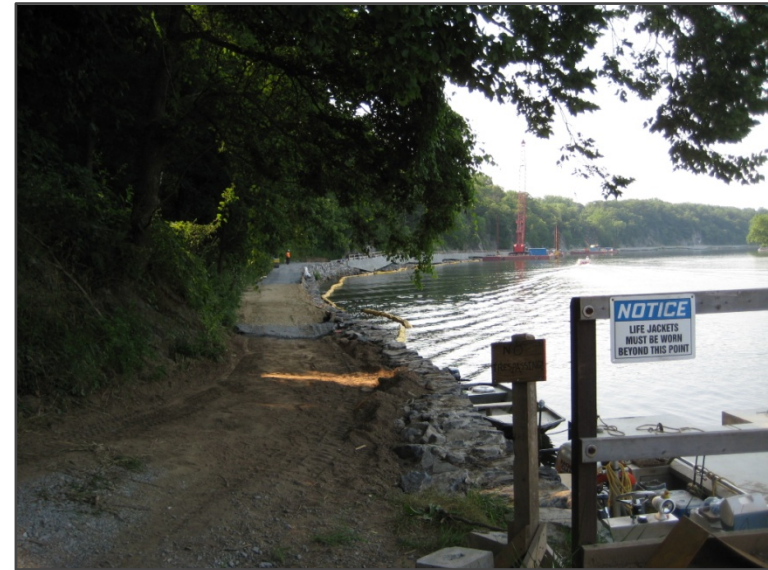
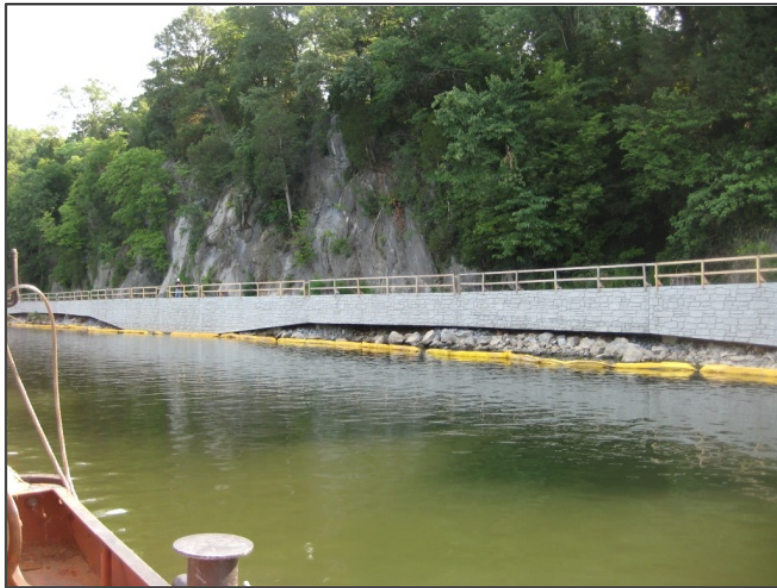
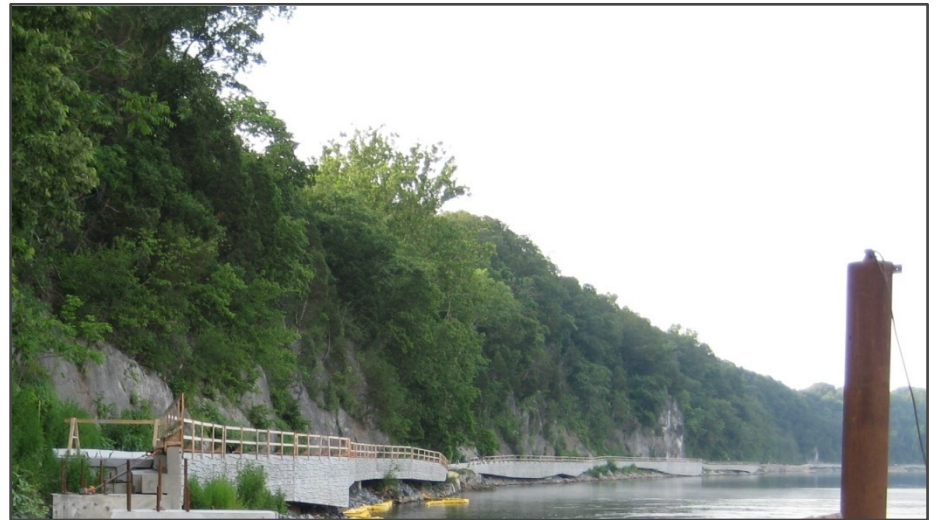
Super Structure/ Jet Grouting
