# 2013 Geohazards and ITGUAM Technical Forum

## PRIORITIZATION OF AGING ROCK SLOPES ON I-77

Virginia Department of Transportation - Salem District  
Interstate 77, MP 0.0 to MP 8.0 (Fancy Gap)  
Slope Inventory and RHRS Slope Rating

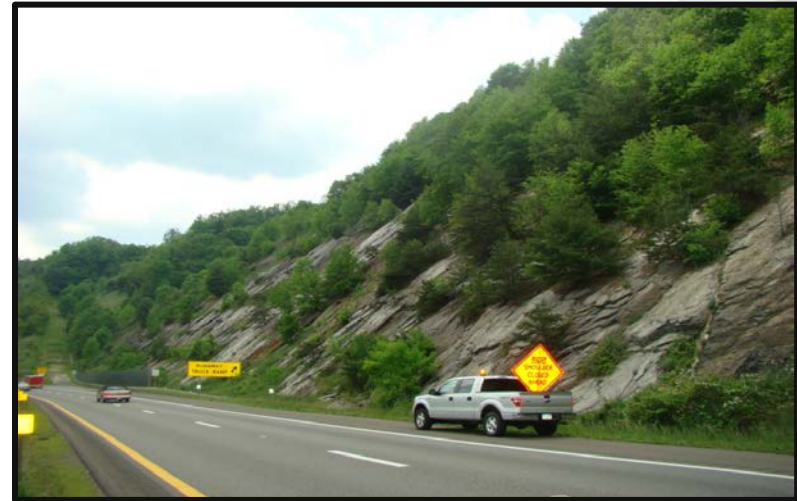
**Slope Heights:  
25 to > 250 ft**

Slope Height (ft)	25	50	75	100
Category Score	3	9	27	81

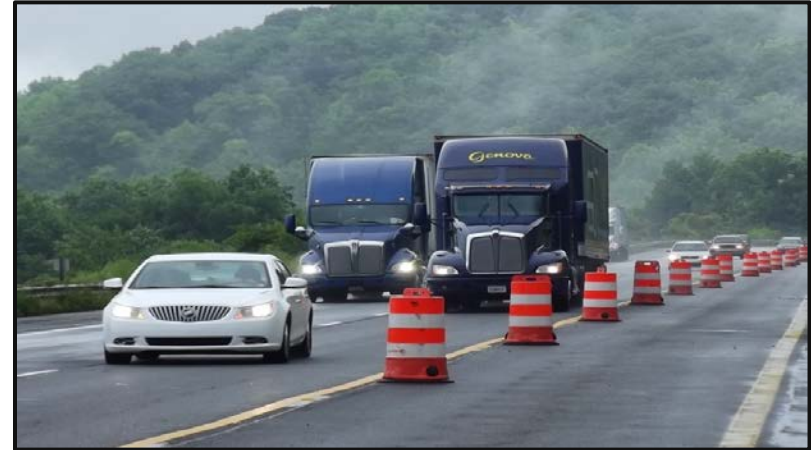
**Average Vehicle Risk:**  
**AADT = 18,000**  
**Slope Length = 1280 feet**  
**Typical AVR Score :81-100**

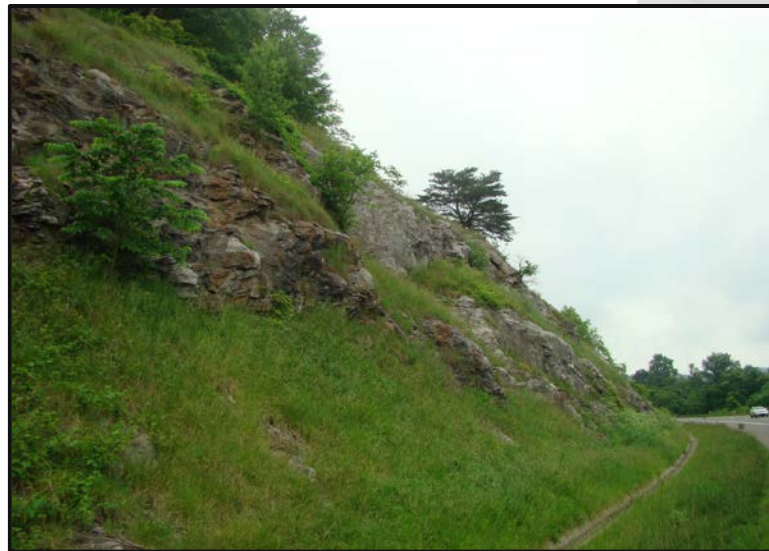
**% Decision Sight Distance:  
 Worst Case: 420 ft  
 % Decision S. D. Score = 81**

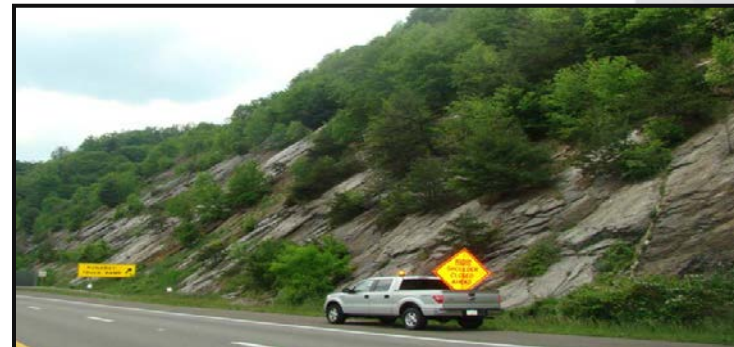
Continuous and Adverse Orientation

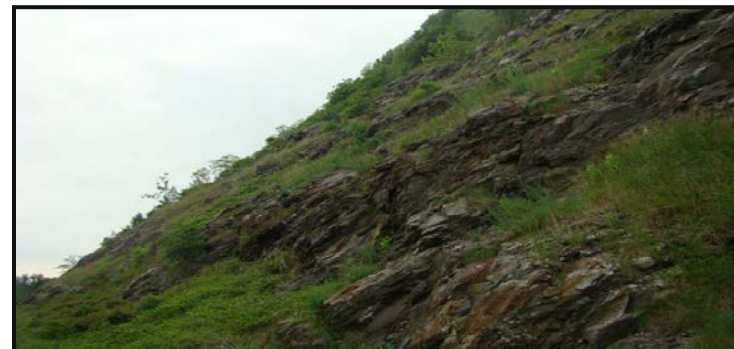
Slopes Showing Their Age
