Lessons Learned from Application of Ground-Based Digital Photogrammetry to Small-scale Movement on Unstable Rock Slopes: A Case Study from Virginia's Valley and Ridge.

William L. Niemann₁

1 – Marshall University Geology Department
Huntington, West Virginia 25701

**Case Study: application of GBDPG to small-scale
movement on six rock slopes in
Virginia's Valley & Ridge**

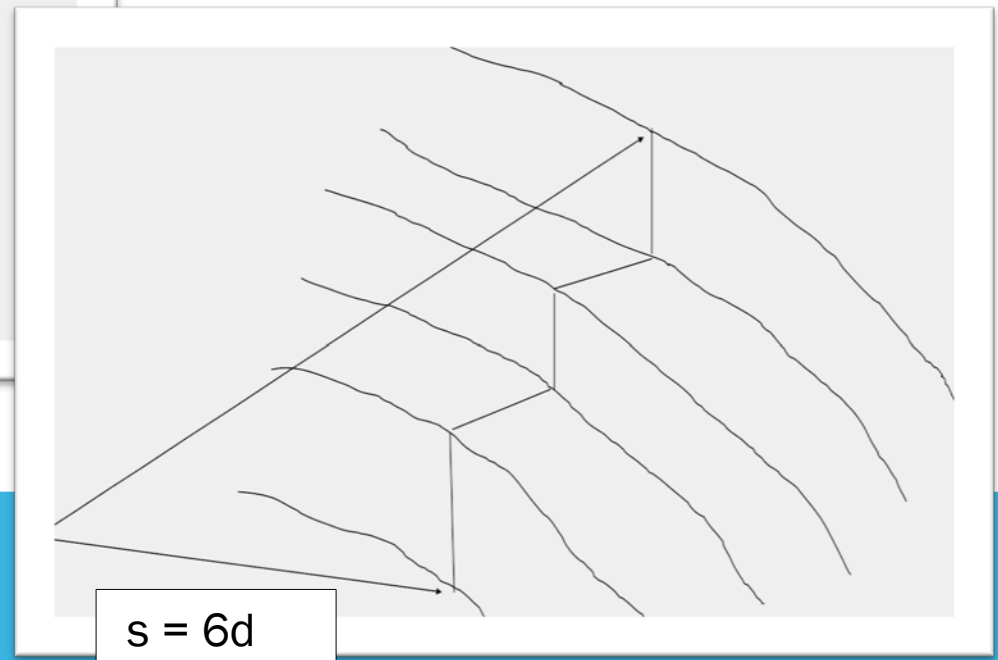
Ground-based Digital Photogrammetry (GBDPG)

- Relative versus Absolute coordinates
- Semi-quantitative vs. Quantitative DPG

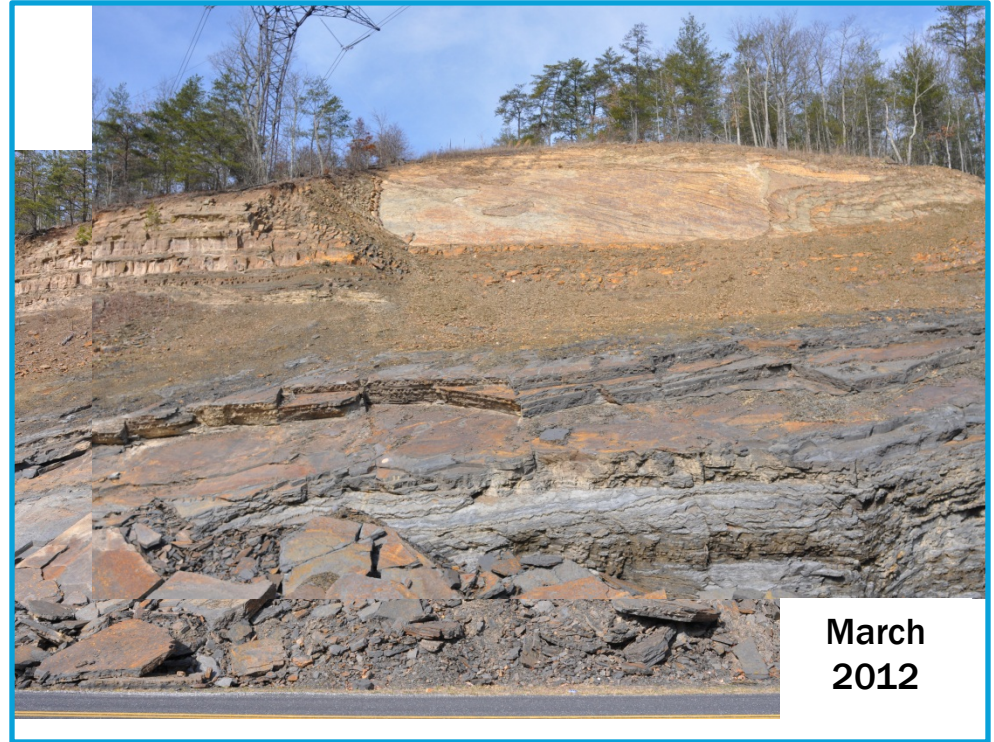
RS 629-001

- Catastrophic slope failure in 2009 (10K yds³).
- **Folded and jointed beds.**
- Clastic metasediments of Brallier Formation (Devonian).
- **Dip slope (35 deg.) on lower cut.**
- Upper and lower slopes imaged separately.

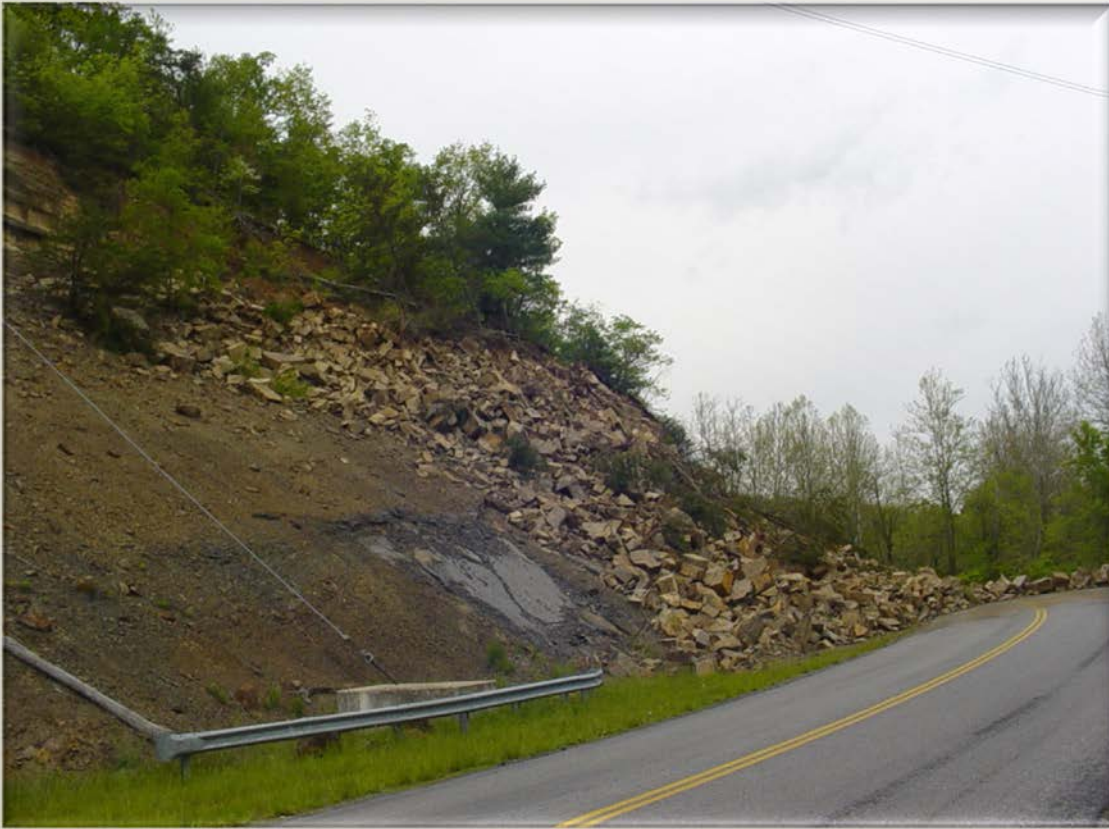
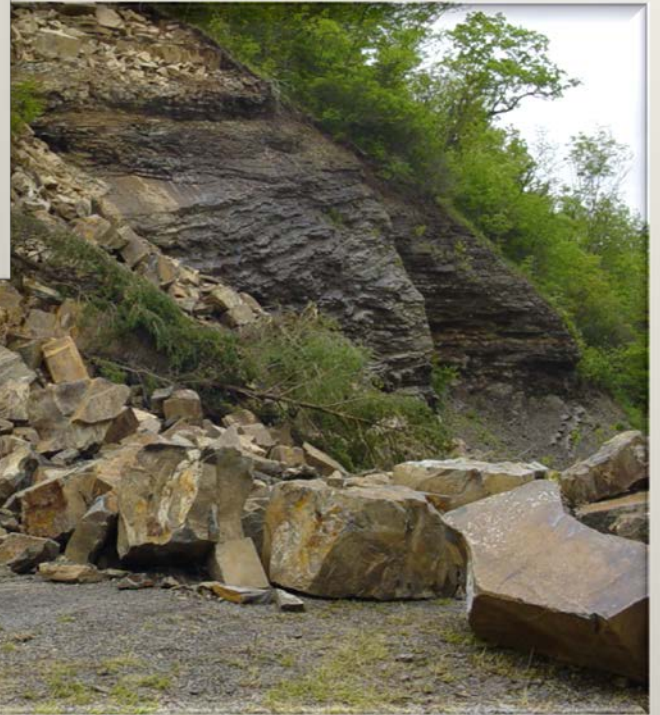
RS 629-001

**Catastrophic slope failure
in 2009 (10K yds³)**

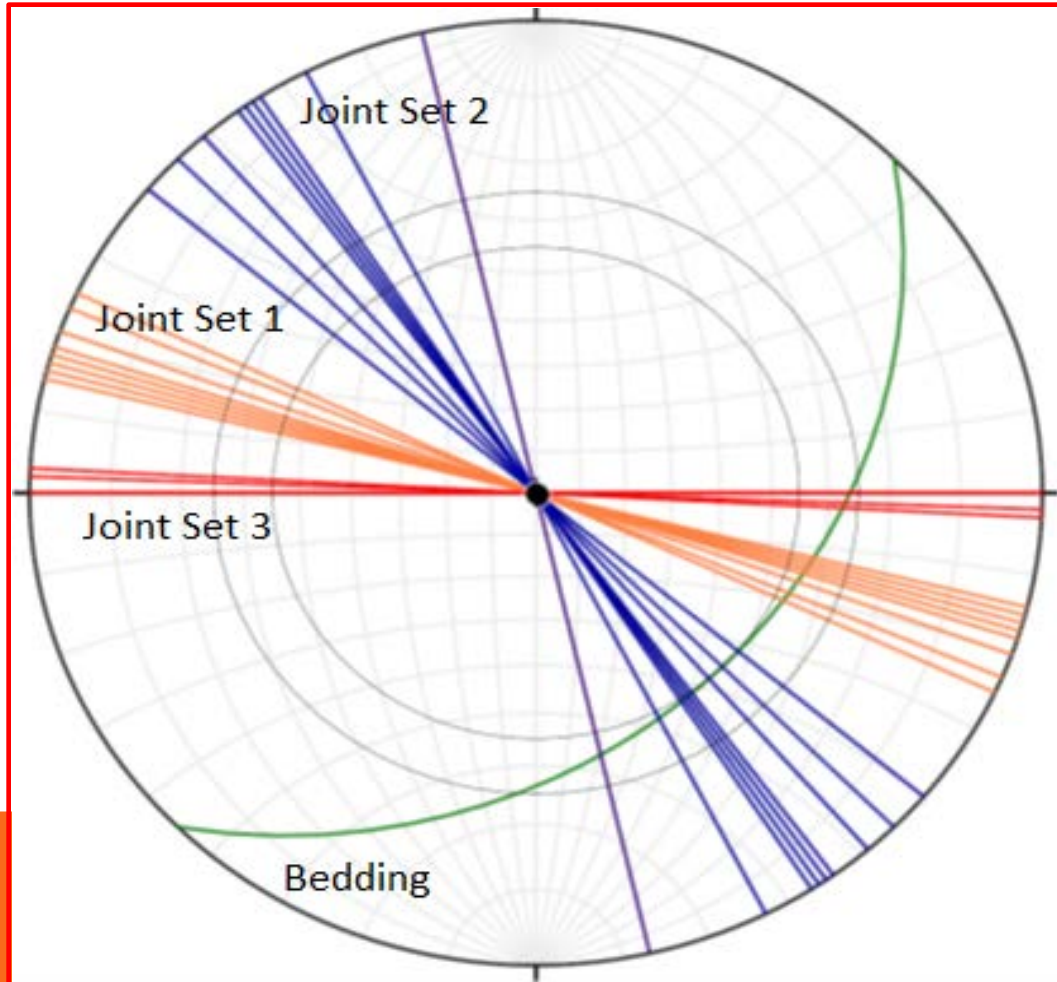
Line survey of
discontinuities
measured with
Brunton compass
(Morris, 2012)

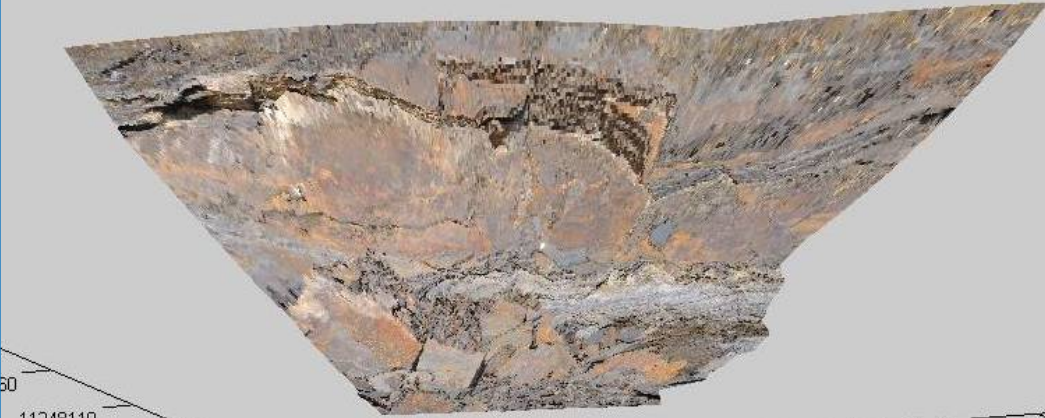
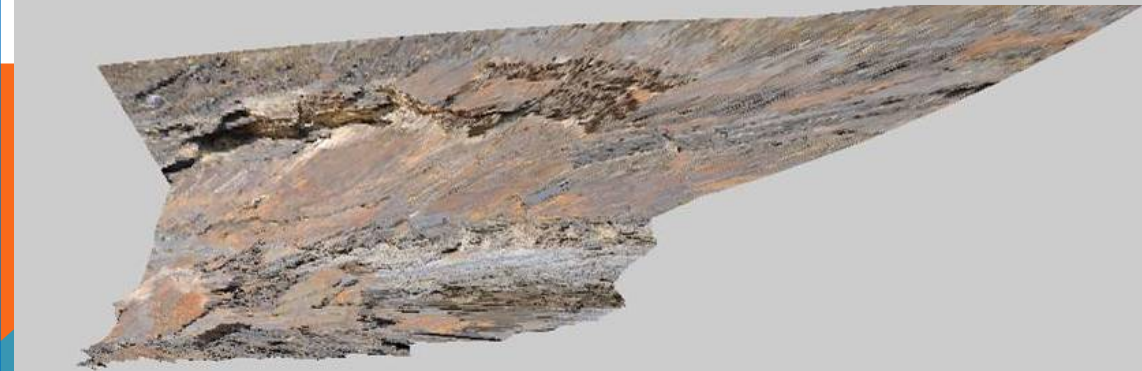
RS 629-001

Displacement Calculations

- Normal to Surface
 - Vertical

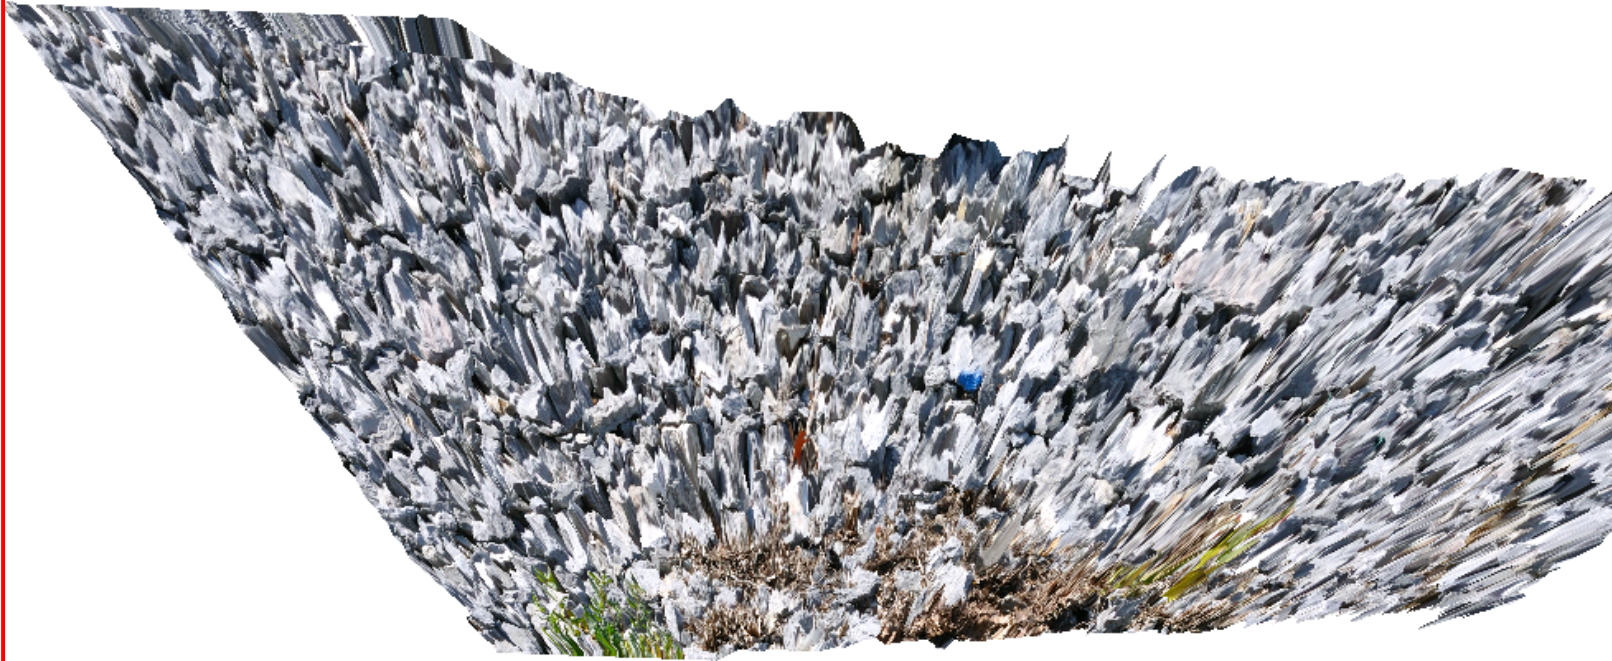
Assessment of Possible Error in Displacement Calculations

- **Site Conditions**
- **Software flaws**
- **Inaccurate coordinates**

- **Displacement calculations are a function of point (spatial) accuracy.**
- **Spatial accuracy of ~0.1% can be expected from GBDPG when site conditions permit high quality photographic images and reference coordinates are accurately determined. Software error is ~0.01% and does not limit accuracy.**

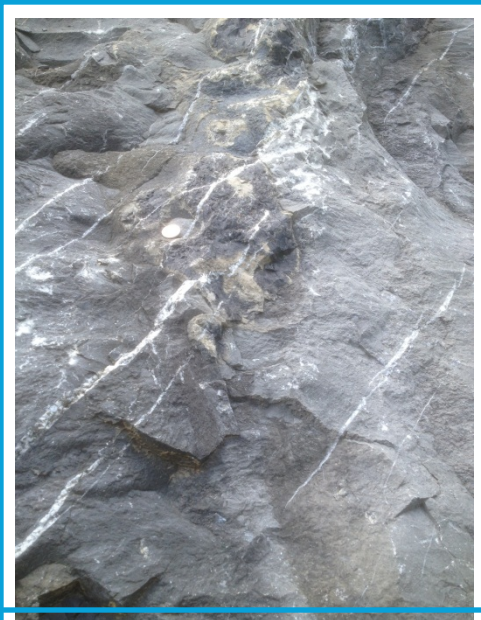
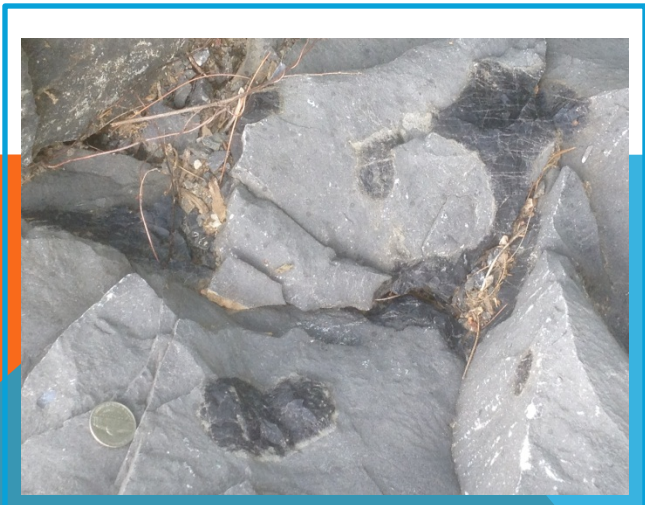
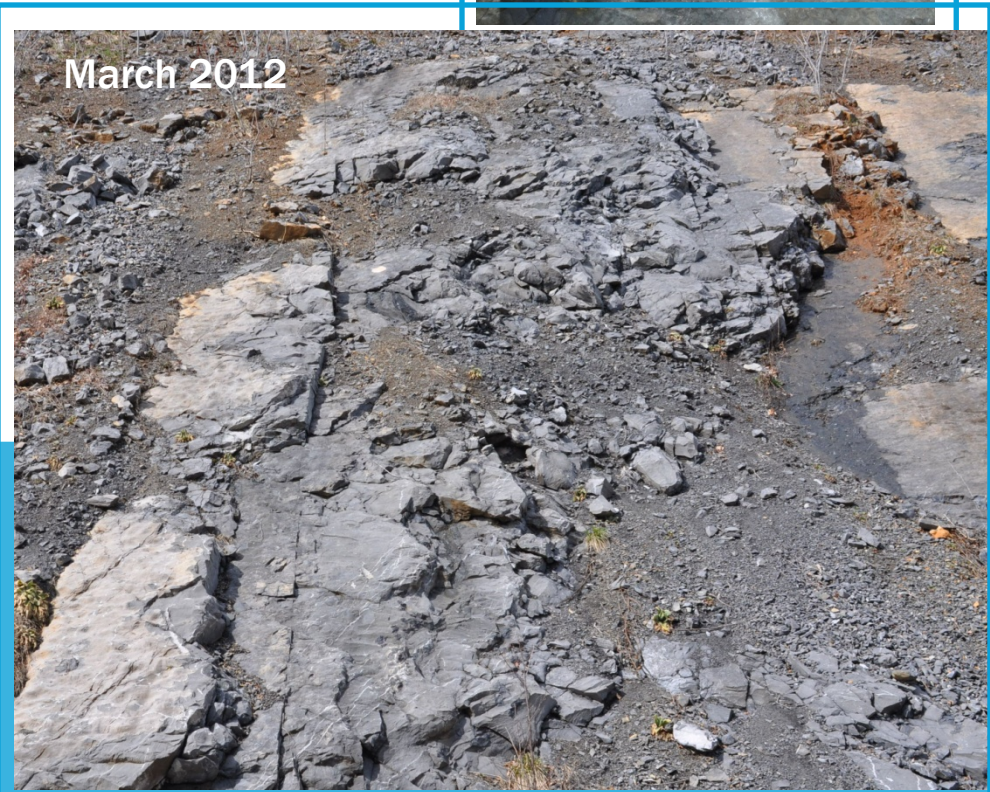
RS-00600-001

- Dip slopes (40 deg.) of cherty, wavy-bedded limestone.
- **Helderberg Group (Devonian-Silurian).**
- High-angle joints intersect bedding and slope, form blocks.

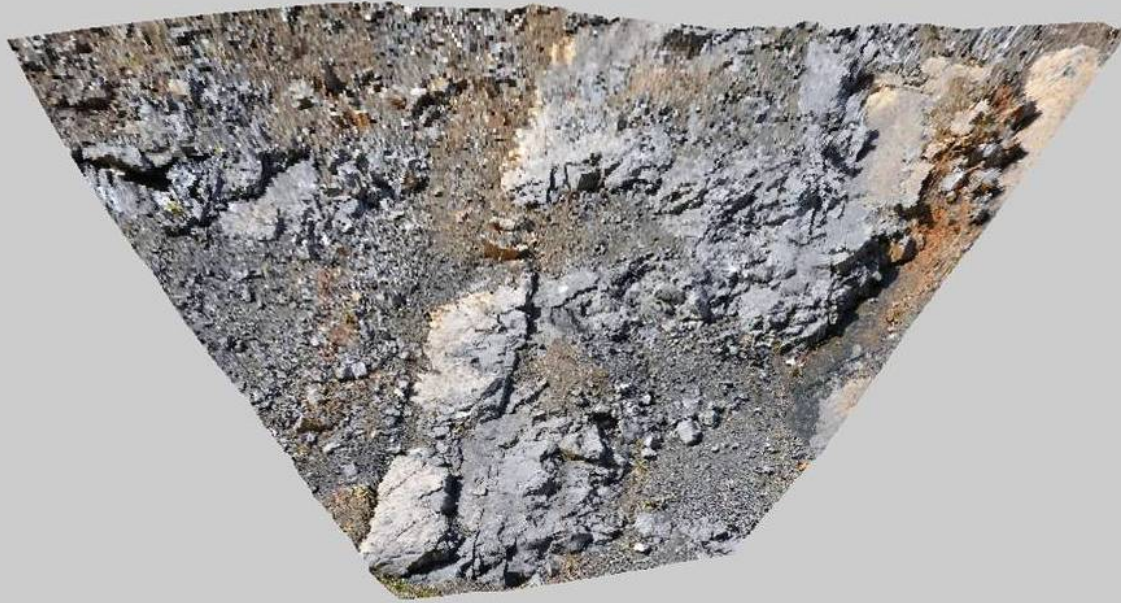
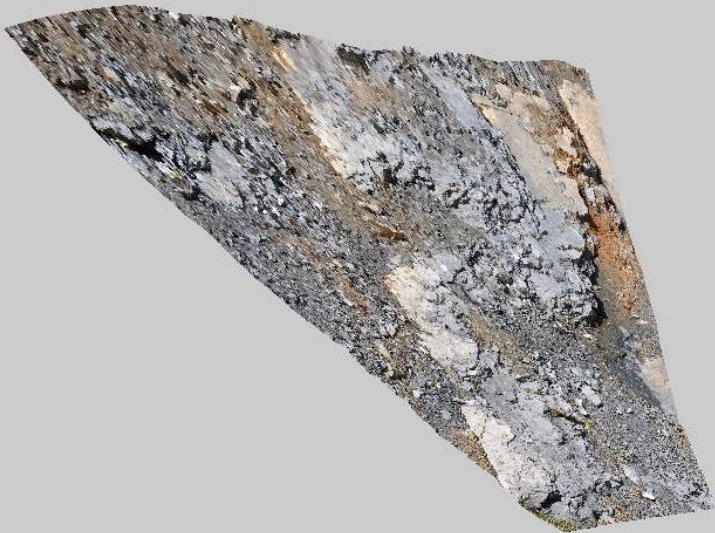
Displacement Calculations from Sirovision®

- **Numerical displacement**
 - **Normal to surface**
 - **Negative versus positive**
 - **Average and maximum**
- **Areas of calculated maximum displacement potentially useful for qualitative assessment**
