CASE HISTORIES OF MINE SHAFT SUBSIDENCE OF ABANDONED COAL MINES IN THE RICHMOND TRASSIC BASIN, RICHMOND, VIRGINIA

Steve Pond, C.P.G.
2013 ITGAUM/CEGAS Annual Technical
Forum
James Madison University

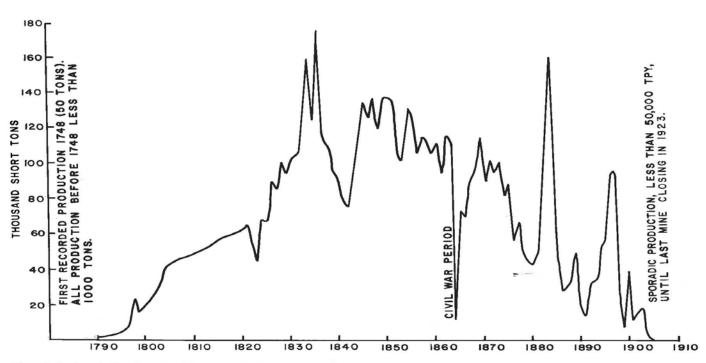
Figure 8. Coal production from the Richmond coalfield.

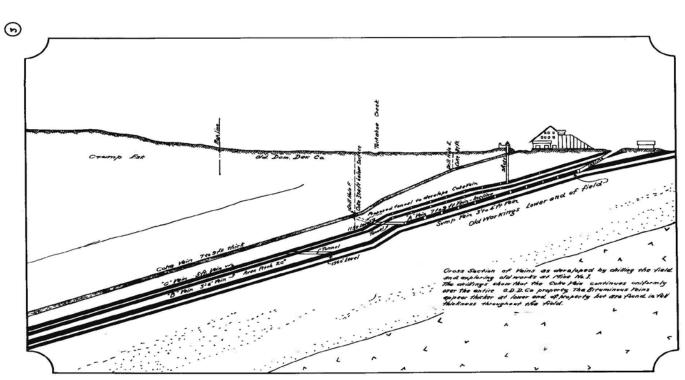
Figure 13. Cross section of the Coalbrook Slope.
