Mt. Washington Landslide, Emergency Response, and Wall Design

Trey Walker, PE

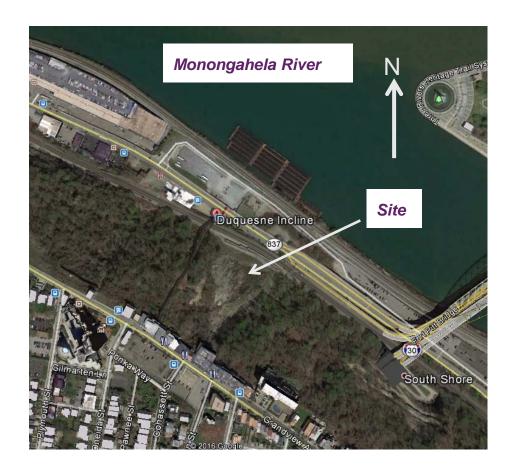
Site Location & Information

- ► Landslide Occurred on April 8, 2014 ≈ 3:00am
- Affected Parties
 - Norfolk Southern Railway
 - City of Pittsburgh
 - Duquesne Incline
 - LeMont Restaurant
 - Other Residents

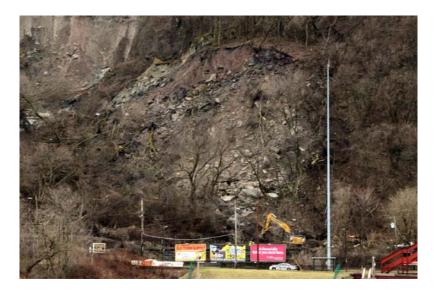
- ► Total Slide
 - 350-feet by 600-feet Slide Mass
 - Estimated 450,000 CY
 - Initiated ≈ 500-feet upslope of track

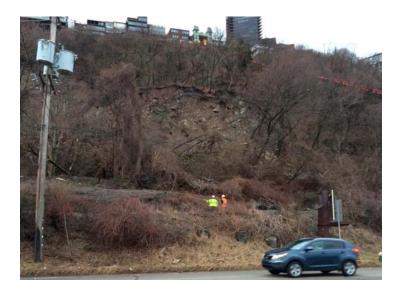
- Norfolk Southern
 - Double Mainline Tracks Covered in Debris
 - ▶ 75' stretch of Main Track #1
 - ▶ 230' stretch of Main Track #2
 - ▶ Up to 15' deep

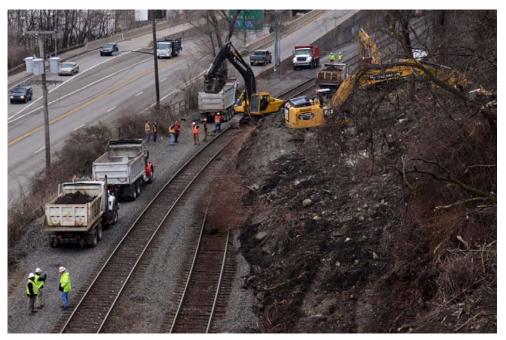
- Objective: Safely Restore
 Freight Operations
- Remove Debris & Restore Traffic on Main Track #1
- Remove Debris & Restore Traffic on Main Track #2
- Total of 3,000 CY Removed from Track
- Continue Observation of Slide Mass
- Begin Site Assessment & Investigation

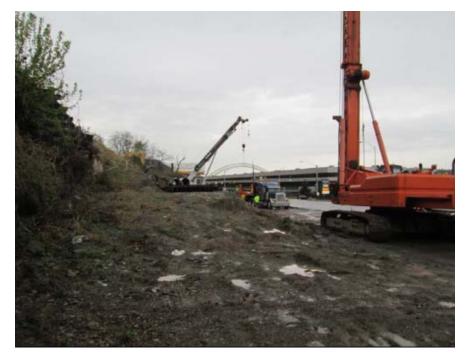
- ► Objectives:
 - Protect track operations
 - Provide a system with advanced warning of additional movement

- Multi-phase approach
 - Provide design for immediate protection (Phase 1)
 - Continue to monitor slope conditions
 - Provide design for alternate reinforcement (Phase 2)
- Design timeline
 - Conceptual design in 5 days
 - Preliminary design in 10 days
 - Owner & Contractor review
 - Final documents/begin construction in 20 days
 - Phase 2 design in 6 weeks

- Design Concept Phase 1
 - Soldier Pile Wall
 - 12' typical design height
 - 6' stickup above stone backfill
 - 355' wall length
 - HP14x117 Soldier Pile (60' Length)
 - 24" diameter socket
 - Backfilled with concrete
 - HP12x53 Continuous Waler
 - Precast Concrete Lagging
- Design Concept Phase 2
 - 225-kip Anchors
 - 2 anchors every other bay
 - Double HP waler connected to wall face
