16th Annual Technical Forum for Geohazards Impacting
Transportation in the Appalachian Region
Dismantling the Tallest
Reinforced Fill in North America —
The Observational Method
Applied at the Yeager Airport

By Gary Brill, PE 3 August 2016

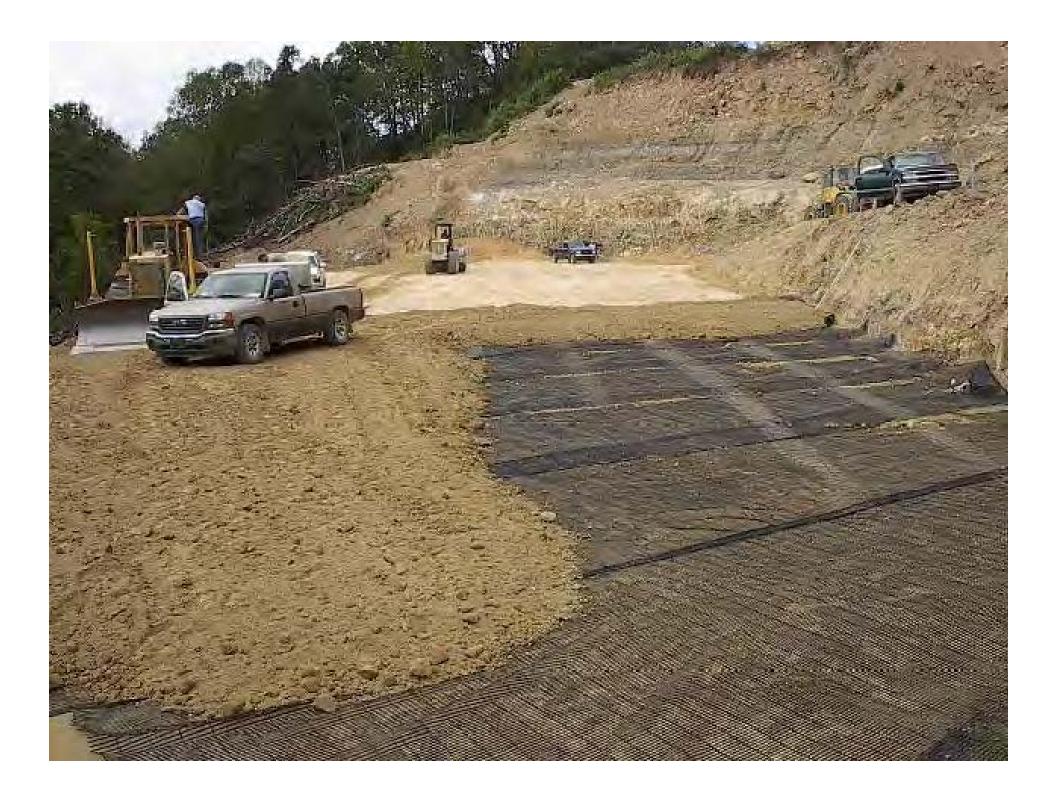
- FAA directed safety zone at end of runway with length of 500'
- Engineered Materials Arresting System (EMAS)
- To support the EMAS, "The tallest known geosynthetic reinforced 1H:1V slope in North America" was constructed

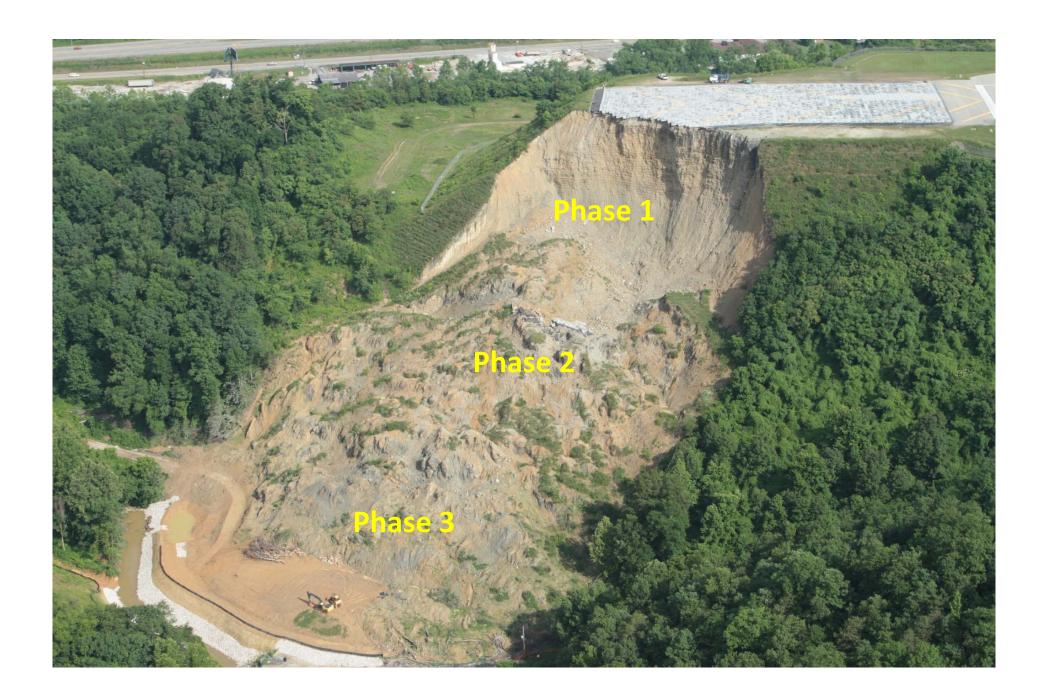
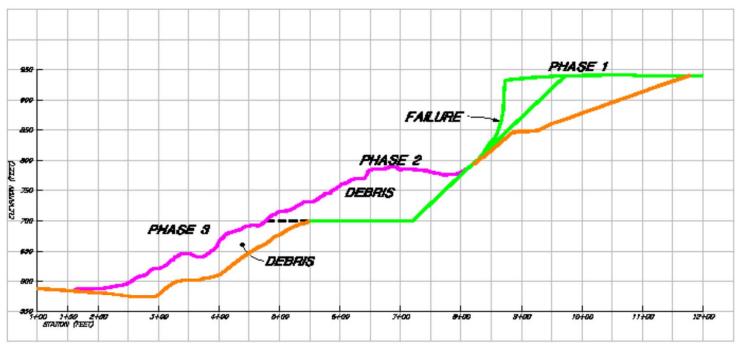
SECTION A-A

- No one gets hurt
- 140 feet high vertical face below runway
- Massive, creeping debris field below vertical face

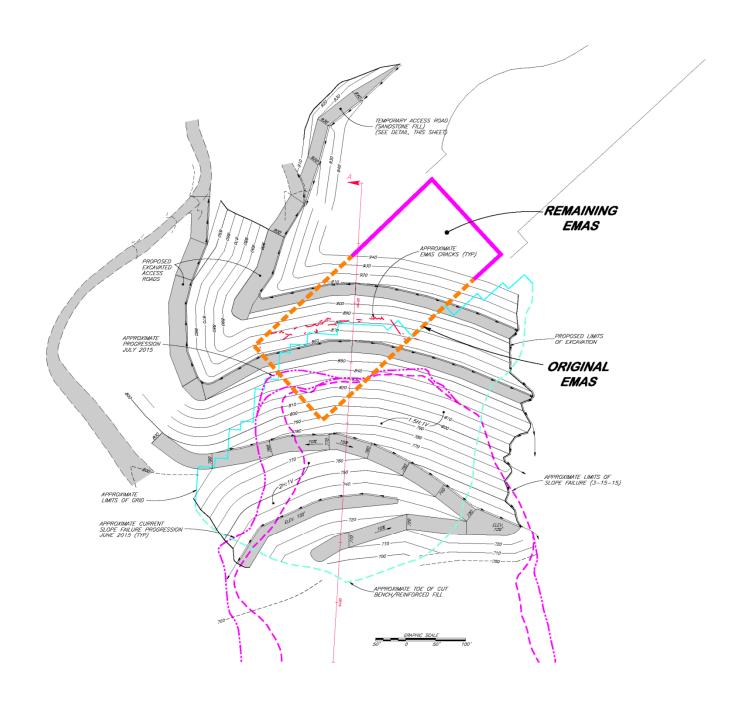
TEMPORARY CUT SLOPES

- Balance safety factor with minimizing removal of remaining fill
- Based on perceived nature of material, used cut slopes of 1.5H:1.0V with benches approximately 50 feet vertical

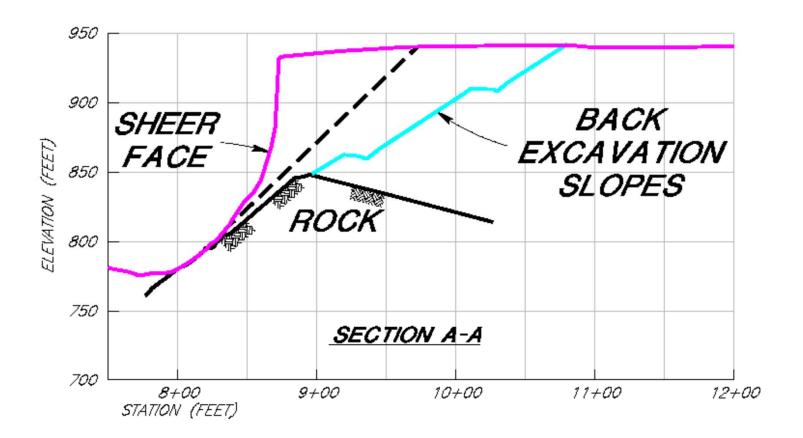
Survey points on outer edge of face with continuous monitoring

Visual observations
