# Challenges During a Top Down Design and Construction Approach of Foothills Parkway Bridge No. 8

**KHALID T. MOHAMED, P.E., PMP**  
**FHWA, WASHINGTON, DC**

Geohazards Impacting Transportation in Appalachia  
Knoxville, TN  
August 2016

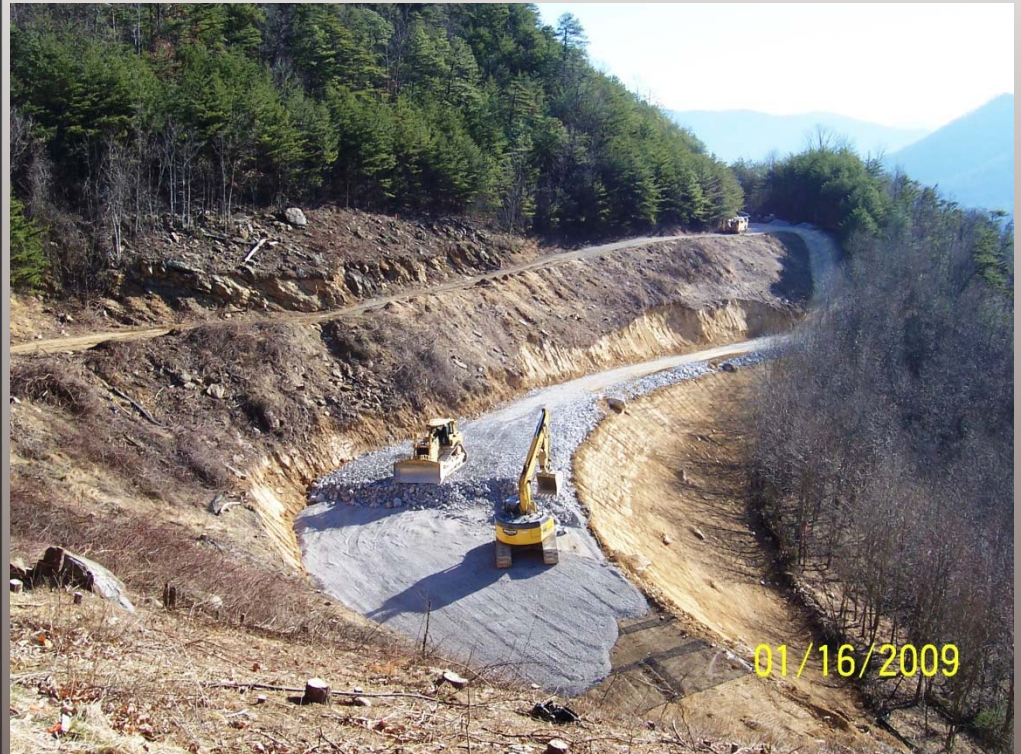
**90 ft High Reinforced Geogrid Limestone  
Shot rock Embankment**

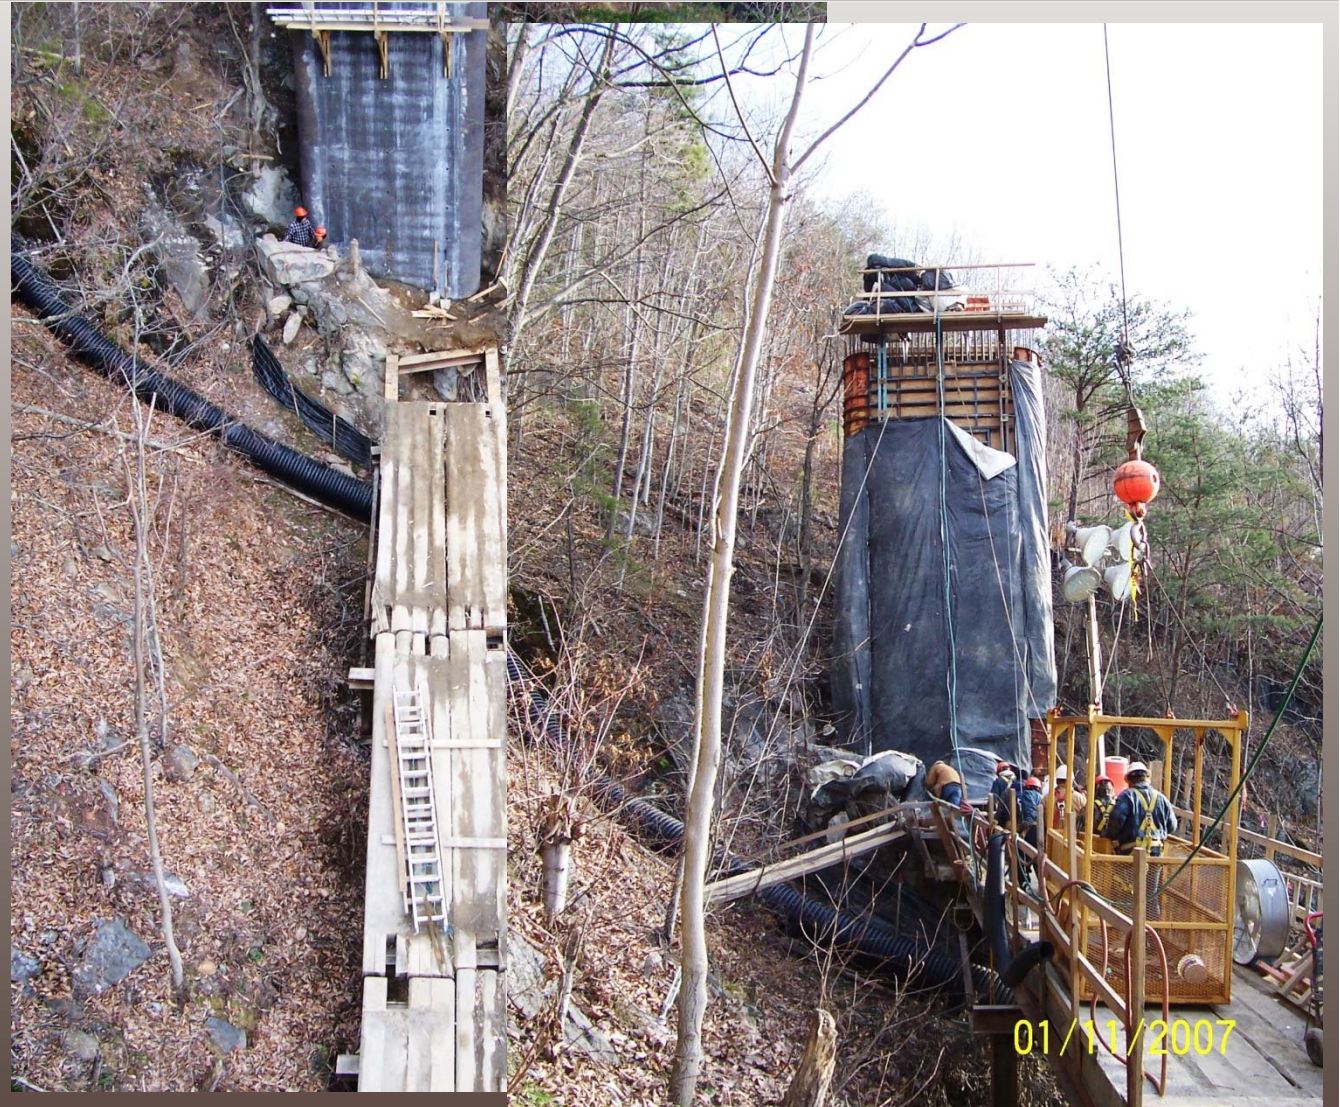
# DESIGN AND CONSTRUCTION CONSTRAINTS (Platform Access)

- The Design and Construction of Bridge No. 8 Has to Work With A Number of Constraints: Hence Was “*Top-Down Construction Concept*”

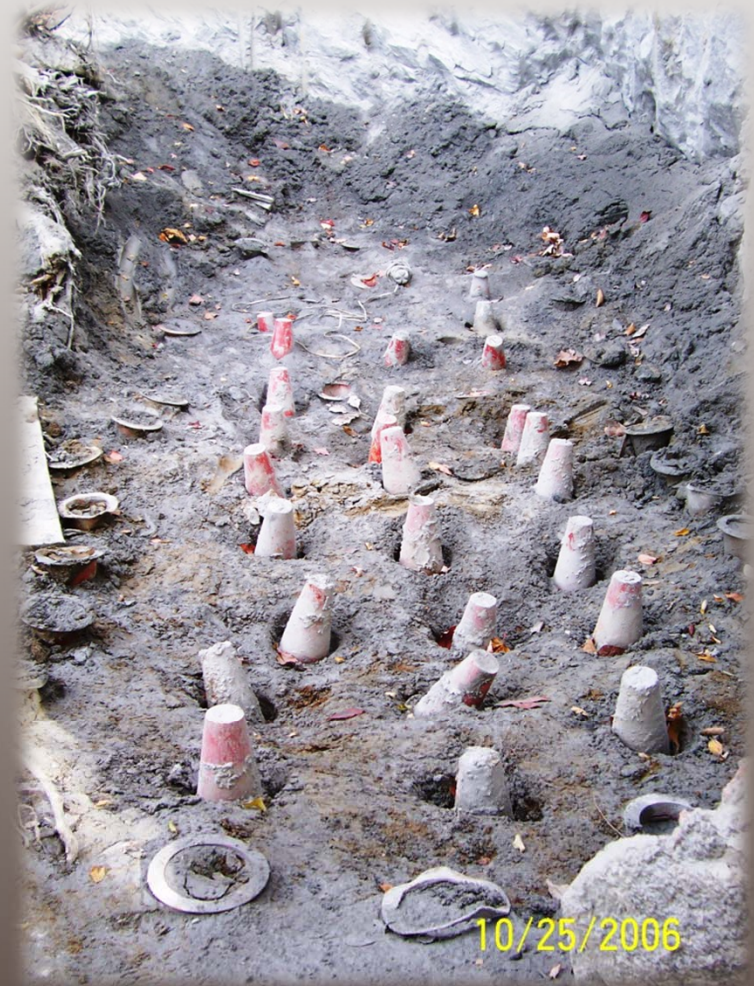
- ❑ The 1997 Consultant's Geotechnical Report Considered Spread footings and Micropiles.
- ❑ Design Accounted for Slope angles Varying from  $38^{\circ}$  to  $40^{\circ}$  at Substructure Locations.
- ❑ Depth to Bedrock Varied from 0 to 0.2 m (0 to 1 foot).

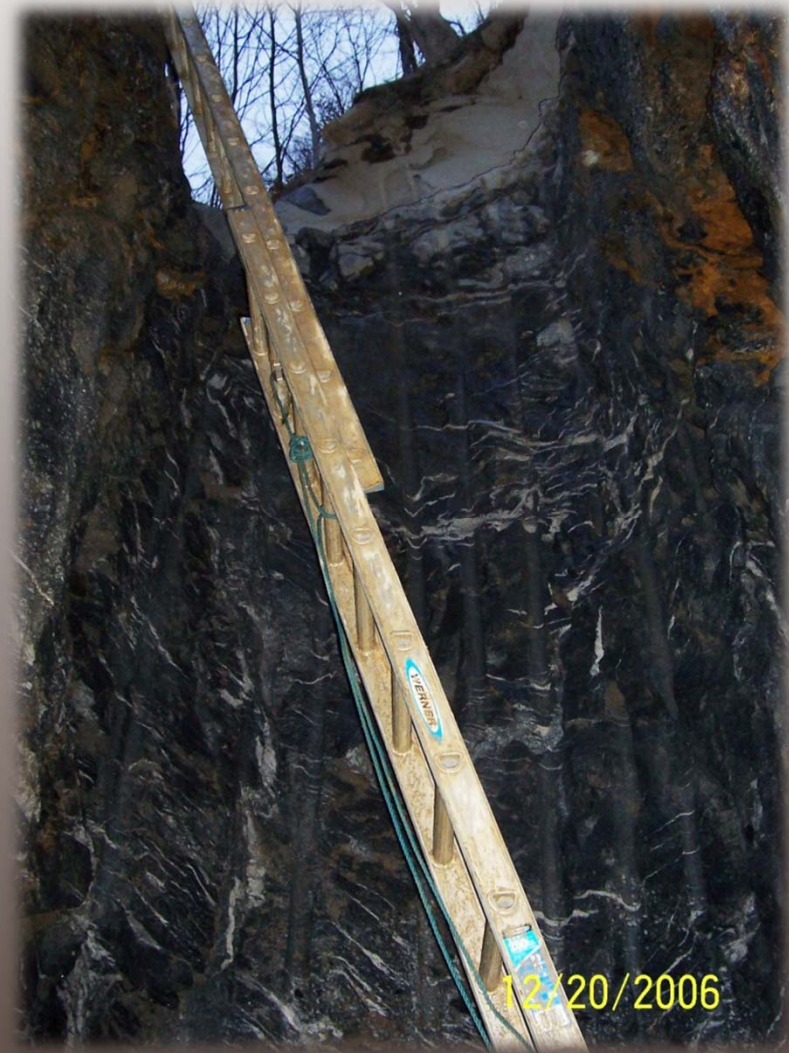
- ❑ RQDs at depths 0 to 5 m Varied From 70% to 100%.
- ❑ RQD & RC below 5 m is 100% at All Substructure Locations.
- ❑ Allowable Bearing Capacities of 1.0 to 1.95 Mpa (10 to 20 tsf) were Recommended By Consultant Based on Competent Rock Conditions.

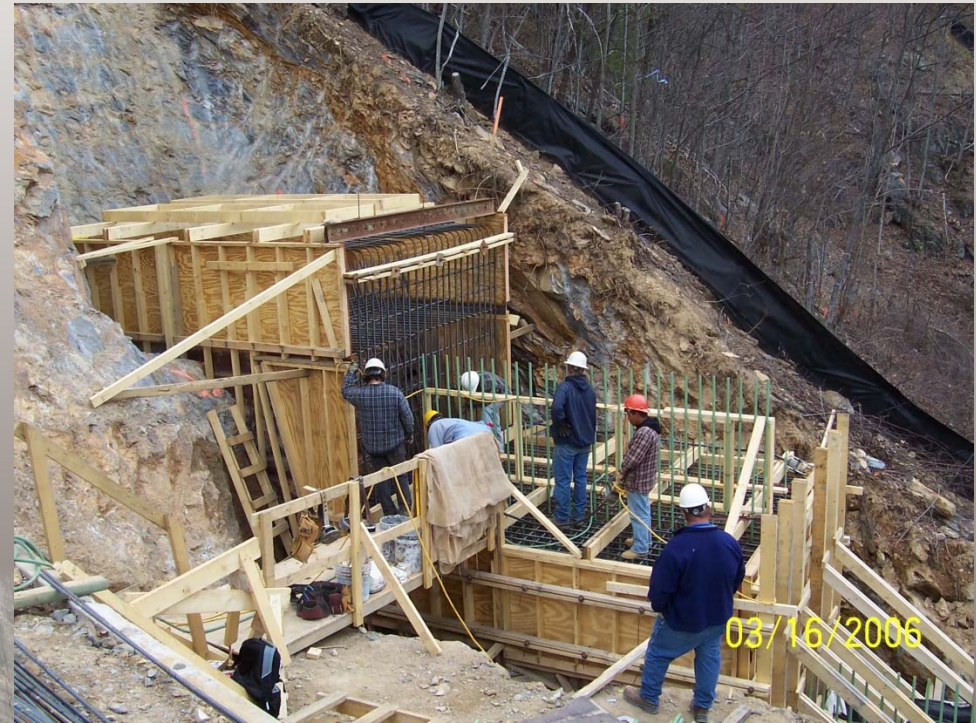
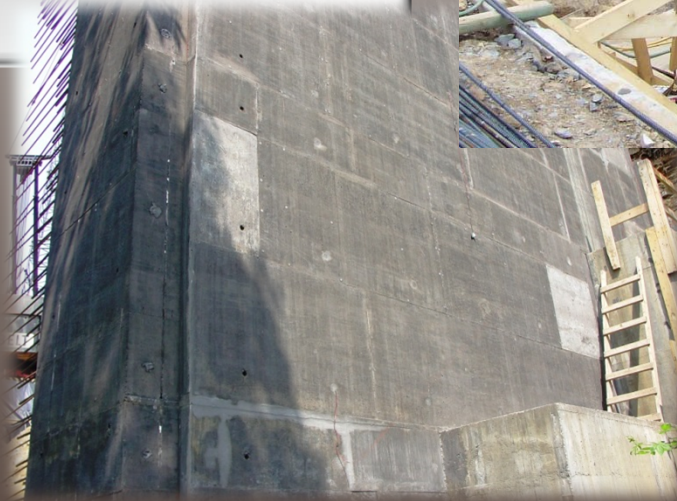
- ❑ **Abutment Footings** were Stepped Up to Avoid Deep Excavations Into Competent Rock (~ 9 m (30-ft))
- ❑ Structural Engineers Used a Vaulted Abutment Design for Added Stability
- ❑ The Vaulted Abutments Consisted of Breast, Back and Side Walls
- ❑ One of The Many Advantages Is Providing Additional Lateral Stability On a Steep Slope

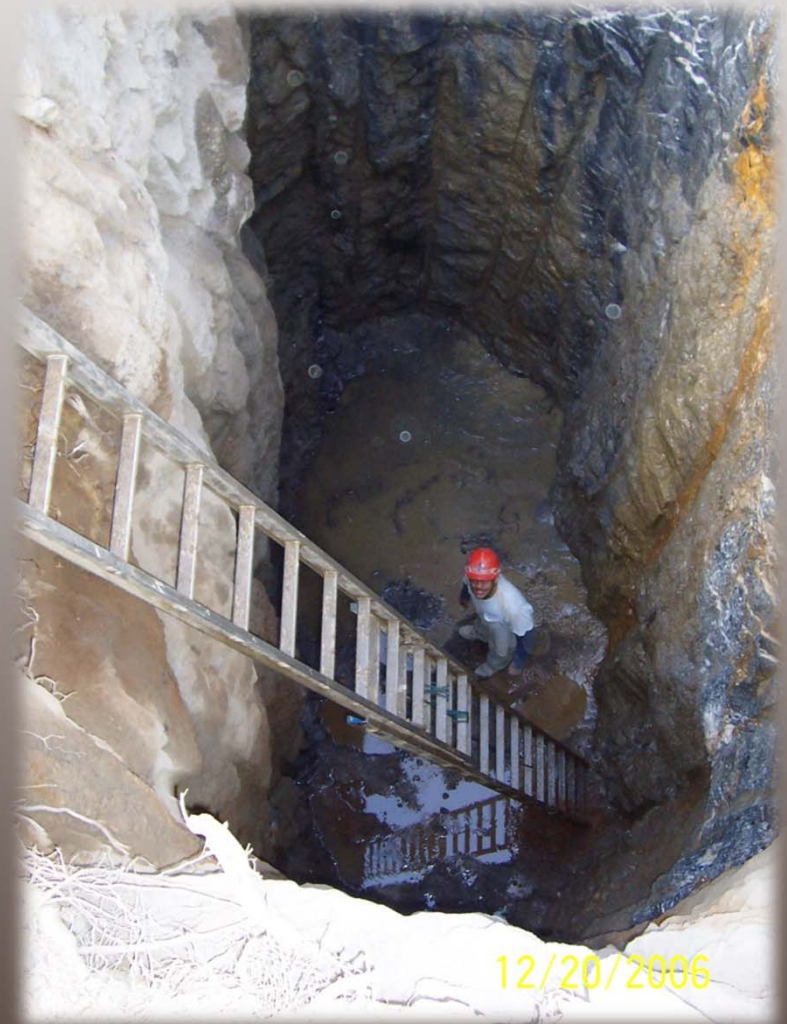
- ❑ *Piers 1 & 2 Foundations*
  - Embedment Depth Into Bedrock Was Modified for Additional Lateral Stability
- ❑ Foundation Embedment Depth Was Extended to 5 Meters (~16.5 ft) Below Ground Low Point Into 100% RC & RQD Competent Rock
- ❑ The New Design is Similar To A Socketed Shaft That Can be Constructed Using Small Equipment
- ❑ Drilled Shafts Were Not Selected Due To Equipment Access Requirements

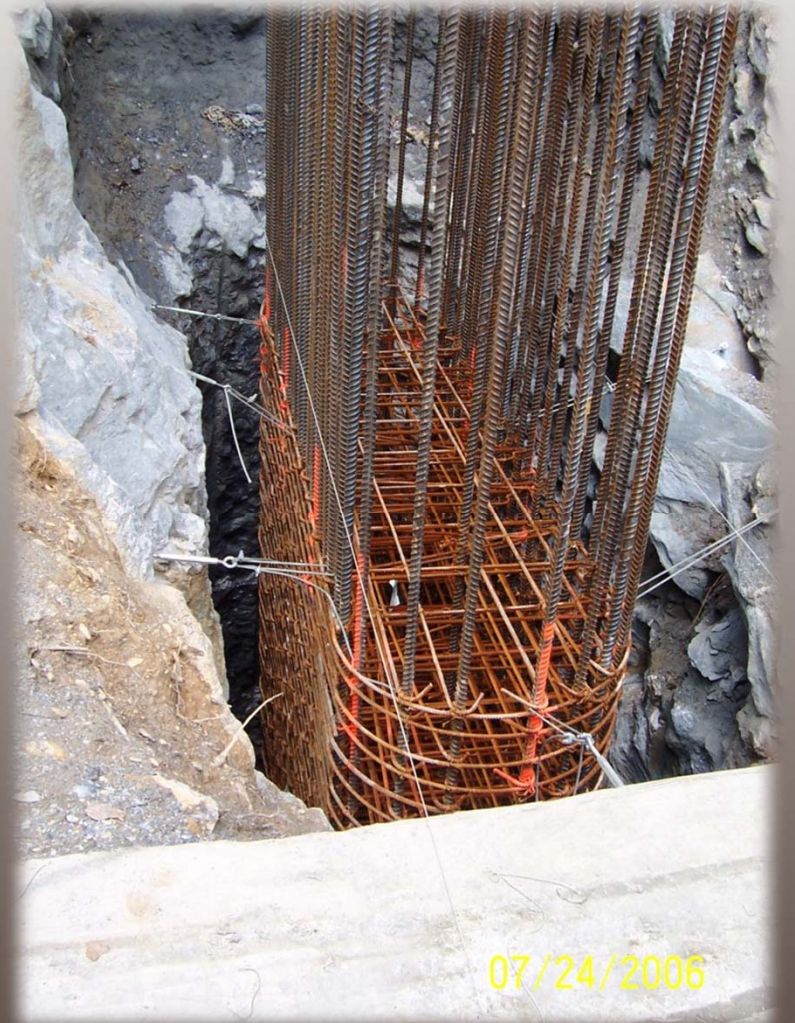
- ❑ Contractor Had Difficulty at The Beginning Excavating Foundations.
- ❑ Contractor Was Successful After Attempting Different Methods
  - ❖ Jack Hammer
  - ❖ Chemical Disintegration Of Bedrock
  - ❖ Drill and Blast
- ❑ Drill And Blast With Jack Hammer Was Successful Method In Excavating Foundation

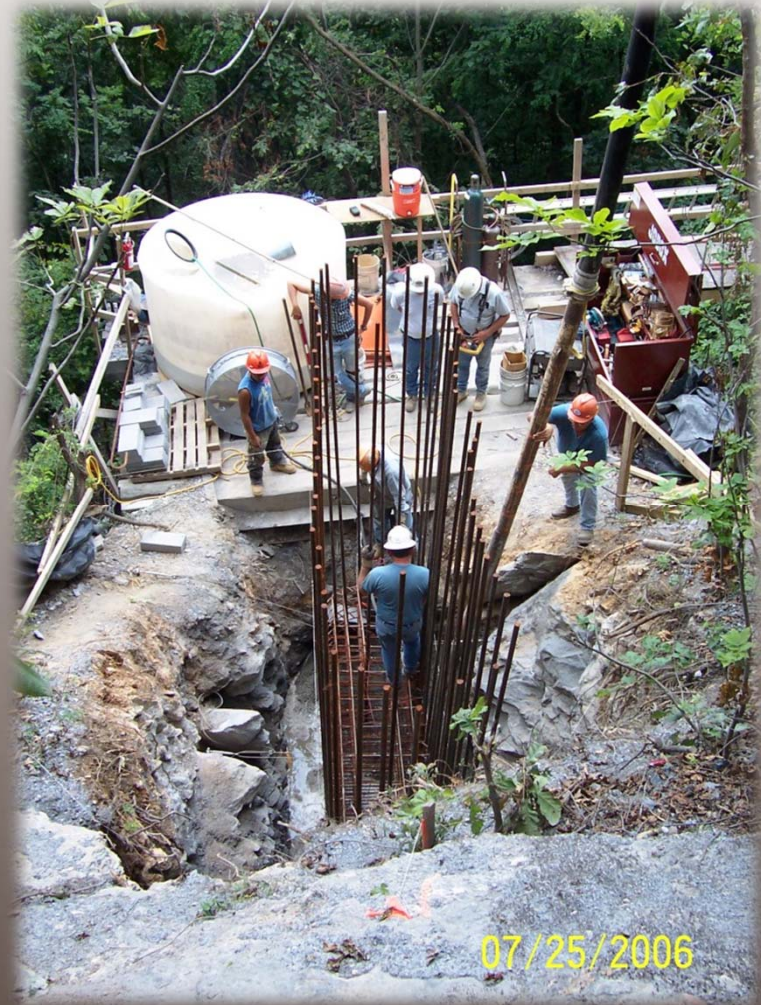
- ❑ Contractor Had Difficulty at The Beginning Excavating Foundations.
- ❑ Contractor Was Successful After Attempting Different Methods
  - ❖ Jack Hammer
  - ❖ Chemical Disintegration Of Bedrock
  - ❖ Drill and Blast
- ❑ Drill And Blast With Jack Hammer Was Successful Method In Excavating Foundation

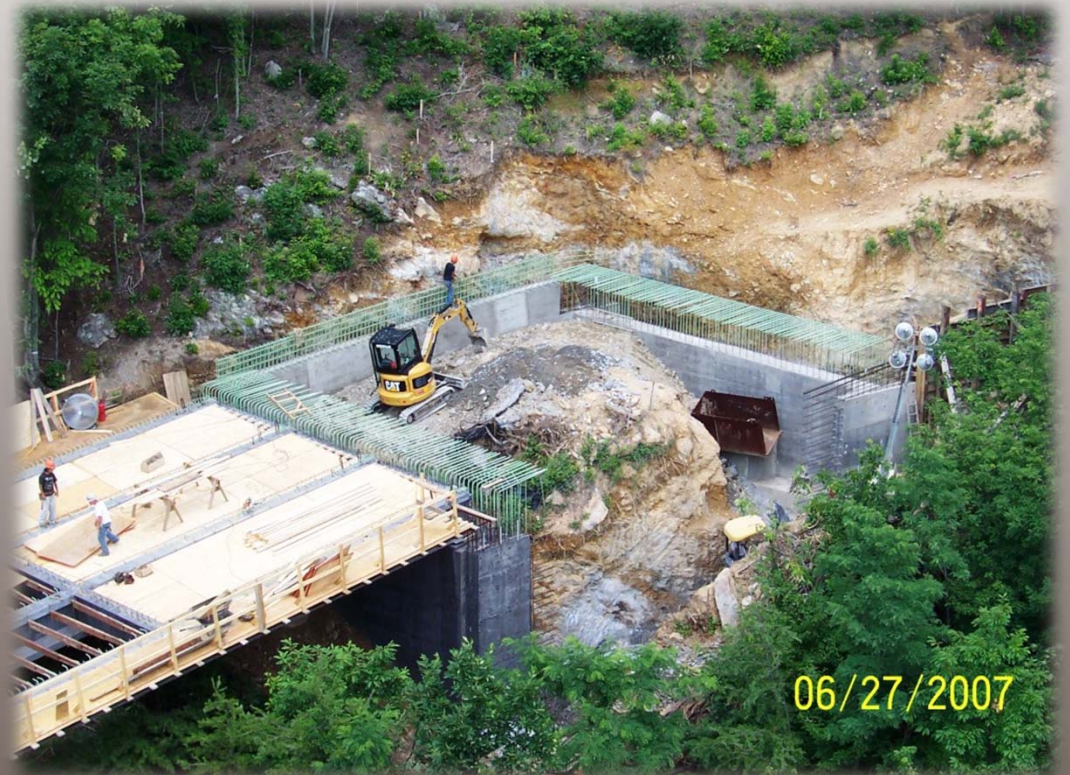
- ❑ Bridge Construction Progressed Successfully After Resolving Initial Problems
- ❑ Coordination and Communication Between Design and Construction Assisted in Quickly Resolving Problems
- ❑ Construction Was Completed Successfully Using A Top-Down Process With Minimum Impact on Environment

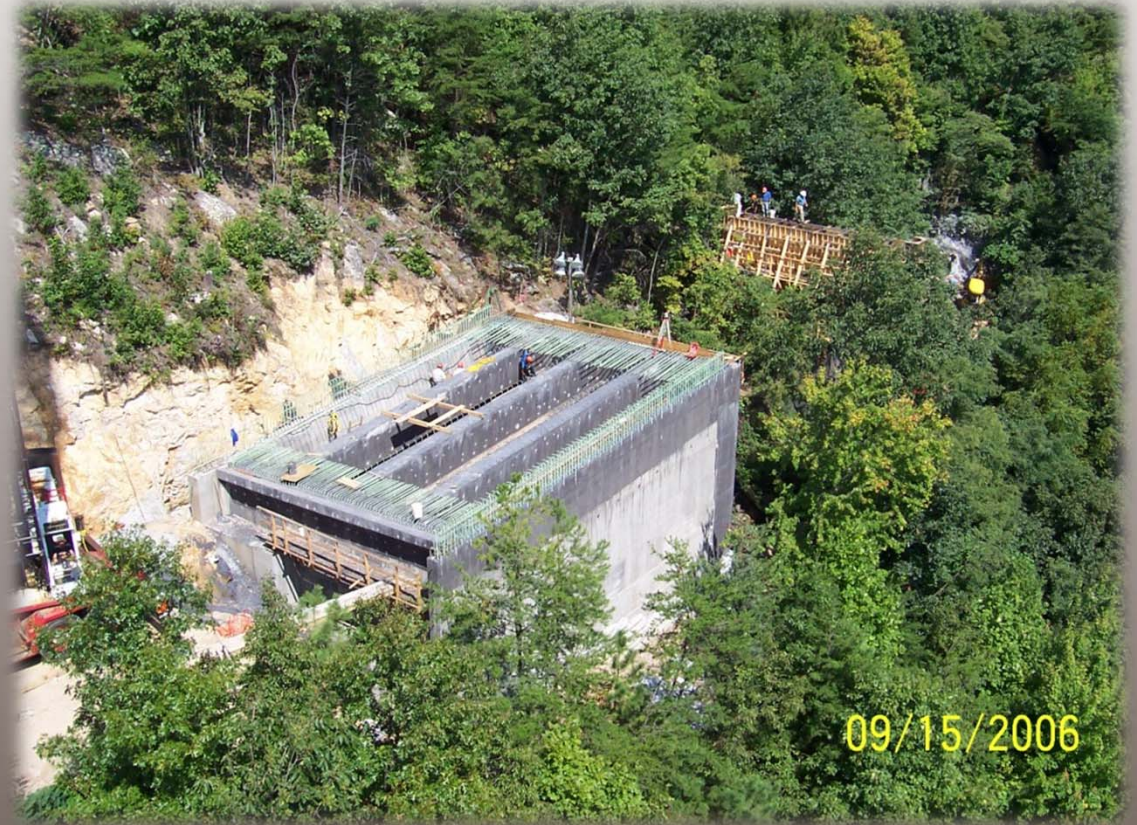
# BRIDGE 8 CONSTRUCTION

- ❑ Bridge 8 Was Completed Successfully After Resolving Initial Problems
- ❑ Coordination and Communication Between Design and Construction Assisted in Quickly Resolving Problems
- ❑ Construction Was Completed Successfully Using A Top-Down Process With Minimum Impact on Environment

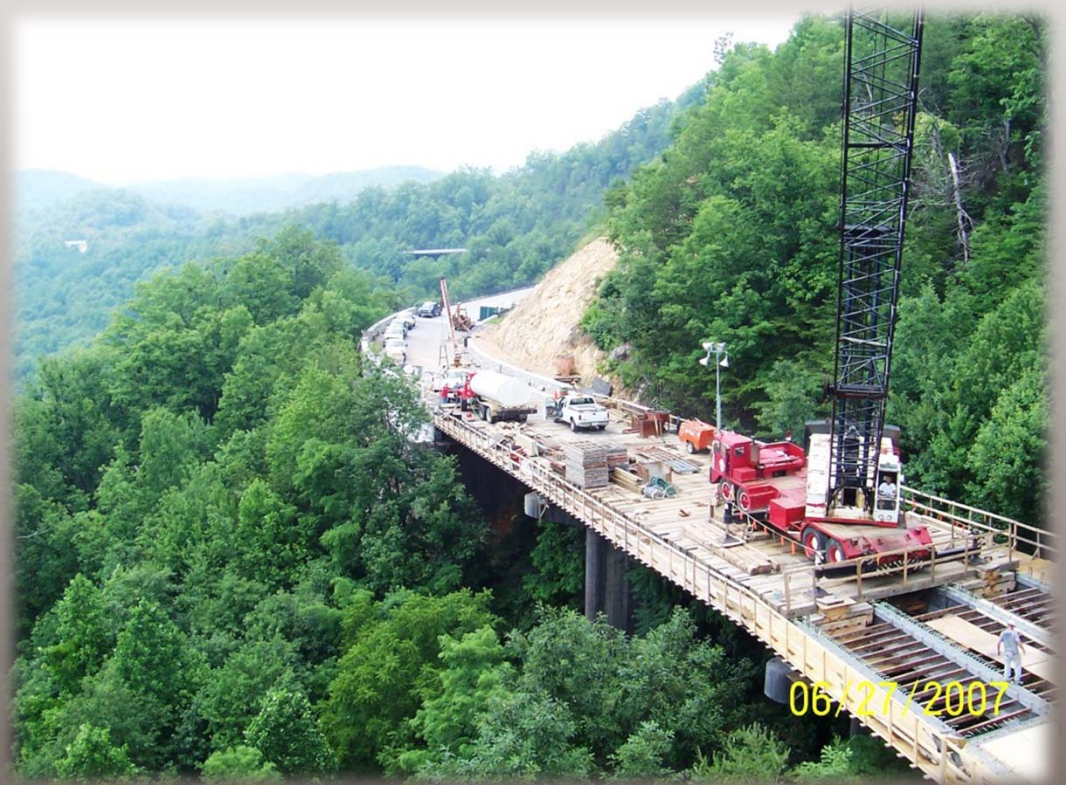
# BRIDGE 8 CONSTRUCTION

- ❑ Bridge 8 Was Completed Successfully After Resolving Initial Problems
- ❑ Coordination and Communication Between Design and Construction Assisted in Quickly Resolving Problems
- ❑ Construction Was Completed Successfully Using A Top-Down Process With Minimum Impact on Environment
