Monitoring the Threat of Sinkhole Formation US 18, Cerro Gordo Co., Iowa Using TDR

*Kevin M. O'Connor, Ph.D., P.E., GeoTDR
Matthew Trainum, Iowa DOT, Office of Design*

**16th Annual Technical Forum for
Geohazards Impacting Transportation in Appalachia
Knoxville, TN
August 2016**

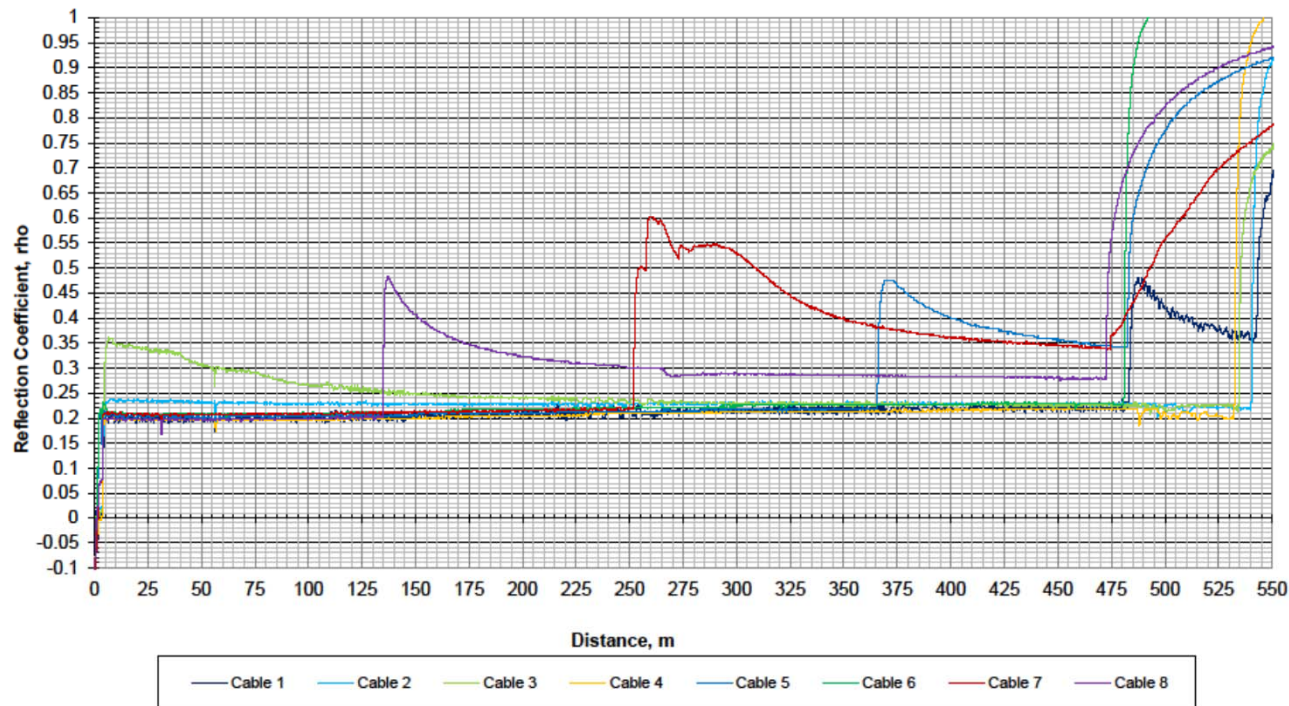
All Cables 1-13-13, 12 pm

Consistent and persistent response on all eight cables

Abrasion not Shear Deformation of Cables

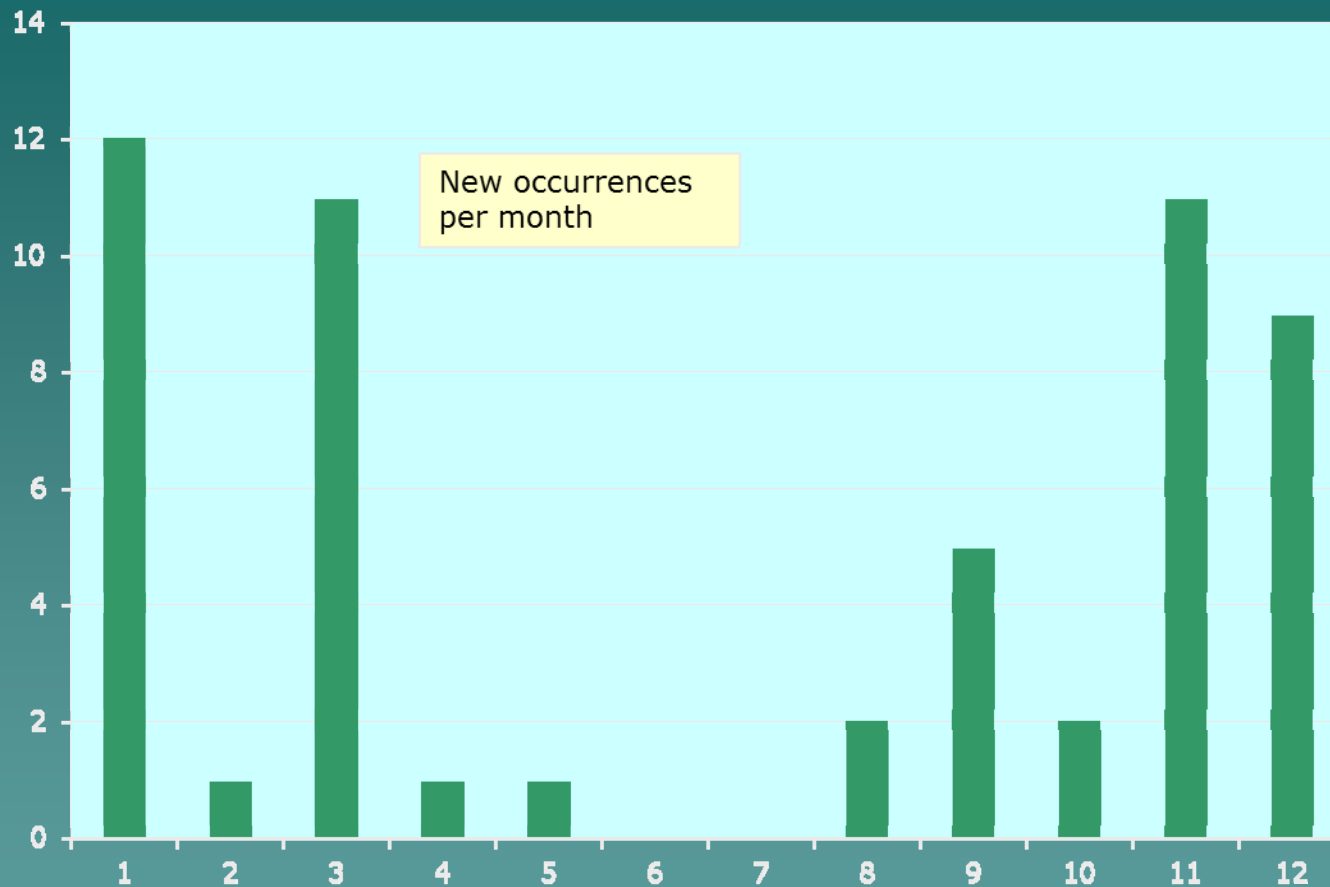
TIMING – new activity develops between September and March
