Rock Slope Stability of the Smart Road Rock Cut in Blacksburg, Virginia

Robin E. Reed, PG August 16, 2017

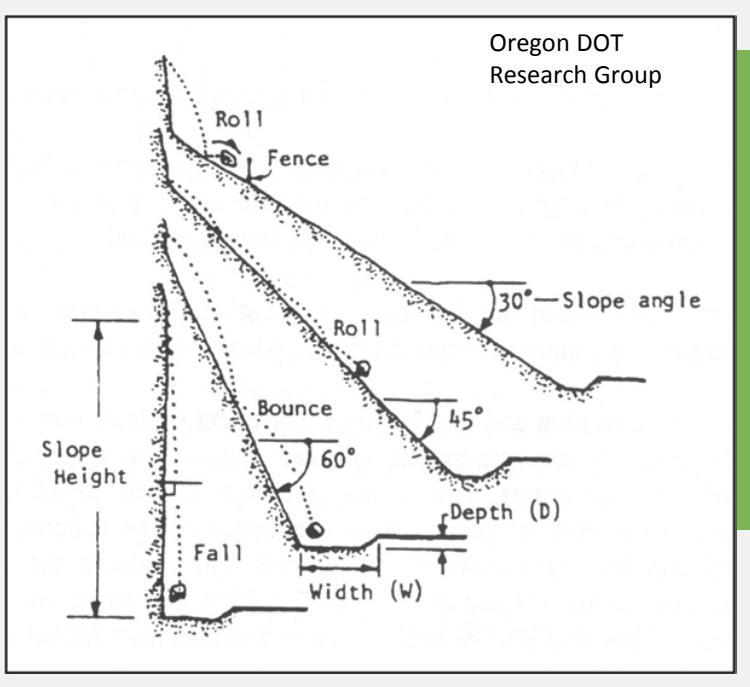
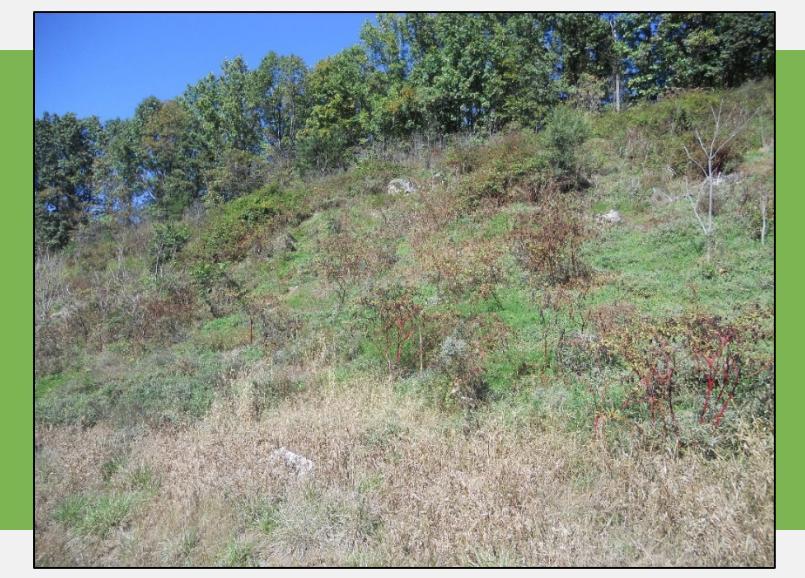
- 1995 1997
 - Limited outcrop exposure
 - Rockslides vs. rock falls
 - Vertical slopes not best in folded and faulted rock

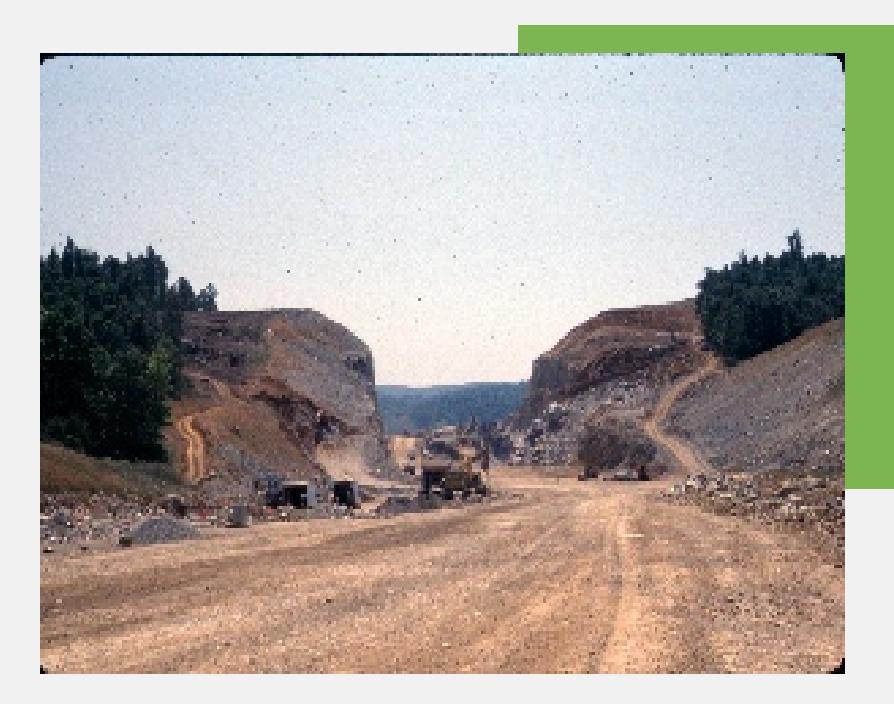
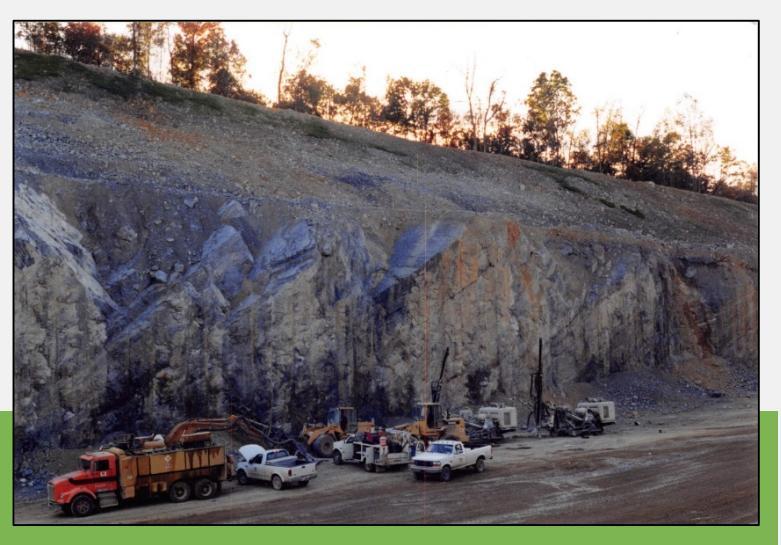
- July 1998
 - Detailed Mapping
 - Concurrent with construction
 - Windows
 - Other significant areas ID, Group and Prioritize

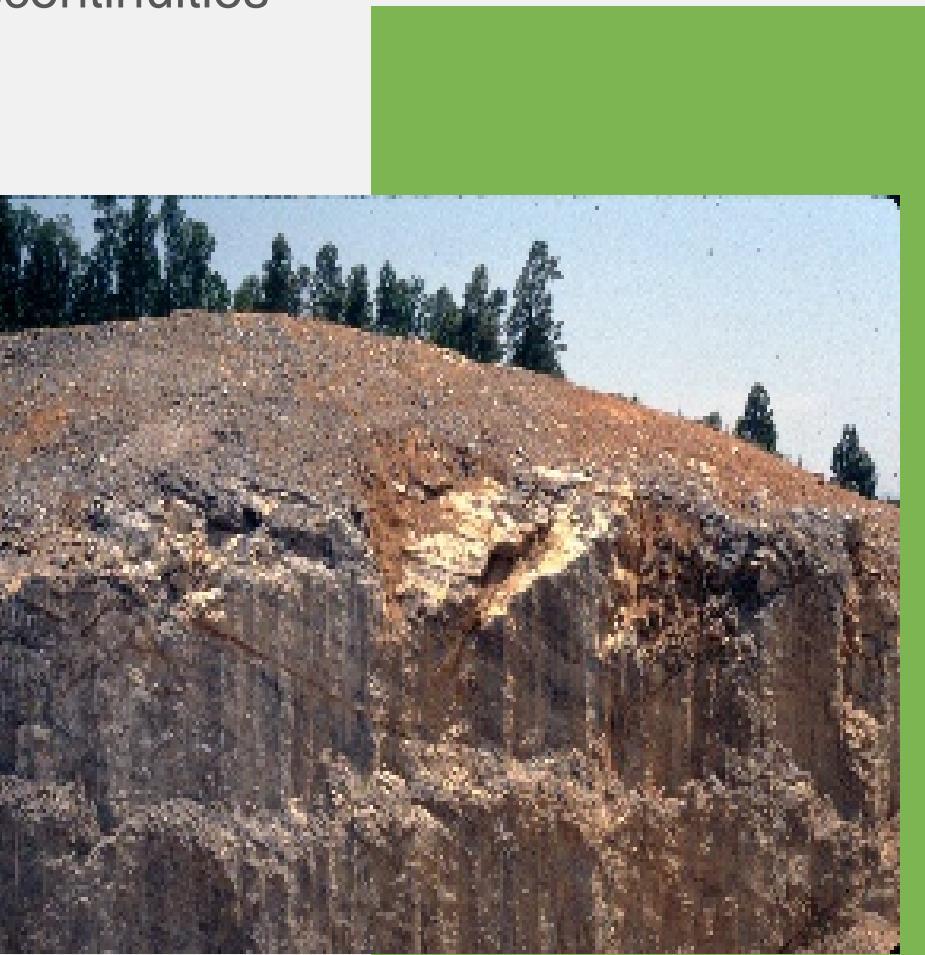
- Rock Structure/Discontinuities
 - Orientation
- Bedding
- Joints/Faults
- Characteristics
 - Lithology
 - Continuity
 - Infilling
 - Water
 - Roughness
 - Samples
 - Shear testing
 - 34° vs 19°

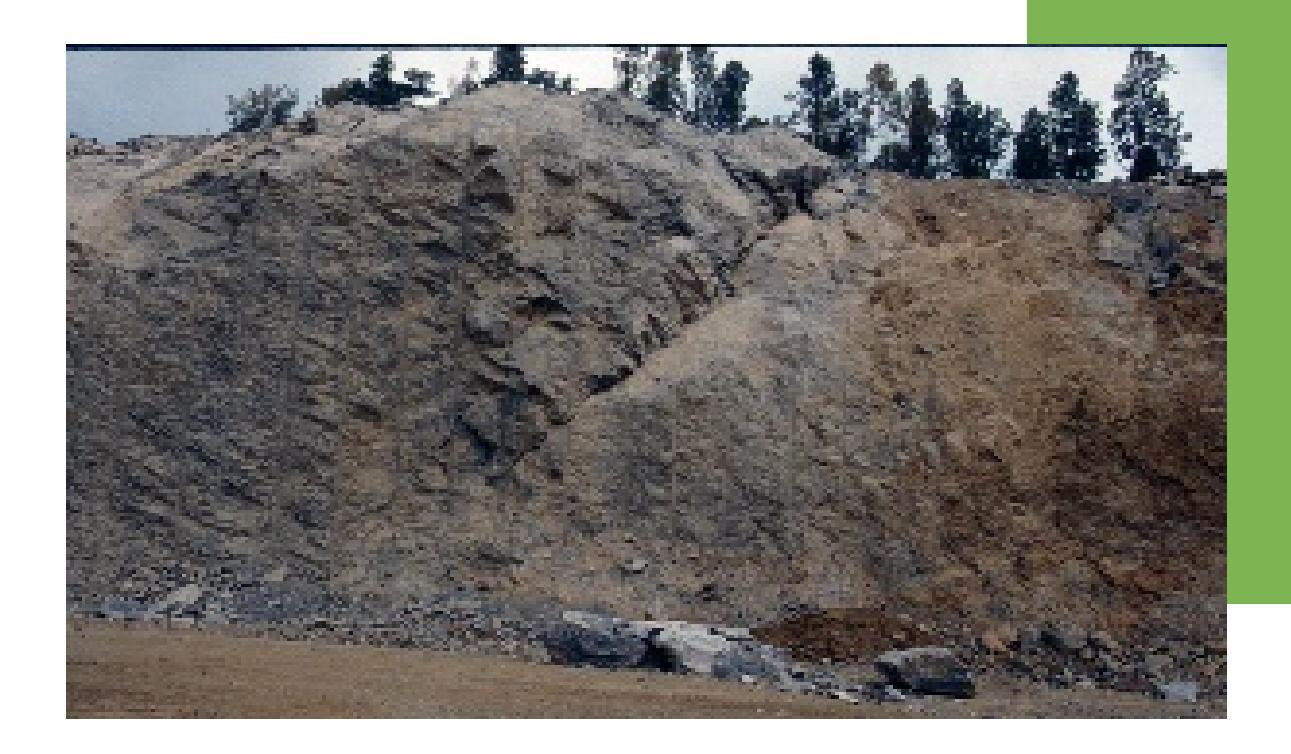
- Vertical slopes will not be safe
 - Subject to large scale falls and slides
- Reduce slope angle to 60 degrees
- Implement monitoring/protective measures

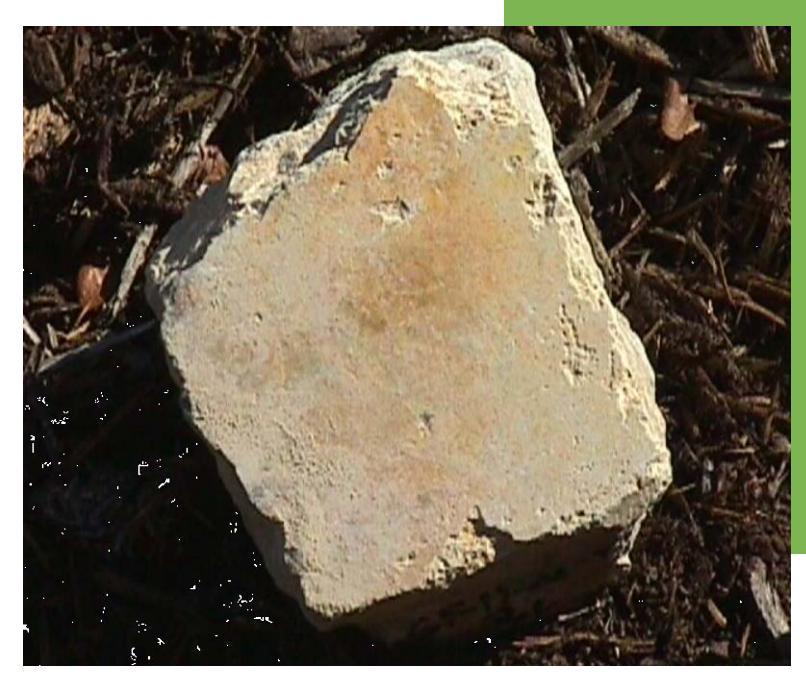
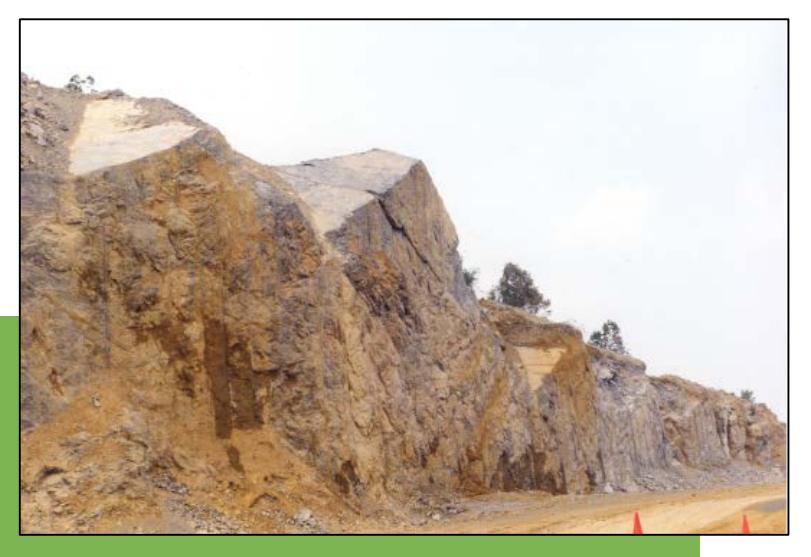
- Design Change Proposed
 - 1.5 H : 1.0 V (34 degrees)
- New Shear Strength Testing
 - Powder-coated bedding planes, zeolite
 - Friction angle of 28 degrees, c=0
- October 1998
 - Delayed for redesign and construction
