"Drilled Shafts for Bridge Foundation Stability Improvement Ohio 833 Bridge over the Ohio River" An Update

Meigs County, Ohio Mason County, West Virginia

By Stan Harris, P.E. and Eric Kistner, P.E. FMSM Engineers

Geohazards in Transportation Appalachian Region Technical Forum August 1-2, 2007

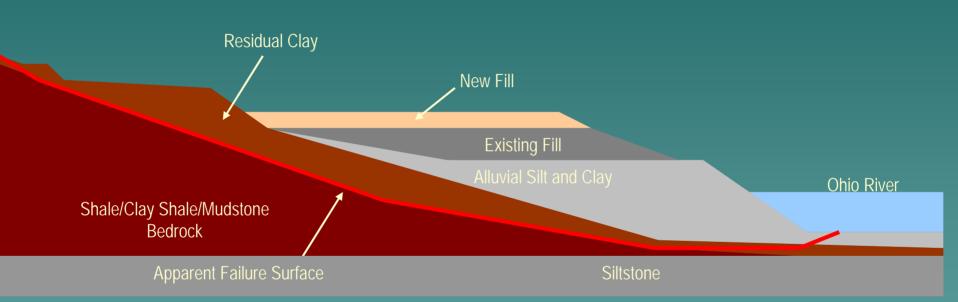
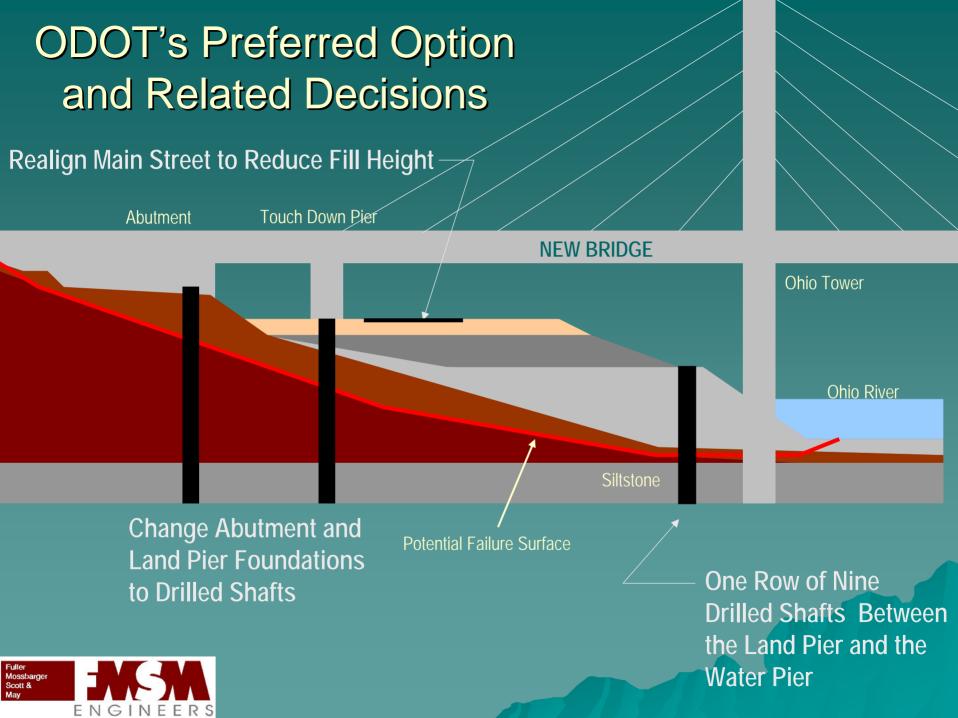
Slope Geology/Geometry

Probable Causes of Slope Movement

Weak slickensided clay shale (mudstone)
 Possible ancient movement
 Construction activity/embankment
 Rapid drawdown cycles of Ohio River

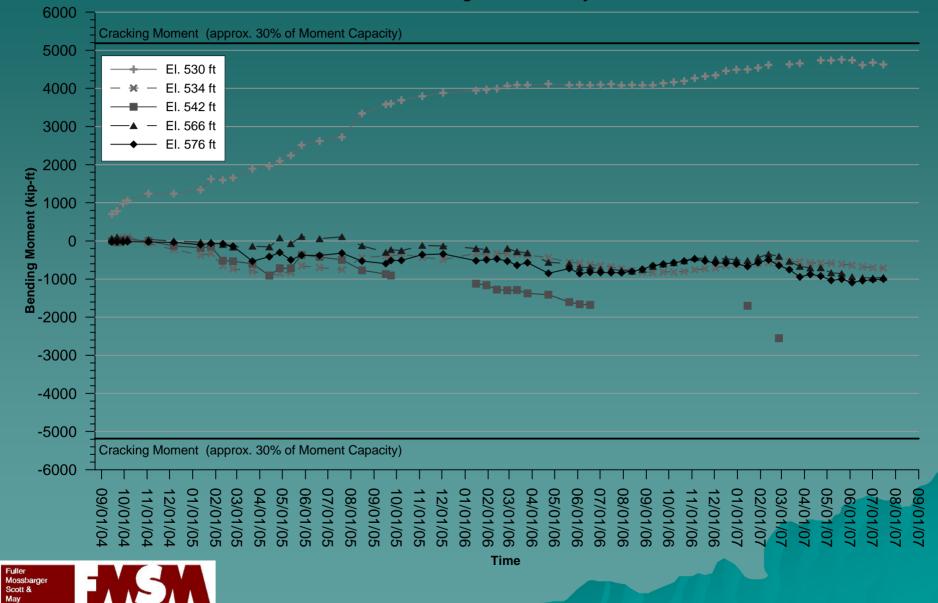
DS-54: Bending Moment History

Touch Down Pier Strain Gage Results

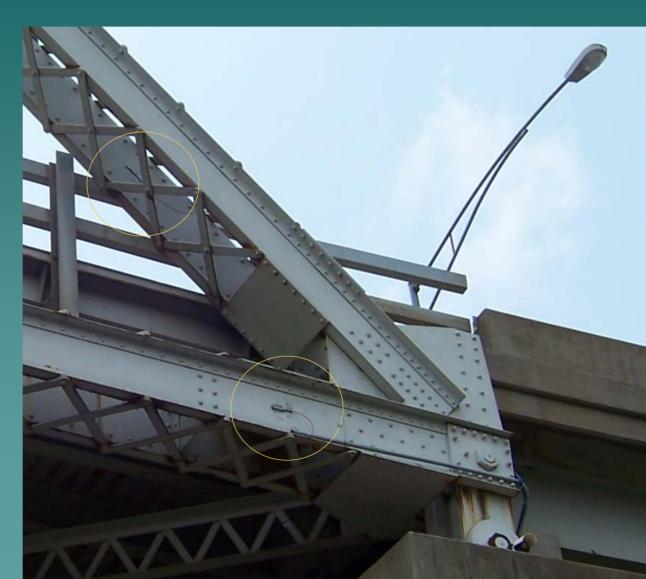
III. New Instrumentation on Existing Bridge

-Jointmeters (3 Joints on Ohio Side) -Tiltmeters on Linkage Assemblies -Strain Gages on Truss **Members**
