“Getting Out of the Pits”

Investigating Ohio’s Coal Mine Hazards

Ohio Department of Natural Resources

Case Study #1
Tunnel Hill Road

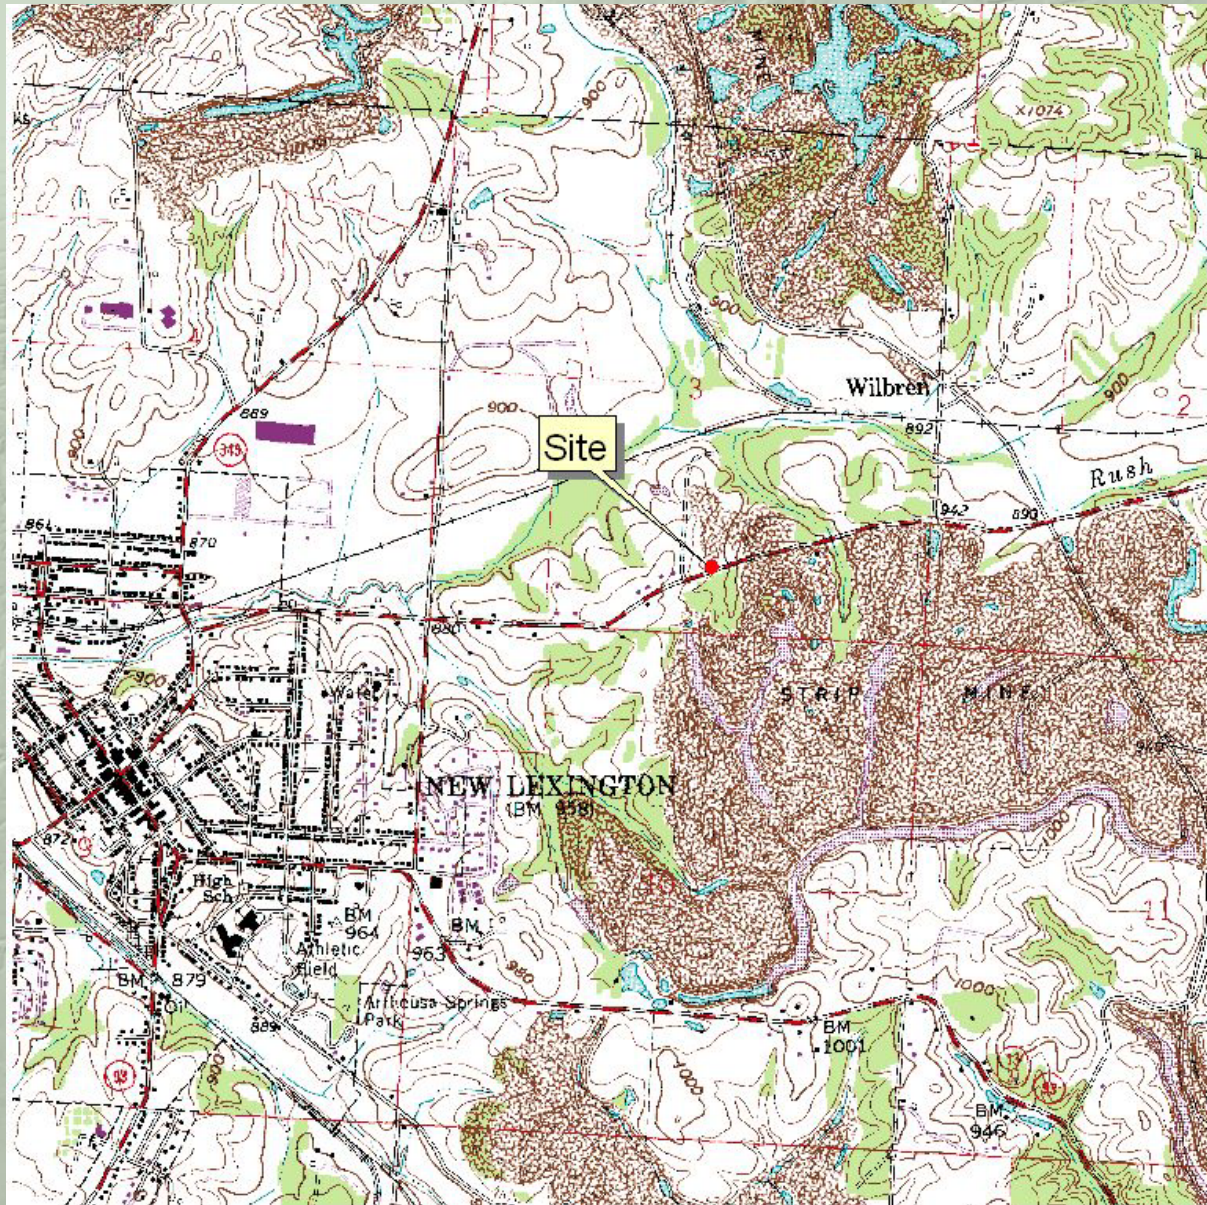
- Tunnel Hill Road
- Connects New Lexington & Crooksville
- Road patched at 3:00 p.m.
- Road collapsed at 5:00 p.m.

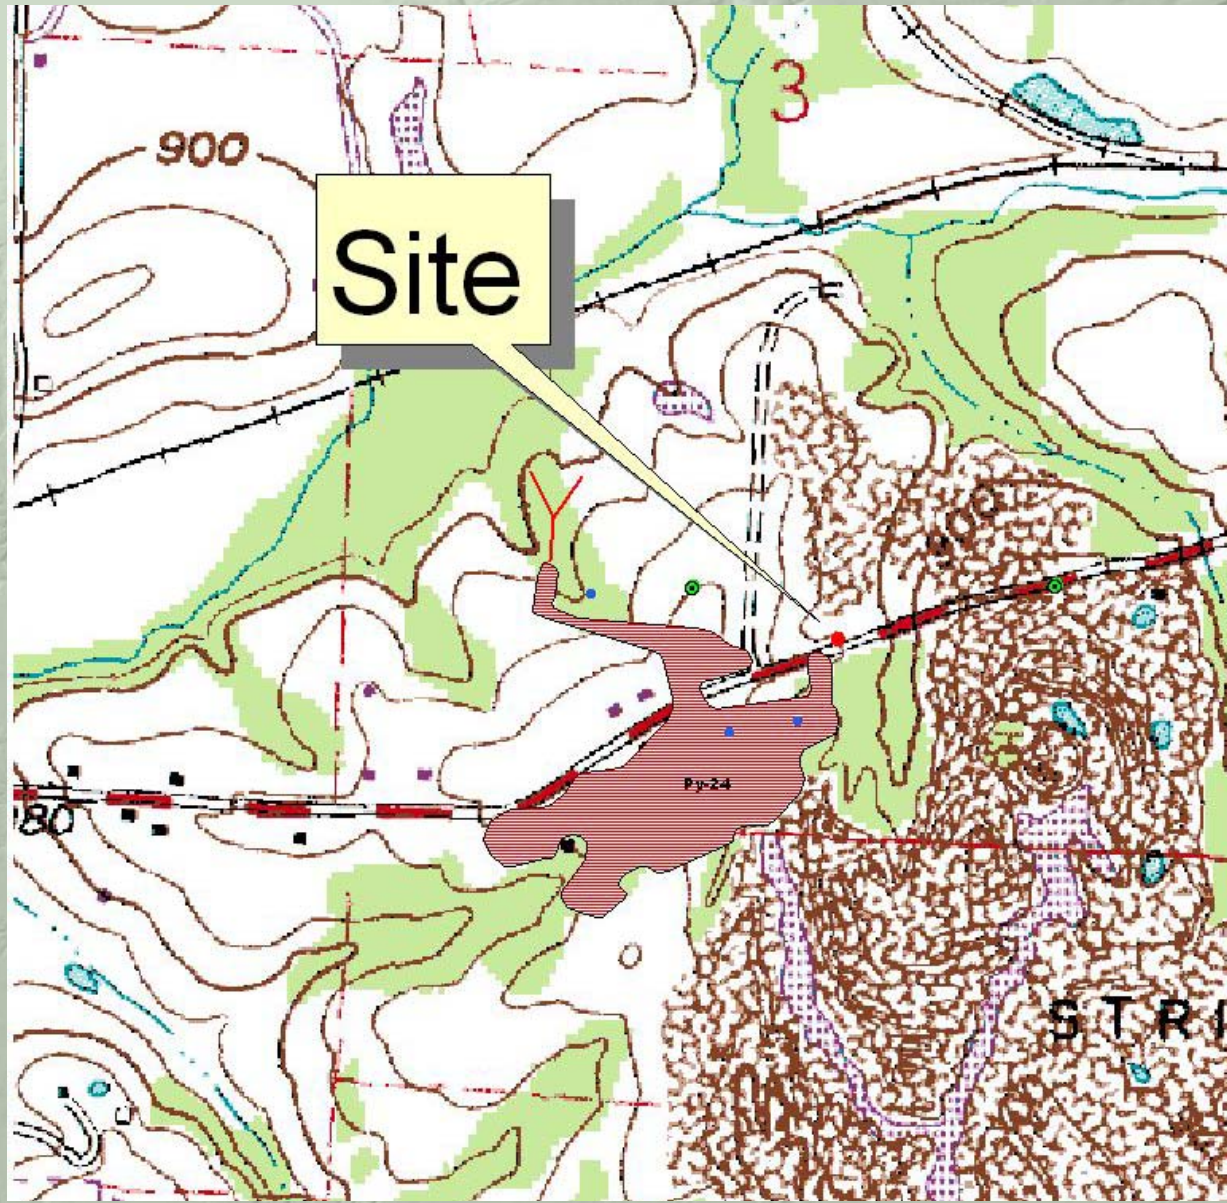
- Tunnel Hill Road
- Connects New Lexington & Crooksville
- Road patched at 3:00
- Road collapsed at 5:00
- Road temporarily closed
- Office research - mines in the vicinity
 - And two past projects
- **Exploratory drilling needed**

- Stabilizing about a length of 60 feet
- 10 borings drilling to a depth of 31 feet
- Placed in the field (~ 15 feet alternating)
- Casing to keep holes from collapsing
- Inject grout 200 CYD (500 psi 10 inch slump)
- Engineers estimate \$26, 220.00

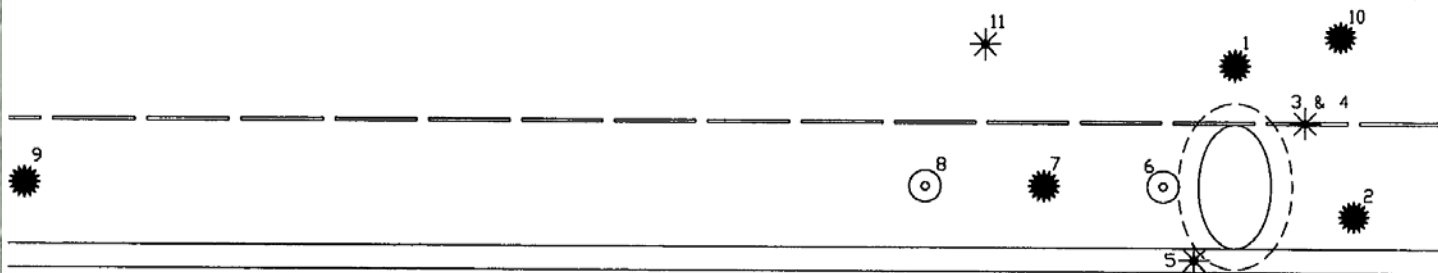
Pr-Pk-33-E
Tunnel Mill Rd
Subsidence

- ☼ - Coal
- * - Collapsed Void
- ⊙ - Open Void

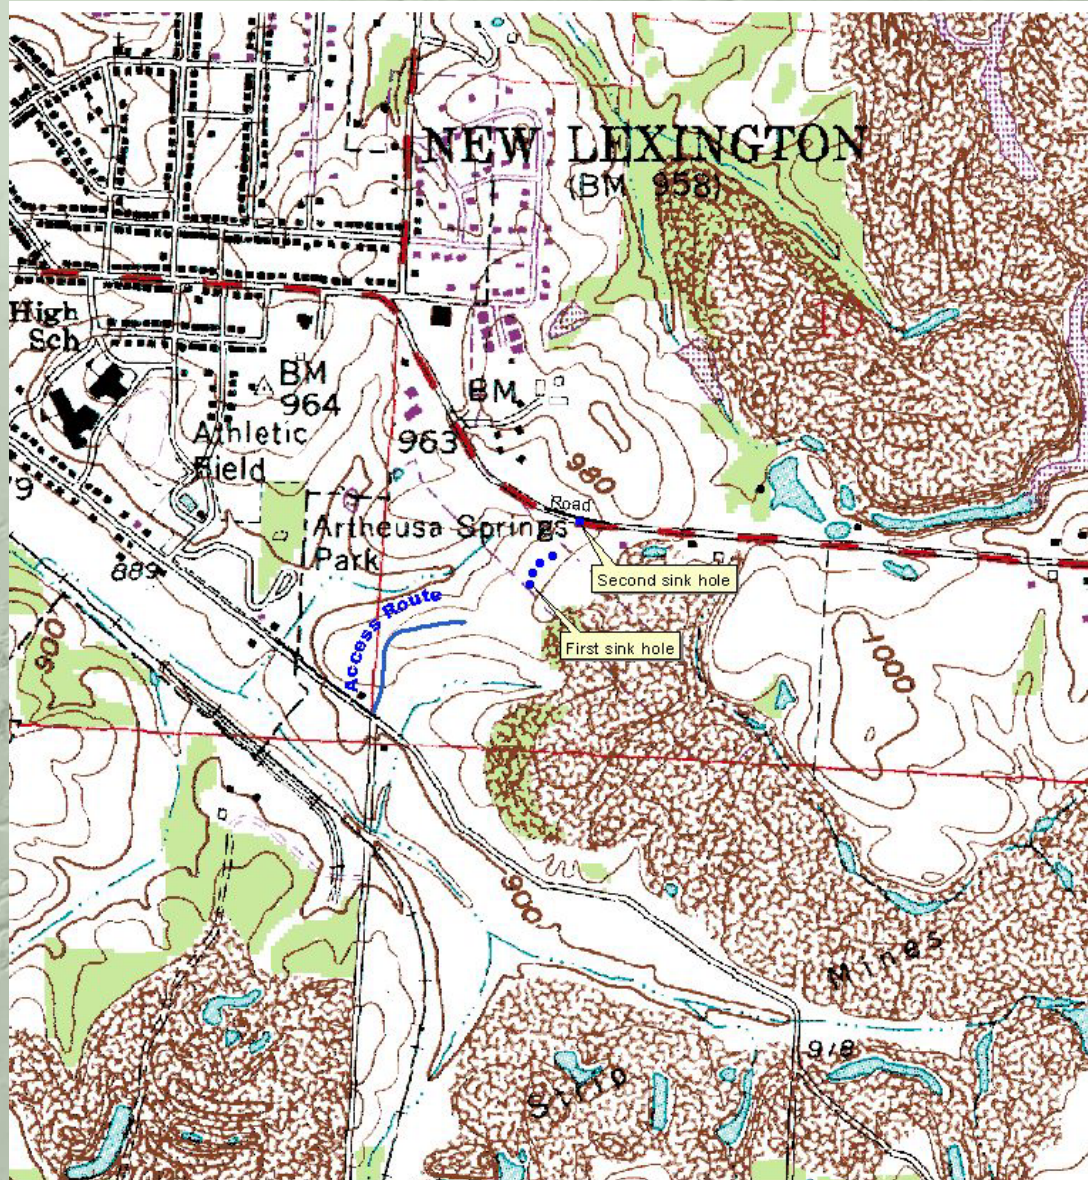
- Subsidence in a field -big deal !?!?
- Another , another , another -
- Hey - What's this by the road?

- **Office Research**
 - No MAPPED mines in vicinity
 - Lots of projects

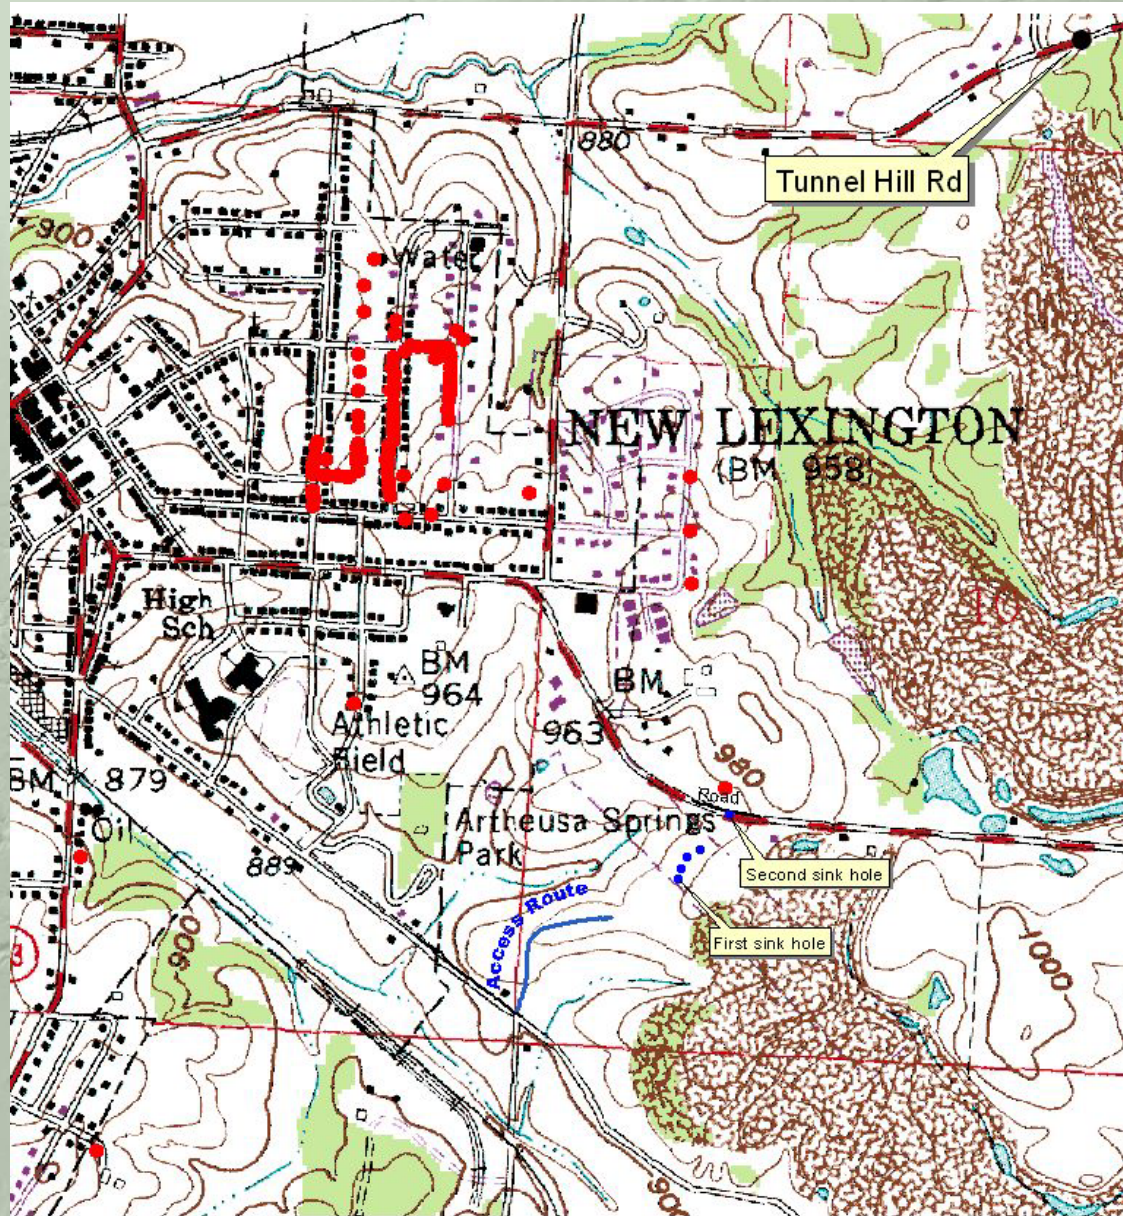
- Subsidence in a field -big deal !?!?
- Another , another, another -
- Hey - What's this by the road
- Office Research

No drilling needed

Yea - We can reach it with a track hoe

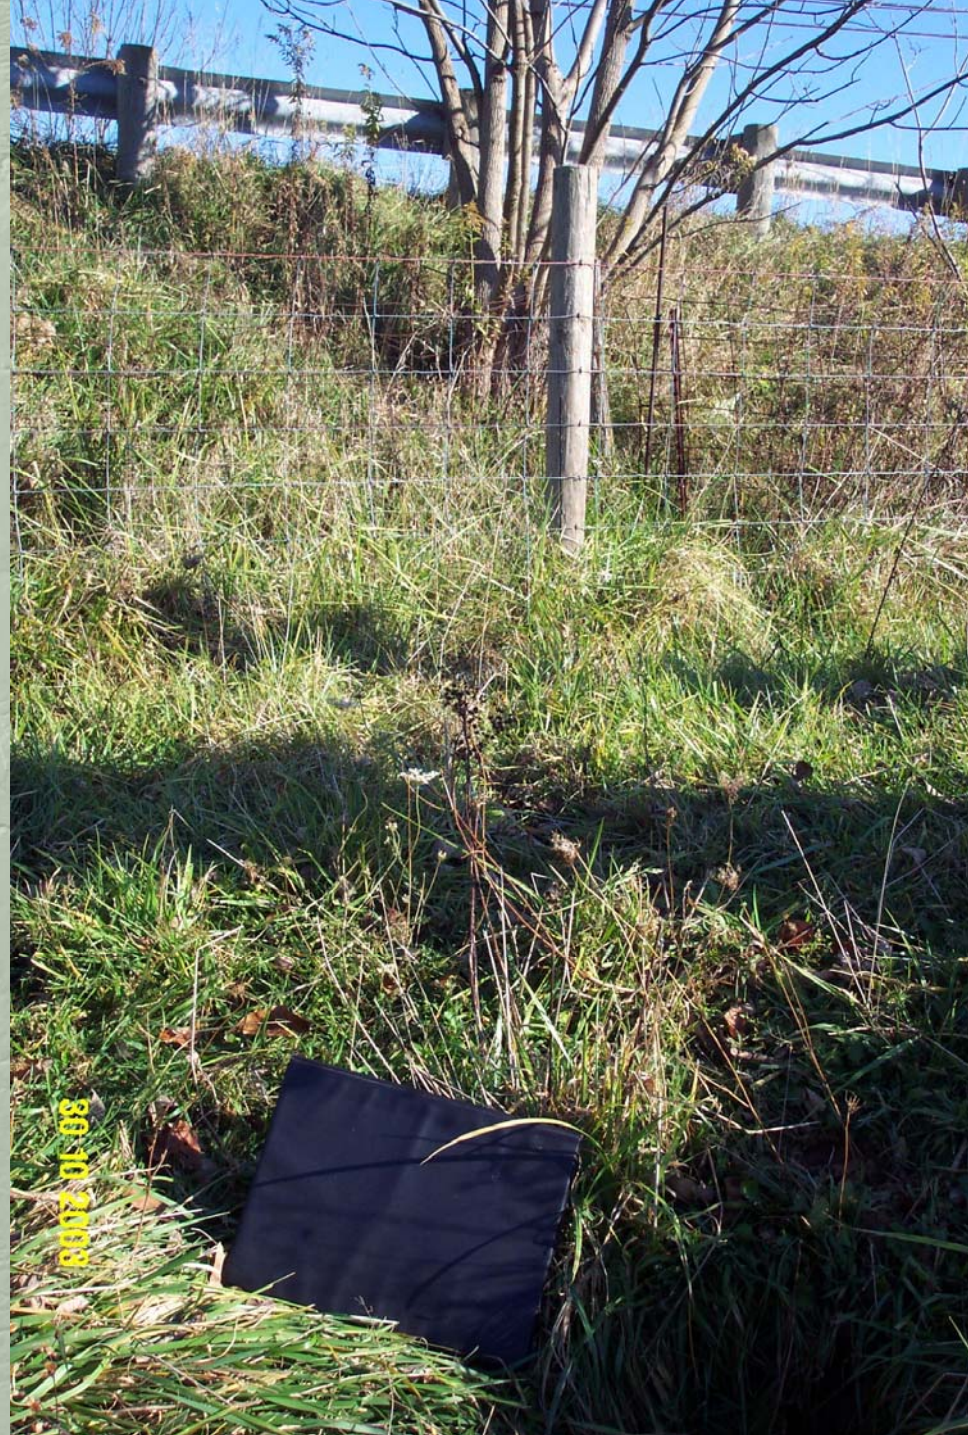
- Not on road but in close proximity
- Small diameter - It doesn't look like much
- Must know the area & history
