Engineering Geophysical Application to Mine Subsidence Risk Assessment

GEOHAZARDS IMPACTING TRANSPORTATION IN THE APPALACHIAN REGION

August 2-4, 2011, Chattanooga, TN

Conduct multi-phase investigation to determine mine subsidence risk along pipeline/utility corridors **leading to nearby power plant**

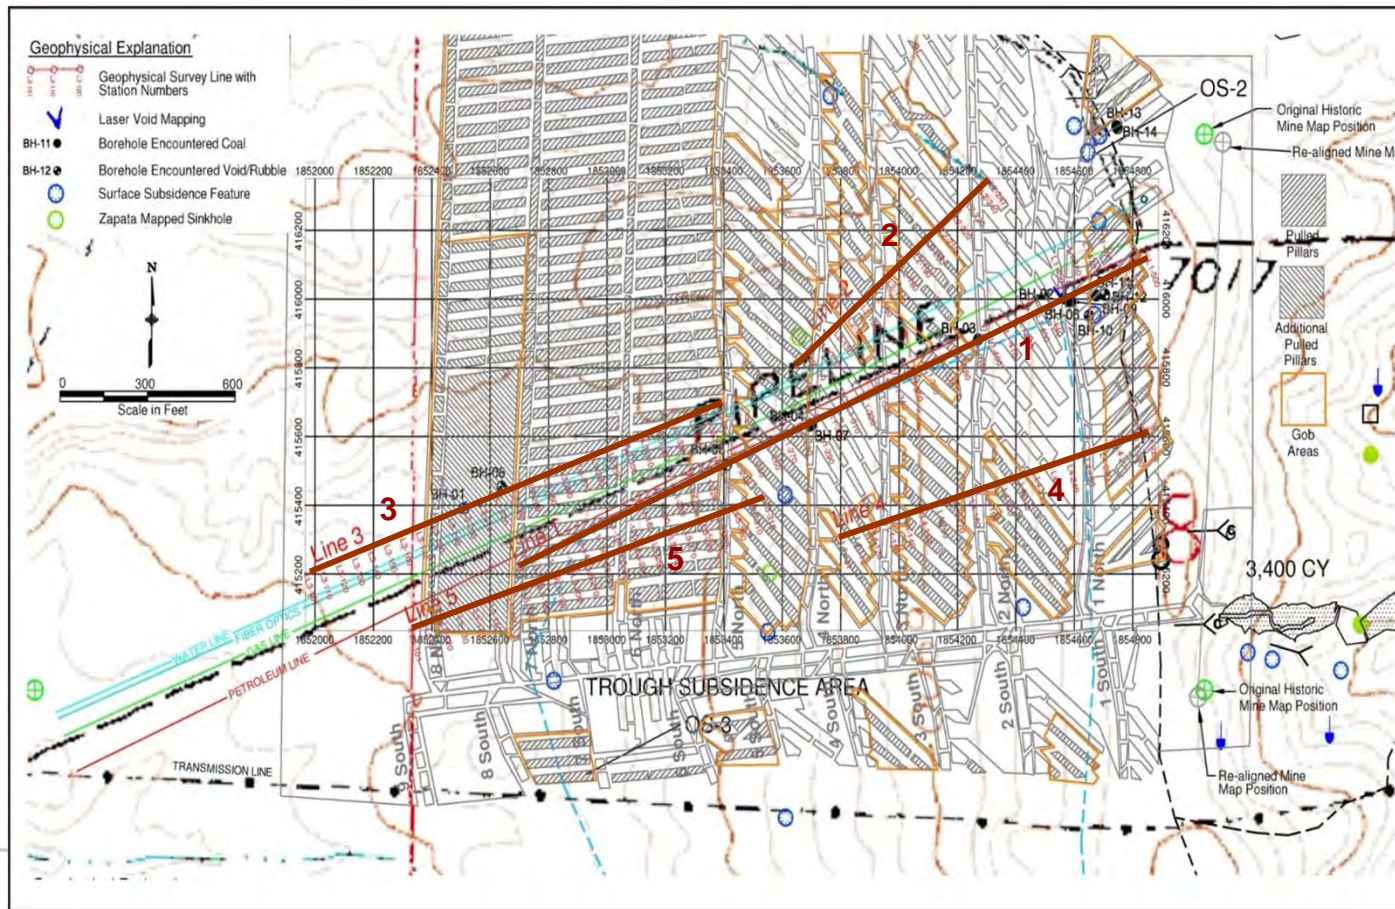
Portion of MASW Profiles for Lines 1 & 3

Line 1

Low velocity anomaly between ST's 445 – 470 (150')
 BH-01 & BH-11 show disturbed / rubblized mine roof, reducing rock shear strength & decreasing its Vs (**weak rock**).

Line 2

Anomalies characterized by **velocity reversal**
 Results of thin but hard sandstone layers above the mine workings.

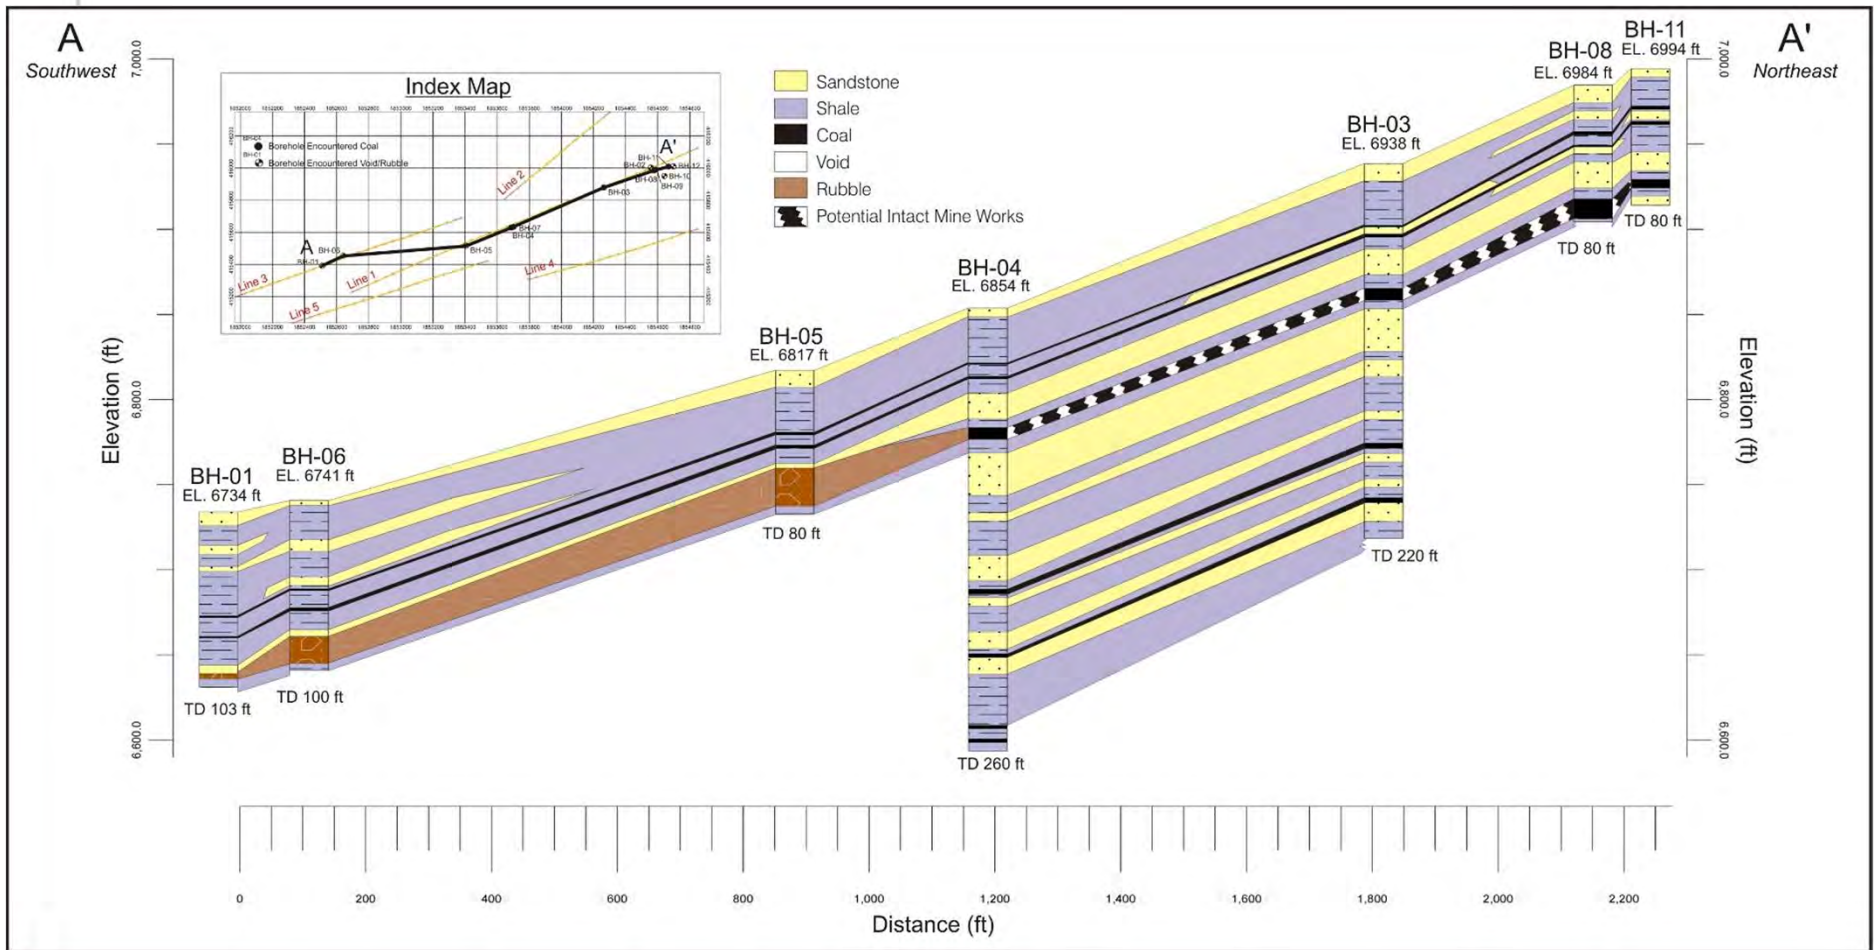
Geologic Cross Sections

No. 7 seam strike ~ N 23° W, dipping 7° to the west

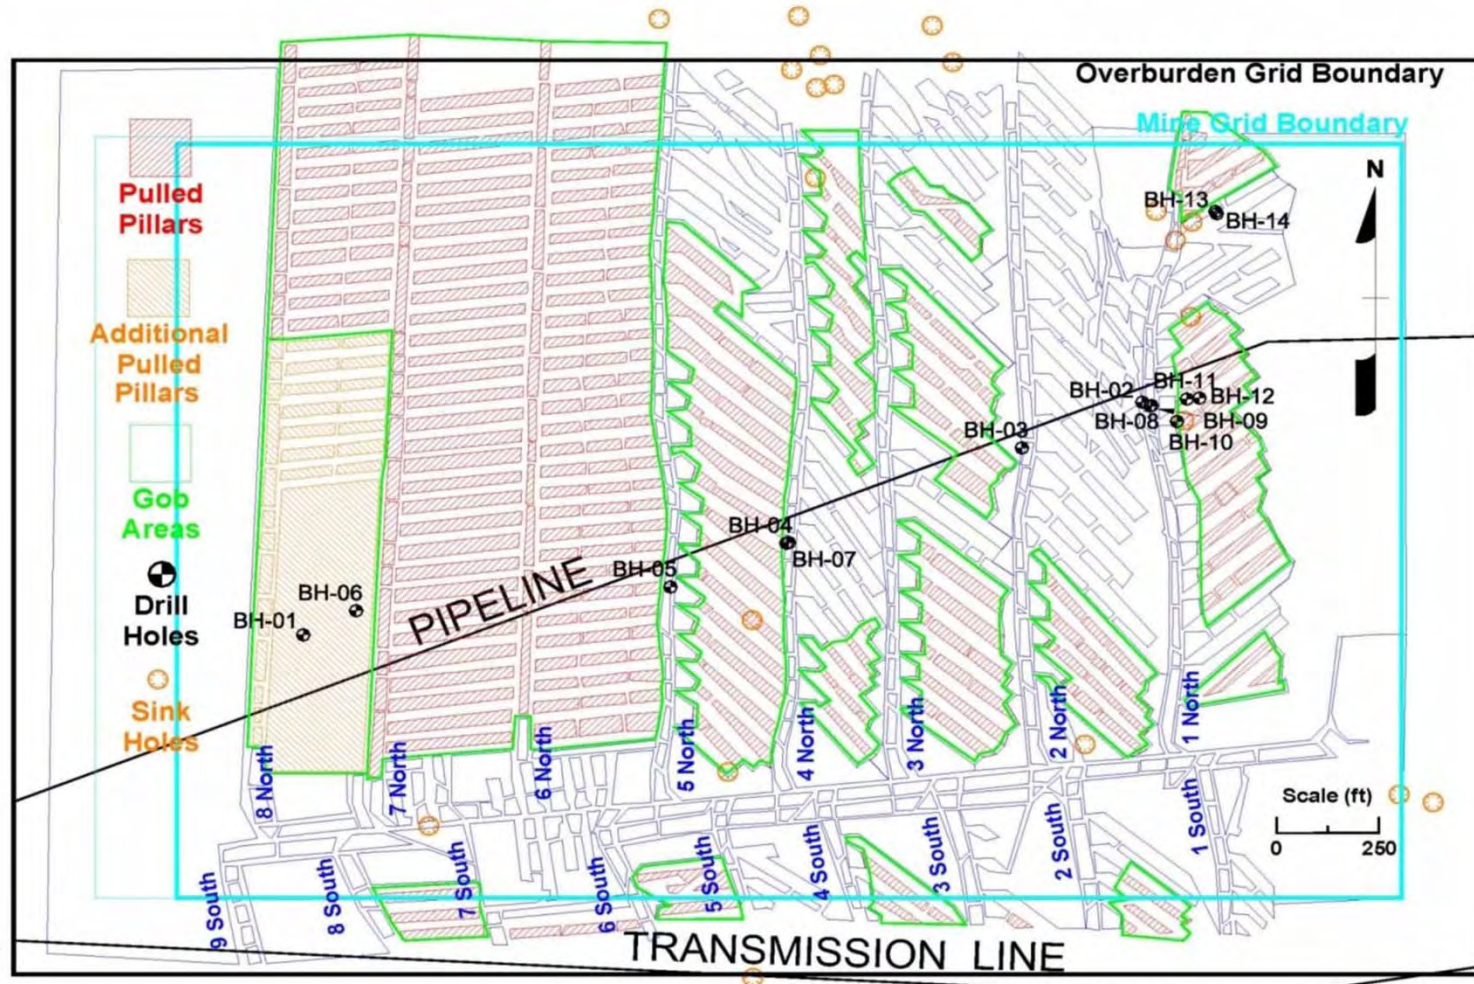
Digitized Mine Map and Topography

Coal seam grid: 3-ft square elements in a 1,000 by 660 element (3,000 by 1,980 ft)

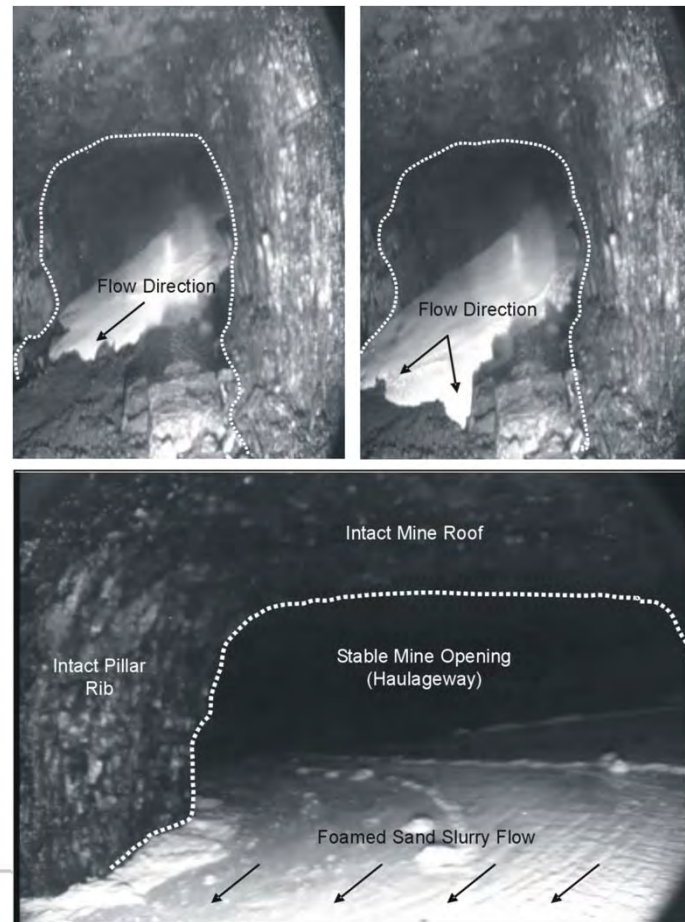
Abandoned Coal Mine beneath
Residential Area, Colorado Springs, CO

Video snapshot images during the
foamed-sand backfilling
